# Affordable Inspections

51 Bryant Street, Adamstown

17th June 2016

# VISUAL TIMBER PEST INSPECTION REPORT

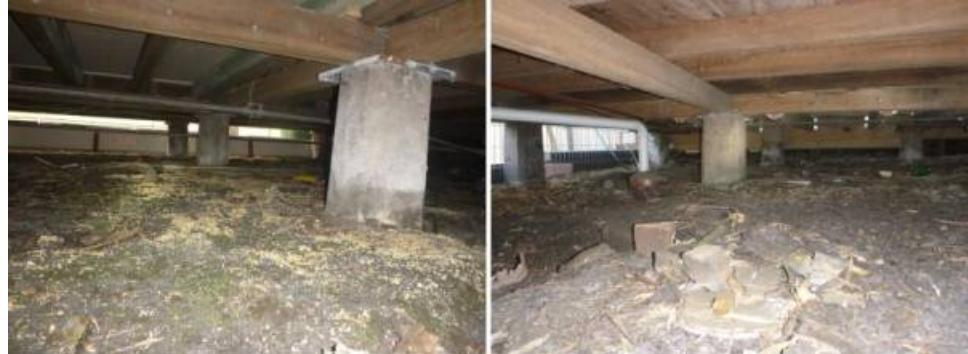
Various areas of the subfloor:

**Description** We note the general lack of ant capping or deficiencies in the fitment of ant capping. The purpose of ant capping is to reduce the risk of concealed termite attack. Ant capping should be repaired or installed where possible, if not possible, some form of termite management be that a chemical management system or a baiting system be installed..

The underfloor soil appears damp. This should be monitored on a regular basis as moist soil conditions are highly conducive to timber pest attack.

Bridging barriers of Piers can conceal termite entry. Bridging barriers to chimney area can conceal termite entry. Bridging of Barriers to Steps can conceal termite entry. Bridging Barriers to Front Verandah can conceal termite entry. Bridging Barriers to Rear Verandah can conceal termite entry.
