Building Inspection Report

Inspection Date: Thu, 13 Oct 2022

Property Address: 51A Iris St, Frenchs Forest NSW 2086,
Australia

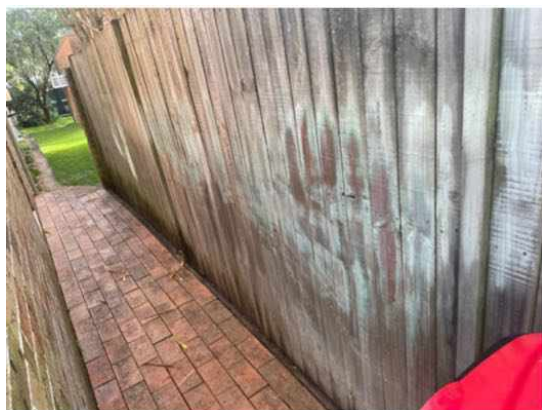
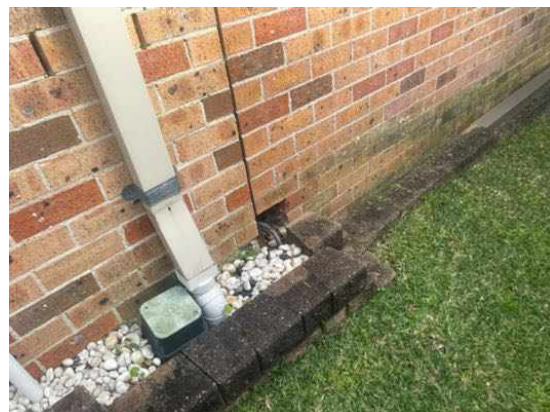
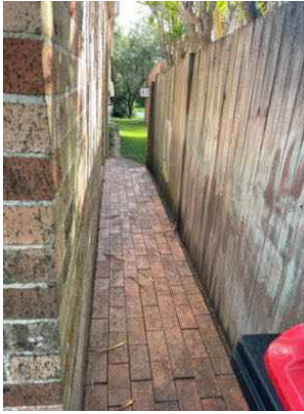
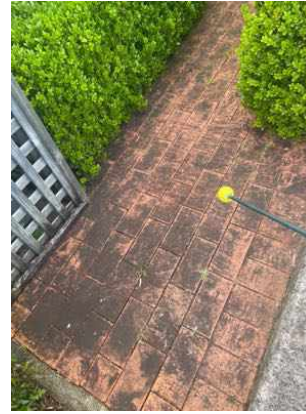
Defects 3.01

Building: Building 1
Location: All Areas
Finding: Evidence of excessive moisture was present at the time of inspection
Information: Excessive moisture can attract termites and produce conditions that promote termite attack fungal growth and wood decay.

Excessive moisture is generally caused by deteriorated inadequate or missing roof drainage leaking plumbing pipes or fixtures poorly plumbed HWS overflows or condenser units and poor site drainage.

It is highly recommended that all plumbing and drainage fixtures and fittings be maintained regularly in order to prevent excessive moisture being present in the external / internal property.

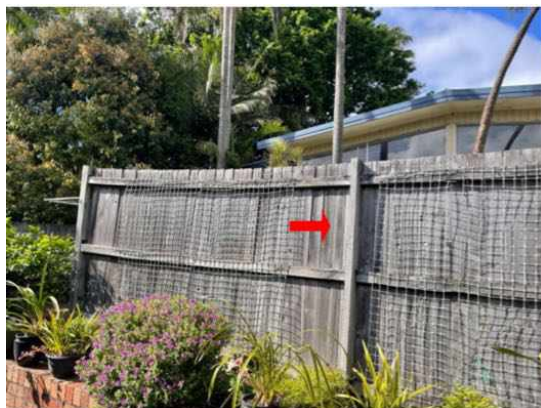
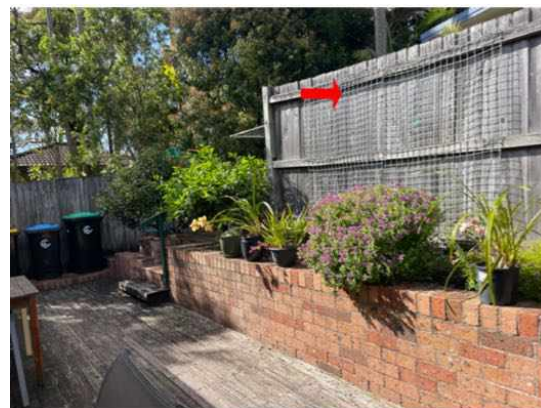
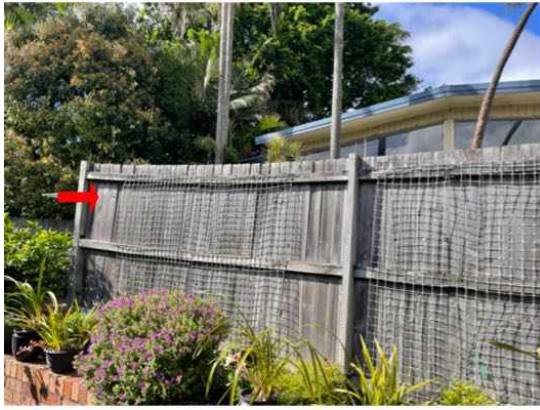
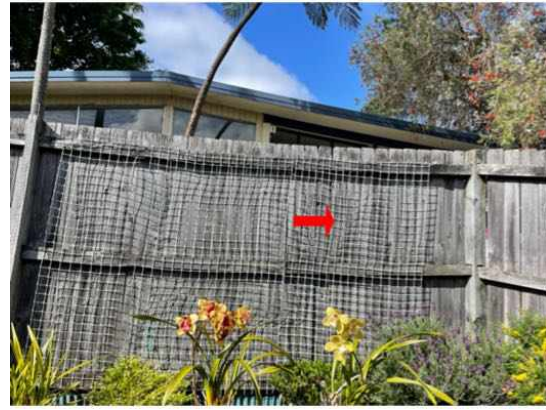
Defects 3.02

Building:	Building 1
Location:	Yard - Back
Finding:	Fencing - Deteriorated
Information:	It was noted at the time of inspection that sections of the fencing throughout the property have deteriorated. Typically fencing deteriorates due to age and or wear, rot and or rust which is generally expected for a structure of this age, due to prolonged exposure to weather conditions. Sometimes inadequate installation or maintenance can be to blame.

If left unattended, it is likely that further damage will occur. It is suspected that repair of several elements of the fencing may be required however replacement may be a consideration of the client also.

A licensed fencing contractor should be appointed to provide further advice and perform rectification works as necessary.

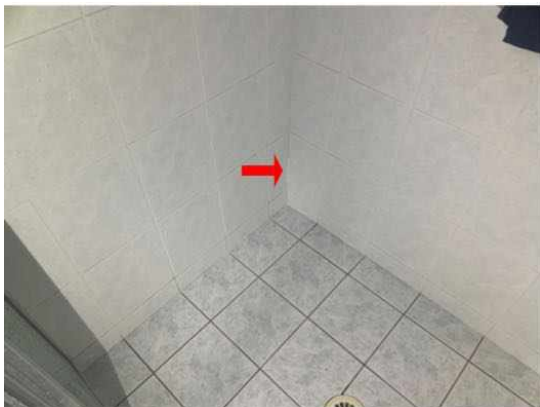
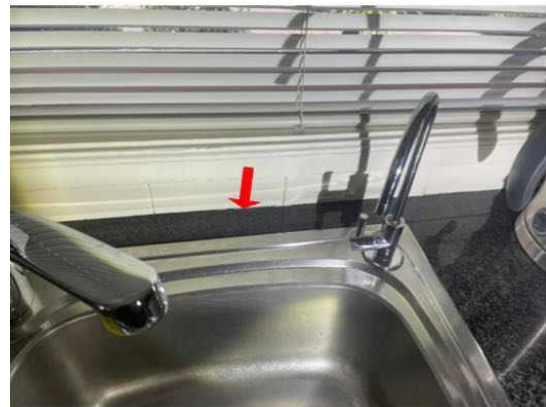
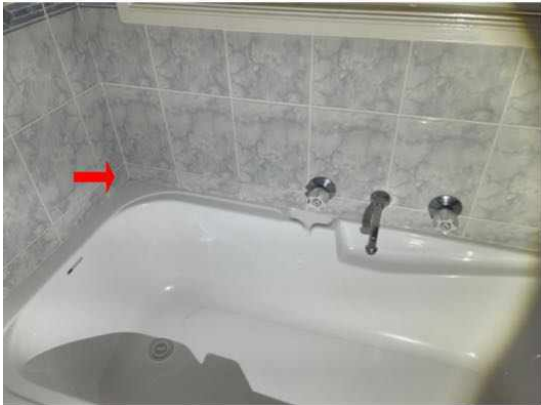
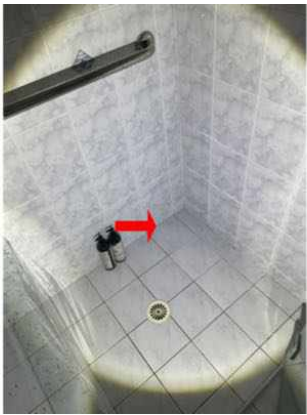
Defects 3.03

Building:	Building 1
Location:	All Areas
Finding:	Sealant - missing/ deteriorated
Information:	Flexible and mould resistant materials should be applied to affected areas to prevent any subsequent water damage that is likely to occur. Regular maintenance and replacement of damage or missing or damaged sealant is highly recommended to the wet areas, as this is a regular wear and tear defect.

Sealant in areas that come into regular contact with water should be maintained for the long term care of your property. A sealant specialist or tiling contractor should be appointed to complete these works as soon as possible

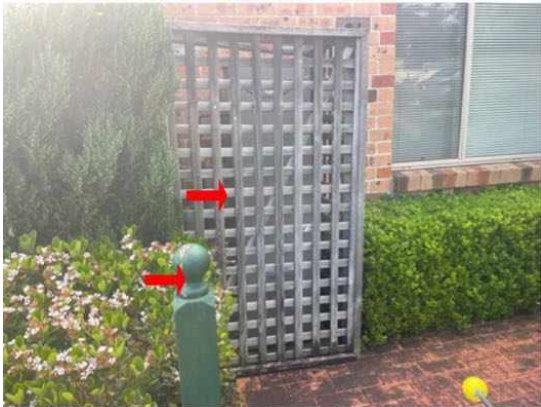
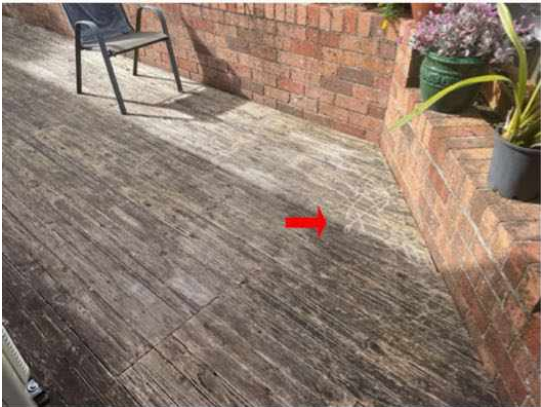
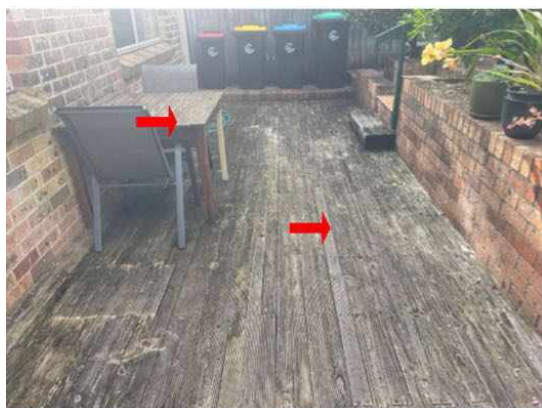
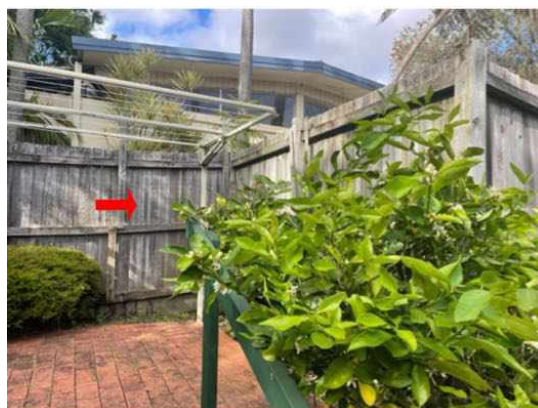
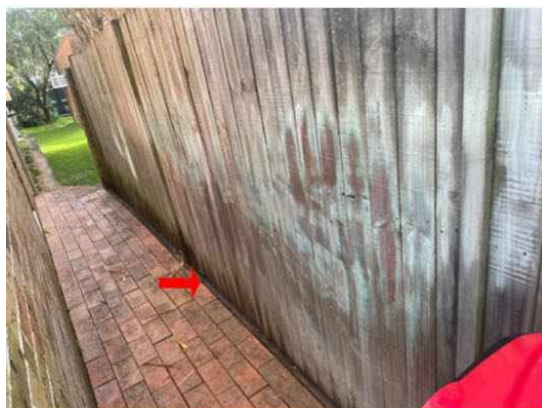
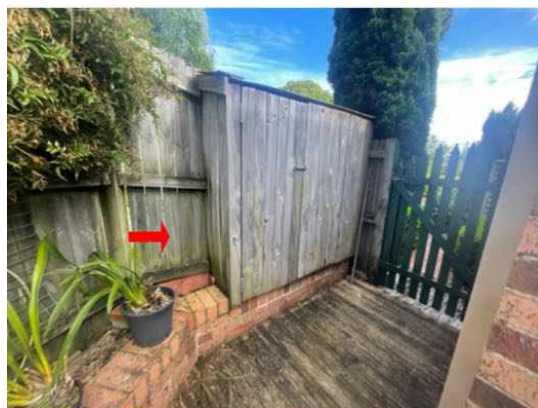
Defects 3.04

Building: Building 1
Location: All Areas
Finding: Timber - exposed to weather
Information: External timbers that are frequently exposed to harsh weather conditions require adequate protection in order to maintain their condition. Where timbers have not been painted or treated adequately, general deterioration is likely to occur at an accelerated rate.

If left unattended, replacement of these timbers is likely to be necessary in the short-term future. Adequate treatment of these timbers is required as soon as possible by a painting contractor or general handyman.

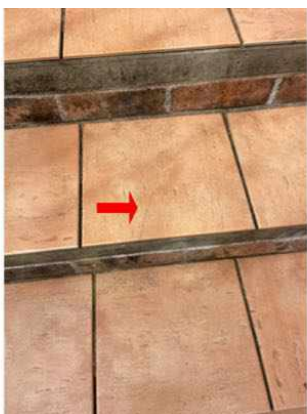
Defects 3.05

Building:	Building 1
Location:	Entry
Finding:	Cracked floor tiles
Information:	Cracking in the floor tiles was evident in this area at the time of inspection. It is suspected that this cracking has occurred as a result of minor settlement or shrinkage of the slab.

Cracked tiles throughout the household detract from the overall appearance of the affected areas however it is unlikely to create or lead to any secondary defects.

While not considered a matter of urgency, replacement of cracked floor tiles is recommended at the clients discretion. A tiling contractor may be appointed to perform these works. Where cracks become more numerous, contact a licensed building inspector for further investigation.

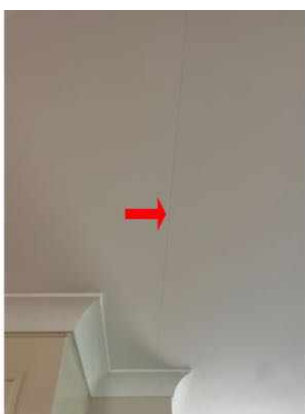
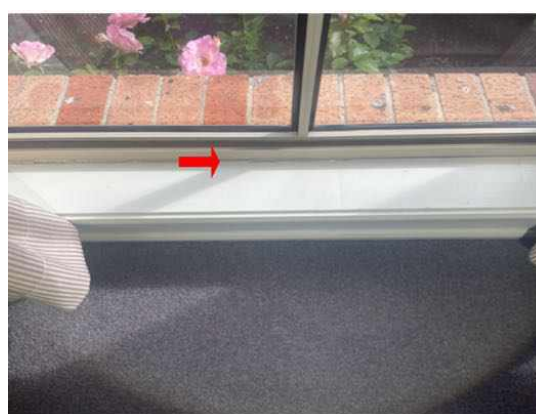
Defects 3.06

Building:	Building 1
Location:	All Areas
Finding:	Cracking - Damage Category 1 - Fine (up to 1mm)
Information:	Although fine cracks are quite noticeable, they are often only considered to be an appearance defect, and usually do not indicate any structural damage. Generally, the cause of a fine crack is indicative of a separation between building materials and finishes (e.g. paint, plaster, etc.) along joins.

Cracking of this nature can generally be repaired with minor sanding, filling and/or repainting. Such works should be performed by a qualified painter or a general handyman.

Monitoring of all cracking should be conducted frequently. Always contact a building inspector should cracks widen, lengthen, or become more numerous.

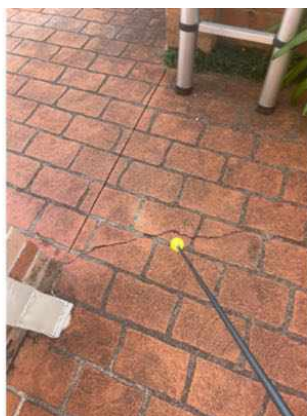
Defects 3.07

Building:	Building 1
Location:	Driveway
Finding:	Cracking - External Concrete Paving Damage Category 1 - Fine (less than 2mm)
Information:	Fine cracks were identified in external concrete paving. Although fine cracks are quite

noticeable, they are often only considered to be an appearance defect, and usually do not indicate any structural damage. To be considered a Category 1 or fine crack, the crack is found to be less than 2mm in width.

Generally the cause of a hairline crack in existing concrete paving such as driveways and pathways is indicative of the expansion and contraction of the concrete. Such causes are generally due to environmental factors, such as moisture levels, weather conditions, root systems of nearby trees or the soil types on which they are laid.

Fine cracks may also be due to poor original installation of the concrete. Factors such as poor compaction of the sub surface and/or inadequate reinforcing of the slab may create cracking and other secondary defects.

Monitoring of all cracking should be conducted frequently. Always contact a building inspector should cracks widen, lengthen, or become more numerous.

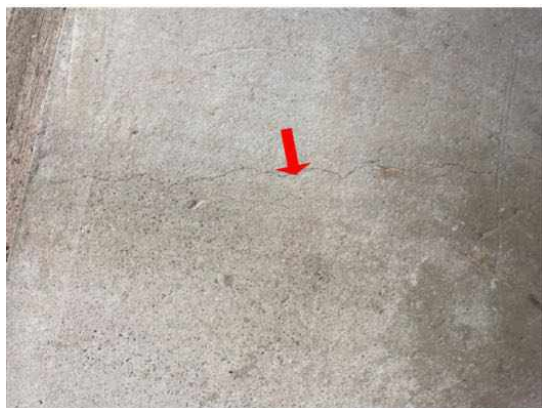
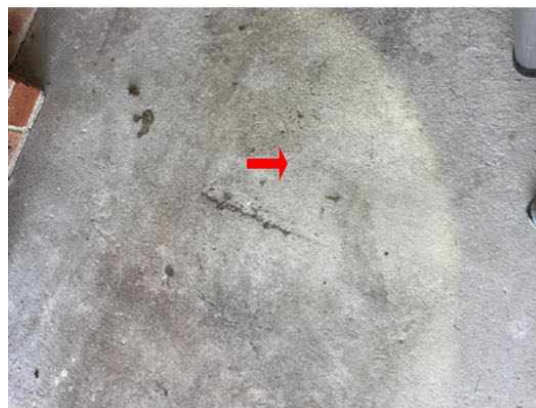
Defects 3.08

Building:	Building 1
Location:	Garage
Finding:	Cracking - Damage Category 0 - Hairline (less than 1mm)
Information:	Hairline cracks are very minor in nature and generally are only ever an appearance defect. While such cracking may be noticeable in some cases, it is quite common and does not indicate any structural damage.

Cracking of this nature can generally be repaired with minor sanding, filling and/or repainting. Such works should be performed by a qualified painter or a general handyman.

Monitoring of all cracking should be conducted frequently. Always contact a building inspector should cracks widen, lengthen, or become more numerous.

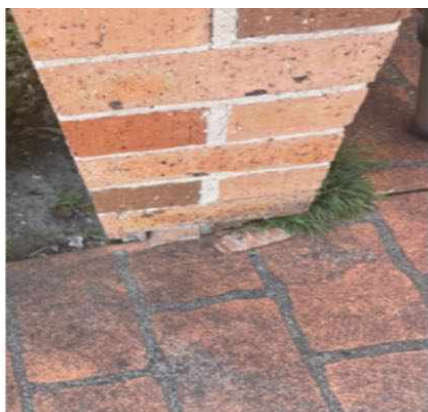
Defects 3.09

Building:	Building 1
Location:	All External Areas
Finding:	Brickwork - Cracking noticeable
Information:	Noticeable cracks are a common occurrence in external brickwork and are a likely result of age expected building movement, general expansion, and/or contraction of building materials in different weather conditions. Noticeable cracks in brickwork may develop if left unattended, with potential for necessitating major remedial works or replacement of the brickwork.

It is advised that a qualified bricklayer be appointed to provide necessary works to cracked brickwork to prevent any further damage. Such works should be conducted as soon as possible.

Always monitor these cracks and contact a builder should cracks widen, lengthen, or become more numerous.

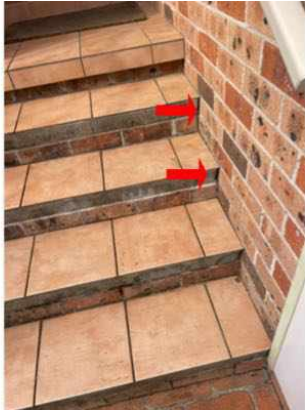
Defects 3.10

Building:	Building 1
Location:	Entry
Finding:	Sealant - missing

Information: Flexible and mould resistant materials should be applied to affected areas to prevent any subsequent water damage that is likely to occur. Regular maintenance and replacement of damage or missing or damaged sealant and grout is highly recommended to the wet areas, as this is a regular wear and tear defect.

Sealant and grouting in areas that come into regular contact with water should be maintained for the long term care of your property. A sealant specialist or tiling contractor should be appointed to complete these works as soon as possible

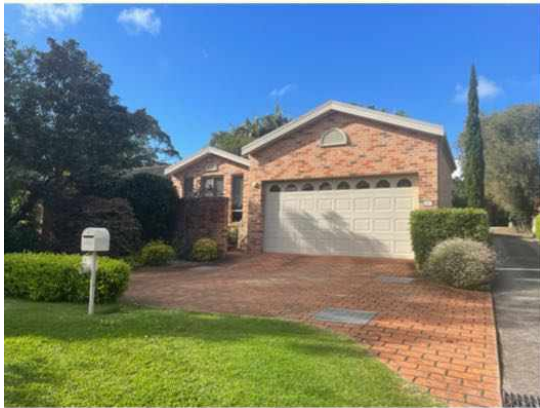
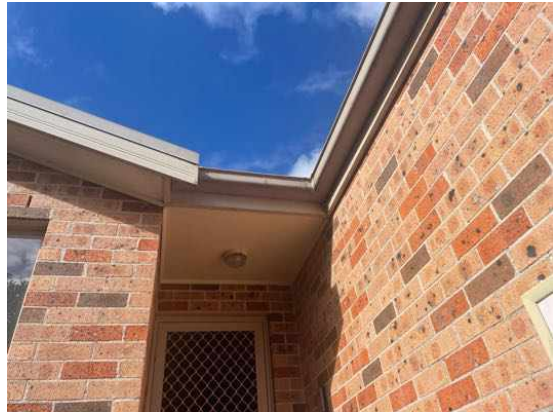
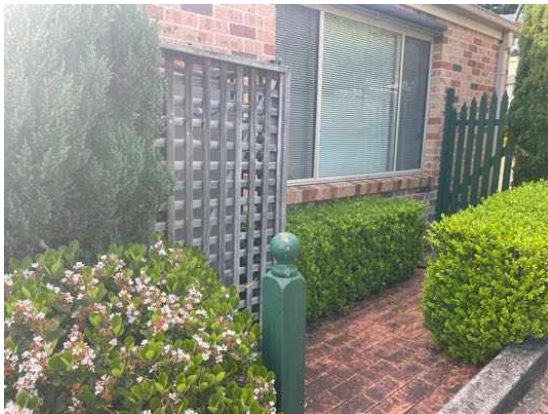
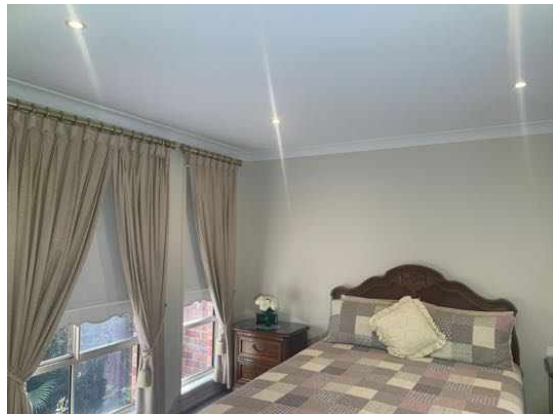
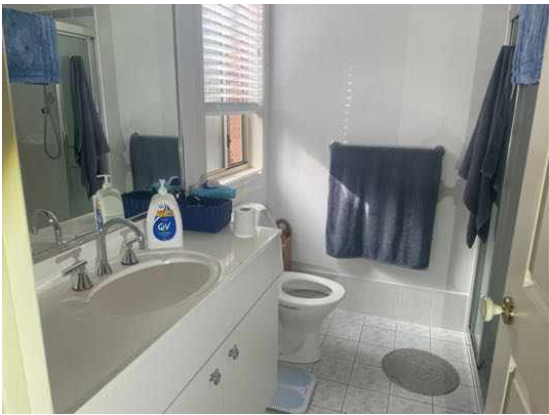
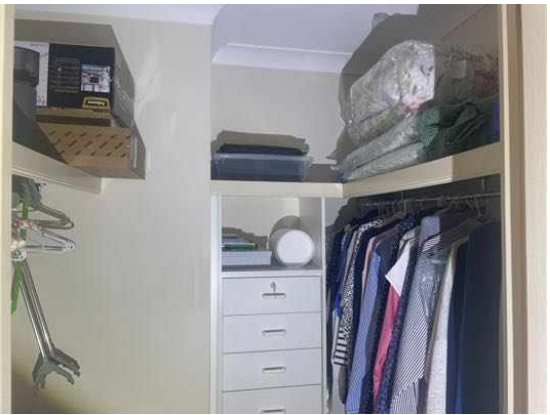
Building: Building 1
Location: All Areas
Finding: Additional Photos - Obstructions and Limitations
Information: These photographs are an indication of the obstructions and limitations which impeded full inspection of the property at the time of inspection. These obstructions can hide an array of defects and should be removed to allow full inspection to be carried out.

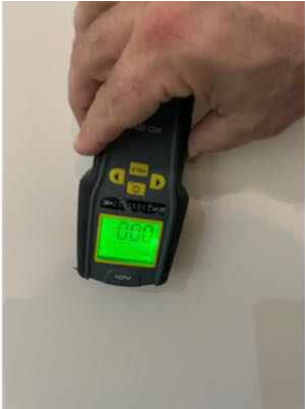
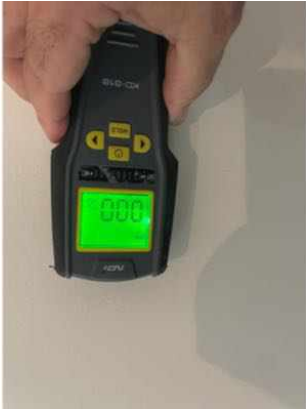
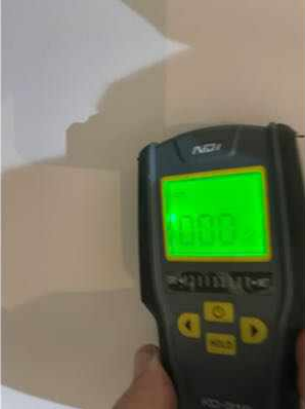
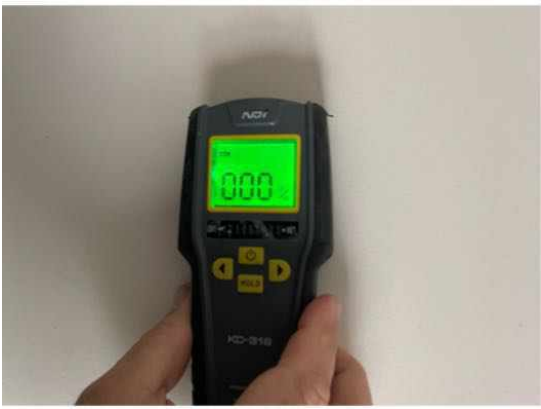
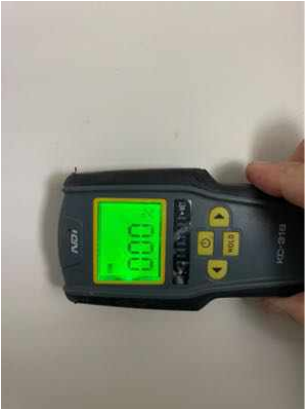
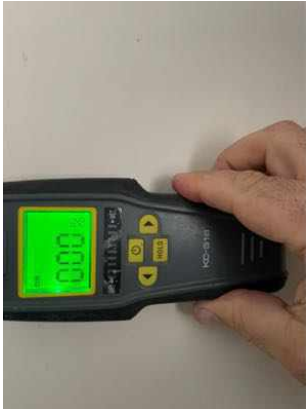
Building: Building 1
Location: All Areas
Finding: Moisture meter readings - low
Information: The moisture meter result for the areas inspected.

The moisture reading of 0-15% is quite normal and gives no cause for concern. However, moisture readings in excess of 15% indicate the need for further inspection.

Levels between 25-30% indicate that there may be water ingress, meaning that remedial work could be required.

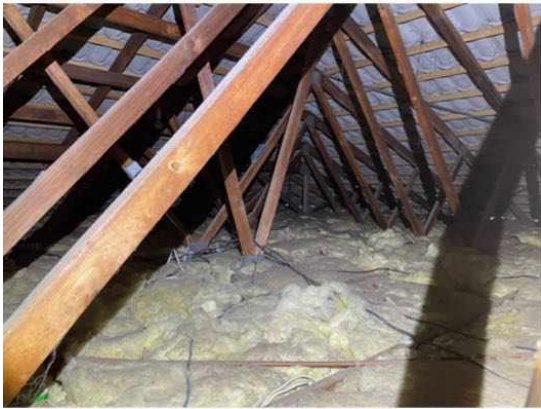
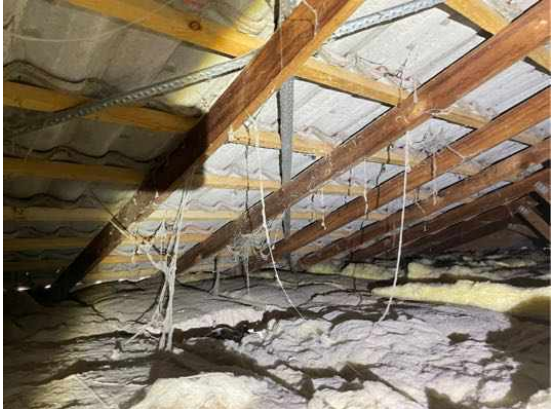
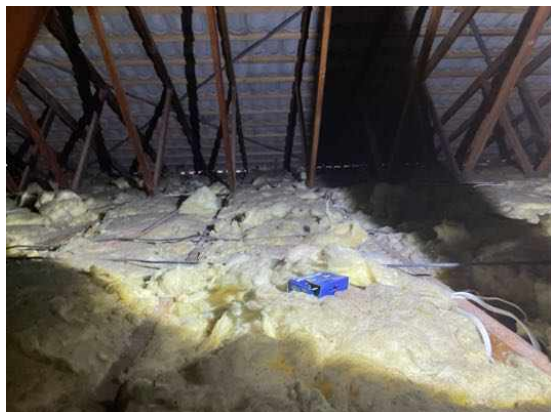
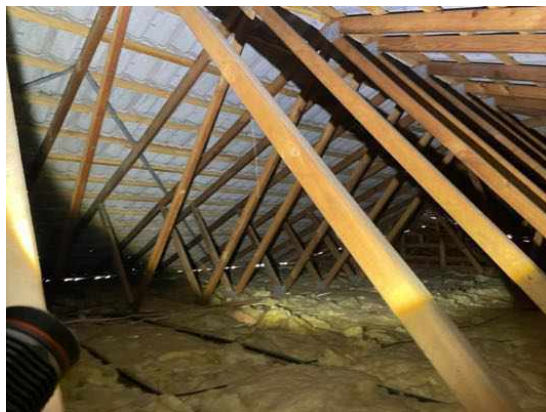
Building: Building 1
Location: Roof Void
Finding: Insulation- installed
Information: Insulation is under the roof sheeting. Insulation acts as an insulator that helps with heat reduction.

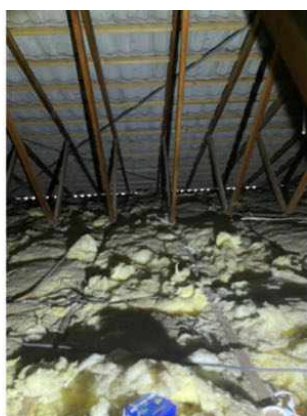
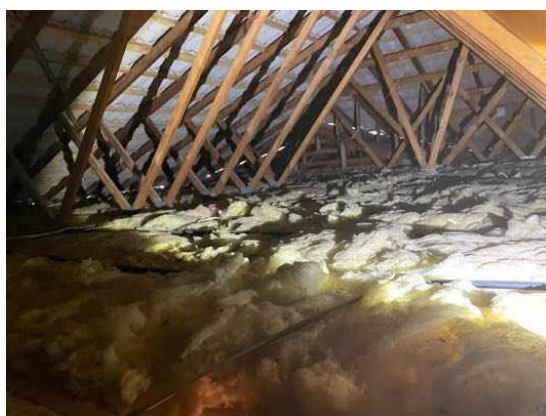
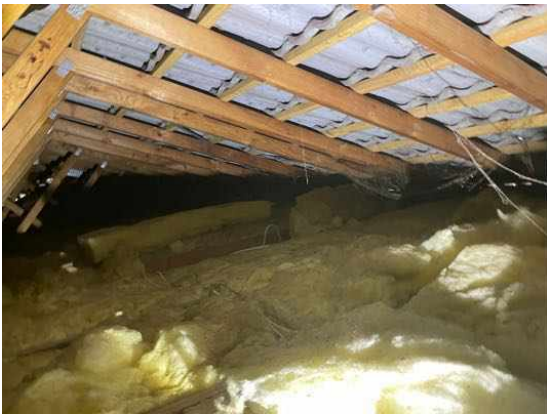
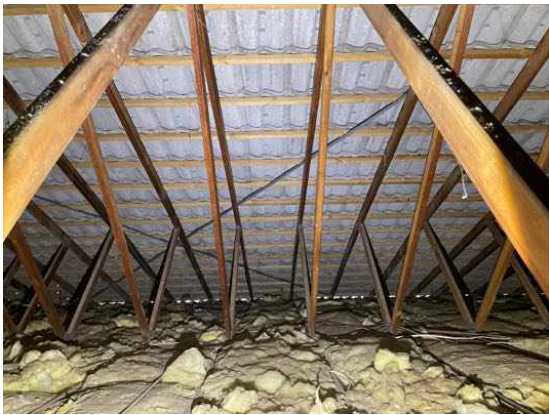
Building: Building 1
 Location: Roof Void
 Finding: Sarking - Not installed
 Information: Sarking is missing under the roof sheeting. Sarking acts as an insulator that helps with noise reduction and protects against water penetration. Sarking plays a key role in the operation and function of the overall roofing structure and its performance.

Although not a requirement at the time of construction, replacement of any missing building element is advisable (although this can be quite expensive to do after the time of construction). Where sarking is missing, regular inspections of the roof tiles for cracking and potential moisture penetration is required.

Sarking may be retrospectively fitted by a registered builder at the discretion of the client.

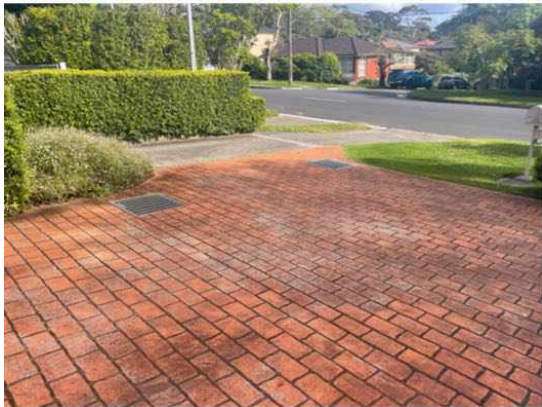
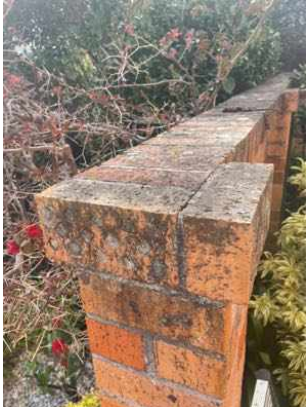
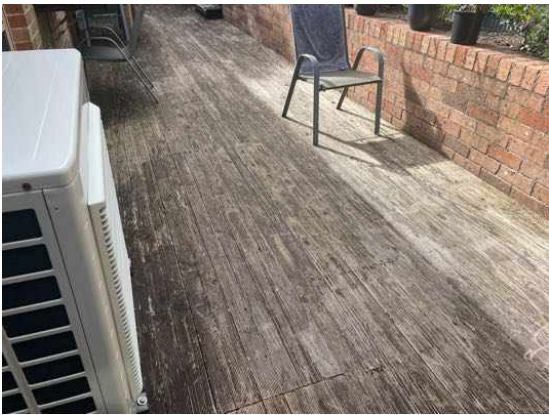
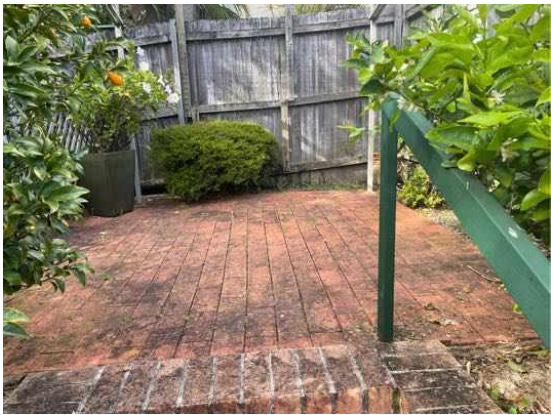
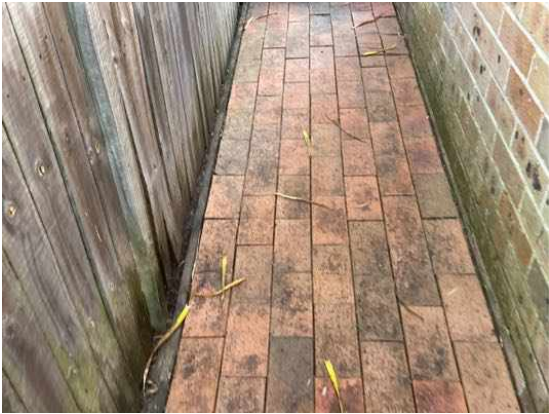
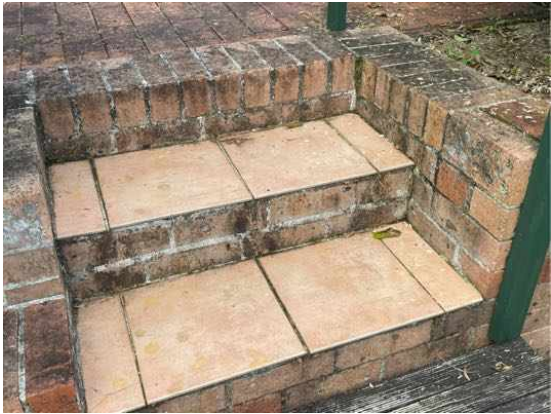
Building: Building 1
Location: All Areas
Finding: Surface - Requires cleaning
Information: Regular cleaning and maintenance improves the longevity of all building elements. A build up of dirt and debris can reduce the useful life of building materials and may result in earlier replacement of items being required.

Excessive dirt is also likely to lead to secondary hazards, including potential health hazards, as the building elements begin to harbour bacteria and/or mould. Remedial cleaning is recommended in order to improve the appearance of this area as well as to counteract the development of bacteria. Such works can be performed by a cleaning contractor and should be completed at the discretion of the client.
