Visual Building Inspection Report

22 Creer Place Narrabeena

Report Number 22 creer pl narrabeena 210616

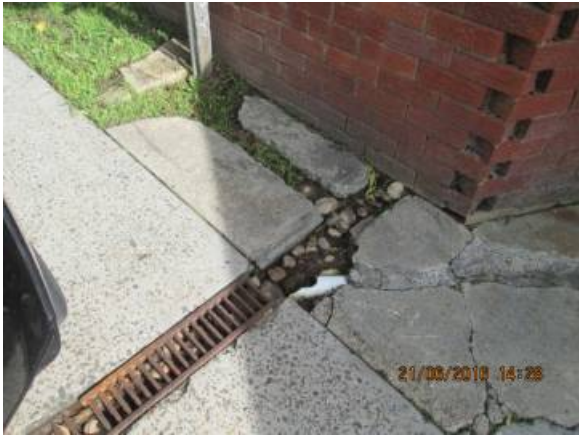
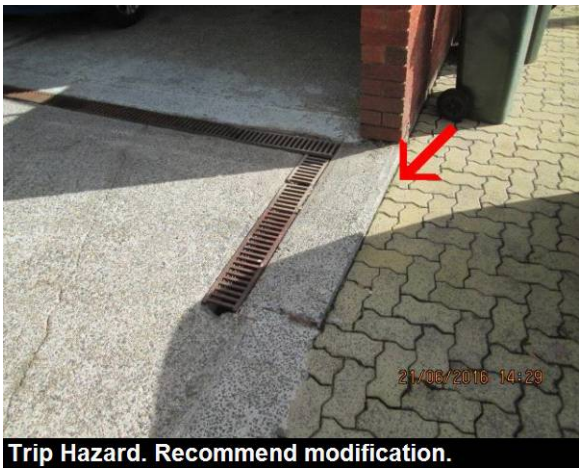
The concrete driveway has some visible cracking. Should this cracking deteriorate further it is recommended a structural engineer inspect & detail rectification. The driveway has a raised edge in some areas and will require repair, maintenance and or replacement. IMPORTANT NOTE: This is a potential trip hazard. Where a trip hazard is identified, it MUST be attended to &/or rectified to avoid the possibility of personal injury to oneself or other parties.

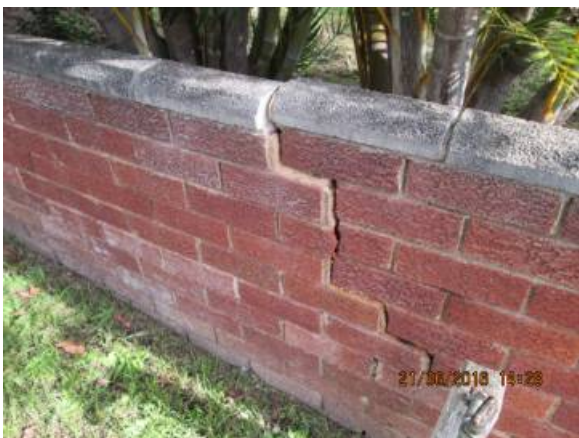
Drive way, northern, eastern, western and south elevations.

Brick fencing has signs of major cracking and will require repair and or replacement. The fences are mainly constructed from brick and block .

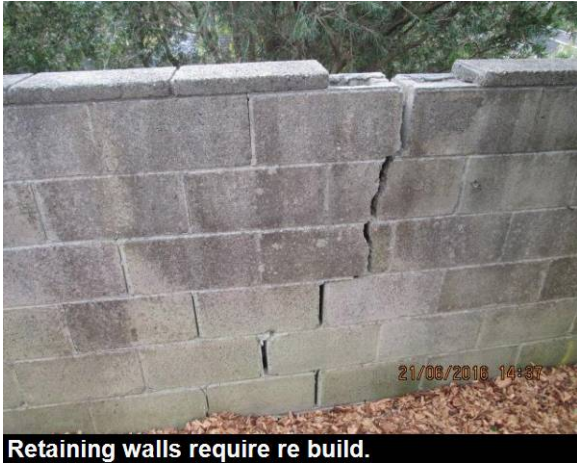
Northern elevation. Eastern elevation. Western elevation. Southern elevation.

The masonry retaining walls are in poor condition and should be repaired urgently. This is a safety hazard & must be remedied. A suitably qualified Structural or Geo technical Engineer should investigate the condition of the retaining wall. The retaining wall appears to be under designed. This is not a qualified engineer's opinion and we recommend that you seek advice from Structural or Geo technical Engineer.

Retaining walls require re build.

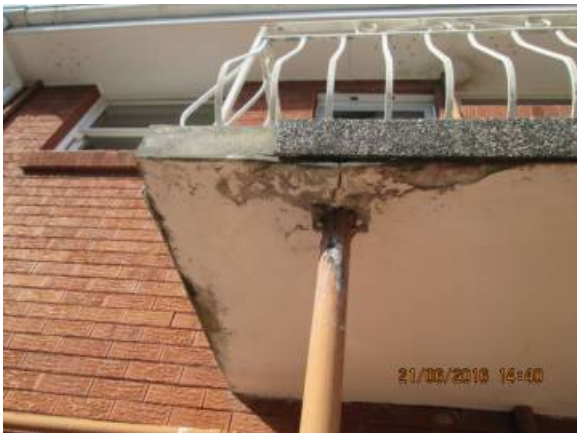
Position/Location:
Western elevation.

The stairs are constructed primarily from concrete. The handrails and balustrades do not comply with Standards for height and or spacing. Recommend they be updated. Concrete spalling is present to the stair area and this damage should be repaired. Recommend a structural engineer inspect & detail Remedial works.

The steps adjacent to verandah western end have subsided & require repair. This appears to be a drainage issue.

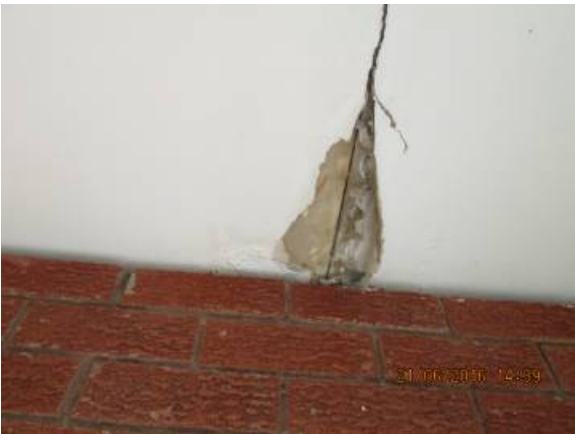
It is strongly recommended a structural engineer inspect & certify the structure for safety & structural integrity. The handrails and balustrades do not comply with Standards for height and or spacing. Recommend they be modified. Moisture damage to floor area. Active leak noted to the floor area. This could be due to a waterproofing defect or failure of the membrane. Significant rectification may be required and this could involve removal of floor finishes and installation of a new water proof membrane.

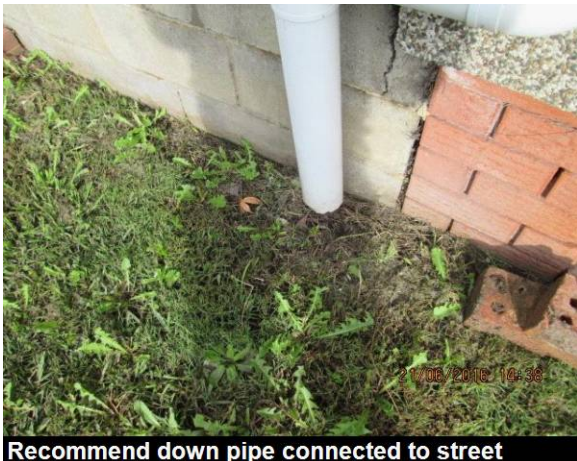
Gutters are damaged or rusting and should be repaired or replaced as necessary. Some down pipes do not appear to be connected to a legal stormwater dispersal system. This should be rectified.

Recommend down pipe connected to street

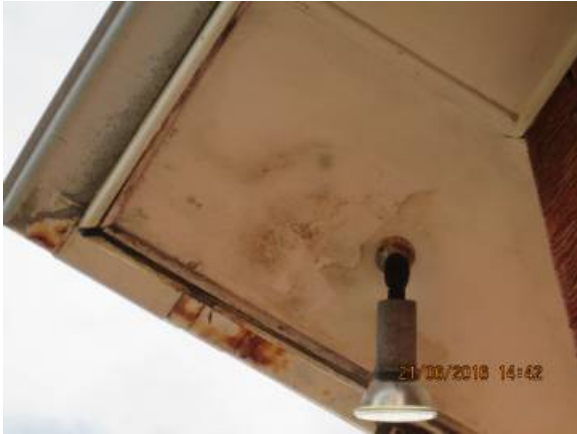
The eaves & or gables appear to be lined with asbestos fibre sheeting. Although we are not qualified in the detection of asbestos material, this item appears to contain asbestos. Asbestos material should not be disturbed or damaged and should only be removed or altered by a licensed asbestos removal contractor. Asbestos is hazardous to health and should be sealed to prevent exposure. Recommend an analysis by a qualified removal expert be conducted of these materials to confirm the amount and importance of the asbestos present, and the cost to seal or remove. Water damage/staining is present to the eaves linings and this may be due to damaged sarking, gutter backflow or leaking roof. Recommend this area be further evaluated by a roofing contractor.

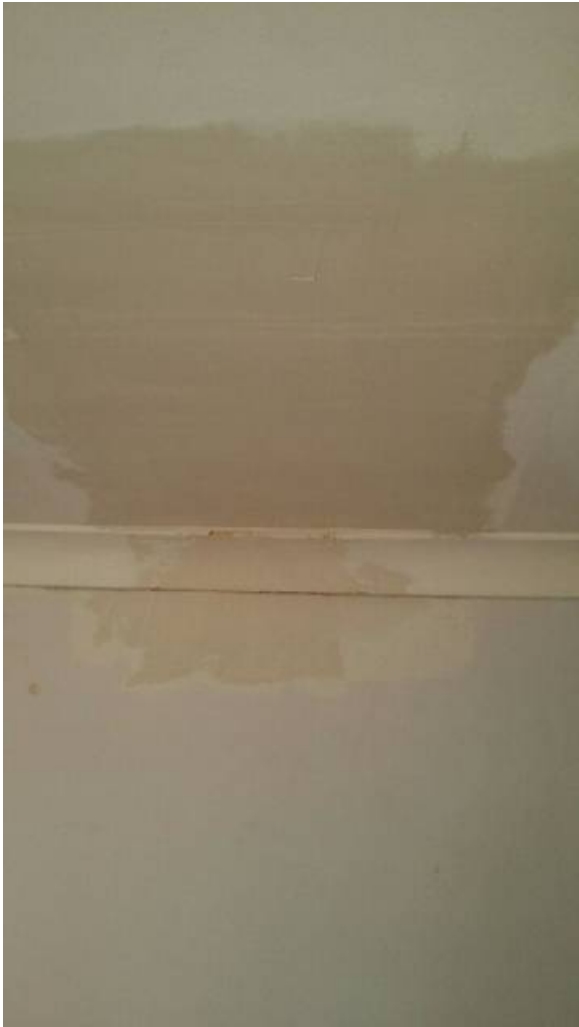
Laundry. Study. Ensuite.

Asbestos may be present to ceiling linings. Further testing will be required to ascertain the amount if any of asbestos fibre present. Cracking is present to cornices and these areas will require maintenance and or repair. There was evidence of water penetration through the ceiling below the ensuite and this area will require repair. Minor maintenance and or repairs are required prior to next repainting.

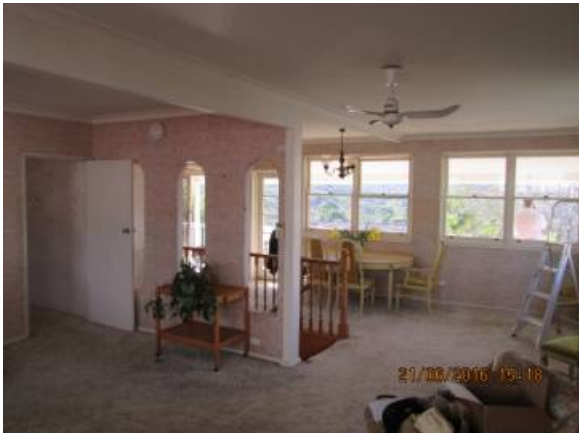
The stairs are constructed primarily from timber. The handrails and balustrades do not comply with Standards for height and or spacing. (This includes openings to wall adjacent to stairs). Recommend they be updated.

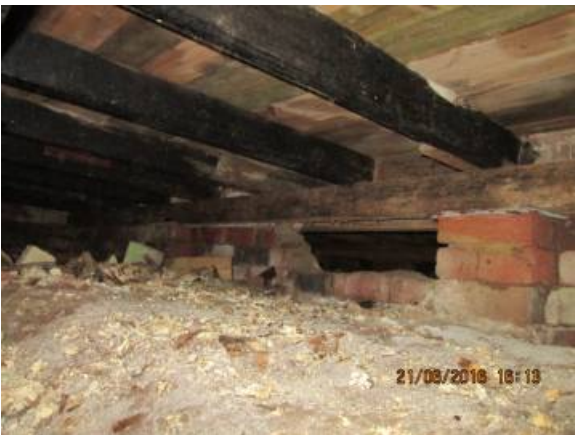
Crawl space was limited due to the method of construction resulting in a limited visual inspection from a distance being carried out. Access gained under ground floor NE bedroom ONLY.
