Building and Timber Pest Inspection Report

Inspection Date: Thu, 23 Jun 2022

Property Address: 43 Ralston Ave, Belrose NSW 2085,
Australia

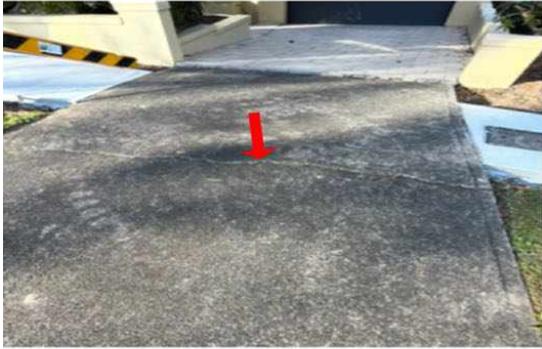
Defects 3.01

Building:	Building 1
Location:	All External Areas
Finding:	Cracking - External Concrete Paving Damage Category 2 - Distinct (less than 3mm)
Information:	Distinct cracks were identified in external concrete paving. Distinct cracks are generally found in older concrete paving, and may also present as a trip hazard as consequence of an uneven or curved surface.

General age and expected deterioration of the paved areas is a common cause of this type of cracking. However, expansion and contraction of the slab may also have occurred due to environmental factors. Such factors include variable moisture and weather conditions, the presence of trees and their roots having a settling or lifting affect on the soil, or the effect of load bearing, e.g. heavy vehicles over a sustained period of time.

Cracking to this degree may also be due to poor original installation of the concrete. Factors such as poor compaction of the sub surface and/or inadequate reinforcing of the slab may create cracking and other secondary defects.

Repairs are likely to be required to prevent further cracking and to reduce hazards associated with cracking, such as tripping. Monitoring of all cracking should be conducted frequently. Always contact a building inspector should cracks widen, lengthen, or become more numerous.

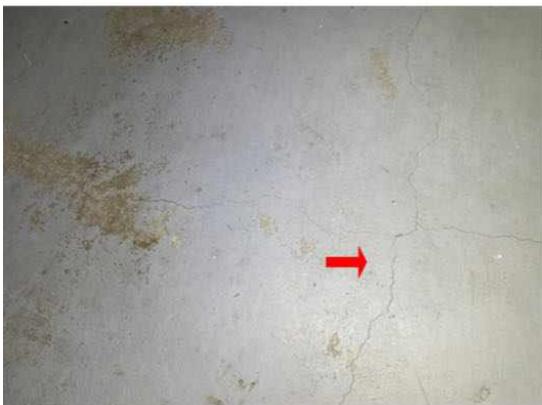
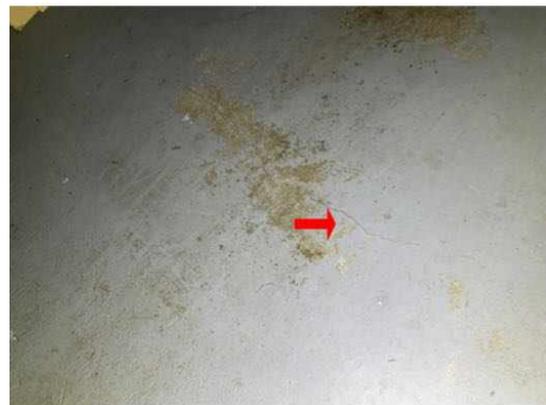
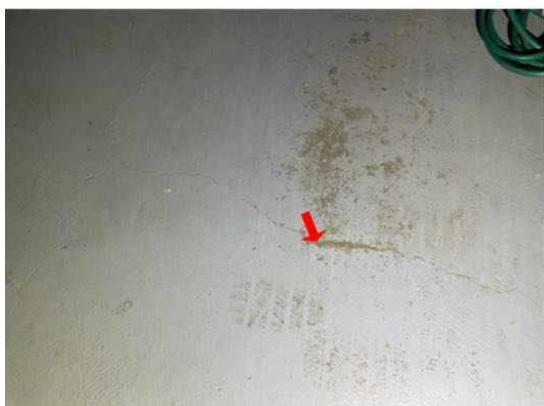
Defects 3.02

Building: Building 1
 Location: Garage
 Finding: Crack in concrete slab - Category 1
 Information: A crack coded as Category 1 was identified in the slab. A Category 1 crack is described as a fine but noticeable crack, with the slab at an otherwise reasonable level.

To be considered Category 1, the approximate width of the crack is less than 1.0mm, or a less than 10mm change in offset when a 3m straight edge is placed over the defect.

Category 1 cracks should be monitored for a period of 12 months. At the end of the monitoring period, identified cracks that are rated greater than Category 2 are considered defects, and require rectification.

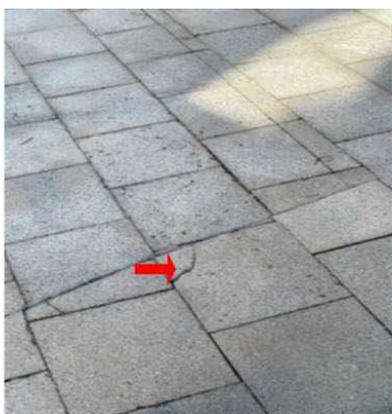
Defects 3.04

Building:	Building 1
Location:	Yard - Front
Finding:	Cracked pavers

Information: Cracking in the pavers was evident in this area at the time of inspection. It is suspected that this cracking has occurred as a result of minor settlement .

Cracked pavers detract from the overall appearance of the affected areas however it is unlikely to create or lead to any secondary defects.

While not considered a matter of urgency, replacement of pavers is recommended at the clients discretion.

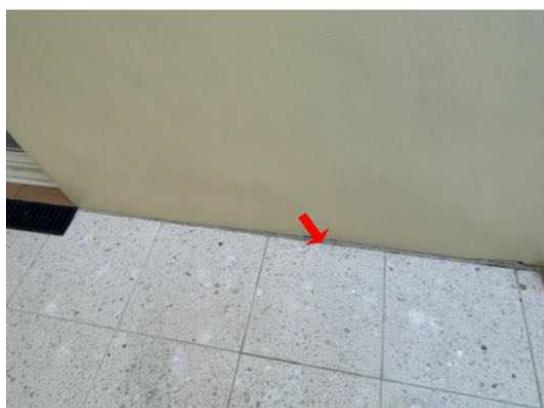
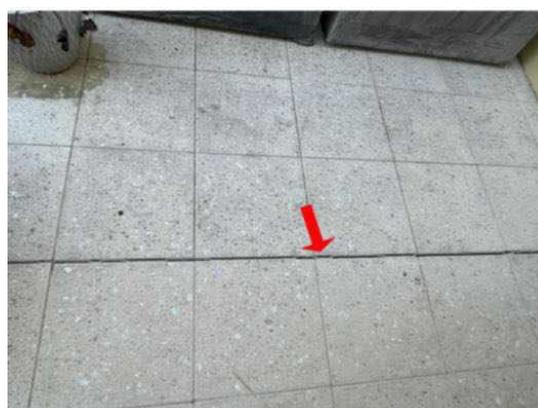
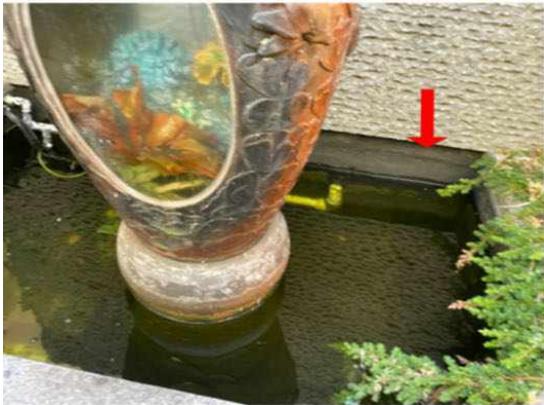
Defects 3.05

Finding: Sealant - missing/ deteriorated

Information: Flexible and mould resistant materials should be applied to affected areas to prevent any subsequent water damage that is likely to occur. Regular maintenance and replacement of damage or missing or damaged sealant and grout is highly recommended to the wet areas, as this is a regular wear and tear defect.

Sealant and grouting in areas that come into regular contact with water should be maintained for the long term care of your property. A sealant specialist or tiling contractor should be appointed to complete these works as soon as possible

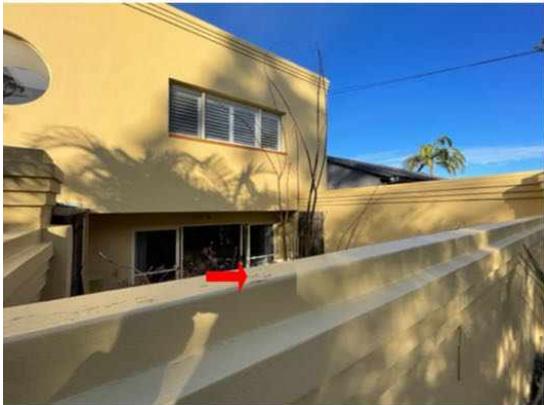
Defects 3.06

Building: Building 1
 Location: Yard - Front
 Finding: painting deteriorated
 Information: Whilst incomplete or missing paint finish is generally an appearance defect, it can also lead to the development of secondary building defects over time. Incomplete areas of paint finish exposes the area to moisture, potentially accelerating the deterioration of underlying building materials.

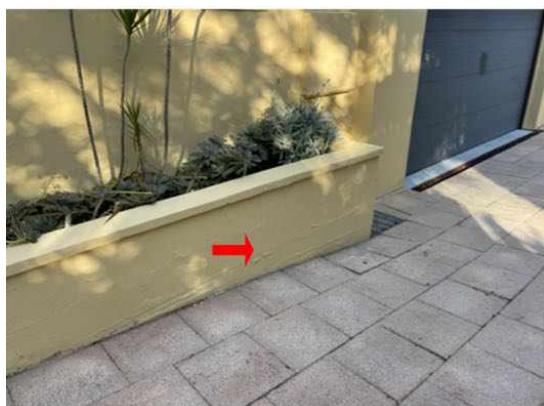
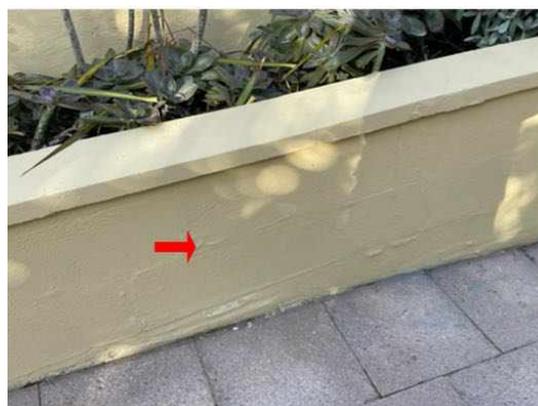
Defects 3.07

Building:	Building 1
Location:	Yard - Front
Finding:	Painted surface - Bubbling
Information:	Sections of paint in this area was found to have bubbled and deteriorated. Paint bubbling is generally an indication of excessive moisture in the area, that is currently hidden by the painted surface.

The presence of excessive moisture can have major implications on associated building elements if left unattended. While only seemingly minor at this stage, the damage cannot be determined due to the paint obstructing any further inspection of the damage.

It is highly advised that the affected paint be cleaned to allow a further, more invasive inspection by a licensed plumber. Failure to act on this defect may necessitate major works in the future.

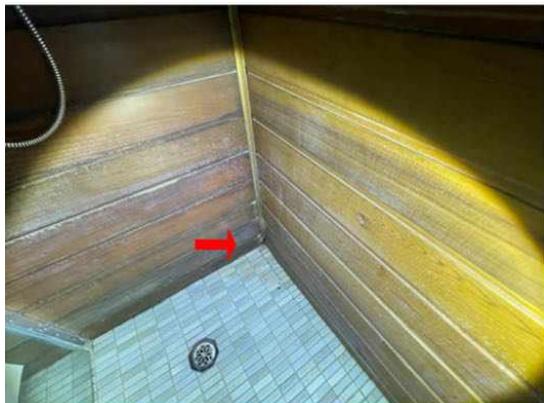
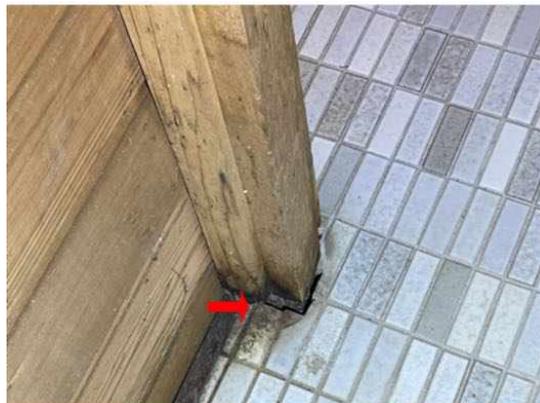
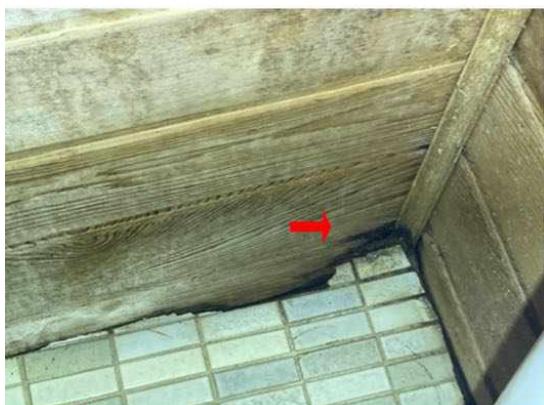
Defects 3.08

Building:	Building 1
Location:	Spa Area
Finding:	Wood rot
Information:	This building element shows evidence of wood rot. Wood rot, also known as Fungal Decay, occurs when timbers and other cellulose building materials are exposed to damp conditions on an ongoing basis. This could be the result of exposure to weathering over a prolonged period of time, or the attraction of excessive moisture from other abutting building materials. Contributing factors also include poor air ventilation in the area.

Early intervention and regular maintenance, particularly of exterior timbers, will prolong the useful life of these building elements. Prior to any works being performed, the cause of the moisture that has created the visible wood rot should be identified and addressed in a suitable manner.

A carpenter may also be required to replace affected building materials.

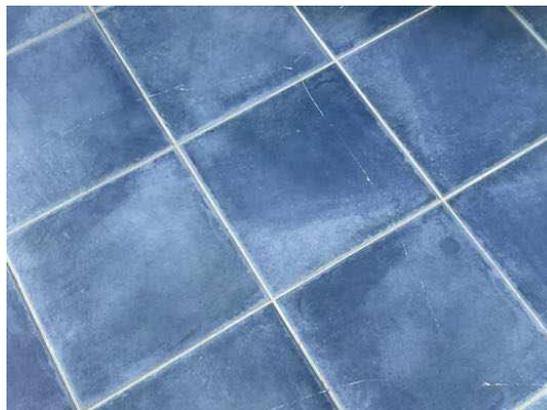
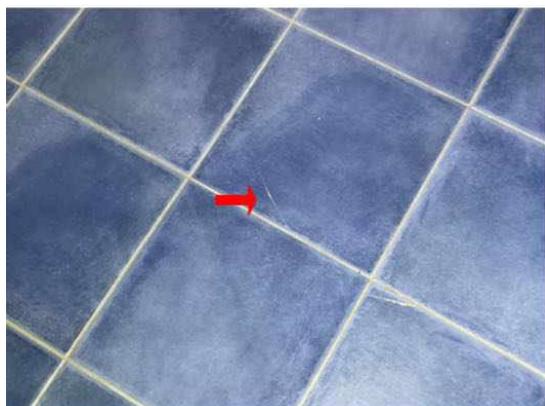
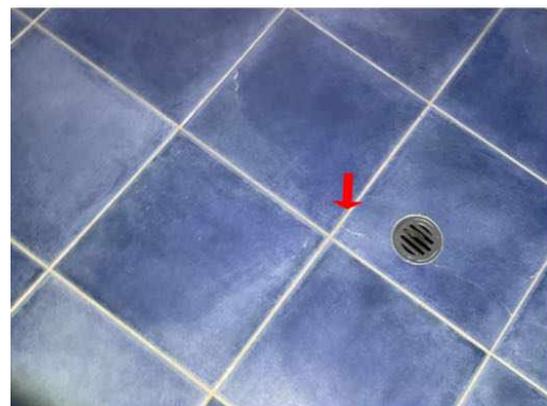
Defects 3.09

Building:	Building 1
Location:	Bathroom
Finding:	Floor tiles - Cracked
Information:	Cracking in the floor tiles was evident in this area at the time of inspection. It is suspected that this cracking has occurred as a result of the floor being uneven and lacking a solid or suitable foundation for the tiles to be laid on. Settlement in the floor foundations may also have caused movement and resulted in the cracking of tiles in this area.

Cracked tiles throughout the household detract from the overall appearance of the affected areas, as well as creating potential for water penetration to adjoining building elements. If left unmanaged, water damage may occur as a result of constant water penetration over a prolonged period of time.

While not considered a matter of urgency, replacement of cracked floor tiles is advised as a solution. A tiling contractor or general handyperson may be appointed to perform these works at client discretion. Where cracks become more numerous, consultation with a registered builder specialising in re-stumping may be required.

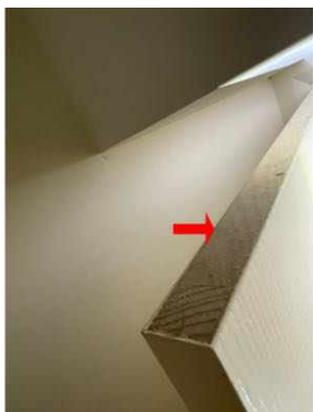
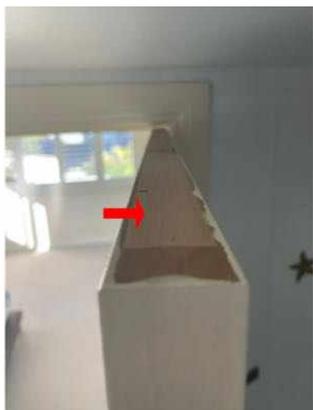
Defects 3.13

Whilst incomplete or missing paint finish is generally an appearance defect, it can also lead to the development of secondary building defects over time. Incomplete areas of paint finish exposes the area to moisture, potentially accelerating the deterioration of underlying building materials.

A painting contractor should be appointed to perform necessary works to aid the appearance of the affected area and to ensure the area is protected against further deterioration. Alternatively, the homeowner following manufacturer instructions may perform these works.

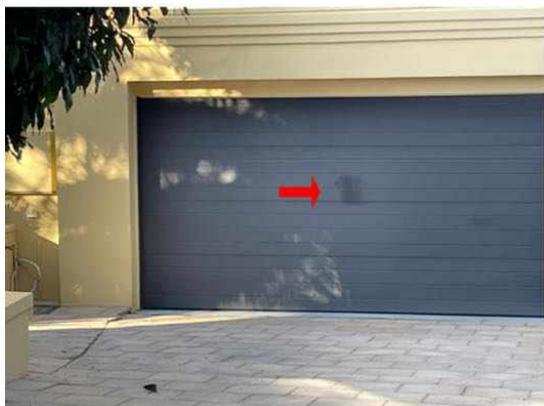
Defects 3.14

Information: Although detracting from the overall appearance, marked or stained surfaces do not indicate any operational or structural damage. This degree of surface damage is consistent with general wear and tear and is expected of a property of this age and condition.

Marked surfaces may be left as is at client discretion, as no repairs or replacement are necessarily required for this appearance defect. However, the client may wish to seek quotations for the cost to refurbish or replace the identified building element.

A painting or cleaning contractor may be appointed to rectify marked surfaces at the discretion of the client.

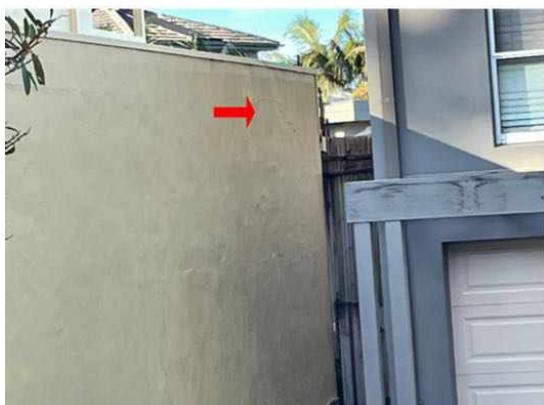
Defects 3.15

Building:	Building 1
Location:	Garage
Finding:	Brickwork - Step cracking
Information:	Step cracking was identified to the brickwork in this area at the time of inspection. Step cracking, which is similar to other forms of cracking, has a variety of possible causes. However, the most common is the subsidence of adjacent footings.

Step cracking is a relatively common defect, and is most likely to occur adjacent to windows, doors and other openings. Mortar failure in the gaps between affected bricks indicates the stresses and tensions affecting the wall.

Where step cracking is extensive or severe, the client is advised to consult a structural engineer. Minor step cracking can be used as a warning sign to address factors causing stress to the wall, which can include the effect of surrounding trees, water leaks, soil erosion, or even the presence of reactive soils in the surrounding area.

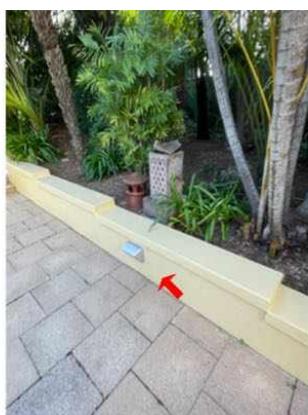
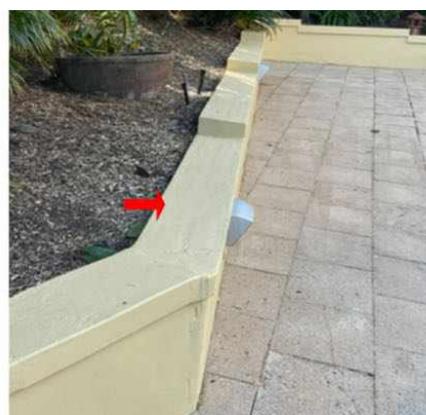
Defects 3.16

Building:	Building 1
Location:	
Finding:	Retaining wall - Defective

Information: The retaining wall in this area was found to be defective at the time of inspection. Generally, defective retaining walls are caused by poor original design or material use. However, deteriorated retaining walls may also be a result of substandard construction, poor site drainage or unmanaged stormwater flows.

If left unmanaged, the retaining wall may become a safety hazard if it continues to destabilise. Where retaining walls further rot and decay, an environment is created that is conducive to termite and pest infestation.

Significant repair and replacement should be expected. Where retaining walls are considered structural walls, a structural engineer / surveyor should be consulted regarding required remedial works. Otherwise, a landscaper or retaining wall installer may be appointed to repair or replace the wall, at the discretion of the client.

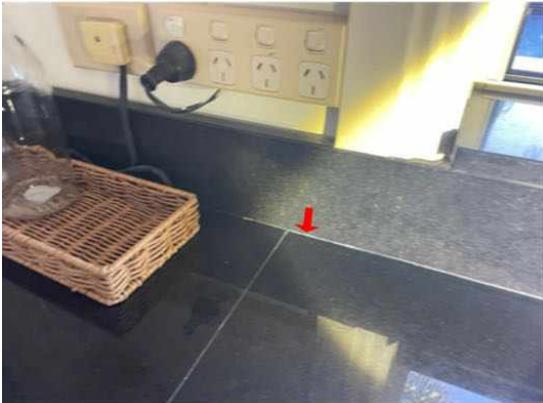
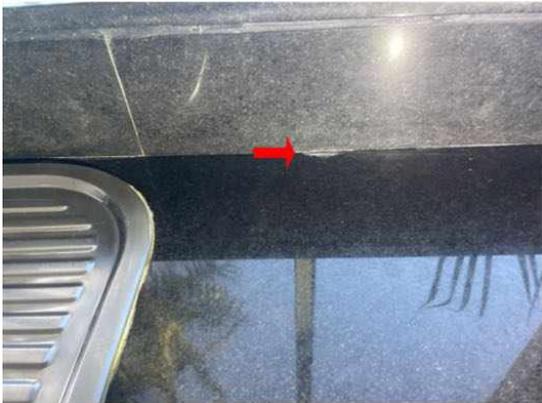
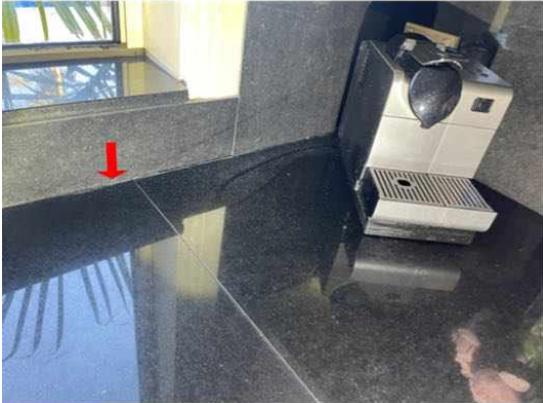
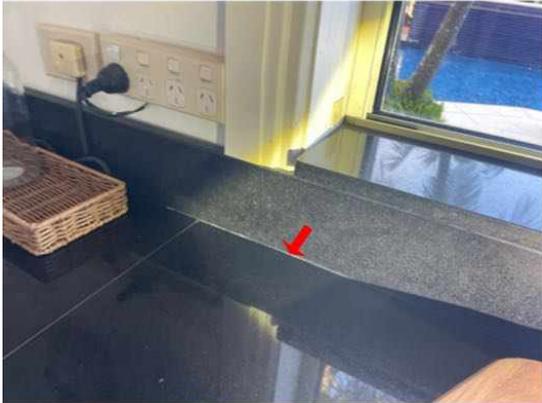
Defects 3.19

Building:	Building 1
Location:	Kitchen
Finding:	Sealant - missing/ deteriorated
Information:	Flexible and mould resistant materials should be applied to affected areas to prevent any subsequent water damage that is likely to occur. Regular maintenance and replacement of damage or missing or damaged sealant and grout is highly recommended to the wet areas, as this is a regular wear and tear defect.

Sealant and grouting in areas that come into regular contact with water should be maintained for the long term care of your property. A sealant specialist or tiling contractor should be appointed to complete these works as soon as possible

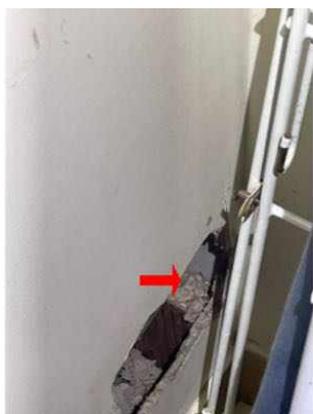
Defects 3.21

Finding: Surface - Holes
 Information: Holes in surfaces are generally indicative of impact damage, whether accidental or deliberate, or a failing of the surface material.

Where holes are apparent in the surface of a building material, the surface is no longer sealed against water penetration or further impact damage, which may lead to additional damage to the surrounding surface.

Repair or replacement of the affected building element is recommended as soon as possible to ensure that any secondary defects are minimised. A qualified carpenter or general handyperson should be appointed to perform these works.

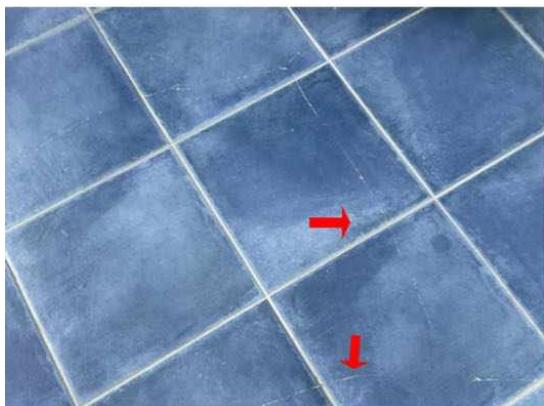
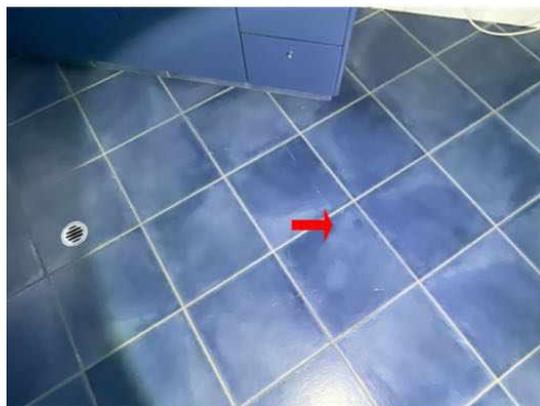
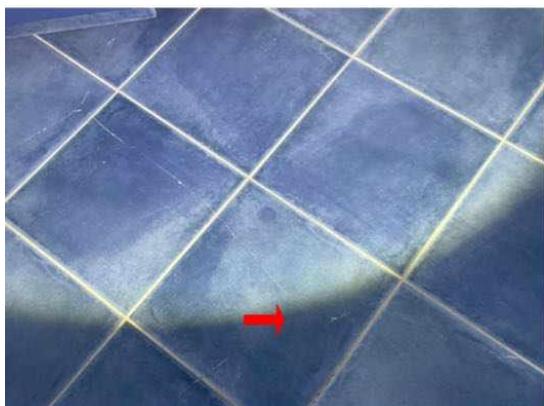
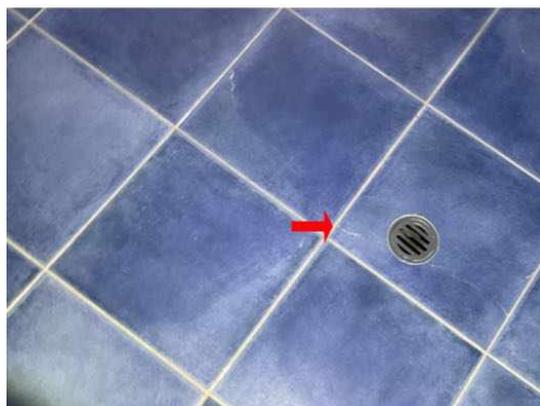
Defects 3.22

Building: Building 1
 Location: Ensuite
 Finding: Tiles - Cracked or damaged
 Information: Cracking was evident to the tiling in this area at the time of inspection. While the cracking appears to be minor, this area is frequently exposed to water, allowing potential for water penetration into adjoining sections of walls or flooring.

If left unmanaged, water penetration to these areas may lead to subsequent water damage, which is likely necessitate repair work to affected building elements.

A tiling contractor should be appointed to ensure that no further water damage occurs. The re-application of silicone and grouting throughout remaining tile work is also advised, to further protect the area against water penetration.

Where water penetration has led to water damage, appointment of a relevant tradesperson may be required to repair damaged building elements.

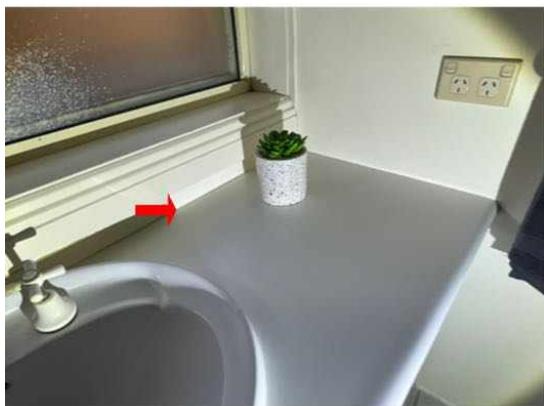
Defects 3.23

Building:	Building 1
Location:	Bathroom
Finding:	Sealant - missing/ deteriorated
Information:	Flexible and mould resistant materials should be applied to affected areas to prevent any subsequent water damage that is likely to occur. Regular maintenance and replacement of damage or missing or damaged sealant and grout is highly recommended to the wet areas, as this is a regular wear and tear defect.

Sealant and grouting in areas that come into regular contact with water should be maintained for the long term care of your property. A sealant specialist or tiling contractor should be appointed to complete these works as soon as possible

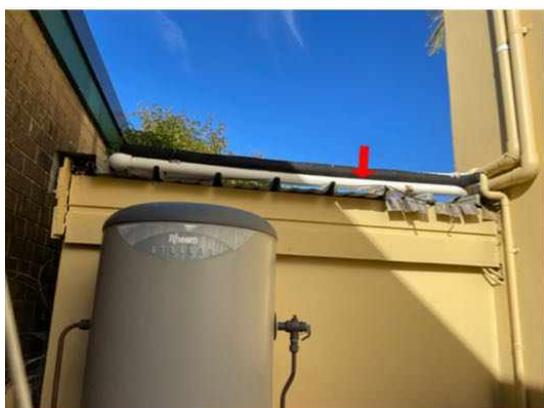
Defects 3.24

Building:	Building 1
Location:	Yard - Side
Finding:	Roof plumbing - Missing
Information:	Some sections of the roof are not adequately drained via gutters and downpipes. Gutters and downpipes that are not installed adequately are likely to result in excessively damp conditions against the exterior surfaces and around the base perimeter of the building.

Excessive moisture creates an environment which accelerates the deterioration of building elements in the area, as well as being conducive to termite and pest infestation. Such an environment is likely to necessitate repair and/or replacement of building elements, which are prone to sustaining wood rot, rust or corrosion.

A roofing plumber should be appointed as soon as possible to install relevant roof plumbing materials. Depending on the extent of the damage, repair and/or replacement of damaged building elements may be required.

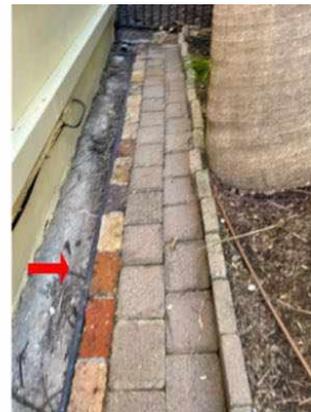
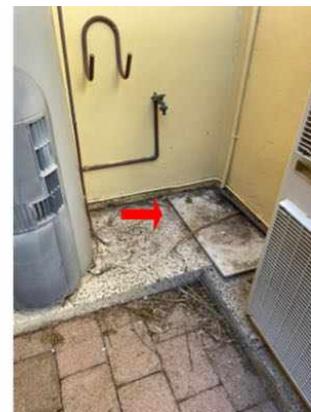
Defects 3.25

Building:	Building 1
Location:	All Internal Areas

Finding: Evidence of excessive moisture was present at the time of inspection
 Information: Excessive moisture can attract termites and produce conditions that promote termite attack fungal growth and wood decay.

Excessive moisture is generally caused by deteriorated inadequate or missing roof drainage leaking plumbing pipes or fixtures poorly plumbed HWS overflows or condenser units and poor site drainage.

It is highly recommended that all plumbing and drainage fixtures and fittings be maintained regularly in order to prevent excessive moisture being present in the external / internal property.

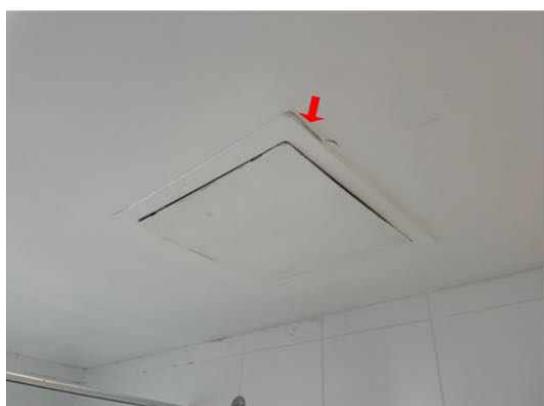
Defects 3.27

Building:	Building 1
Location:	Bathroom
Finding:	Cracking - Damage Category 1 - Fine (up to 1mm)
Information:	Although fine cracks are quite noticeable, they are often only considered to be an appearance defect, and usually do not indicate any structural damage. Generally, the cause of a fine crack is indicative of a separation between building materials and finishes (e.g. paint, plaster, etc.) along joins.

Cracking of this nature can generally be repaired with minor sanding, filling and/or repainting. Such works should be performed by a qualified painter or a general handyman.

Monitoring of all cracking should be conducted frequently. Always contact a building inspector should cracks widen, lengthen, or become more numerous.

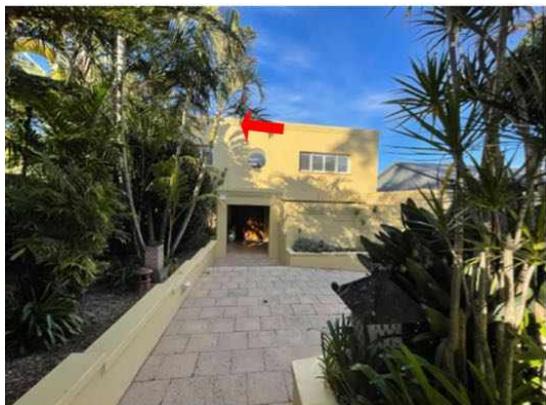
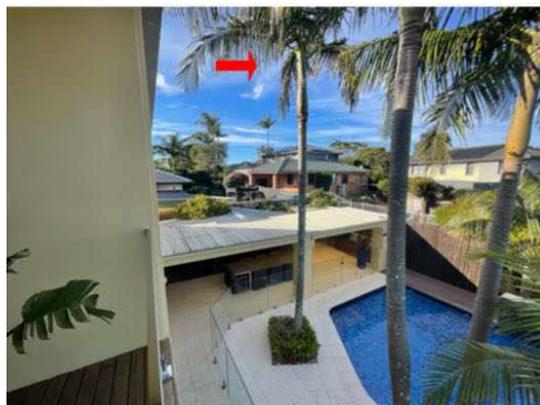
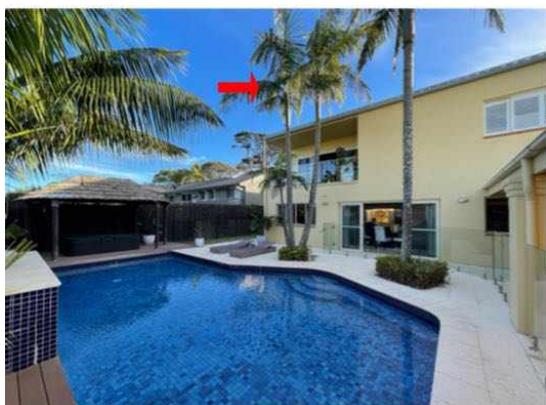
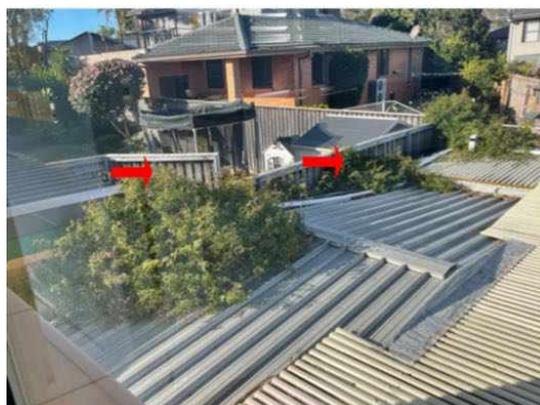
Noted Item

Building:	Building 1
Location:	All Areas
Finding:	Trees - Overhanging and filling gutters
Information:	Overhanging trees often result in excessive amounts of leaf debris accumulating in gutters.

Such works should be performed by the homeowner; however, appointment of a landscape contractor or an arborist may be required. Consultation with a licensed roof plumber is required where guttering has been damaged.

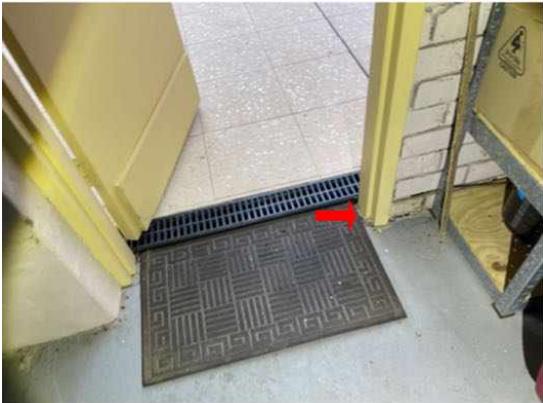
Noted Item

Building:	Building 1
Location:	All Areas
Finding:	Building materials in direct ground contact - conducive to termites
Information:	Where timber elements are in direct contact with the ground and consequently moisture or dampness they become conducive to termite activity.

The removal of any such materials that may be conducive to termite activity should be removed as soon as possible to minimise the risk of termite attack.

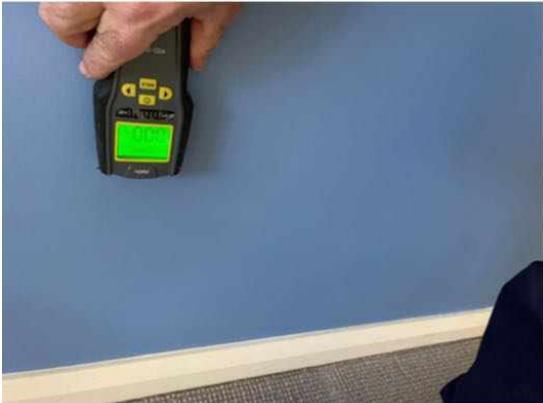
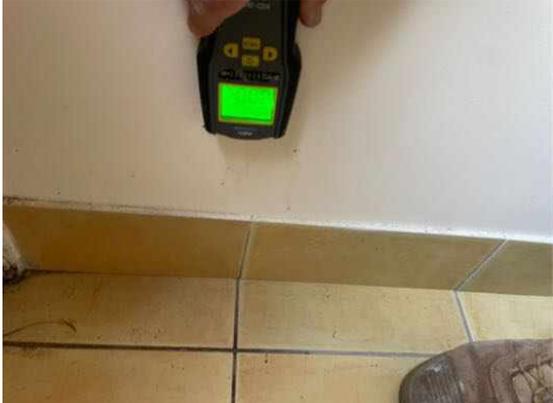
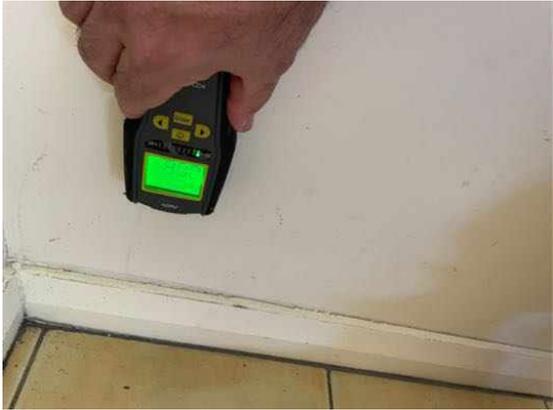
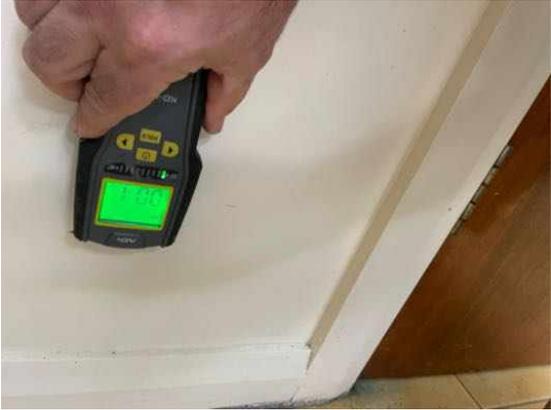
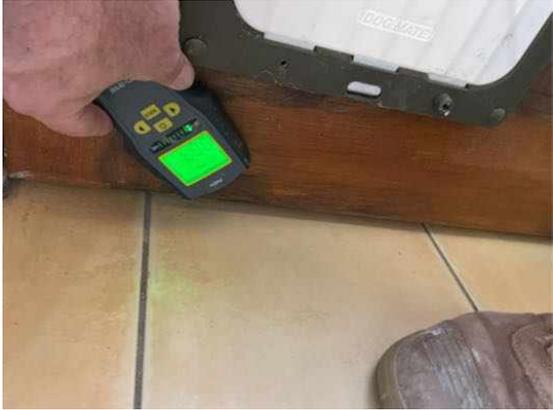
Noted Item

Building: Building 1
Location: All Areas
Finding: Moisture meter readings
Information: The moisture meter result for the areas inspected.

Levels between 25-30% indicate that there may be water ingress, meaning that remedial work could be required.
