## Section D Significant Items

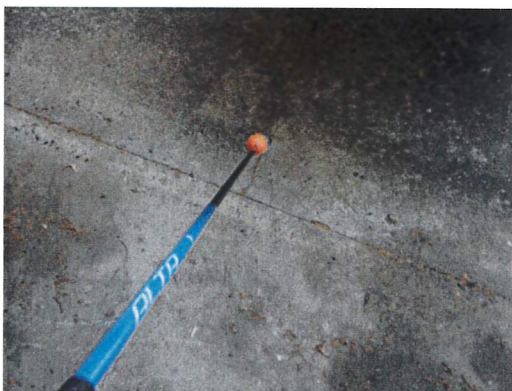
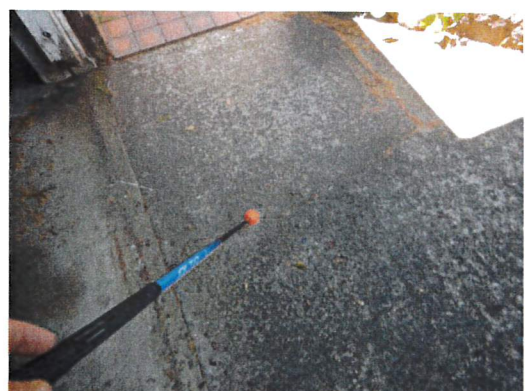
### Defects 3.1

| Location: | Driveway |
| Finding: | Crack in concrete slab - Category 2 |
| Information: | A crack coded as Category 2 was identified in the slab. A Category 2 crack is described as a distinct crack, with the slab being noticeably curved or changed in level. |
| | To be considered Category 2, the approximate width of the crack is $<1.0\text{mm}$ , or a change in offset of $<10\text{mm}$ when a 3m straight edge is placed over the defect. |

| | Category 2 cracks to slabs should be monitored for a period of 12 months. At the end of the monitoring period, cracks rated greater than Category 2 are considered defects that require rectification. |

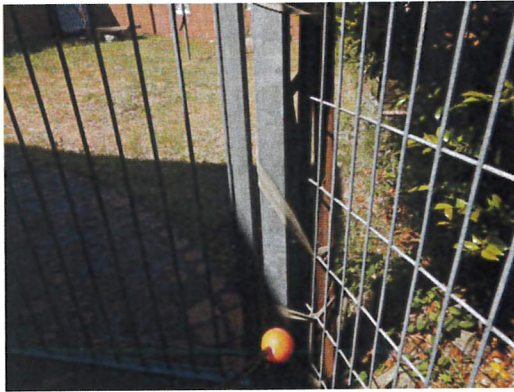
### Defects 3.11

| Location: | Yard - Back |
| Finding: | Gate - Broken |
| Information: | Breakage occurs generally when the building materials have either aged and decayed, or as a result of damage (accidental or deliberate). |

Repair and/or replacement of broken elements is advised to ensure that additional secondary defects do not arise as a consequence. Such works are necessary, as all building elements play a key role in the operation and function of the overall structure and its performance.

A relevant tradesperson should be appointed to repair or replace the affected building element prior to any subsequent damage being caused.

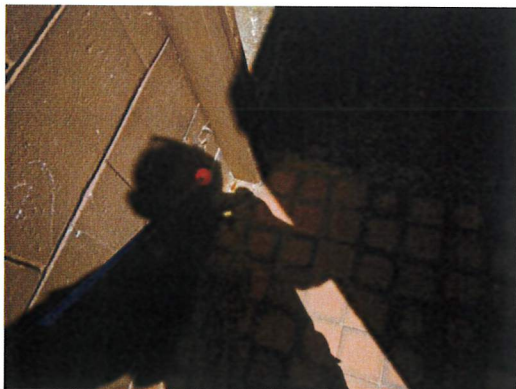
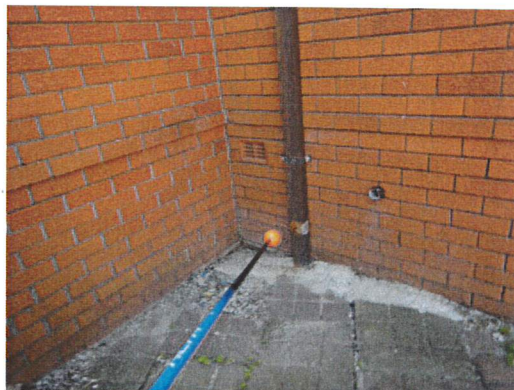
## Defects 3.12

Location: All Areas

Finding: Roof plumbing - Rusted or corroded

Information: The roof plumbing has areas of rust and corrosion. It is suspected that this has been caused by blockages, resulting in pooling or standing water, that have prematurely rusted elements of the roof plumbing.

Rusted roof plumbing will generally develop holes and leaks that can affect other building elements with poor drainage of storm water. Poorly drained roof areas will also lead to damp conditions surrounding the base perimeter of the building which, if left unmanaged, can lead to a range of secondary building defects.

Repair and/or replacement of rusted roof plumbing is highly required in order to reinstate the roof drainage system to a fully operational level. To further maintain these areas, gutters should be cleaned frequently, allowing the avoidance of any partial blockages.

A licensed plumber or specialist roof restoration company should be appointed to undertake these works. It is advised that such works be completed as soon as possible to prevent any further damage and deterioration.

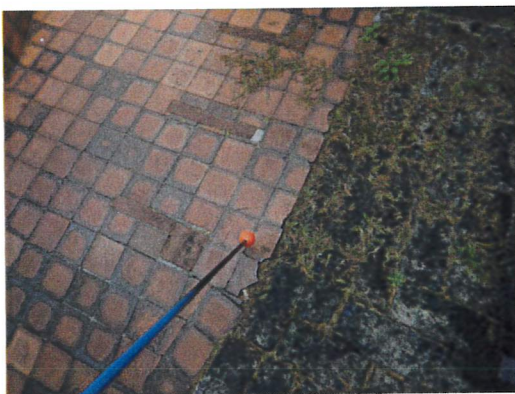
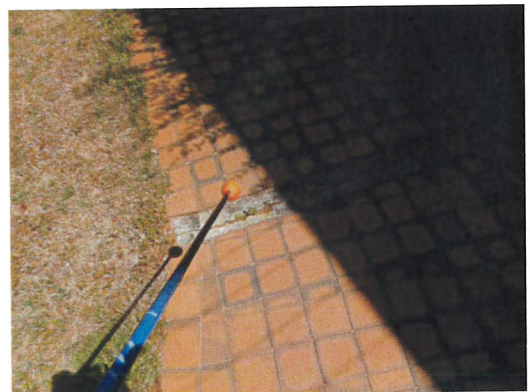
### Defects 3.13

Location: Yard - Back

Finding: Tiles - Cracked or damaged

Information: Cracking was evident to the tiling in this area at the time of inspection. While the cracking appears to be minor, this area is frequently exposed to water, allowing potential for water penetration into adjoining sections of walls or flooring.

Where water penetration has led to water damage, appointment of a relevant tradesperson may be required to repair damaged building elements.

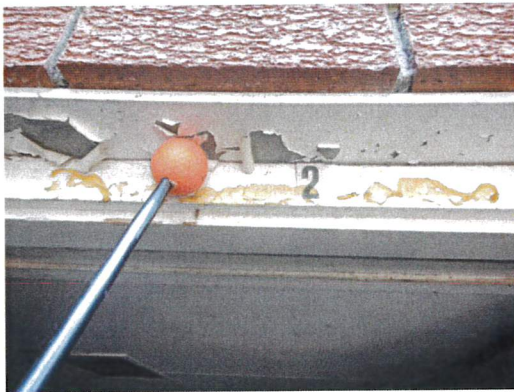
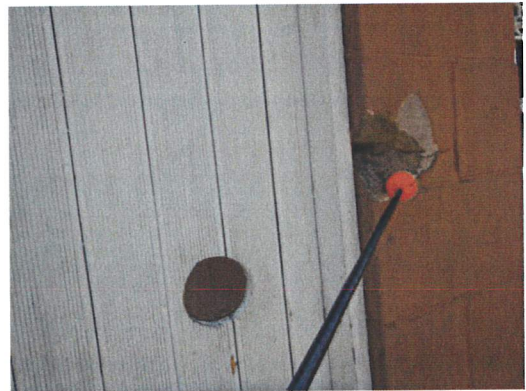
## Defects 3.14

Location: Yard - Back

Finding: External painting deteriorated

Information: Degraded paint finishes should be sanded back, filled, leveled and painted, as applicable. Where inadequate or missing paint protection has led to the deterioration of the associated building element, repair and/or replacement of this building element may be required.

A painting contractor should be appointed as soon as possible to perform necessary works to aid the appearance of the affected area and to ensure the area is protected against further deterioration. Alternatively, the homeowner following manufacturer instructions may perform these works.

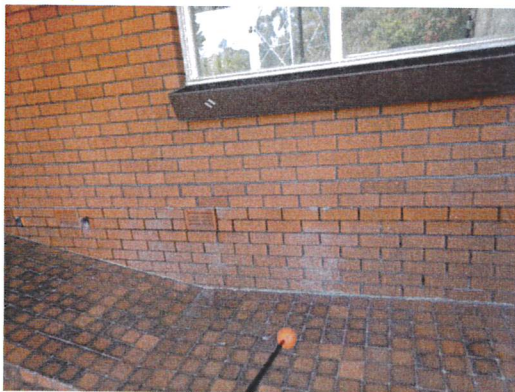
## Defects 3.15

Location: Yard - Back

Finding: Brickwork - Efflorescence

Information: Generally, soluble salt deposits can be removed by dry brushing with a stiff-bristled brush. Repeated dry brushing is an ideal treatment for eliminating this forming of efflorescence. A cleaning contractor or general handyperson may be appointed to perform these works at the discretion of the client.

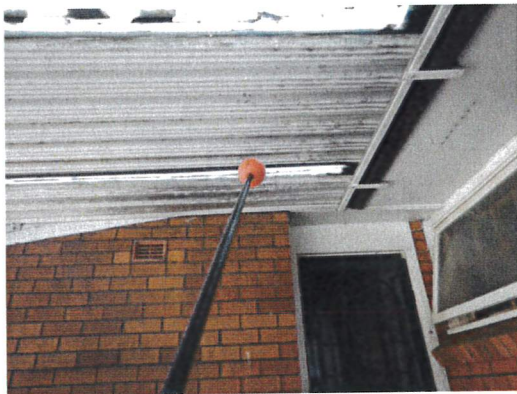
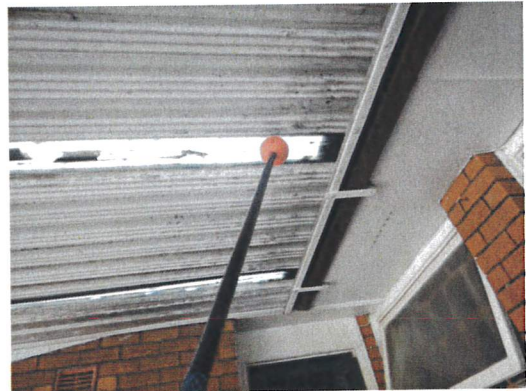
## Defects 3.16

Location: Yard - Back

Finding: Roof sheets - Deteriorated

Information: Upon inspection of the exterior roofing, it was found that the roof sheets show signs of deterioration, with some sheets having come loose from their original fixing.

The roofing has sustained an array of issues due to the age of the materials and a lack of general maintenance over time, including loose sheeting, lifting and sagging of sheets, and deterioration of associated building elements.

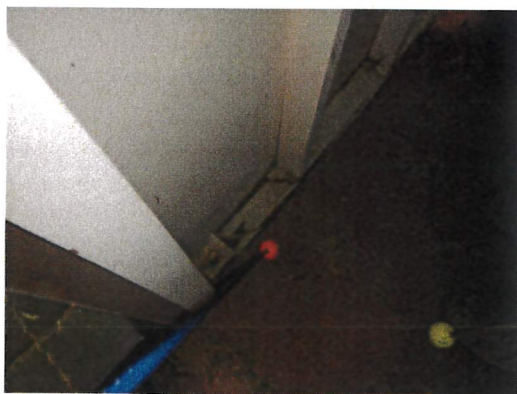
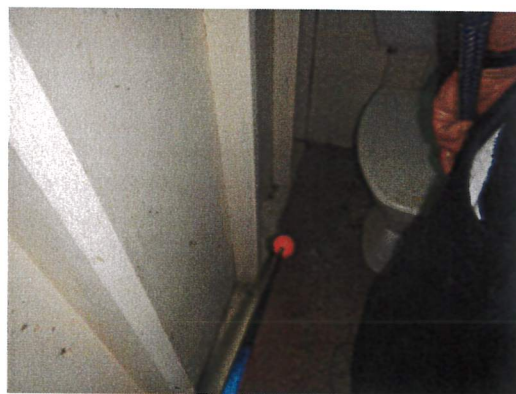
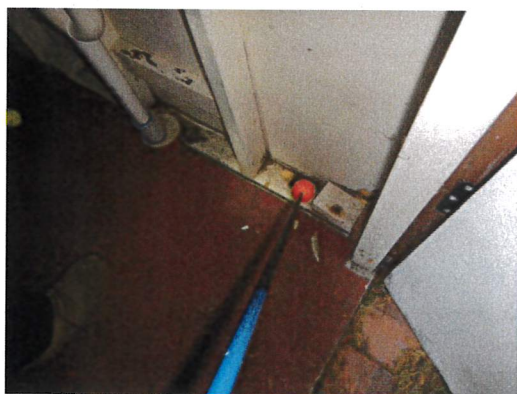
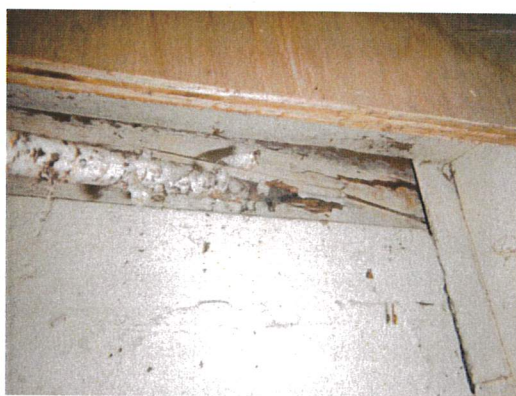
## Defects 3.17

Location: Bathroom

Finding: Wood rot

Information: Wood rot is often associated with general damp problems and is evidenced by a 'musty' smell or mould and mildew occurring on surfaces. If left unmanaged, damp conditions can lead to further health problems and the decay of timbers will continue.

Early intervention and regular maintenance, particularly of exterior timbers, will prolong the useful life of these building elements.

A qualified carpenter or registered builder may also be required to replace affected building materials.

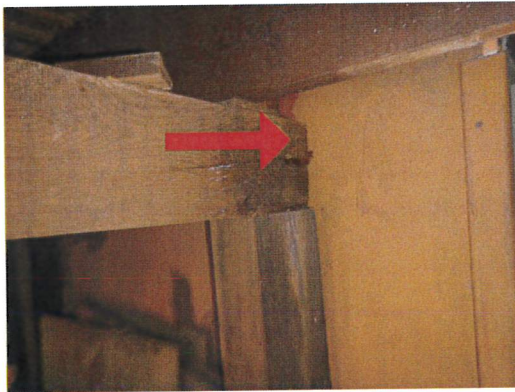
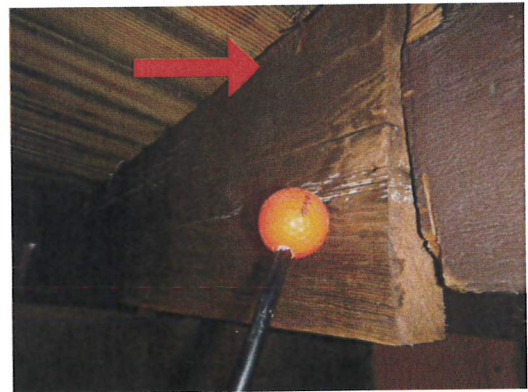
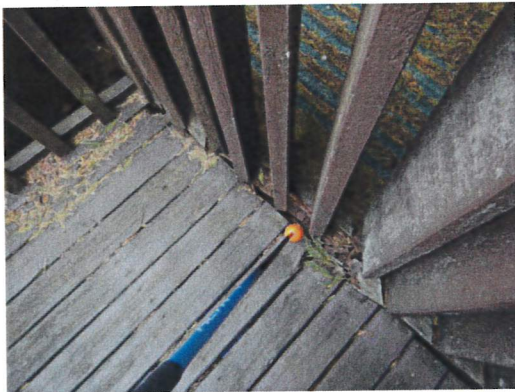
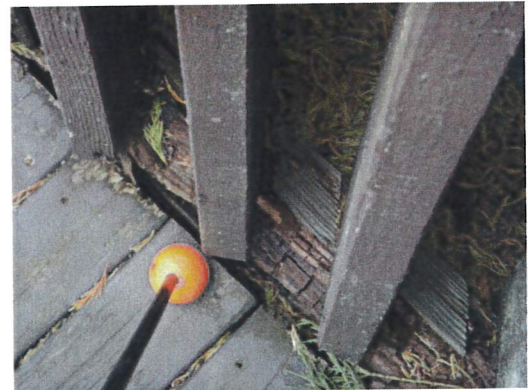
### Defects 3.18

Location: Balcony

Finding: Wood rot

Information: This building element shows evidence of wood rot. Wood rot, also known as Fungal Decay, occurs when timbers and other cellulose building materials are exposed to damp conditions on an ongoing basis. This could be the result of exposure to weathering over a prolonged period of time, or the attraction of excessive moisture from other abutting building materials. Contributing factors also include poor air ventilation in the area.

A qualified carpenter or registered builder may also be required to replace affected building materials.

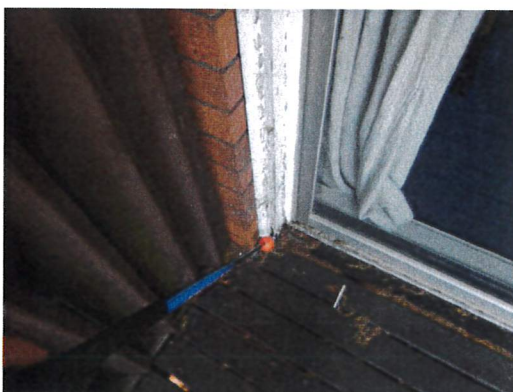
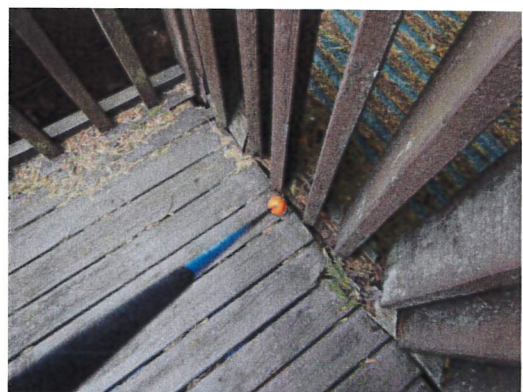
### Defects 3.19

Location: Balcony

Finding: External painting deteriorated

Information: Degraded paint finishes should be sanded back, filled, leveled and painted, as applicable. Where inadequate or missing paint protection has led to the deterioration of the associated building element, repair and/or replacement of this building element may be required.

A painting contractor should be appointed as soon as possible to perform necessary works to aid the appearance of the affected area and to ensure the area is protected against further deterioration. Alternatively, the homeowner following manufacturer instructions may perform these works.

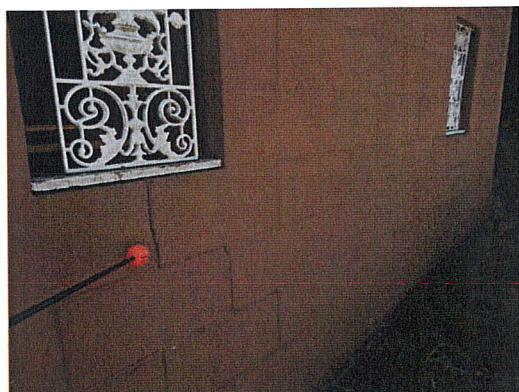
### Defects 3.2

| Location: | Fencing |
| Finding: | Blockwork - Step cracking |
| Information: | Step cracking was identified to the brickwork in this area at the time of inspection. Step cracking, which is similar to other forms of cracking, has a variety of possible causes. However, the most common is the subsidence of adjacent footings. |

Where step cracking is extensive or severe, the client is advised to consult a structural engineer. Minor step cracking can be used as a warning sign to address factors causing stress to the wall, which can include the effect of surrounding trees, water leaks, soil erosion, or even the presence of reactive soils in the surrounding area.

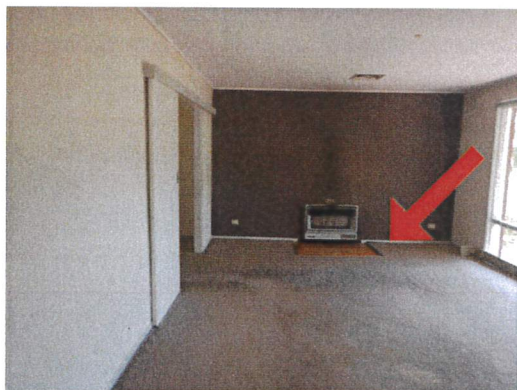
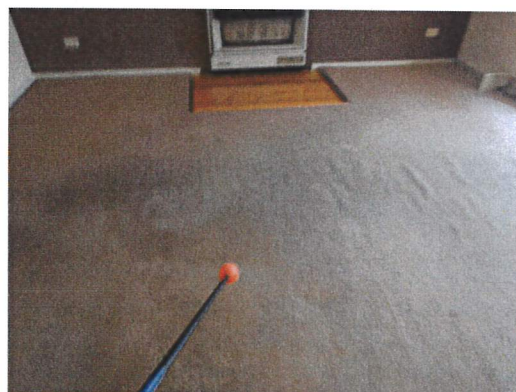
## Defects 3.21

Location: Lounge Room

Finding: Water staining

Information: Water staining was evident in this area at the time of inspection. Water staining indicates that surfaces have been exposed to excessive moisture over time. The minerals and other elements in the water lead to staining, which may graduate to corrosion and deterioration if left unmanaged.

While mostly an appearance defect, water staining can be indicative of more serious defects, which may be currently concealed by other building elements.

Conversely, where water staining is old and inactive, affected building materials may be repaired or replaced at client discretion.

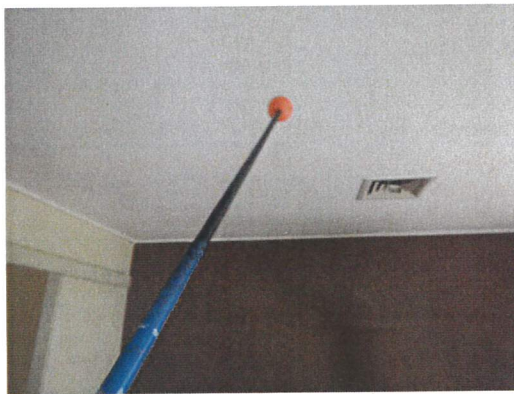
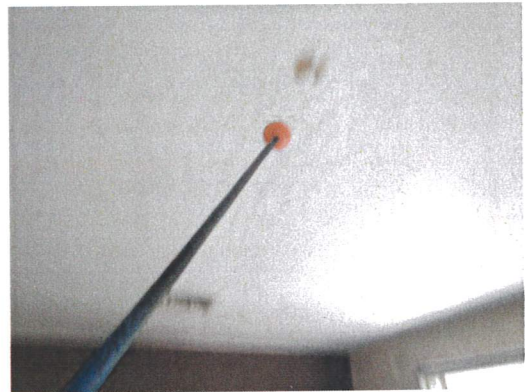
## Defects 3.22

Building: Main Building  
Location: Lounge Room  
Finding: Ceiling - Water stained  
Information: Water staining to ceiling linings in this area was evident at the time of inspection. Water staining indicates that surfaces have been exposed to excessive moisture over time. The minerals and other elements in the water lead to staining, which may graduate to corrosion and deterioration if left unmanaged.

While mostly an appearance defect, water staining can be indicative of more serious defects, which may be currently concealed by interior ceilings.

Where water staining is active, a licensed plumber must be consulted to identify the cause of the staining and to provide advice on any reparation works that may be required. Replacement of any damaged structures is advised.

Conversely, where water staining is old and inactive, affected building materials may be repaired or replaced at client discretion.

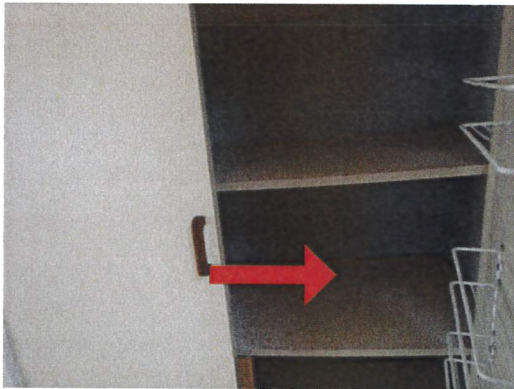
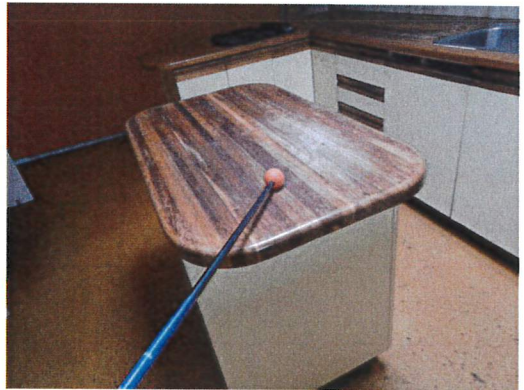
### Defects 3.23

Building: Main Building  
Location: Kitchen  
Finding: Cabinetry - Damaged  
Information: Evidence of damage was identified.

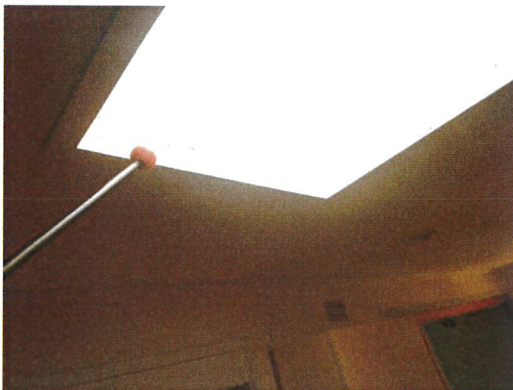
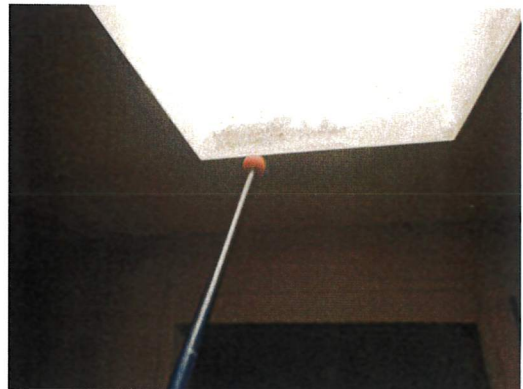
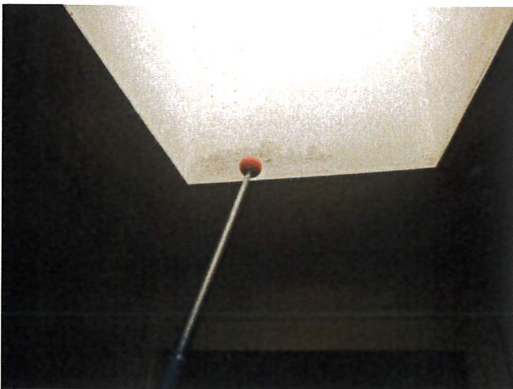
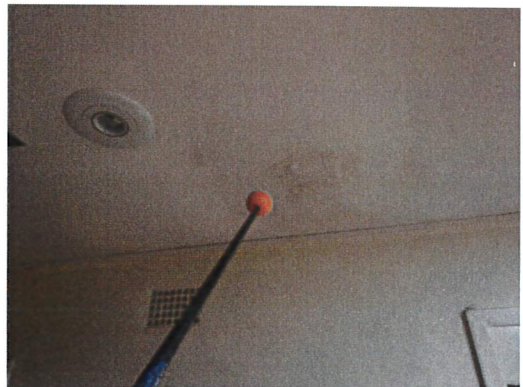
## Defects 3.24

Location: Kitchen

Finding: Internal painting deteriorated

Information: Whilst incomplete or missing paint finish is generally an appearance defect, it can also lead to the development of secondary building defects over time. Incomplete areas of paint finish exposes the area to moisture, potentially accelerating the deterioration of underlying building materials.

Degraded paint finishes should be sanded back, filled, leveled and painted, as applicable. Where inadequate or missing paint protection has led to the deterioration of the associated building element, repair and/or replacement of this building element may be required.

A painting contractor should be appointed as soon as possible to perform necessary works to aid the appearance of the affected area and to ensure the area is protected against further deterioration. Alternatively, the homeowner following manufacturer instructions may perform these works.

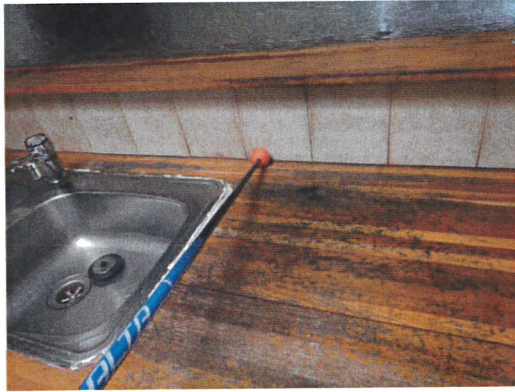
### Defects 3.25

Building: Main Building  
Location: Kitchen  
Finding: Sealant  
Information: Flexible and mould resistant materials should be applied to affected areas to prevent any subsequent water damage that is likely to occur. Regular maintenance and replacement of damage or missing or damaged sealant and grout is recommended to the wet areas, as this is a regular wear and tear defect.

Sealant and grouting in areas that come into regular contact with water should be maintained for the long term care of your property.

A sealant specialist or tiling contractor should be appointed to complete these works.
