# Building and Timber Pest Inspection Report

Inspection Date: Mon, 8 Apr 2024

Property Address: 35 Sciberras Av, Schofields NSW 2762, Australia

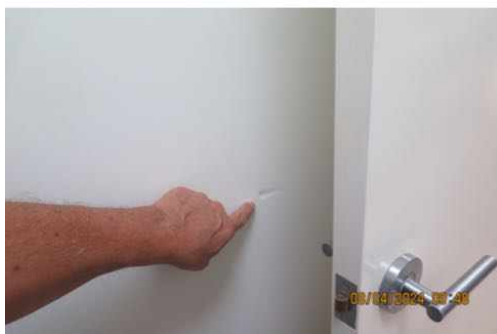
#### Finding 3.01

Building: Main Building  
 Location: Kitchen  
 Finding: Door stop - Missing  
 Information: The door stop is missing or is inadequate to stop the door handle from damaging the wall. Although some building elements may seem irrelevant or unnecessary, all building elements play a key role in the operation and function of the overall structure and its performance.

Re-installation or replacement of the door stop is advised as soon as possible to prevent any subsequent damage to the door or associated structures. A general handyman may be appointed to perform these works at client discretion.

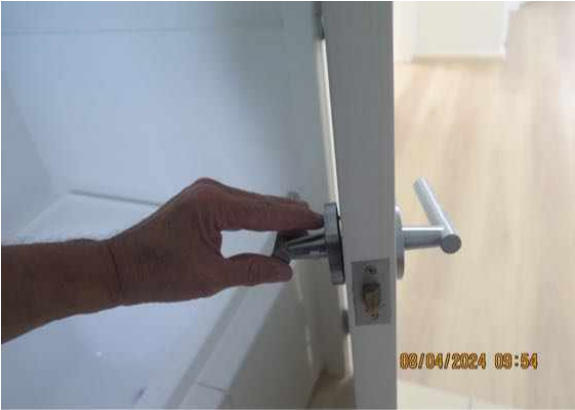
#### Finding 3.02

Building: Main Building  
 Location: Bathroom  
 Finding: Door lock - Loose  
 Information: The fitting in this area is loose and requires adjustment to tighten.

If left unmanaged, the fitting may further deteriorate, causing potential for the

development of other minor secondary defects.

A relevant tradesperson should be appointed to perform these rectification works at discretion of the client.

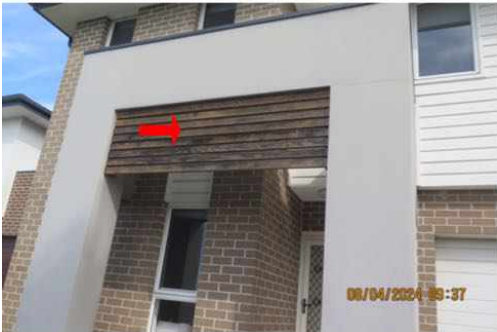
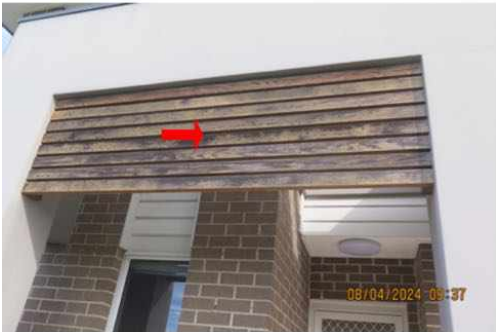
**Finding 3.03**

Building: Main Building  
Location: Yard - Front  
Finding: Painted surface - Bubbling  
Information: Sections of paint in this area was found to have bubbled and deteriorated. Paint bubbling is generally an indication of excessive moisture in the area, that is currently hidden by the painted surface.

The presence of excessive moisture can have major implications on associated building elements if left unattended. While only seemingly minor at this stage, the damage cannot be determined due to the paint obstructing any further inspection of the damage.

It is highly advised that the affected paint be cleaned to allow a further, more invasive inspection by a licensed plumber. Failure to act on this defect may necessitate major works in the future.

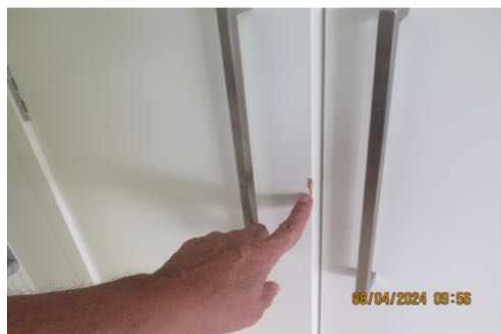
### Finding 3.04

Building:	Main Building
Location:	Bedroom
Finding:	Building element - Damaged
Information:	Breakage occurs generally when the building materials have either aged and decayed, or as a result of damage (accidental or deliberate).

Repair and/or replacement of broken elements is advised to ensure that additional secondary defects do not arise as a consequence. Such works are necessary, as all building elements play a key role in the operation and function of the overall structure and its performance.

A relevant tradesperson should be appointed to repair or replace the affected building element prior to any subsequent damage being caused.

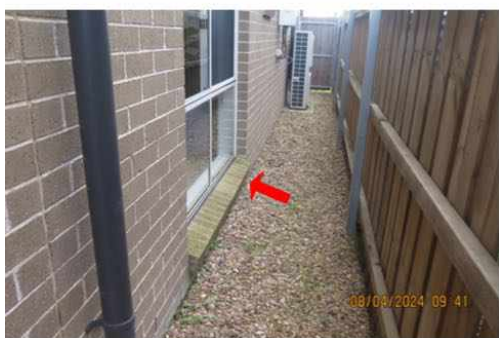
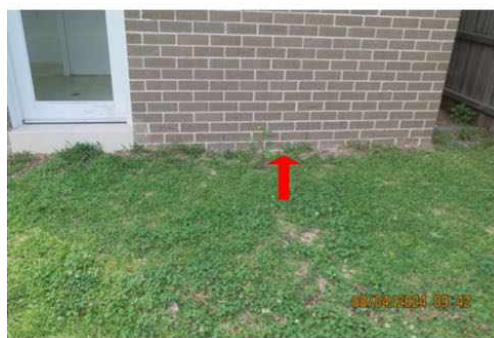
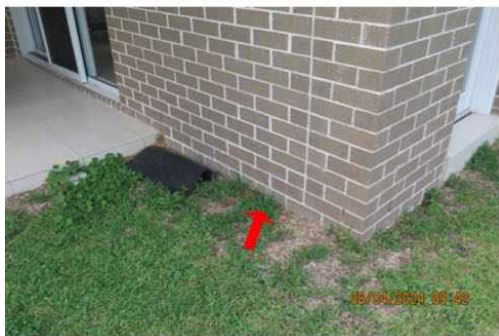
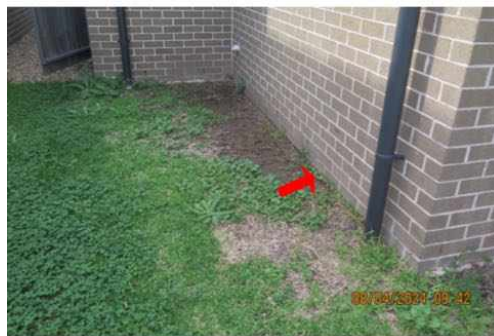
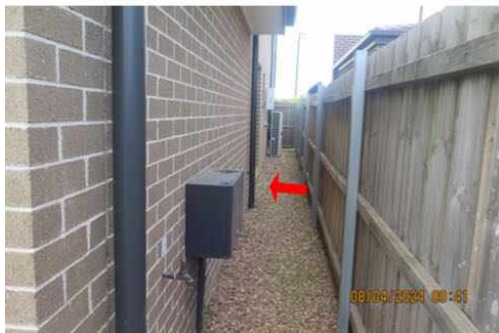
#### Finding 6.01

Building:	Main Building
Location:	All Areas
Finding:	Slab Edge - Exposure
Information:	An inspection zone of at least 75mm in relation to the exposed slab edge, between the bottom brick and the perimeter pavement, is required. This inspection zone

should be maintained in order to force termites into the open where they can be detected more readily during regular inspections. The slab edge should not be concealed by anything that may prevent inspection of the area, including render, landscaping, soil, turf, paving, concrete cladding or other structures.

If the slab edge is not properly exposed there is a high risk of termite attack. Sometimes, in order to determine the type of slab, a suitably qualified person such as an architect or builder may be required to consult the construction plans.

Where the slab edge cannot be properly inspected, it is highly recommended that termite or timber pest inspections be carried out every 6-12 months to aid protection of the property against infestation.
