## Building Inspection Report

Inspection Date: Wed, 14 Apr 2021

Property Address: 10 Rounce Ave, Forestville NSW 2087,  
Australia

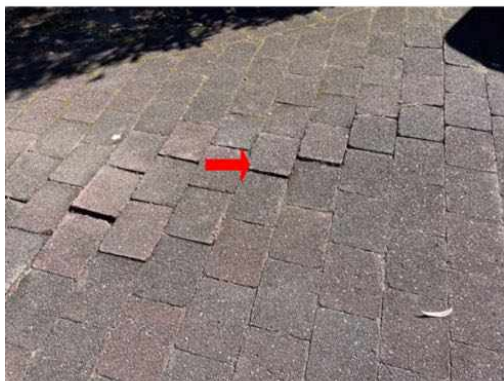
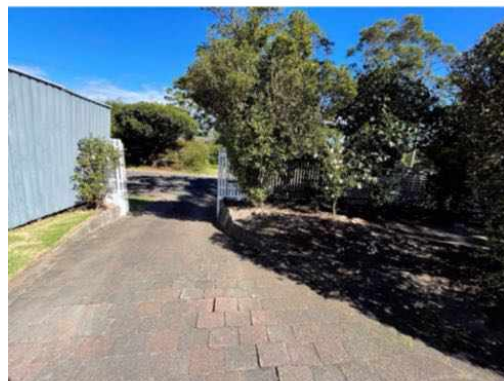
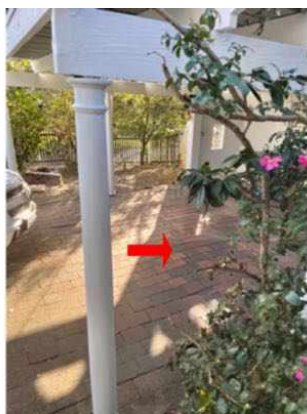
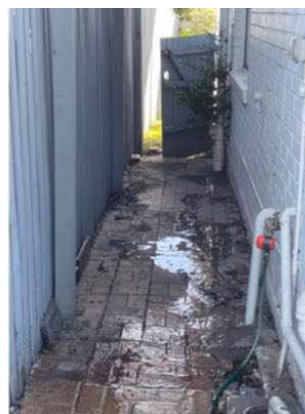
#### Defects 3.01

Location: Yard - Back

Finding: Paving - Uneven

Information: Sections of the external paved area are uneven, creating a potential trip hazard. It appears as though the area has been subject to rough installation, or that paving sections have lifted due to movements in the foundation of the property.

Where paving creates a trip hazard, personal injury may ensue if due caution is not taken by all persons within this area.

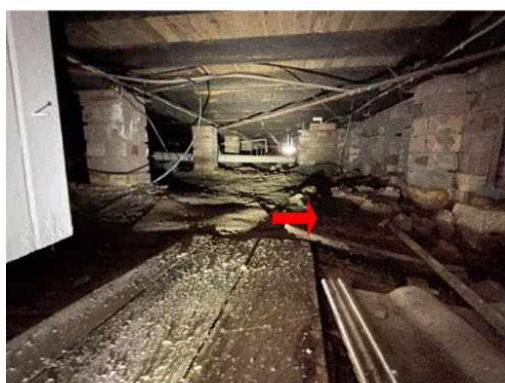
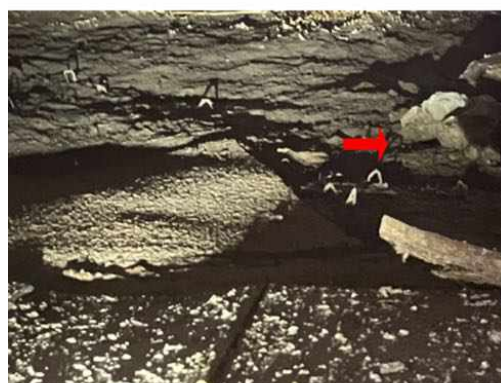
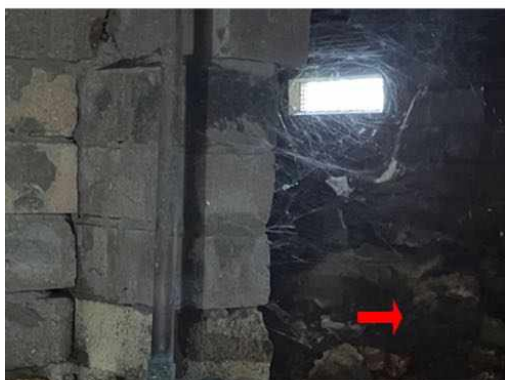
### Defects 3.02

Building:	Building 1
Location:	Subfloor
Finding:	Evidence of excessive moisture was present at the time of inspection
Information:	Excessive moisture can attract termites and produce conditions that promote termite attack fungal growth and wood decay.

Excessive moisture is generally caused by deteriorated inadequate or missing roof drainage leaking plumbing pipes or fixtures poorly plumbed HWS overflows or condenser units and poor site drainage.

It is recommended that all plumbing and drainage fixtures and fittings be maintained regularly in order to prevent excessive moisture being present in the external / internal property.

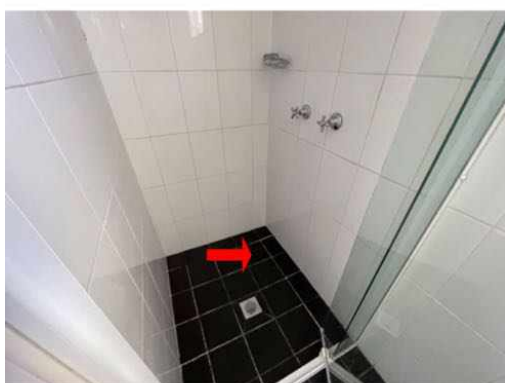
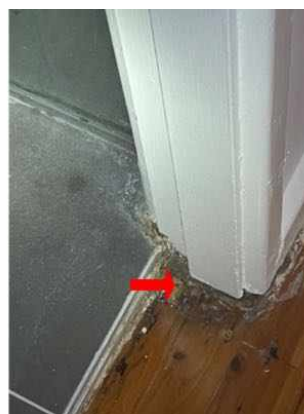
### Defects 3.03

Building:	Building 1
Location:	All Areas
Finding:	Sealant and grouting - Missing or damaged
Information:	.

Flexible and mould resistant materials should be applied to affected areas to prevent any subsequent water damage that is likely to occur. Regular maintenance and replacement of damage or missing or damaged sealant and grout is highly recommended to the wet areas, as this is a regular wear and tear defect. Sealant and grouting in areas that come into regular contact with water should be maintained for the long term care of your property.

A sealant specialist or tiling contractor should be appointed to complete these works.

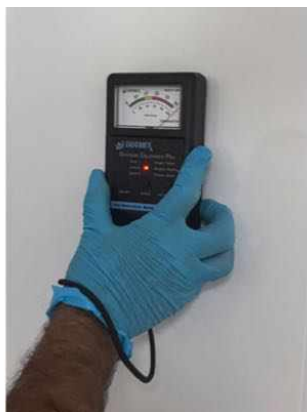
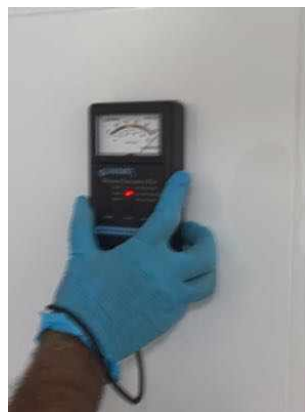
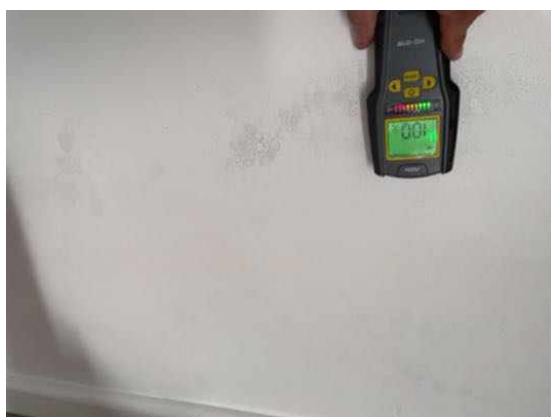
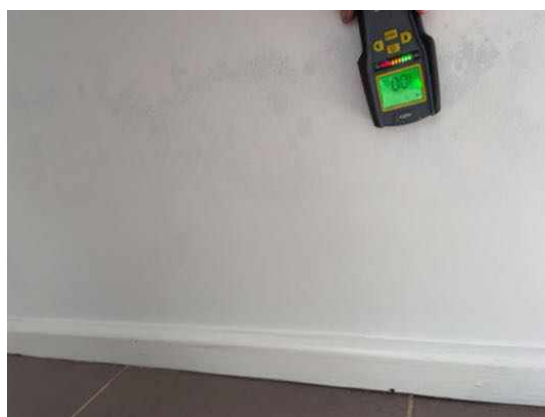
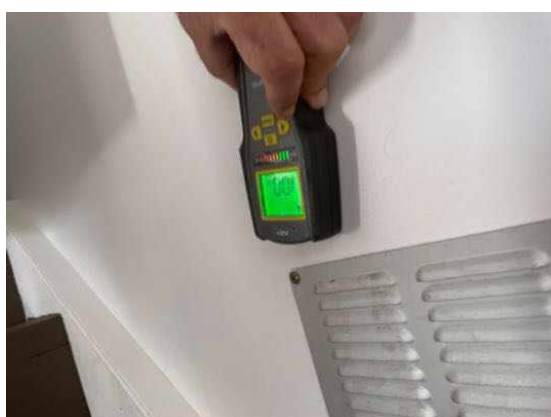
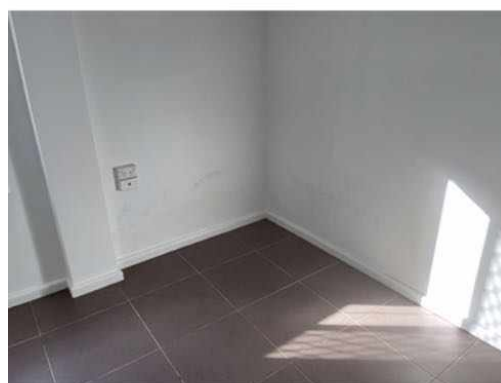
### Defects 3.04

Building:	Building 1
Location:	All Areas
Finding:	Evidence of excessive moisture was present at the time of inspection
Information:	Excessive moisture can attract termites and produce conditions that promote termite attack fungal growth and wood decay.

Excessive moisture is generally caused by deteriorated inadequate or missing roof drainage leaking plumbing pipes or fixtures poorly plumbed HWS overflows or condenser units and poor site drainage.

It is highly recommended that all plumbing and drainage fixtures and fittings be maintained regularly in order to prevent excessive moisture being present in the external / internal property.

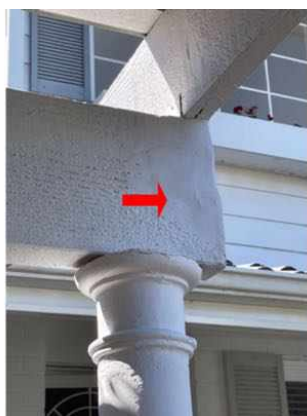
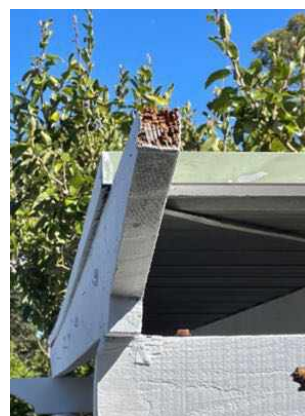
### Defects 3.05

Building: Building 1  
Location: Yard - Back

Finding:	Wood rot
Information:	This building element shows evidence of wood rot. Wood rot, also known as Fungal Decay, occurs when timbers and other cellulose building materials are exposed to damp conditions on an ongoing basis. This could be the result of exposure to weathering over a prolonged period of time, or the attraction of excessive moisture from other abutting building materials. Contributing factors also include poor air ventilation in the area.

Early intervention and regular maintenance, particularly of exterior timbers, will prolong the useful life of these building elements. Prior to any works being performed, the cause of the moisture that has created the visible wood rot should be identified and addressed in a suitable manner. Replacement of affected timbers may then be a necessary step in protecting surrounding building elements from such deterioration.

A qualified carpenter or registered builder may also be required to replace affected building materials.

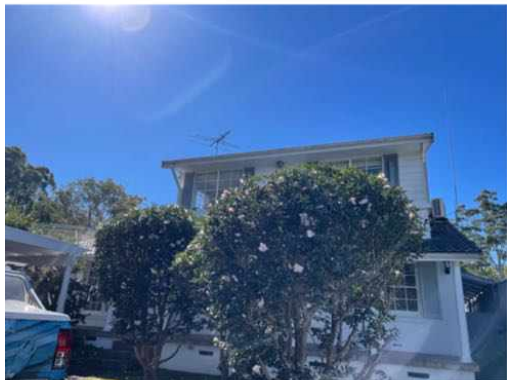
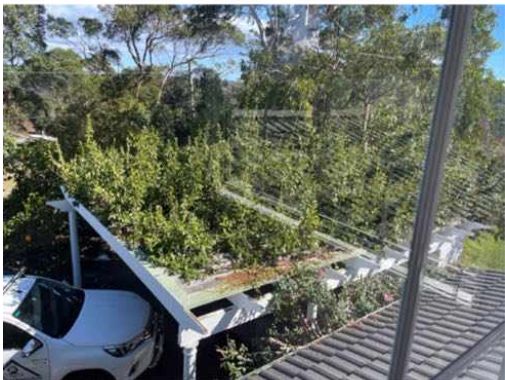
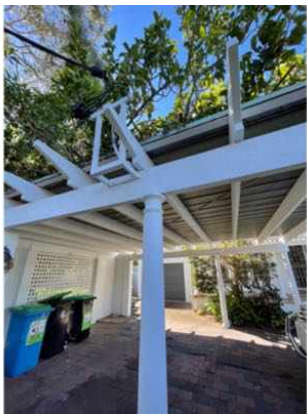
### Defects 3.06

Building:	Building 1
Location:	All External Areas
Finding:	Trees - Overhanging and filling gutters
Information:	Overhanging trees often result in excessive amounts of leaf debris accumulating in gutters.

Gutters are a critical part of the building's management of storm water and rain. It is therefore important that they be kept clear to prevent secondary damage to associated building elements, including exterior and interior walls, ceiling linings and any adjoining building elements. Where gutters are blocked, pooling of rainwater is likely to occur, fast-tracking rust and corrosion of the roof plumbing elements.

It is advised that all overhanging tree branches be removed as soon as possible to prevent any further damage. Repair and/or replacement of sections of damaged guttering may also be required where the extent of the damage necessitates.

Such works should be performed by the homeowner; however, appointment of a landscape contractor or an arborist may be required. Consultation with a licensed roof plumber is required where guttering has been damaged.

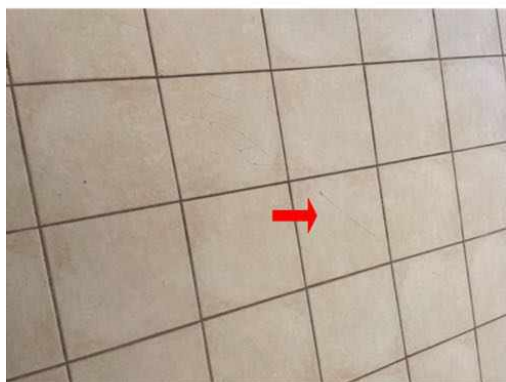
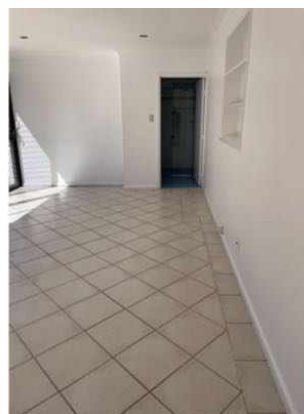
**Defects 3.07**

Building:	Building 1
Location:	All Areas
Finding:	Cracked floor tiles
Information:	Cracking in the floor tiles was evident in this area at the time of inspection. It is suspected that this cracking has occurred as a result of minor settlement or shrinkage of the slab.

Cracked tiles throughout the household detract from the overall appearance of the affected areas however it is unlikely to create or lead to any secondary defects.

While not considered a matter of urgency, replacement of cracked floor tiles is recommended at the clients discretion. A tiling contractor may be appointed to perform these works.

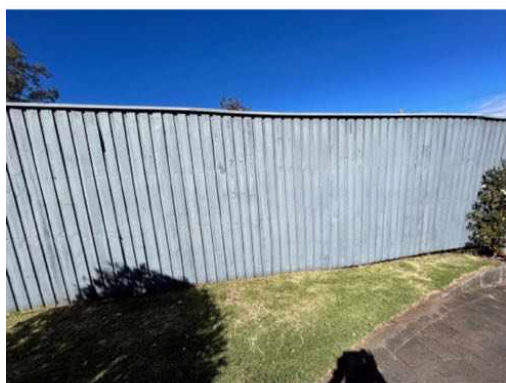
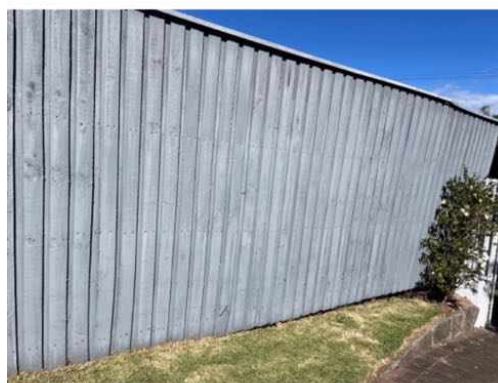
### Defects 3.08

Location: All Areas

Finding: Fencing - Deteriorated

Information: It was noted at the time of inspection that sections of the fencing throughout the property have deteriorated. Typically fencing deteriorates due to age and or wear, rot and or rust which is generally expected for a structure of this age, due to prolonged exposure to weather conditions. Sometimes inadequate installation or maintenance can be to blame.

If left unattended, it is likely that further damage will occur. It is suspected that repair of several elements of the fencing may be required however replacement may be a consideration of the client also.

A licensed fencing contractor should be appointed to provide further advice and perform rectification works as necessary.

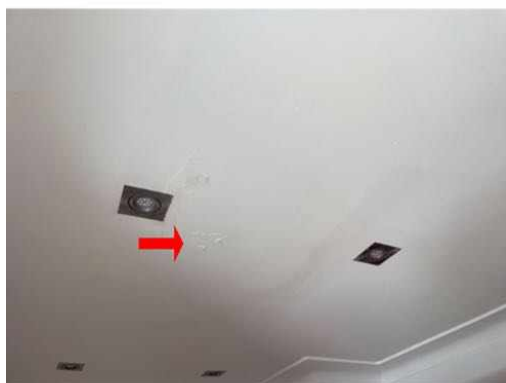
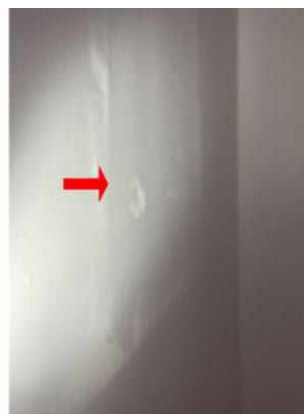
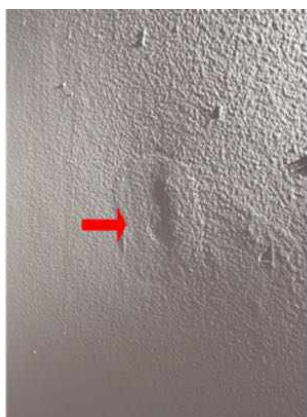
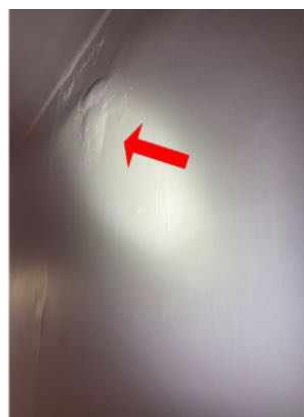
### Defects 3.09

Location: All Internal Areas

Finding: Unconventional handyman work

Information: This handyman work appears to have been completed to a substandard level and does not comply with regular building practices. Where handyman work is not completed satisfactorily, accelerated deterioration of the associated building elements is likely to occur and secondary defects to surrounding structures may develop.

It is highly recommended that the substandard work be rectified by professional services. Works to improve this area are likely to increase the safety and the operation of the associated building elements.

The client should exercise care when coming into the immediate vicinity of the substandard works. Rectification works are advised as soon as possible by the appropriate trades.

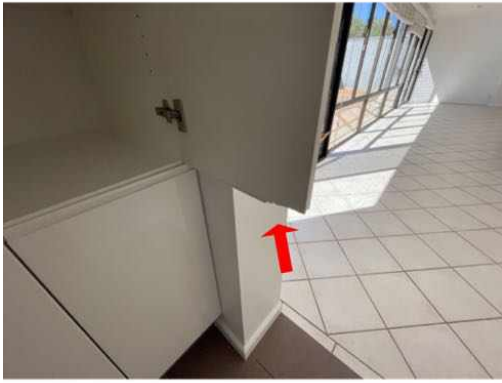
### Defects 3.10

Building:	Building 1
Location:	Kitchen
Finding:	Cabinetry - Damaged
Information:	Evidence of damage was identified to the kitchen cabinetry.

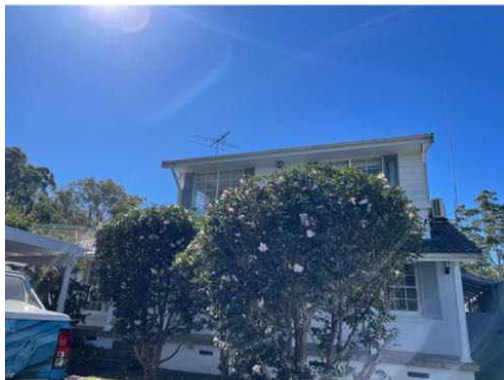
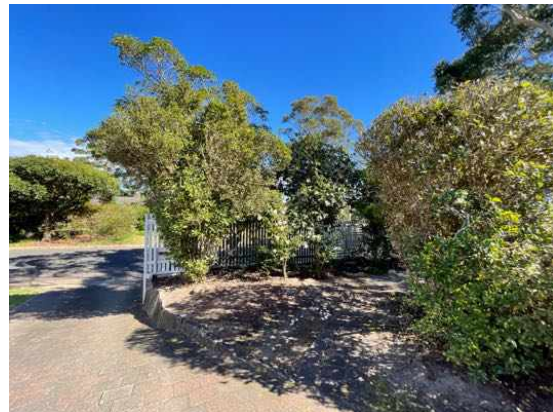
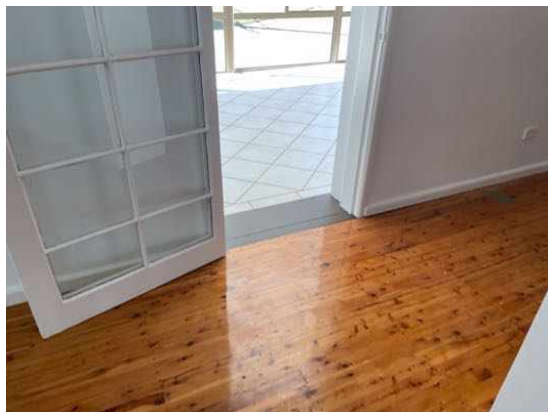
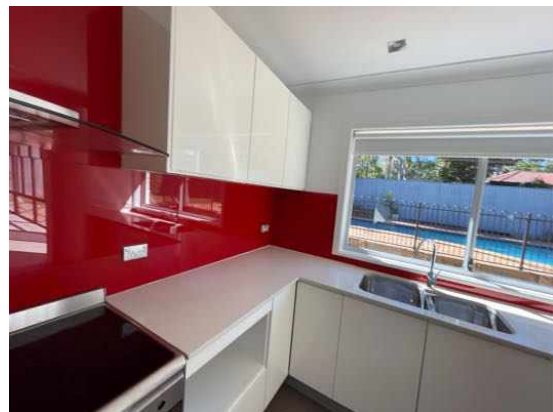
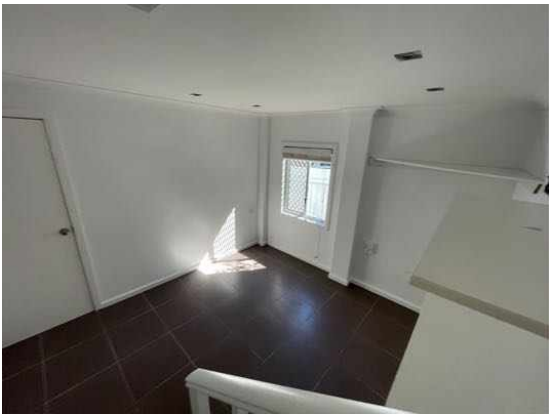
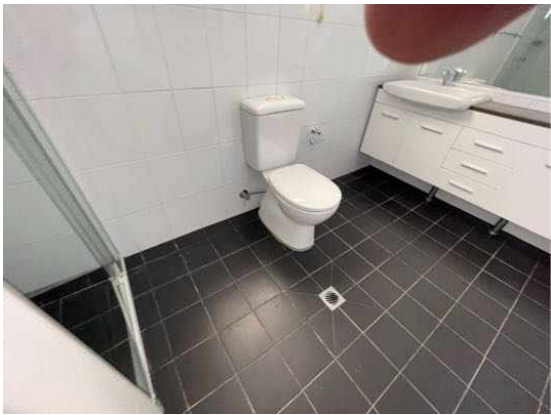
#### Noted Item

Building: Building 1  
Location: All Areas  
Finding: Additional Photos - Obstructions and Limitations  
Information: These photographs are an indication of the obstructions and limitations which impeded full inspection of the property at the time of inspection. These obstructions can hide an array of defects and should be removed to allow full inspection to be carried out.
