Building and Timber Pest Inspection Report

Inspection Date: Thu, 7 Oct 2021

Property Address: 43 Townsend Ave, Frenchs Forest NSW
2086, Australia

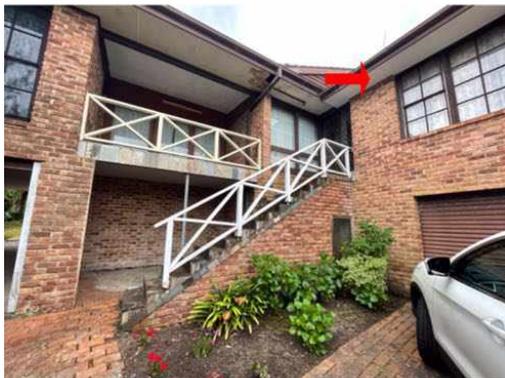
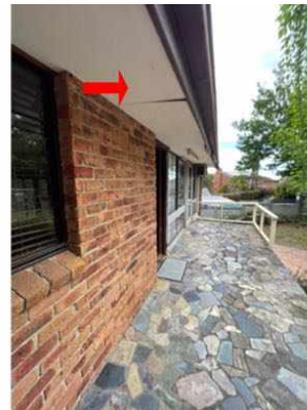
Defects 1.01

| Information: | Reporting on Asbestos is outside the Scope of this Report. This suspected defect is highlighted as a caution only. We suspect, based on our experience in the building industry, that there is a higher risk of the identified building element containing asbestos. |

As Asbestos Reporting is outside the scope of this report, we advise that you consider a separate Asbestos Inspection and Condition Audit, which can include the taking of samples for definitive confirmation of the presence of Asbestos.

In the interim, the client is advised to act with caution, especially when considering any damage to building materials general wear and tear renovations extensions demolition and general maintenance activities due to the suspected presence of Asbestos.

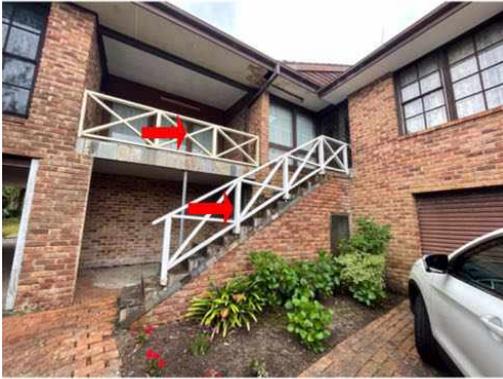
Defects 1.02

| Information: | The balustrade was measured and found to be less than the present building regulation requirement of 1000mm high. Additionally the gaps between the balustrade cladding were found to be greater than the present building regulation requirement of 125mm. |

This defect creates a potential safety hazard and should be rectified as soon as possible to ensure the safety of the area and to meet present building standards and regulations.

A registered builder should be contacted to discuss possible rectification solutions.

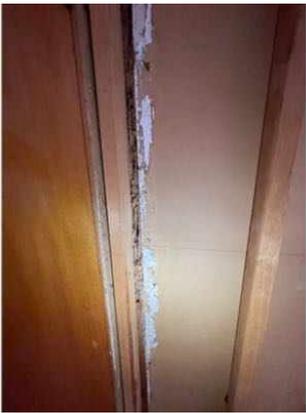
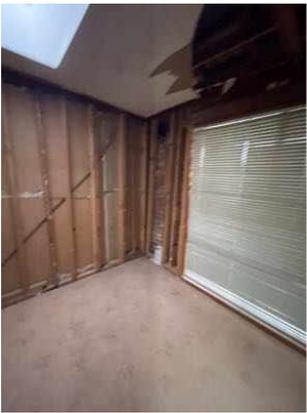
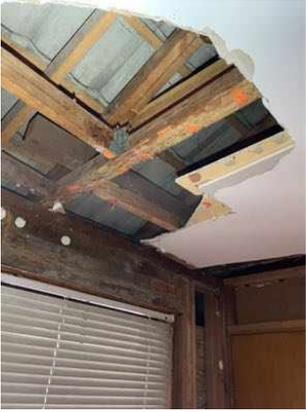
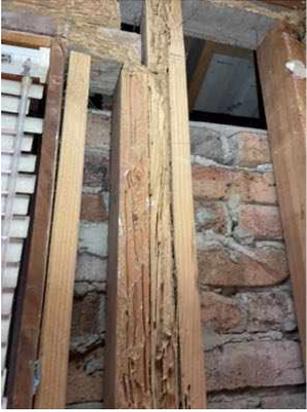
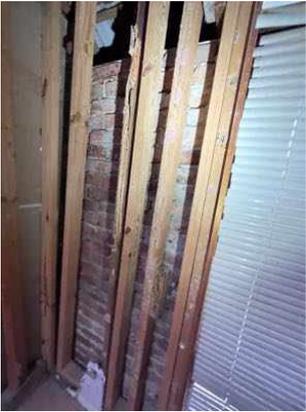
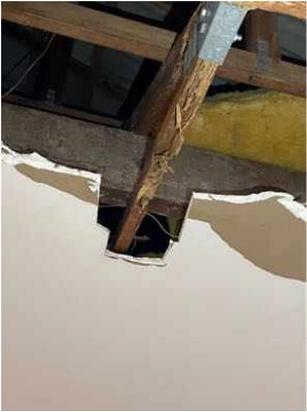
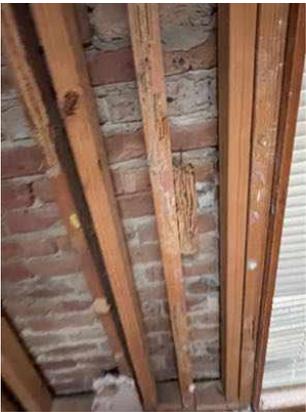
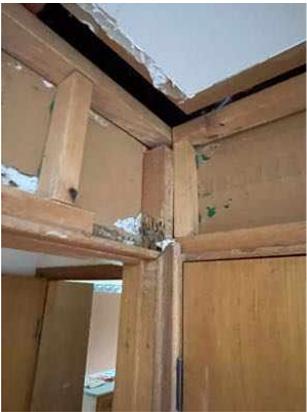
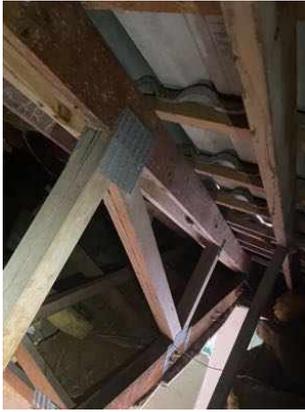
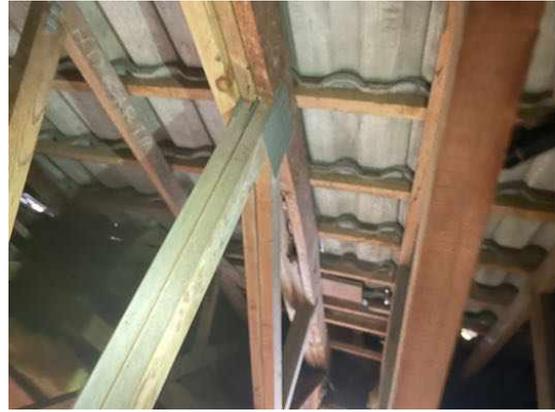
Defects 2.01

| Finding: | Termite - evidence of termite damage |
| Information: | Despite no live termite or timber pest activity being indicated, previous termite damage was found to have affected. |

At the time of inspection, some damage was noted to be structural.

It is advised that the area be visually inspected frequently to ensure that the condition of affected building materials does not worsen.

A building contractor should be appointed to provide a further invasive inspection if further damage is evident.

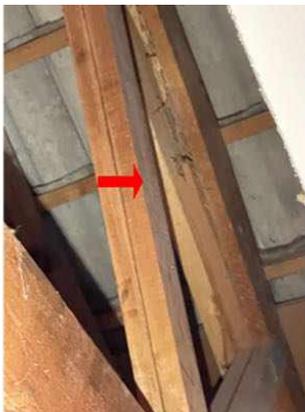
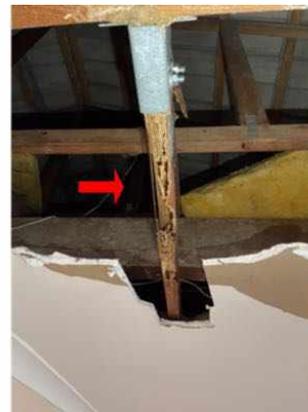
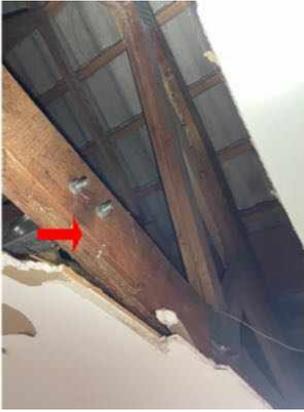
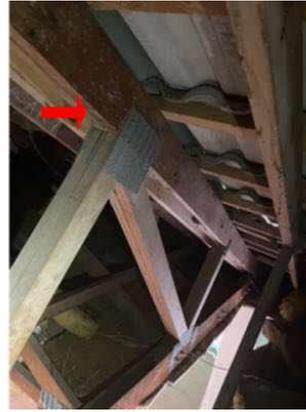
Defects 2.02

| Information: | Alterations to the roof structure have occurred. The modifications do not comply with current building practices and standards and require remedial works to reinstate to a suitable standard. |

Replacement of major sections of roofing is likely to be required in order to comply with building regulations. Further assessment and necessary works should be performed immediately by a registered builder. Until works are completed to bring the roofing structure to an appropriate level, the surrounding area should be avoided by all persons as a safety precaution.

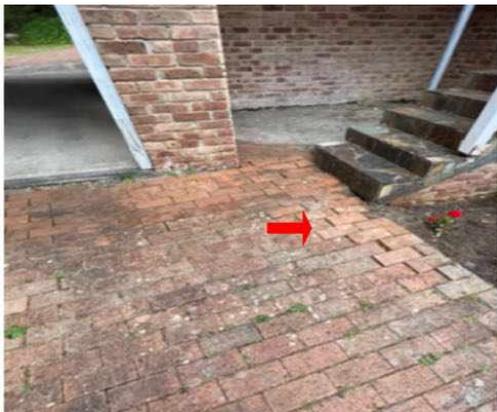
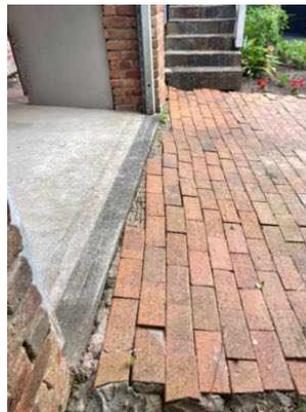
Defects 3.01

Sections of the external paved area are uneven, creating a potential trip hazard. It appears as though the area has been subject to rough installation, or that paving sections have lifted due to movements in the foundation of the property.

Where paving creates a trip hazard, personal injury may ensue if due caution is not taken by all persons within this area.

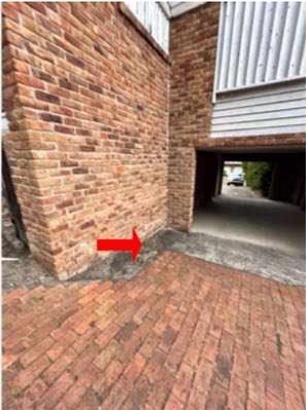
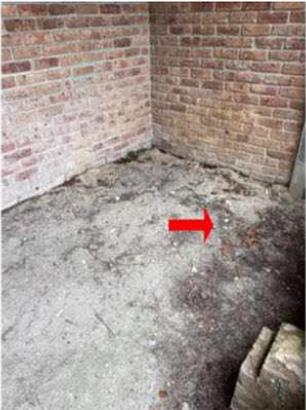
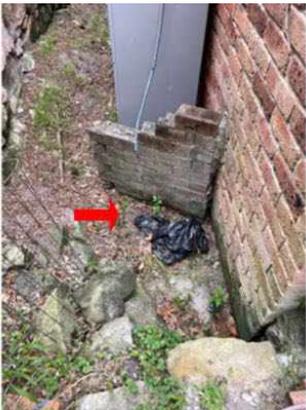
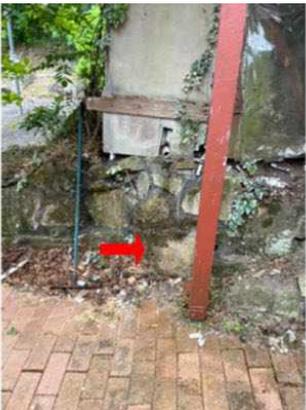
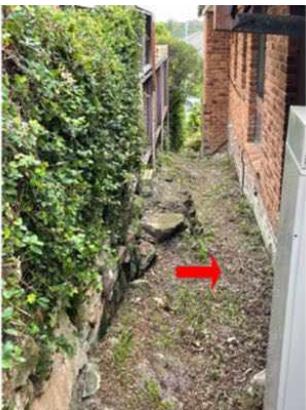
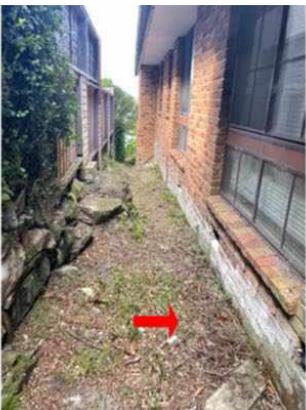
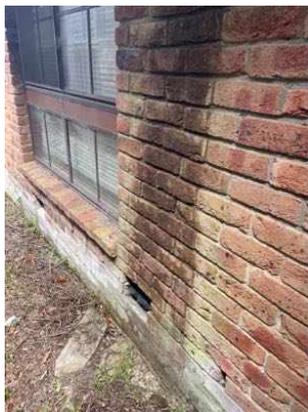
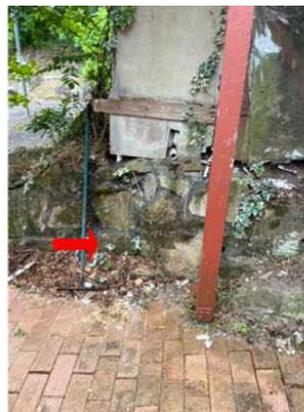
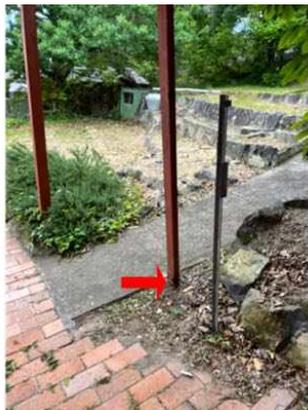
Defects 3.02

Building: Building 1
 Location: All Areas
 Finding: Evidence of excessive moisture was present at the time of inspection
 Information: Excessive moisture can attract termites and produce conditions that promote termite

attack fungal growth and wood decay.

Excessive moisture is generally caused by deteriorated inadequate or missing roof drainage leaking plumbing pipes or fixtures poorly plumbed HWS overflows or condenser units and poor site drainage.

It is recommended that all plumbing and drainage fixtures and fittings be maintained regularly in order to prevent excessive moisture being present in the external / internal property.

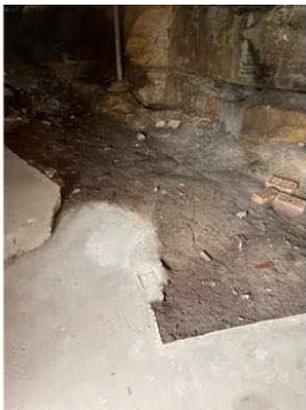
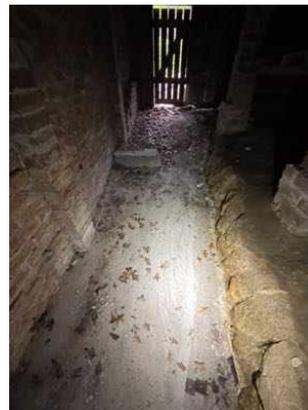
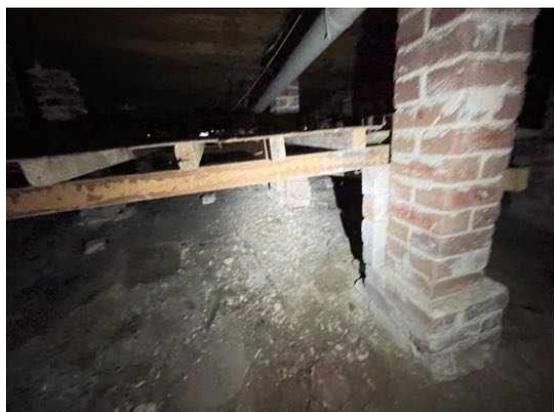
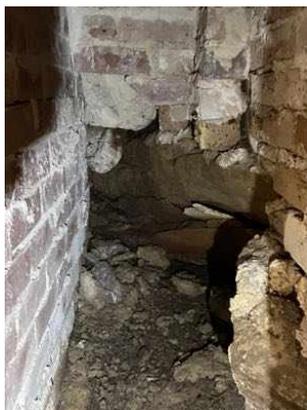
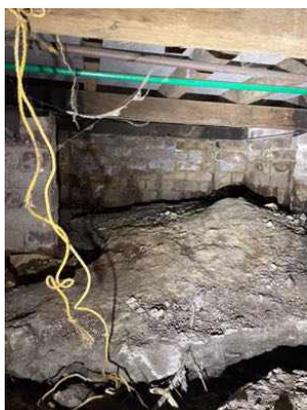
Defects 3.04

| Finding: | Evidence of excessive moisture was present at the time of inspection |
| Information: | Excessive moisture can attract termites and produce conditions that promote termite attack fungal growth and wood decay. |

Excessive moisture is generally caused by deteriorated inadequate or missing roof drainage leaking plumbing pipes or fixtures poorly plumbed HWS overflows or condenser units and poor site drainage.

It is highly recommended that all plumbing and drainage fixtures and fittings be maintained regularly in order to prevent excessive moisture being present in the external / internal property.

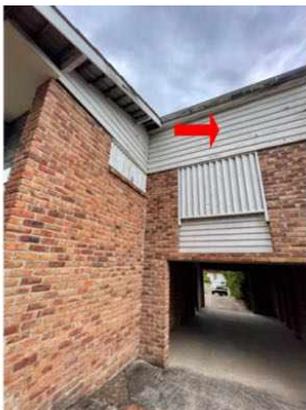
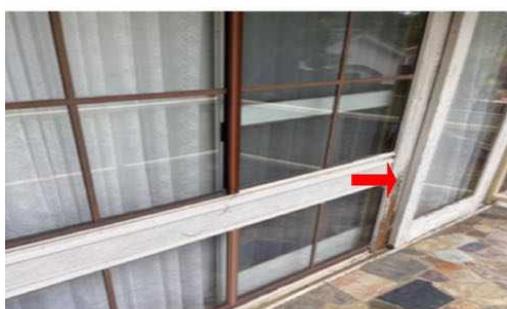
Defects 3.05

| Information: | External timbers that are frequently exposed to harsh weather conditions require adequate protection in order to maintain their condition. Where timbers have not been painted or treated adequately, general deterioration is likely to occur at an accelerated rate. |

If left unattended, replacement of these timbers is likely to be necessary in the short-term future. Adequate treatment of these timbers is required as soon as possible by a painting contractor or general handyman.

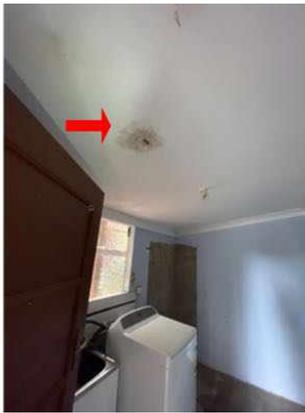
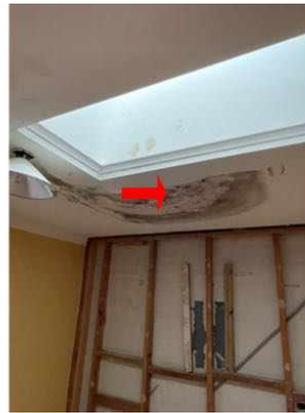
Defects 3.06

| Finding: | Ceiling - Water damaged |
| Information: | Water damage to the ceiling lining is generally an indication of excessive moisture being present in the roof void, usually via a leak to the roof covering. |

Where water damage is evident to the ceiling, the primary requirement is to identify and rectify the source of the leak. A roofing plumber should be appointed as soon as possible to identify the leak and perform rectification works as necessary, ensuring the water damage is restricted.

Once the leak is repaired, consultation with relevant tradespeople, including plasterers and painters, is advised. Rectification works may include replacement of ceiling lining or minor repainting, depending on the extent of the damage.

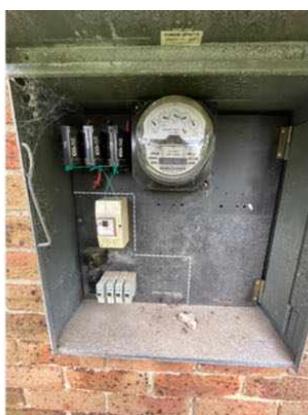
Defects 3.08

Information: The application of a post-construction chemical termite barrier is highly recommended for all properties, particularly if live termite activity has been found on the site previously. Such barriers are highly effective in preventing termite attack on any timber building elements throughout the property.

A durable notice should be placed in the switchboard unit to indicate current termite barriers. At the time of inspection, it appeared as though no termite management system has been installed, with no evidence to suggest preventative works taking place.

The client may consider gaining further advice from a pest controller as to the costs and procedures involved with this application. It is recommended that obtaining such advice be a short-term priority.

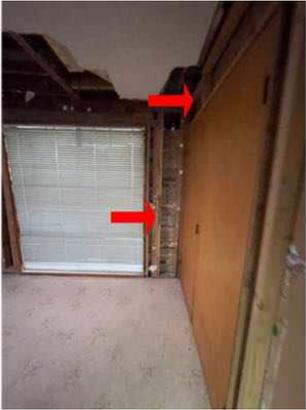
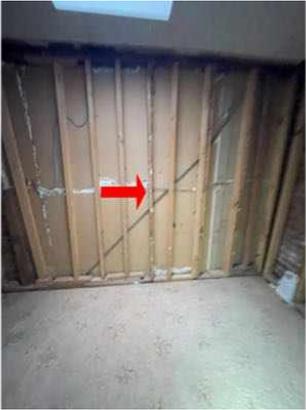
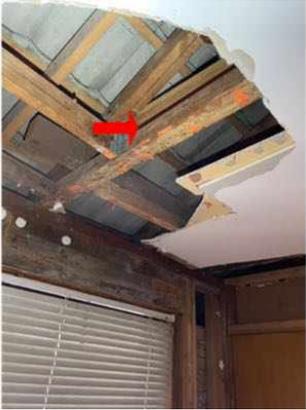
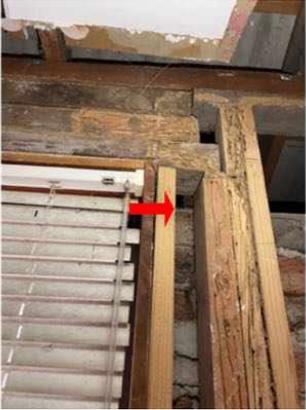
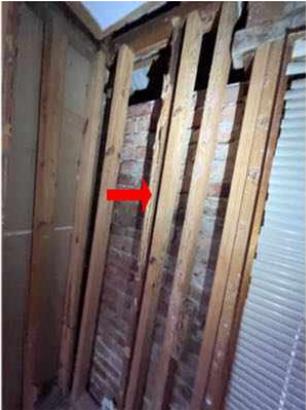
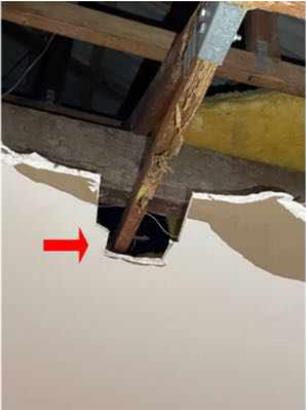
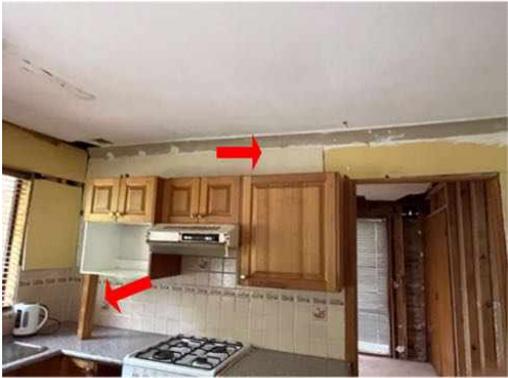
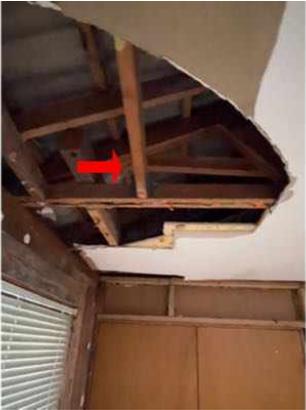
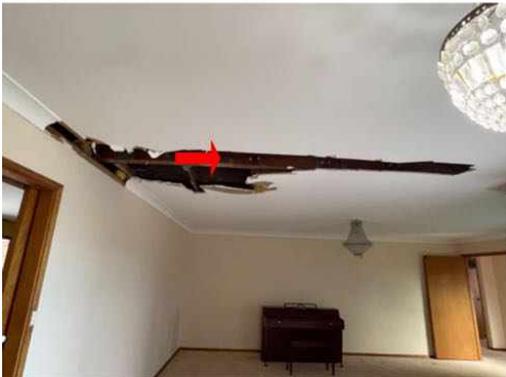
Defects 3.09

Building: Building 1
Location: All Areas
Finding: Incomplete or substandard works
Information: The works to this area appear to be incomplete or have been completed to a substandard level.

Works that have not been completed to a satisfactory level create potential for the development of building defects and may impede on the safety and integrity of the overall structure.

It is highly recommended that the relevant trades be appointed to complete these works and ensure the safety of the area and the longevity of all associated building elements.

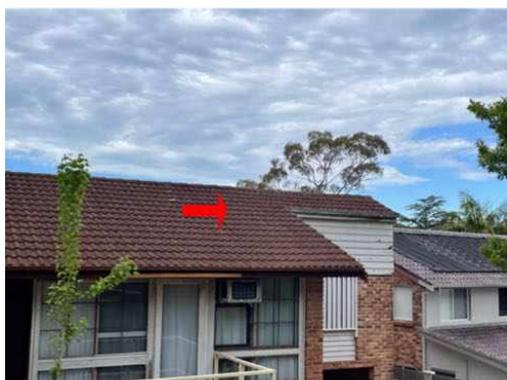
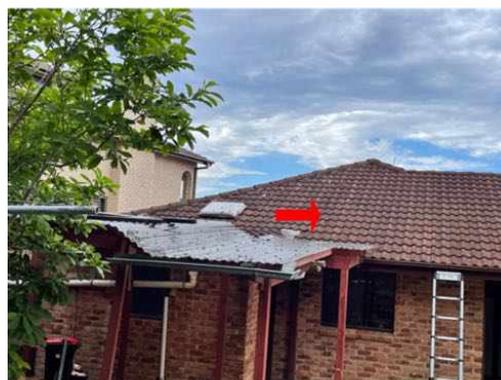
Defects 3.10

| Information: | Upon inspection of the exterior roofing, the majority of roof tiles were considered to be in a fair condition. While weathering of the tiles is consistent with the age of the property, maintenance works are required. |

Isolated areas of mortar have come loose in the valleys and minor cracking is also present. Re-pointing and re-sealing the may be considered as an interim solution by the client to help preserve and extend the life span of the tiles.

Where left unmanaged, deteriorating roof tiles are likely to lead to a number of secondary defects, including minor water leaks and weather exposure to internal roofing structures.

Consultation with a roofing contractor is highly advised to gain advice on cost of remedial works that may be required in the short to medium term. Remedial works are likely to increase the longevity of the exterior roofing structure.

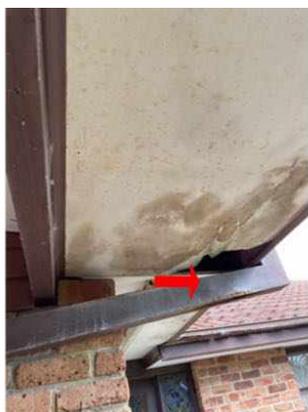
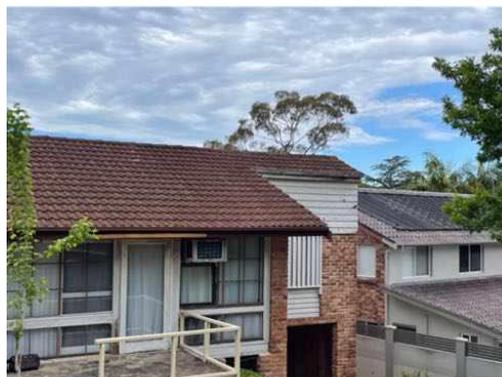
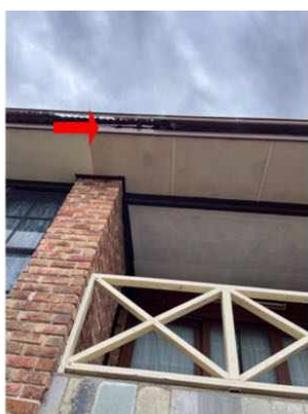
Defects 3.11

| Finding: | Roof plumbing - Rusted or corroded |
| Information: | The roof plumbing has areas of rust and corrosion. It is suspected that this has been caused by blockages, resulting in pooling or standing water, that have prematurely rusted elements of the roof plumbing. |

Rusted roof plumbing will generally develop holes and leaks that can affect other building elements with poor drainage of storm water. Poorly drained roof areas will also lead to damp conditions surrounding the base perimeter of the building which, if left unmanaged, can lead to a range of secondary building defects.

Repair and/or replacement of rusted roof plumbing is highly required in order to reinstate the roof drainage system to a fully operational level. To further maintain these

areas, gutters should be cleaned frequently, allowing the avoidance of any partial blockages.

A licensed plumber or specialist roof restoration company should be appointed to undertake these works. It is advised that such works be completed as soon as possible to prevent any further damage and deterioration.

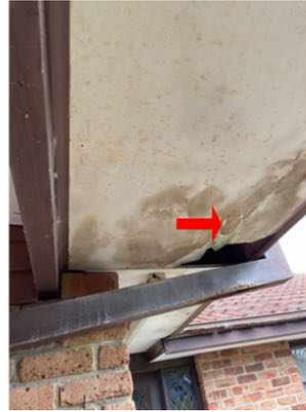
Defects 3.12

| Finding: | Eaves - Damaged |
| Information: | The eaves around the external property were found to be in a visibly poor condition. The damage may have been sustained as a result of a number of possible causes, including poor roof drainage, leaking roof plumbing or minor impact damage. |

The damage to the eave sheeting in this area detracts from the appearance of the structure, as well as potentially compromising the structural integrity of the roofing area.

Where eaves show moderate to severe damage, remedial works may be required. Where water damage is suspected as being the underlying cause, appointment of a licensed plumber is advised as a matter of urgency to identify the source of the water

leak.

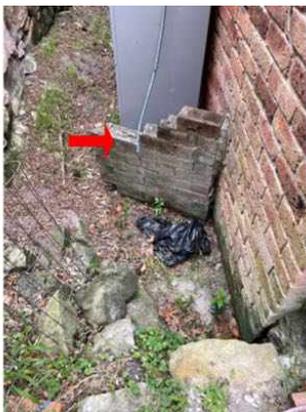
Defects 3.13

| Information: | The Hot Water System (HWS) overflow was found to be disconnected from storm water drainage and is creating excessive moisture in the surrounding area. |

These damp conditions can lead to secondary defects such as rot, rust or corrosion of associated building elements, the formation of fungal decay, or even the creation of potential slip hazards. When coupled with poor site drainage, pooling of water may also attract termite activity to this area.

It is highly recommended that a licensed plumber be appointed to connect the HWS overflow in order to prevent such an environment from being created. These minor works should be carried out as soon as possible.

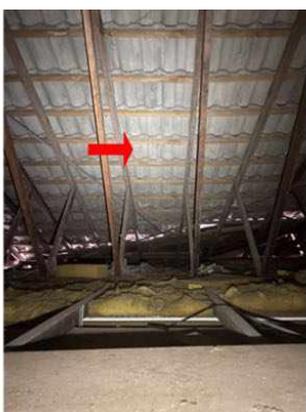
Defects 3.14

| Finding: | Sarking - Missing |
| Information: | Sarking is missing under the roof sheeting. Sarking acts as an insulator that helps with noise reduction and protects against water penetration. Sarking plays a key role in the operation and function of the overall roofing structure and its performance. |

Although not a requirement at the time of construction, replacement of any missing building element is advisable (although this can be quite expensive to do after the time of construction). Where sarking is missing, regular inspections of the roof tiles for cracking and potential moisture penetration is required.

Sarking may be retrospectively fitted by a registered builder at the discretion of the client.

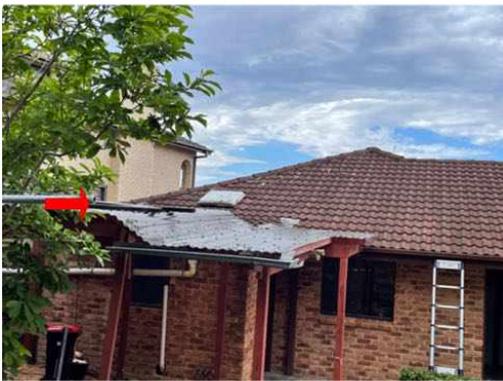
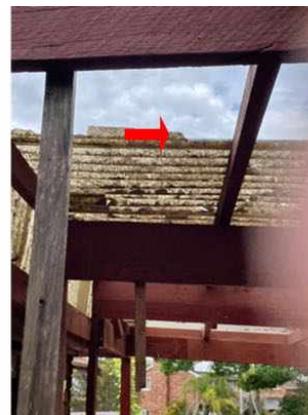
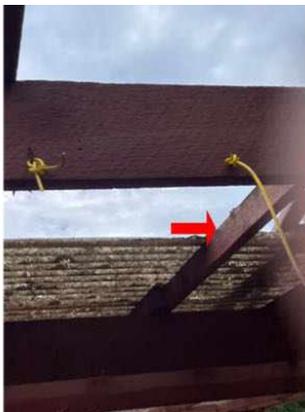
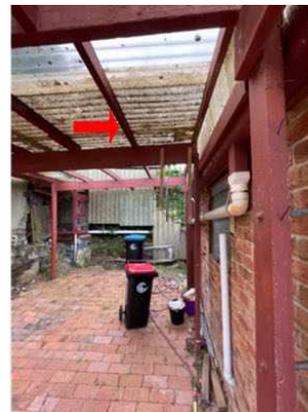
Defects 3.15

| Finding: | Roof sheets - Deteriorated |
| Information: | Upon inspection of the exterior roofing, it was found that the roof sheets show signs |

of deterioration, with some sheets having come loose from their original fixing. The roofing has sustained an array of issues due to the age of the materials and a lack of general maintenance over time, including loose sheeting, lifting and sagging of sheets, and deterioration of associated building elements.

Loose, deteriorated and damaged roof sheets are susceptible to water penetration, exposing the surrounding associated area to internal roof leaks and water damage.

Re-fixing of all loose roof sheets should be conducted as soon as possible to ensure that no further damage occurs. Depending on the extent of the damage, replacement of sections of roof sheets or associated materials may be required. Engagement of a roofing restoration contractor is highly advised to perform remedial works as necessary.

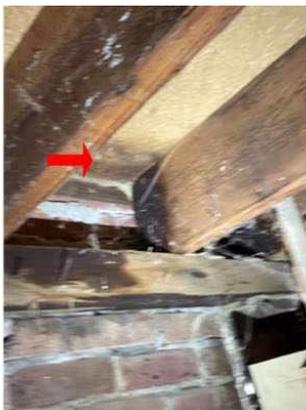
Defects 3.16

| Finding: | Flooring - Evidence of water damaged |
| Information: | Water damage to the flooring is generally an indication of excessive moisture being present in the floor. Rectification works may include replacement of flooring depending on the extent of the damage. |

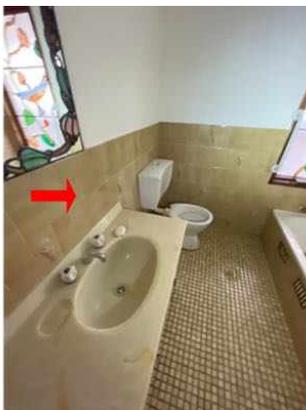
Defects 3.17

Information: Drummy tiled areas were identified at the time of inspection. The term 'drummy' refers to tiles that have become detached from their fixing, despite otherwise being in relatively good condition. Such defects are generally caused by physical or moisture damage to the area. Drummy tiled areas may also be a direct result of poor workmanship during the construction process.

Tiled areas may swell and shrink with changes in air humidity if the area has sustained moisture damage. Any exposure to moisture is capable of causing tiled areas to become drummy and/or cracked over a prolonged period of time. Drummy tiled areas generally require removal and replacement of affected tiles, with adequate sealant and grouting.

Specialist trades are available for these types of services. A registered builder may be required to undertake works if damage is extensive or if secondary building defects have resulted. Otherwise, it is advised that a tiling contractor be appointed to perform works as necessary. Immediate action is recommended to ensure that no further damage is sustained in the affected area.

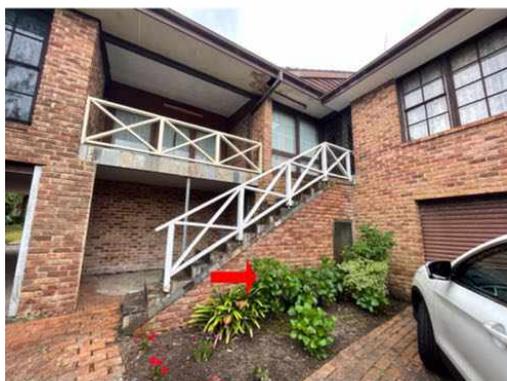
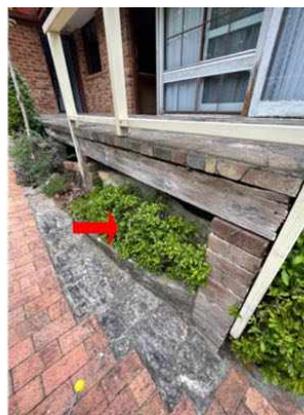
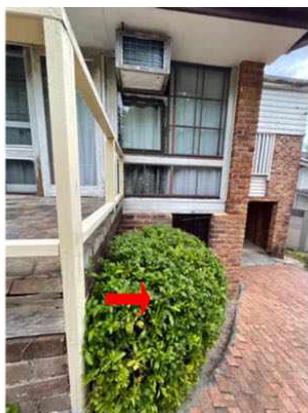
Building: Building 1
 Location: All External Areas
 Finding: Garden Beds - Conditions Conducive to Termites
 Information:

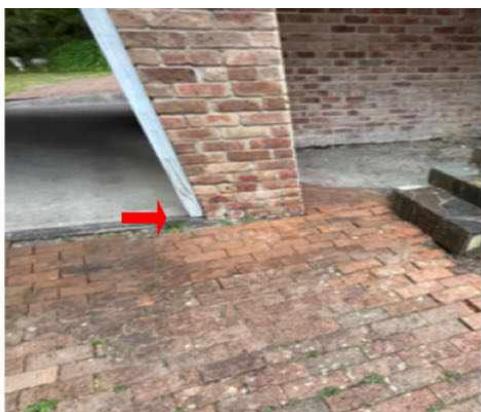
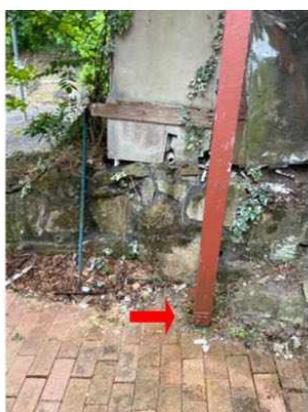
Building: Building 1
 Location: All External Areas
 Finding: Building materials in direct ground contact - conducive to termites
 Information: Where timber elements are in direct contact with the ground and consequently moisture or dampness they become conducive to termite activity. Whether timber is used as a building element part of a fencing structure or stored as an unused item they can provide an environment that is attractive to termite infestation. When met with excessive moisture timber begins to decay and develop wood rot. Any timbers that are in direct contact with external grounds especially if left untreated or non- durable

also provide ingress for subterranean termites into that particular element. The removal of any such materials that may be conducive to termite activity should be removed as soon as possible to minimise the risk of termite attack.

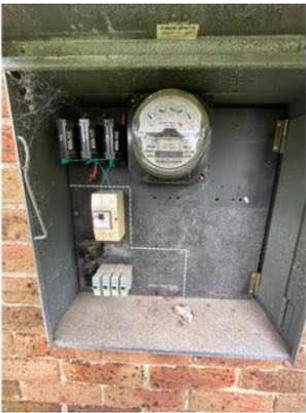
A durable notice should be placed in the switchboard unit to indicate current termite barriers. At the time of inspection, it appeared as though no termite management system has been installed, with no evidence to suggest preventative works taking place.

The client may consider gaining further advice from a pest controller as to the costs and procedures involved with this application. It is recommended that obtaining such advice be a short-term priority.

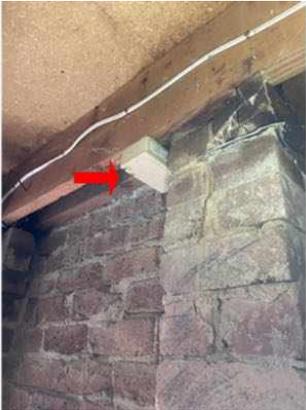
Building: Building 1
Location: Subfloor
Finding: Evidence of a previous termite baiting system was identified
Information: There are a number of factors which indicate the presence of a previously installed or applied termite barrier.

Where a Termite Baiting System has been identified you should refer to the type of barrier date of installation warranty conditions and any documentation provided by a builder or past owner. Consult the company who installed the barrier to confirm whether the system is still under warranty.
