## Building and Timber Pest Inspection Report

Inspection Date: Wed, 13 Oct 2021

Property Address: 678 Warringah Rd, Forestville NSW 2087,  
Australia

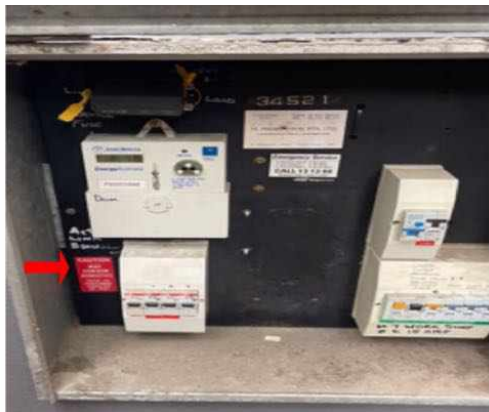
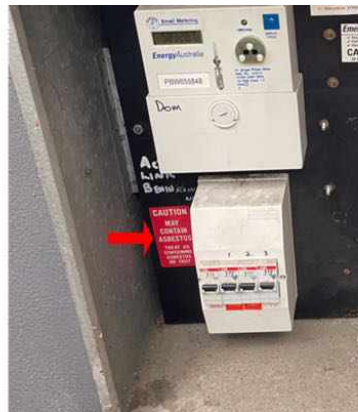
#### Defects 1.01

Building:	Building 1
Location:	All Areas
Finding:	Asbestos - Suspected ACM Identified on Site
Information:	Reporting on Asbestos is outside the Scope of this Report. This suspected defect is highlighted as a caution only. We suspect, based on our experience in the building industry, that there is a higher risk of the identified building element containing asbestos.

As Asbestos Reporting is outside the scope of this report, we advise that you consider a separate Asbestos Inspection and Condition Audit, which can include the taking of samples for definitive confirmation of the presence of Asbestos.

In the interim, the client is advised to act with caution, especially when considering any damage to building materials general wear and tear renovations extensions demolition and general maintenance activities due to the suspected presence of Asbestos.

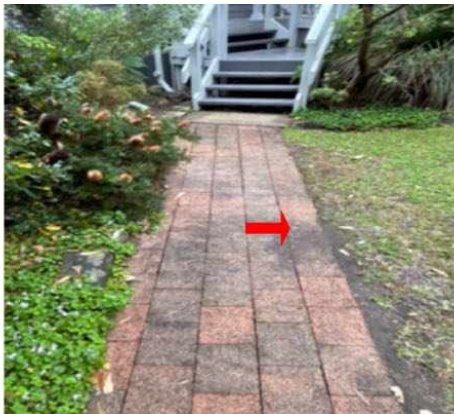
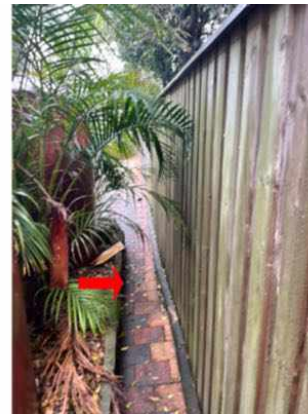
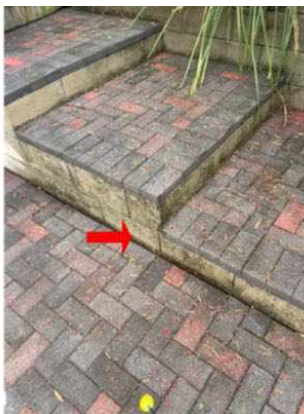
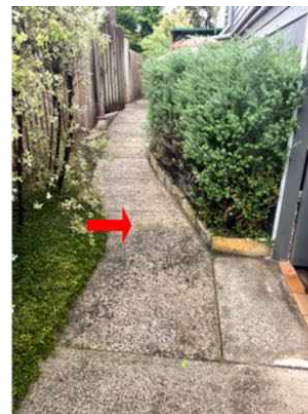
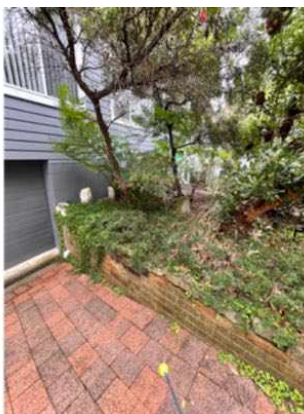
#### Defects 3.01

Building:	Building 1
Location:	All Areas
Finding:	Evidence of excessive moisture was present at the time of inspection

Information: Excessive moisture can attract termites and produce conditions that promote termite attack fungal growth and wood decay.

Excessive moisture is generally caused by deteriorated inadequate or missing roof drainage leaking plumbing pipes or fixtures poorly plumbed HWS overflows or condenser units and poor site drainage.

It is recommended that all plumbing and drainage fixtures and fittings be maintained regularly in order to prevent excessive moisture being present in the external / internal property.

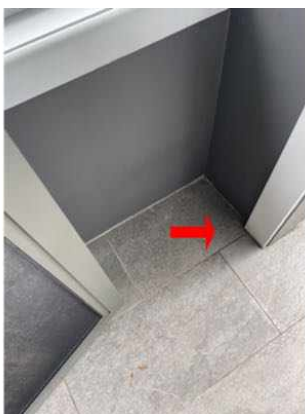
### Defects 3.02

Building:	Building 1
Location:	All Areas
Finding:	Sealant - missing
Information:	Flexible and mould resistant materials should be applied to affected areas to prevent any subsequent water damage that is likely to occur. Regular maintenance and replacement of damage or missing or damaged sealant and grout is highly recommended to the wet areas, as this is a regular wear and tear defect.

Sealant and grouting in areas that come into regular contact with water should be maintained for the long term care of your property. A sealant specialist or tiling contractor should be appointed to complete these works as soon as possible

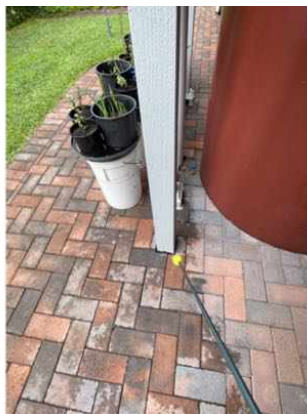
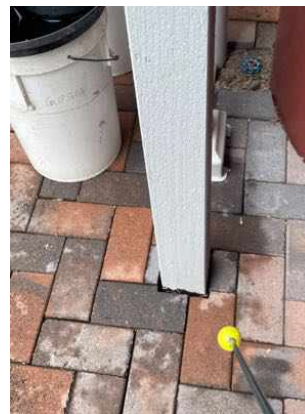
### Defects 3.03

Building:	Building 1
Location:	All External Areas
Finding:	Wood rot
Information:	This building element shows evidence of wood rot. Wood rot, also known as Fungal Decay, occurs when timbers and other cellulose building materials are exposed to damp conditions on an ongoing basis.

This could be the result of exposure to weathering over a prolonged period of time, or the attraction of excessive moisture from other abutting building materials. Contributing factors also include poor air ventilation in the area.

Early intervention and regular maintenance, particularly of exterior timbers, will prolong the useful life of these building elements. Prior to any works being performed, the cause of the moisture that has created the visible wood rot should be identified and addressed in a suitable manner. Replacement of affected timbers may then be a necessary step in protecting surrounding building elements from such deterioration.

A qualified carpenter or builder may also be required to replace affected building materials.

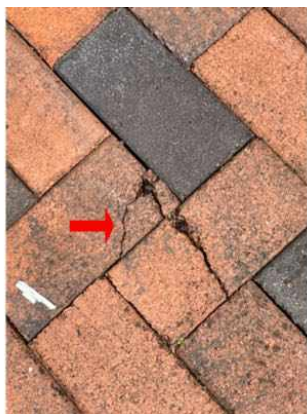
### Defects 3.04

Building:	Building 1
Location:	Yard - Back
Finding:	Paver - Cracked or damaged
Information:	Cracking was evident to the paver in this area at the time of inspection. While the cracking appears to be minor.

Relevant tradesperson may be required to repair damaged building elements.

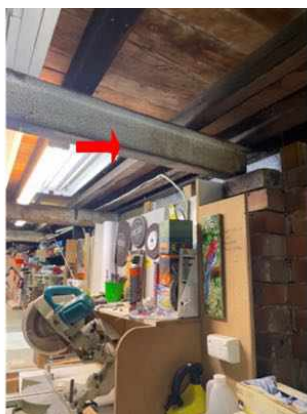
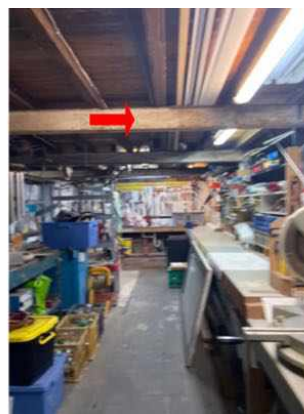
### Defects 3.05

Building:	Building 1
Location:	Subfloor
Finding:	Building element - Rusted or corroded
Information:	This building element shows evidence of rusting and corrosion, which is likely to have developed as a result of excessive exposure to moisture and or inadequate coatings.

Rusting and corrosion should be managed by ideally removing or limiting the affected surface from exposure to moisture.

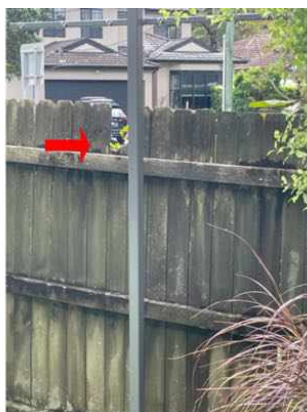
### Defects 3.06

Building:	Building 1
Location:	Yard - Back
Finding:	Fencing - Deteriorated
Information:	It was noted at the time of inspection that sections of the fencing throughout the property have deteriorated. Typically fencing deteriorates due to age and or wear, rot and or rust which is generally expected for a structure of this age, due to prolonged exposure to weather conditions. Sometimes inadequate installation or maintenance can be to blame.

If left unattended, it is likely that further damage will occur. It is suspected that repair of several elements of the fencing may be required however replacement may be a consideration of the client also.

A licensed fencing contractor should be appointed to provide further advice and perform rectification works as necessary.

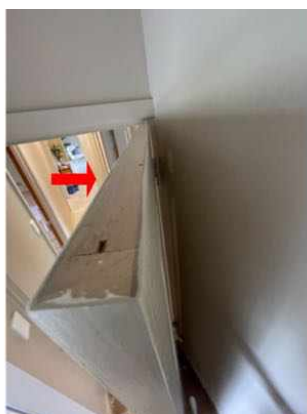
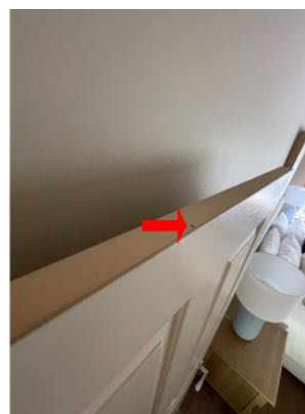
### Defects 3.07

Building:	Building 1
Location:	All Areas
Finding:	Door finish - incomplete on top and bottom of door

Information: The paint finish in this area was identified as being incomplete at the time of inspection. Whilst incomplete or missing paint finish is generally an appearance defect, it can also lead to the development of secondary building defects over time. Incomplete areas of paint finish exposes the area to moisture, potentially accelerating the deterioration of underlying building materials. A painting contractor should be appointed to perform necessary works to aid the appearance of the affected area and to ensure the area is protected against further deterioration. Alternatively, the homeowner following manufacturer instructions may perform these works.

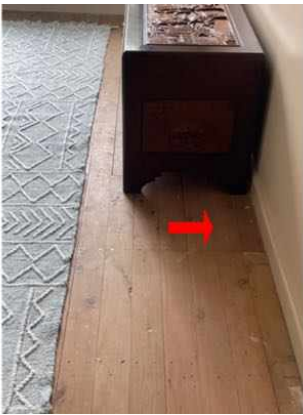
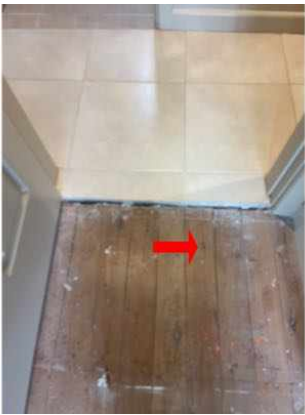
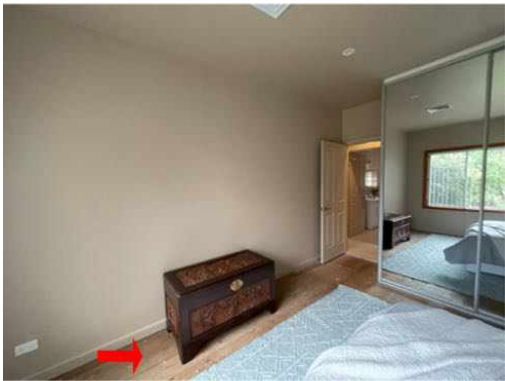
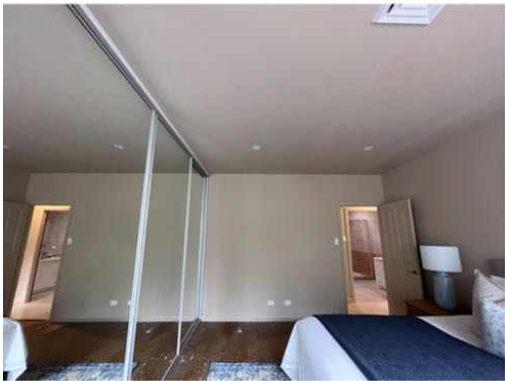
### Defects 3.08

Building: Building 1  
Location: All Areas  
Finding: Incomplete or substandard works  
Information: The works to this area appear to be incomplete or have been completed to a substandard level.

Works that have not been completed to a satisfactory level create potential for the development of building defects and may impede on the safety and integrity of the overall structure.

It is highly recommended that the relevant trades be appointed to complete these works and ensure the safety of the area and the longevity of all associated building elements.

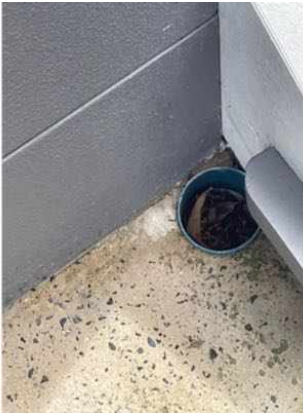
**Defects 3.09**

Building: Building 2  
Location: Yard - Back  
Finding: Drainage grate - suspected missing  
Information: it is suspected that a drainage grate is missing at this location.

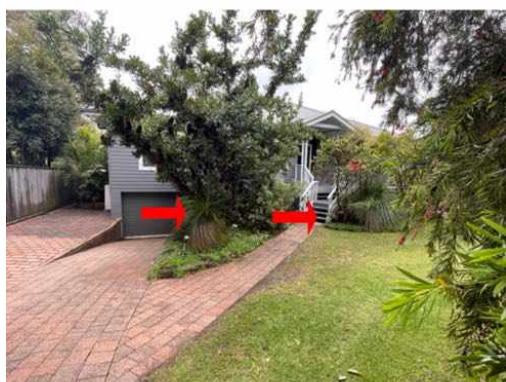
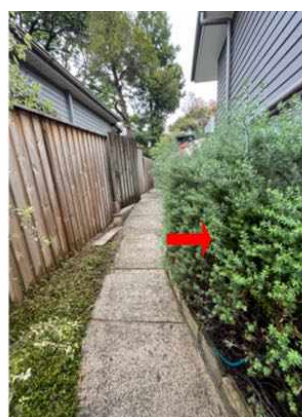
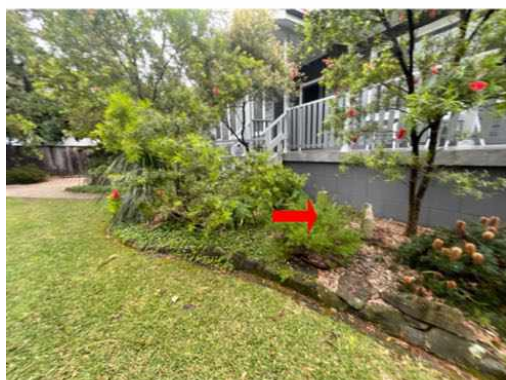
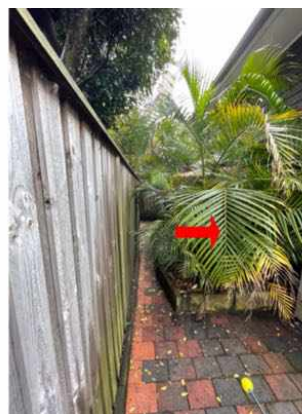
Building: Building 1  
Location: All External Areas  
Finding: Garden Beds - Conditions Conducive to Termites  
Information: Garden beds were found to be evident in the garden area. These garden beds can include untreated timber, and with a combination of moisture from watering hosing can make conditions conducive to termite activity and termite ingress.

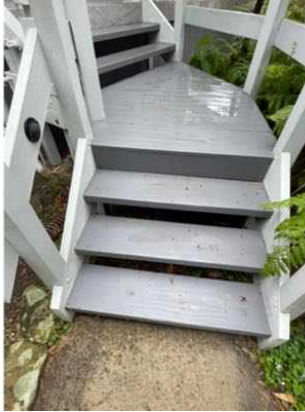
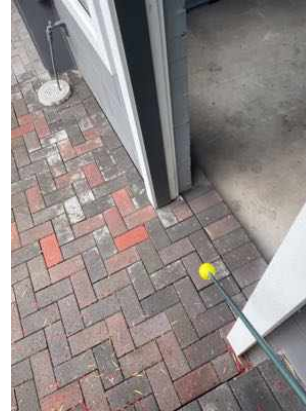
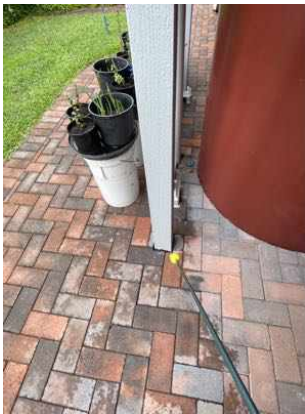
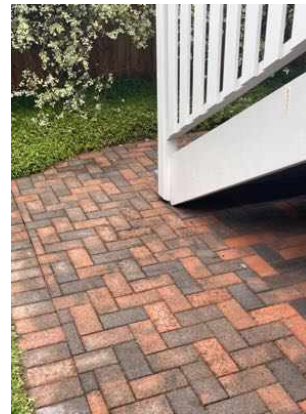
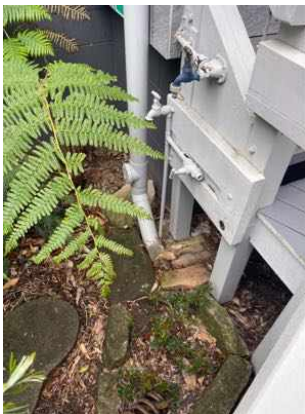
Building: Building 1  
Location: All External Areas  
Finding: Building materials in direct ground contact - conducive to termites  
Information: Where timber elements are in direct contact with the ground and consequently moisture or dampness they become conducive to termite activity. Whether timber is used as a building element part of a fencing structure or stored as an unused item they can provide an environment that is attractive to termite infestation.

When met with excessive moisture timber begins to decay and develop wood rot. Any timbers that are in direct contact with external grounds especially if left untreated or non- durable also provide ingress for subterranean termites into that particular element. The removal of any such materials that may be conducive to termite activity should be removed as soon as possible to minimise the risk of termite attack.

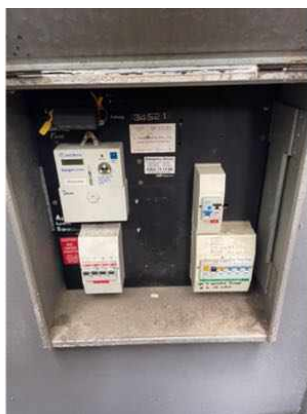
Building:	Building 1
Location:	Yard - Side
Finding:	Termite Management System - no evidence of a chemical installation
Information:	The application of a post-construction chemical termite barrier is highly recommended

A durable notice should be placed in the switchboard unit to indicate current termite barriers. At the time of inspection, it appeared as though no termite management system has been installed, with no evidence to suggest preventative works taking place.

The client may consider gaining further advice from a pest controller as to the costs and procedures involved with this application. It is recommended that obtaining such advice be a short-term priority.

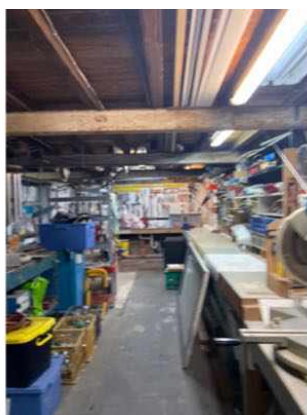
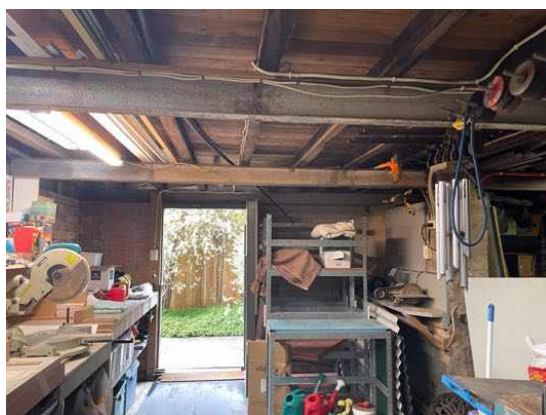
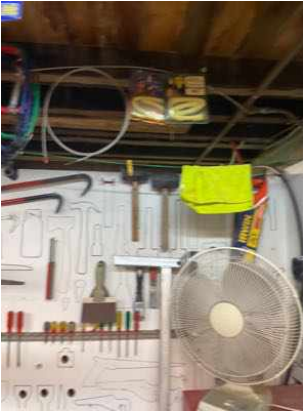
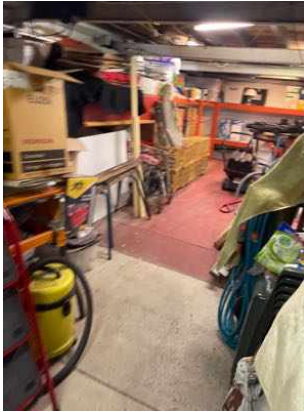
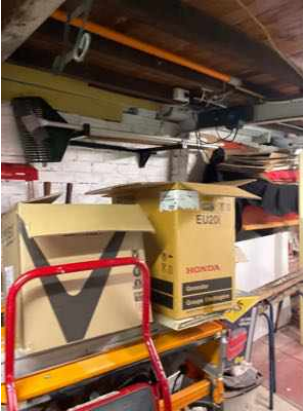
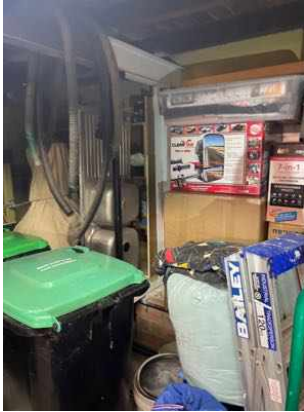
Building:	Building 1
Location:	All Areas
Finding:	Additional Photos - Obstructions and Limitations
Information:	These photographs are an indication of the obstructions and limitations which impeded full inspection of the property at the time of inspection. These obstructions can hide an array of defects and should be removed to allow full inspection to be carried out.
