Section D Significant Items

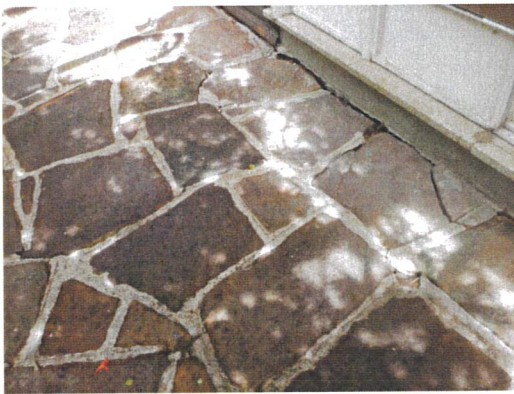
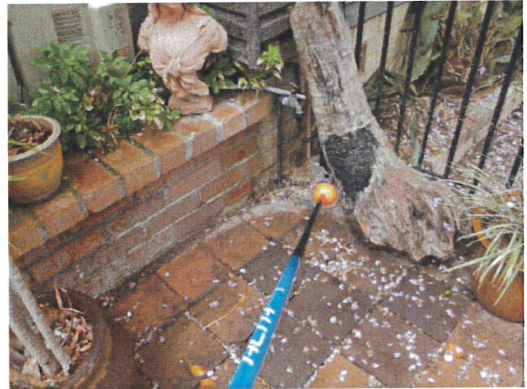
Defects 3.04

Building: Main Building
Location: All Areas
Finding: Evidence of excessive moisture was present at the time of inspection
Information: Excessive moisture can attract termites and produce conditions that promote termite attack fungal growth and wood decay.

Excessive moisture is generally caused by deteriorated inadequate or missing roof drainage leaking plumbing pipes or fixtures poorly plumbed HWS overflows or condenser units and poor site drainage.

It is highly recommended that all plumbing and drainage fixtures and fittings be maintained regularly in order to prevent excessive moisture being present in the external / internal property.

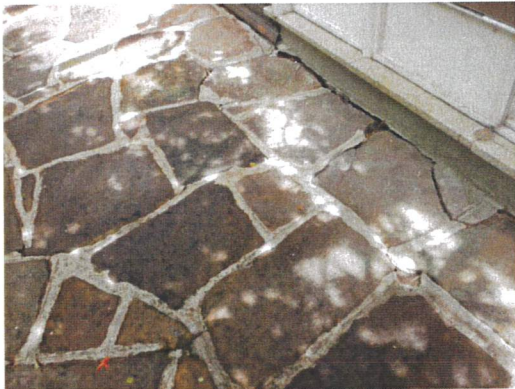
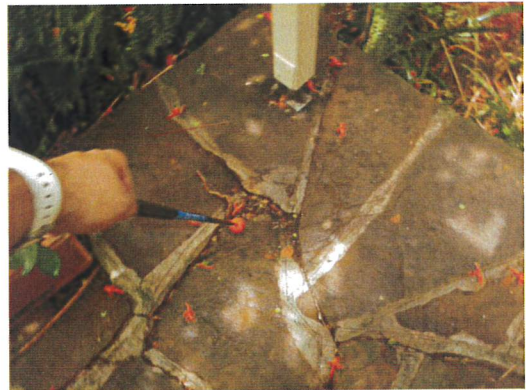
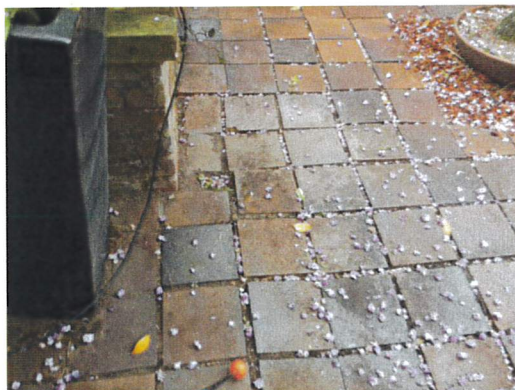
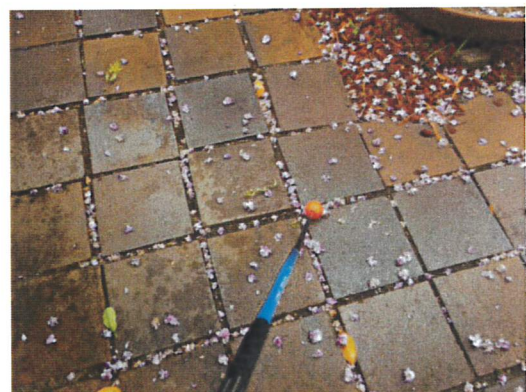
Defects 3.05

Building: Main Building

Location: Yard - Back

Finding: Paving - Uneven

Information: Sections of the external paved area are uneven, creating a potential trip hazard. It appears as though the area has been subject to rough installation, or that paving sections have lifted due to movements in the foundation of the property.

Where paving creates a trip hazard, personal injury may ensue if due caution is not taken by all persons within this area.

Re-paving of the area is required as soon as possible to remedy this situation. Further consultation with a specialist concreter is advised.

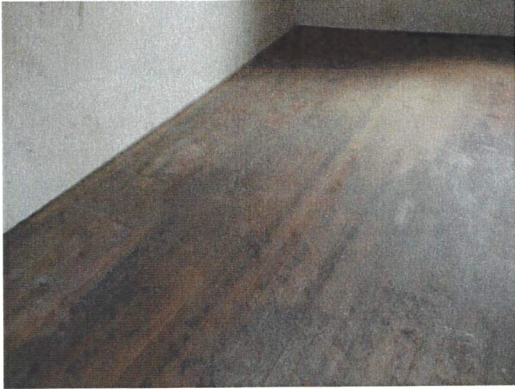
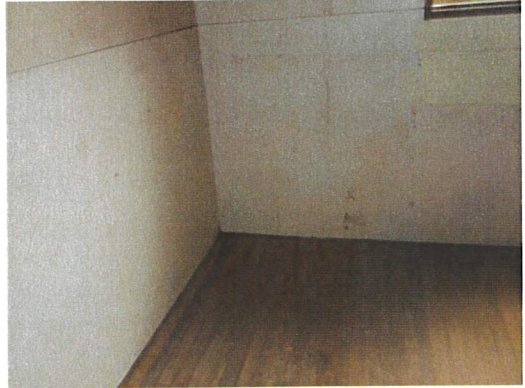
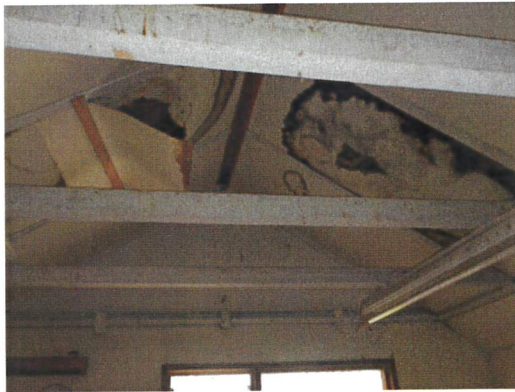
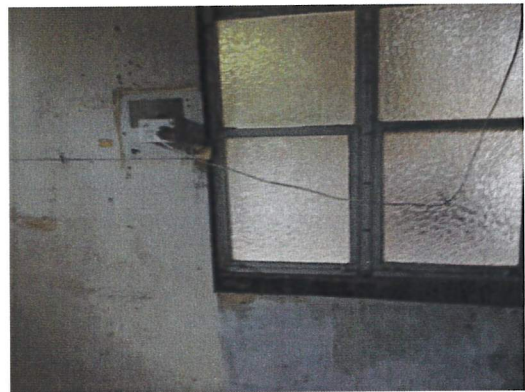
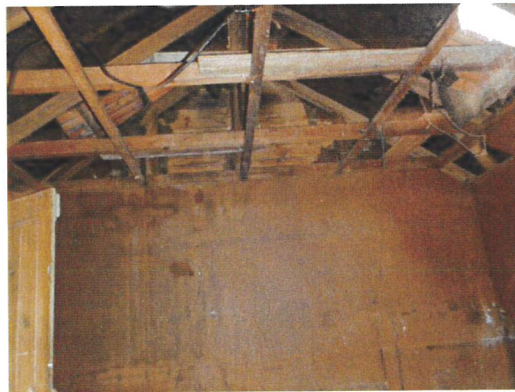
Defects 3.06

Building: Garage
Location: All Areas
Finding: Building element - Damaged
Information: [MUST EDIT]

Evidence of damage was identified. Include findings, identify causes, potential implications if left unmanaged and suggest trade responsible for rectification.

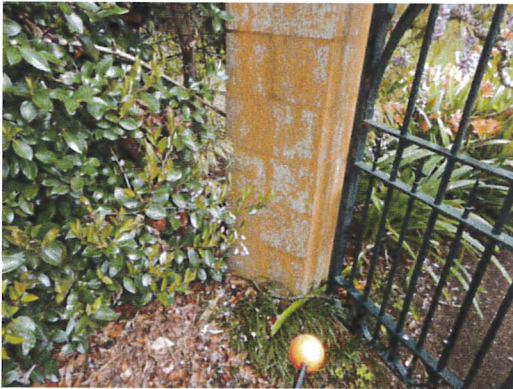
Defects 3.07

| Building: | Main Building |
| Location: | Yard - Front |
| Finding: | Front Gate - Broken |
| Information: | Breakage occurs generally when the building materials have either aged and decayed, or as a result of damage (accidental or deliberate). |

Repair and/or replacement of broken elements is advised to ensure that additional secondary defects do not arise as a consequence. Such works are necessary, as all building elements play a key role in the operation and function of the overall structure and its performance.

A relevant tradesperson should be appointed to repair or replace the affected building element prior to any subsequent damage being caused.

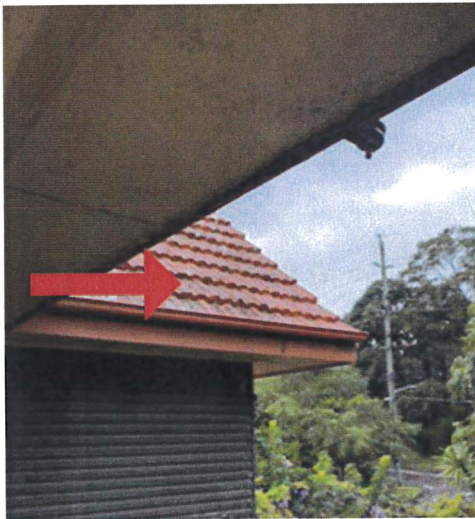
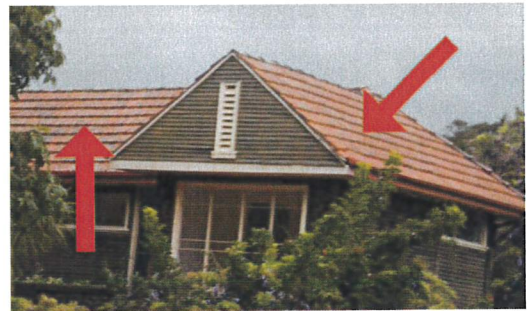
Defects 3.08

Building: Main Building

Location: Roof

Finding: Roof tiles - Weathered

Information: Upon inspection of the exterior roofing, the majority of roof tiles were considered to be in a fair condition. While weathering of the tiles is consistent with the age of the property, maintenance works are required.

Isolated areas of mortar have come loose in the valleys and minor cracking is also present. Re-pointing and re-sealing the may be considered as an interim solution by the client to help preserve and extend the life span of the tiles.

Where left unmanaged, deteriorating roof tiles are likely to lead to a number of secondary defects, including minor water leaks and weather exposure to internal roofing structures.

Consultation with a roofing contractor is highly advised to gain advice on cost of remedial works that may be required in the short to medium term. Remedial works are likely to increase the longevity of the exterior roofing structure.

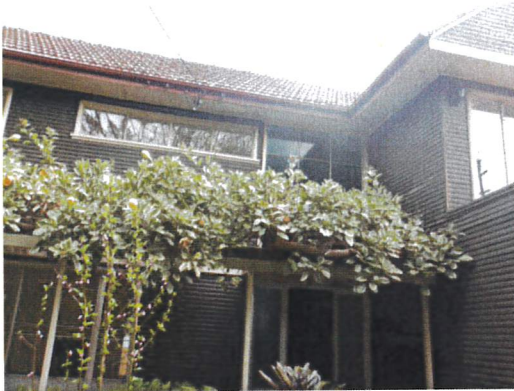
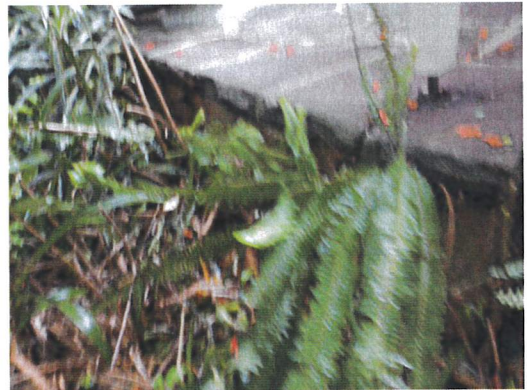
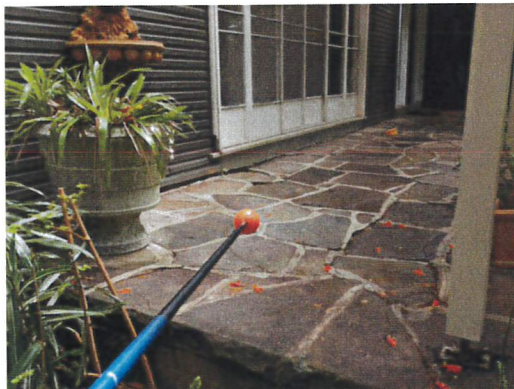
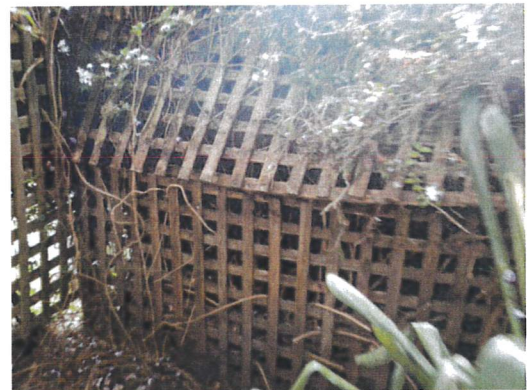
These photographs are an indication of the obstructions and limitations which impeded full inspection of the property at the time of inspection. These obstructions can hide an array of defects and should be removed to allow full inspection to be carried out. A re-inspection is recommended once the areas are made accessible.

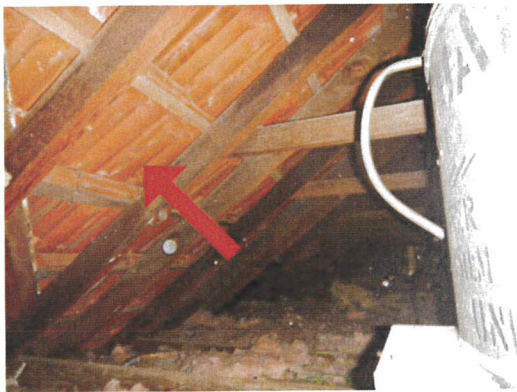
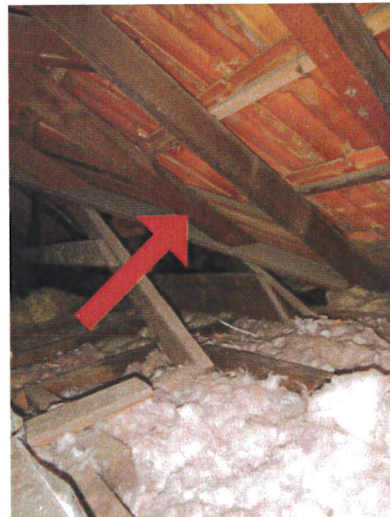
Noted Item

Building: Main Building
Location: Roof
Finding: Sarking - Missing
Information: Sarking is missing under the roof sheeting. Sarking acts as an insulator that helps with noise reduction and protects against water penetration. Sarking plays a key role in the operation and function of the overall roofing structure and its performance.

Although not a requirement at the time of construction, replacement of any missing building element is advisable (although this can be quite expensive to do after the time of construction). Where sarking is missing, regular inspections of the roof tiles for cracking and potential moisture penetration is required.

Sarking may be retrospectively fitted by a registered builder at the discretion of the client.
