## **VISUAL BUILDING & PEST INSPECTION REPORT**

### **Vendor Report**

**17 Townsend Avenue Frenchs Forest**

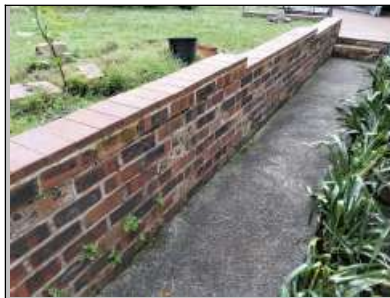
The masonry retaining walls appear in acceptable condition.

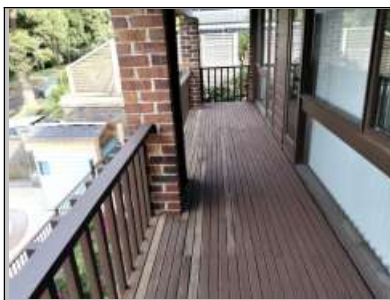
Front elevation.

The general condition of this structure is fair.

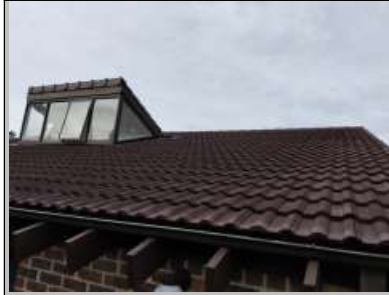
The roof is of pitched construction.

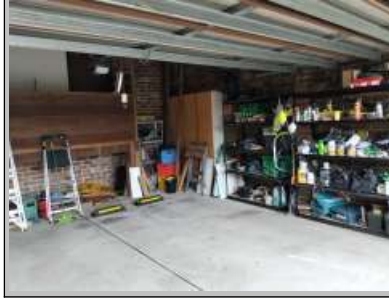
Garage.

The structure is generally in good condition.

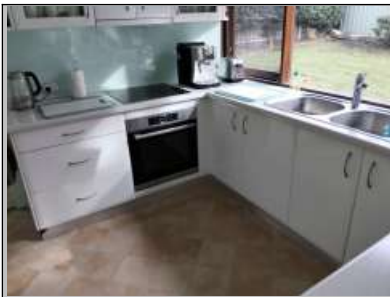
The condition of the fixtures is generally fair. A glass splashback is located over the benchtop area.

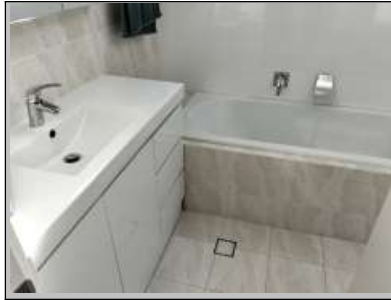
Upstairs.

The shower recess was tested and there was no visible water penetration to surrounding areas. IMPORTANT NOTE: This test may not reveal water leaks until the shower is put into constant use and surrounding areas monitored over a period of time.

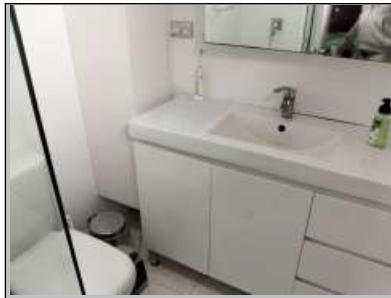
Rear.

The shower recess was tested and there was no visible water penetration to surrounding areas. IMPORTANT NOTE: This test may not reveal water leaks until the shower is put into constant use and surrounding areas monitored over a period of time.

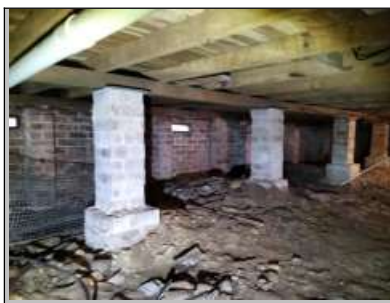
The building is constructed on a combination of strip footings and piers. The footings appear to be generally sound.

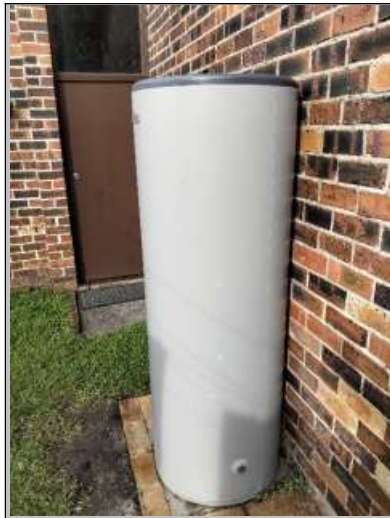
Mains electric hot water system: Mains pressure: Located externally: The hot water system appears to be in working condition. No specific tests other than running the hot water tap were carried out. No determination has been made as to the suitability or adequacy of the hot water system in relation to capacity or otherwise.

The unit was manufactured in 2017.
