## Pre-Purchase Timber Pest Detection Report

Name of client:	<b>Vendor report</b>
Address of client:	
Address of property inspected:	<b>19 Elliot St Beacon Hill</b>
Date of inspection:	<b>23-07-2024</b>
Duration of inspection:	<b>1hrs 13min</b>
Name of principal (where applicable):	<b>Vendor report</b>

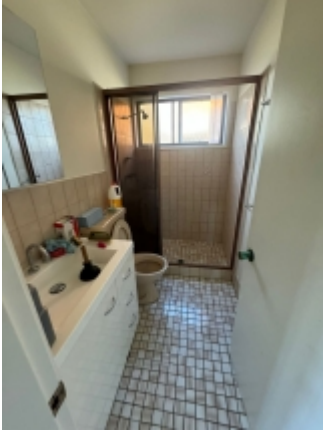
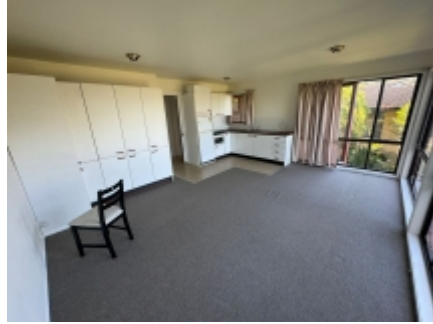
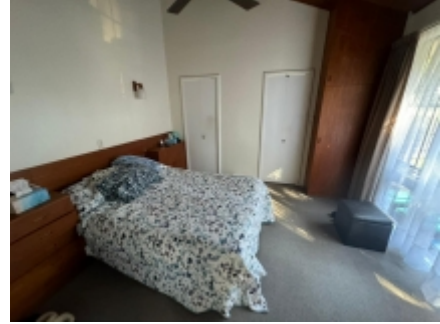
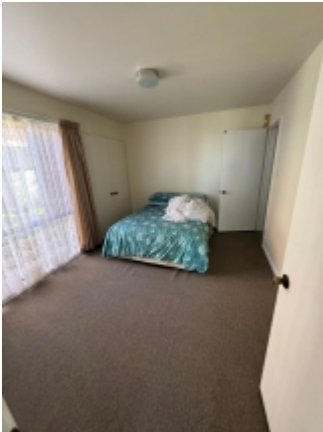
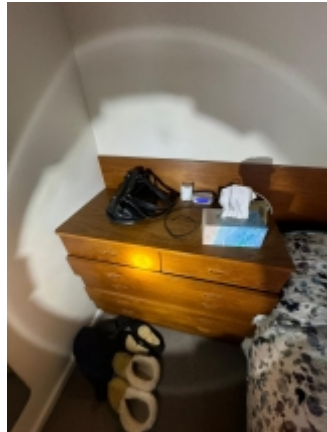
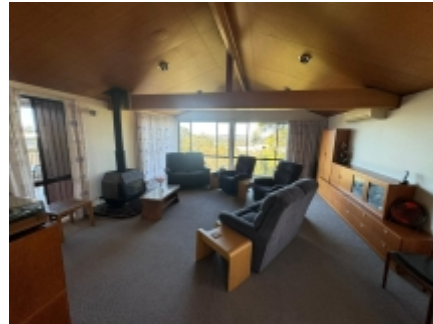
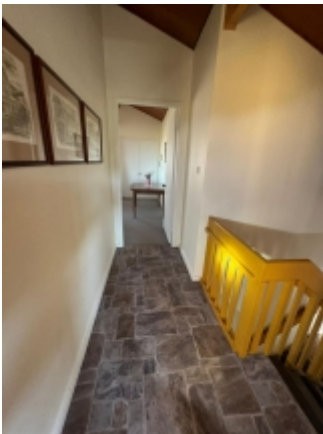
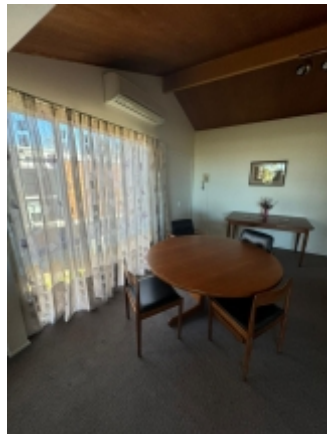
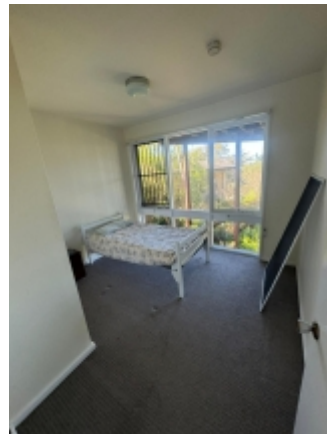
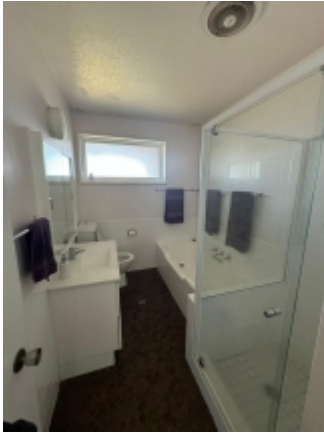
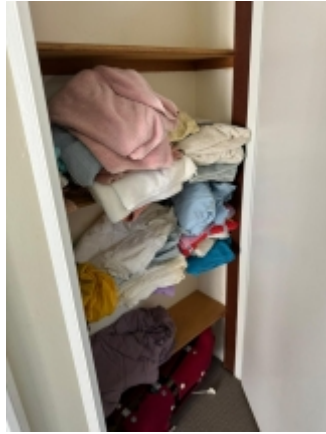
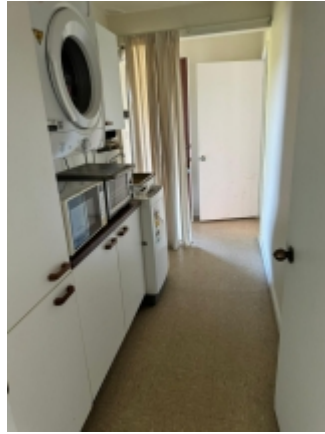
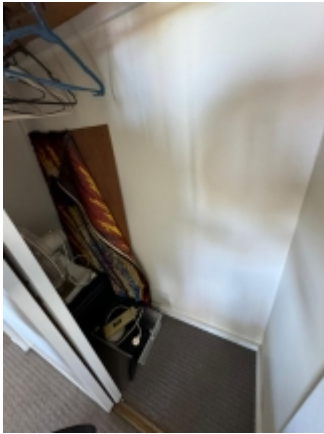
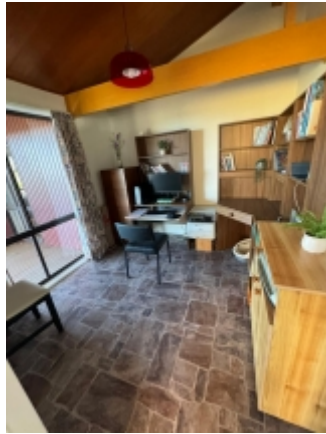
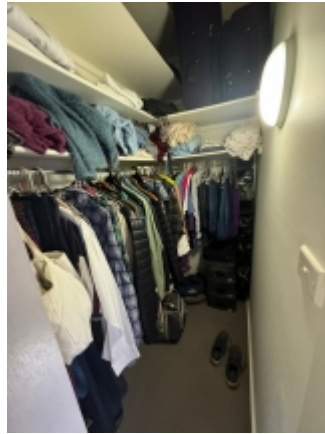
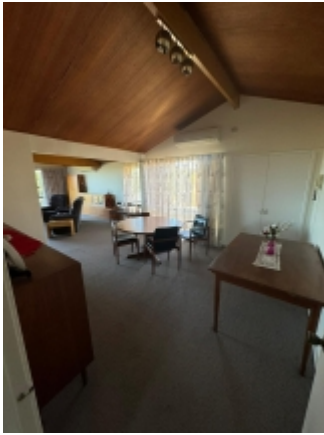
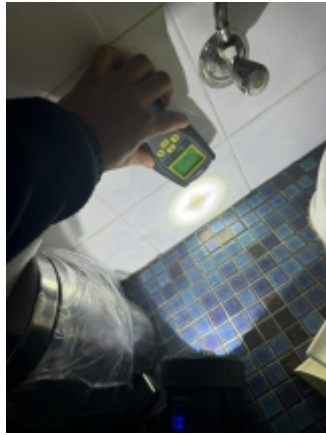
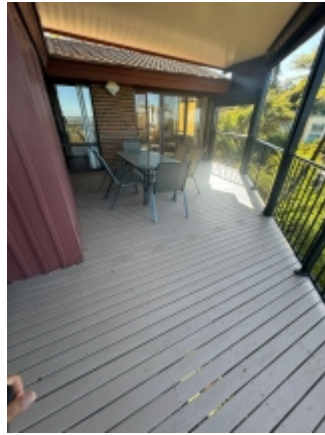
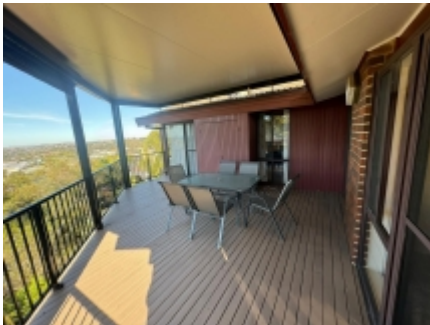
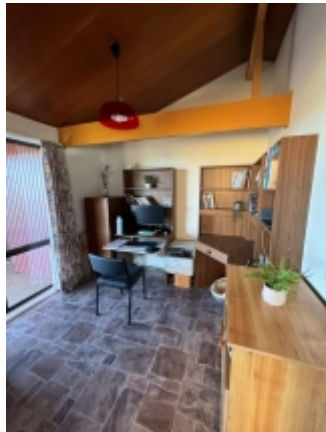
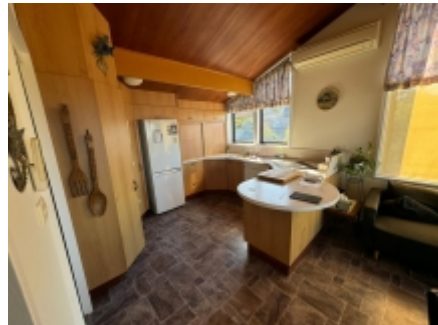
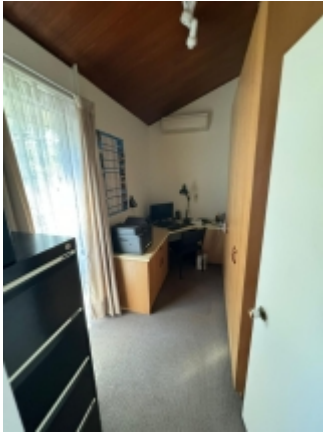
### 2.2.2 Obstructions (cont.) - Photos

Obstruction photos at the time of inspection.

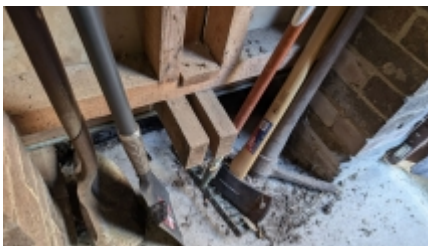
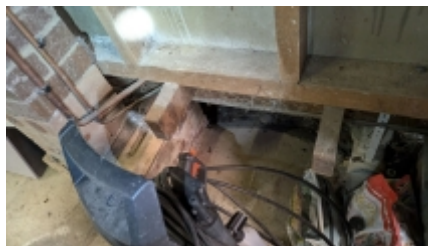
### 2.2.3 Inaccessible Areas

Yes

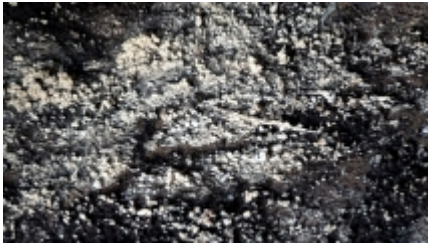
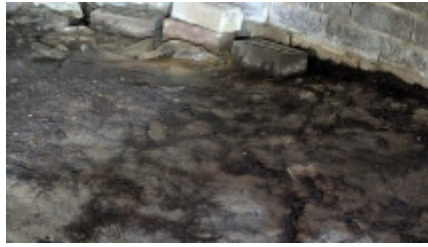
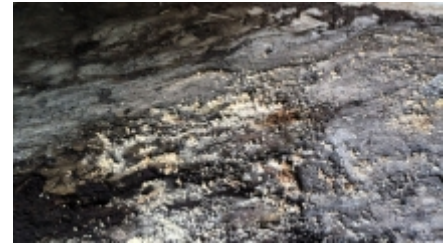
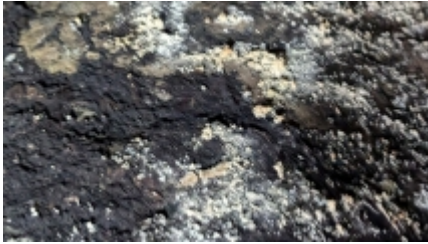
**High moisture was found under the house and mould growth developing.**

Mould treatment under the house is strongly recommended. Contact Daniel on 0402813266 for further advice

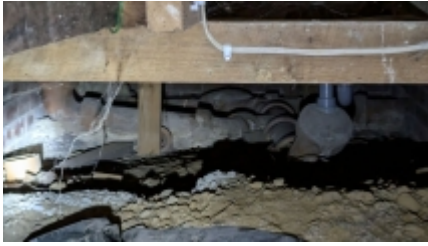
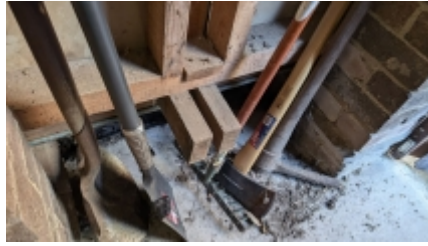
**Form work timber under the house touching the ground need to be removed or treated with termite repellent chemical**
