Building and Timber Pest Inspection Report

Inspection Date: Thu, 4 Nov 2021

Property Address: 10 Jindabyne St, Frenchs Forest NSW 2086,
Australia

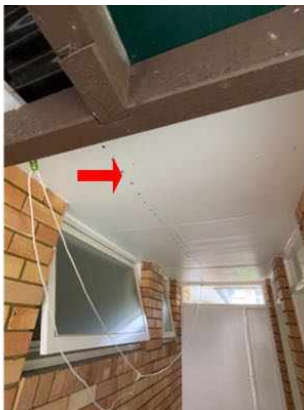
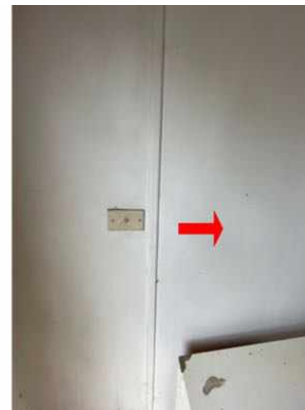
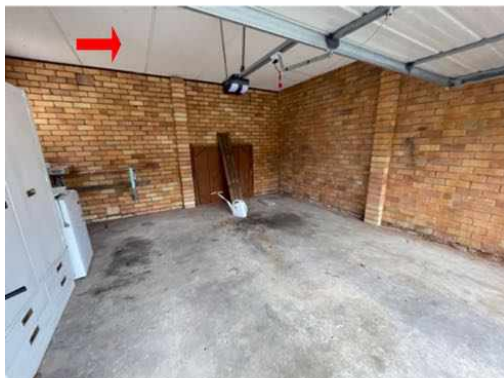
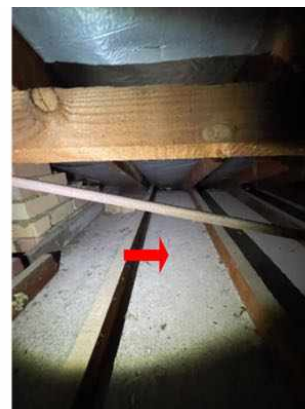
Defects 1.01

Building:	Building 1
Location:	All Areas
Finding:	Asbestos - Suspected ACM Identified on Site
Information:	Reporting on Asbestos is outside the Scope of this Report. This suspected defect is highlighted as a caution only. We suspect, based on our experience in the building industry, that there is a higher risk of the identified building element containing asbestos.

As Asbestos Reporting is outside the scope of this report, we advise that you consider a separate Asbestos Inspection and Condition Audit, which can include the taking of samples for definitive confirmation of the presence of Asbestos.

In the interim, the client is advised to act with caution, especially when considering any damage to building materials general wear and tear renovations extensions demolition and general maintenance activities due to the suspected presence of Asbestos.

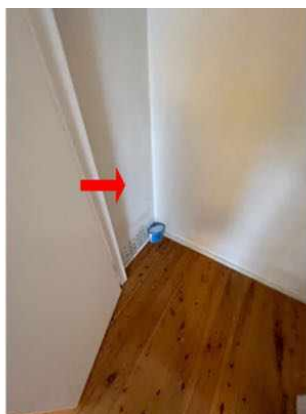
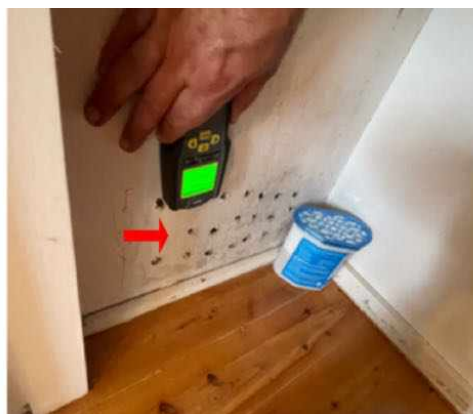
Defects 1.02

Building: Building 1
 Location: All Areas
 Finding: Mould - Present
 Information: Where evidence of mould growth was noted, there may be environmental, biological or health issues associated with the report. A specialist inspection by a suitably qualified environmental health inspector is warranted, where mould is extensive or where any queries regarding air quality spores or other related issues apply.

Generally, the client is advised to ensure that the general environment is free of moisture and humidity to aid in the prevention of mould formation and development. Any mould found during the inspection should be cleaned immediately by a cleaning contractor or the homeowner as applicable.

Please note that severely affected building elements may require replacement by a registered builder or qualified carpenter.

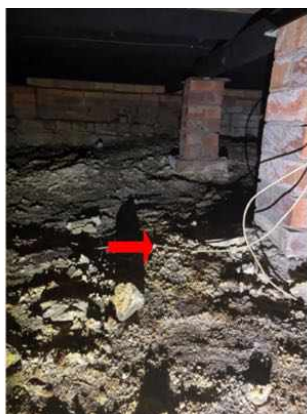
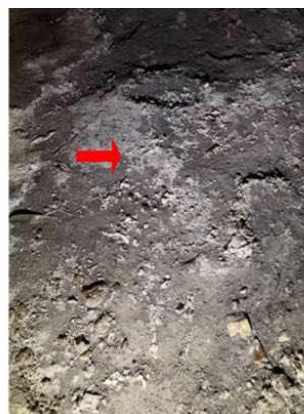
Defects 1.03

Building: Building 1
 Location: Subfloor
 Finding: Mould - Present
 Information: Where evidence of mould growth was noted, there may be environmental, biological or health issues associated with the report. A specialist inspection by a suitably qualified environmental health inspector is warranted, where mould is extensive or where any queries regarding air quality spores or other related issues apply.

Generally, the client is advised to ensure that the general environment is free of moisture and humidity to aid in the prevention of mould formation and development. Any mould found during the inspection should be cleaned immediately by a cleaning contractor or the homeowner as applicable.

Please note that severely affected building elements may require replacement by a registered builder or qualified carpenter.

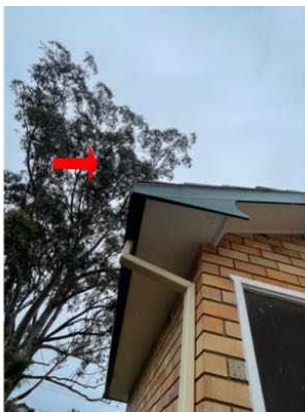
Defects 3.01

Building:	Building 1
Location:	All External Areas
Finding:	Trees - Overhanging and filling gutters
Information:	Overhanging trees often result in excessive amounts of leaf debris accumulating in gutters.

Gutters are a critical part of the building's management of storm water and rain. It is therefore important that they be kept clear to prevent secondary damage to associated building elements, including exterior and interior walls, ceiling linings and any adjoining building elements. Where gutters are blocked, pooling of rainwater is likely to occur, fast-tracking rust and corrosion of the roof plumbing elements.

It is highly advised that all overhanging tree branches be removed as soon as possible to prevent any further damage. Repair and/or replacement of sections of damaged guttering may also be required where the extent of the damage necessitates.

Such works should be performed by the homeowner; however, appointment of a landscape contractor or an arborist may be required. Consultation with a licensed roof plumber is required where guttering has been damaged.

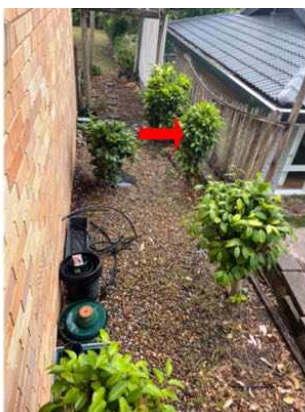
Defects 3.02

Building:	Building 1
Location:	Yard - Side
Finding:	Fencing - Deteriorated
Information:	It was noted at the time of inspection that sections of the fencing throughout the property have deteriorated. Typically fencing deteriorates due to age and or wear, rot and or rust which is generally expected for a structure of this age, due to prolonged exposure to weather conditions. Sometimes inadequate installation or maintenance can be to blame.

If left unattended, it is likely that further damage will occur. It is suspected that repair of several elements of the fencing may be required however replacement may be a consideration of the client also.

A licensed fencing contractor should be appointed to provide further advice and perform rectification works as necessary.

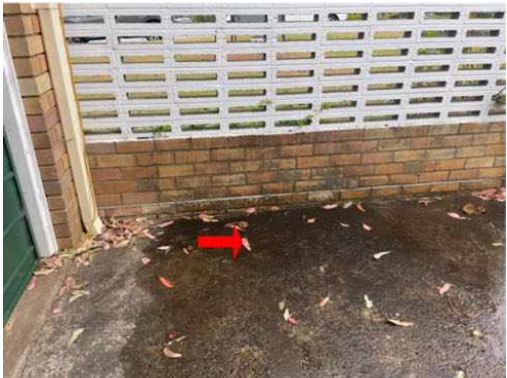
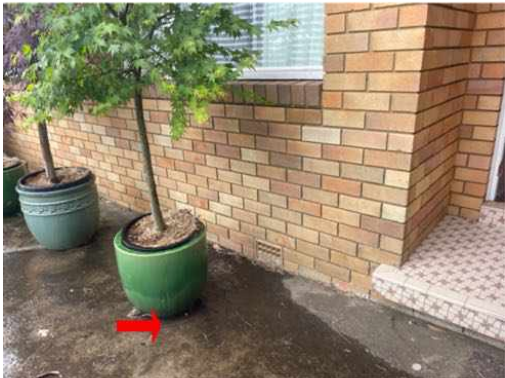
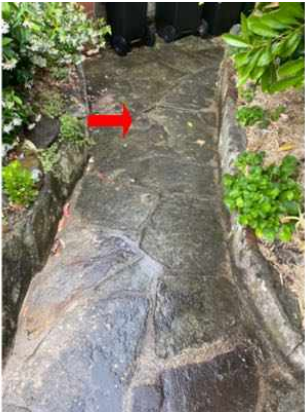
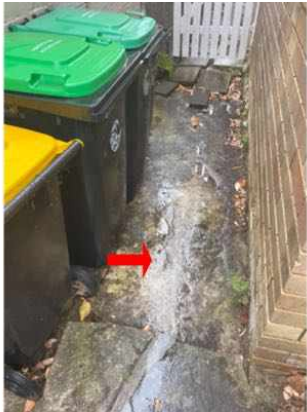
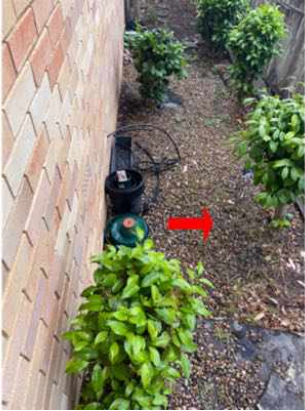
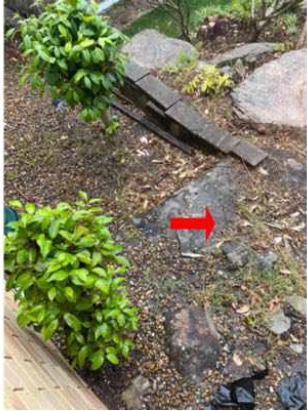
Defects 3.03

Building:	Building 1
Location:	All External Areas
Finding:	Evidence of excessive moisture was present at the time of inspection

Information: Excessive moisture can attract termites and produce conditions that promote termite attack fungal growth and wood decay.

Excessive moisture is generally caused by deteriorated inadequate or missing roof drainage leaking plumbing pipes or fixtures poorly plumbed HWS overflows or condenser units and poor site drainage.

It is highly recommended that all plumbing and drainage fixtures and fittings be maintained regularly in order to prevent excessive moisture being present in the external / internal property.

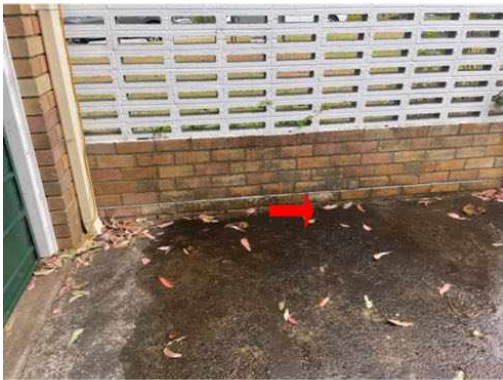
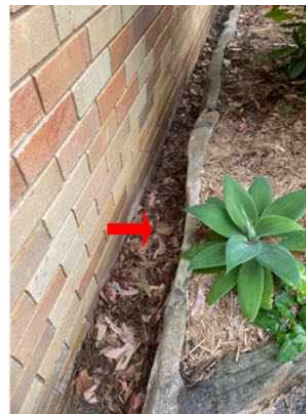
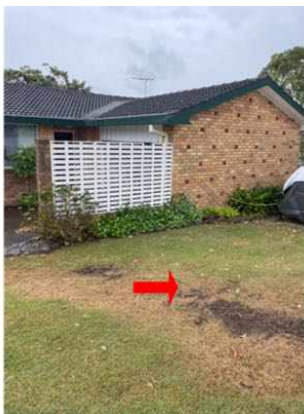
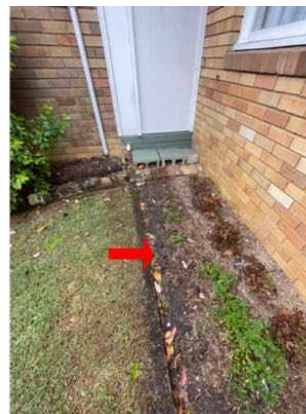
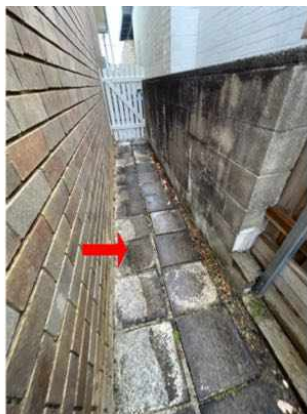
Defects 3.04

Building: Building 1
Location: All External Areas
Finding: Site drainage - suspected Inadequate
Information: The site drainage in this area was suspected to be inadequate at the time of inspection, creating potential for subsequent water damage to associated building elements.

It is important that water does not lie against the base of walls; surrounding paths and ground levels should be sloped to drain water away from walls. Downpipes should not discharge stormwater onto lower walls or plinths. Stormwater should be carried away by large, regularly cleaned drains. Ground levels may need to be lowered to expose a buried DPC.

Where site drainage is inadequate, installation of an Agricultural (Aggie) Drain may be required. A qualified plumber should be appointed to further inspect the property and perform any remedial works as necessary. Water damage and secondary defects are likely to occur if left unmanaged.

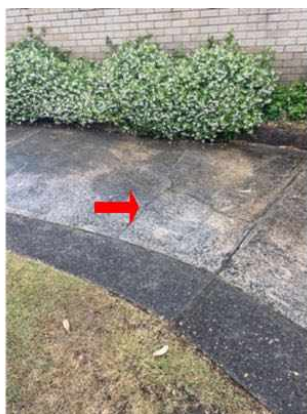
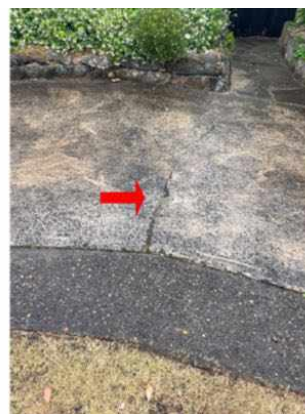
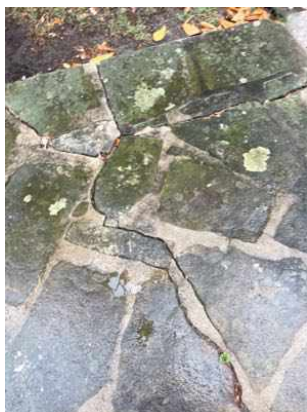
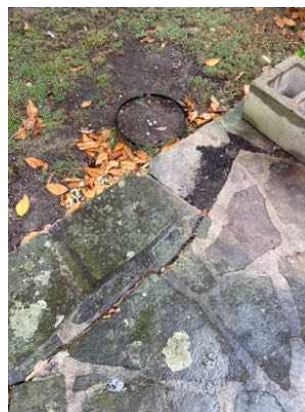
Defects 3.05

Building:	Building 1
Location:	All External Areas
Finding:	Cracking - External Concrete Paving Damage Category 2 - Distinct (less than 3mm)
Information:	Distinct cracks were identified in external concrete paving. Distinct cracks are generally found in older concrete paving, and may also present as a trip hazard as consequence of an uneven or curved surface.

General age and expected deterioration of the paved areas is a common cause of this type of cracking. However, expansion and contraction of the slab may also have occurred due to environmental factors. Such factors include variable moisture and weather conditions, the presence of trees and their roots having a settling or lifting affect on the soil, or the effect of load bearing, e.g. heavy vehicles over a sustained period of time.

Cracking to this degree may also be due to poor original installation of the concrete. Factors such as poor compaction of the sub surface and/or inadequate reinforcing of the slab may create cracking and other secondary defects.

Repairs are likely to be required to prevent further cracking and to reduce hazards associated with cracking, such as tripping. Monitoring of all cracking should be conducted frequently. Always contact a building inspector should cracks widen, lengthen, or become more numerous.

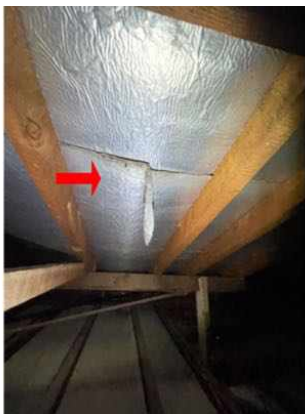
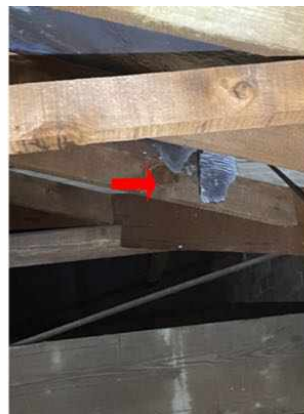
Defects 3.06

Building:	Building 1
Location:	Roof Void
Finding:	Sarking - Damaged
Information:	Sarking, a laminated aluminium foil applied to the interior of the roof covering, assists in insulating the property and acting as a vapour-barrier to the roof void and, subsequently, to the household.

Where sarking is damaged, both insulation and moisture protection of the property are inhibited. This creates a loss of energy and thus negatively impacts the energy efficiency of the property, allowing potential for moisture ingress from condensation or leaking roof tiles.

It is important to repair any holes or damaged sections of sarking to ensure that the building material is fully functional. A registered builder or qualified carpenter should be consulted to provide further advice on this defect and to perform rectification works at client discretion.

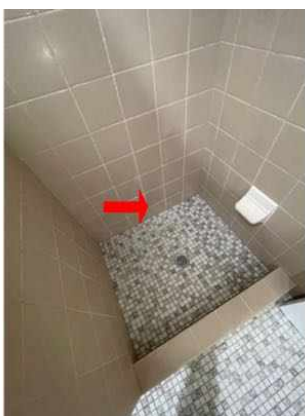
Defects 3.07

Building:	Building 1
Location:	Bathroom
Finding:	Sealant - missing
Information:	Flexible and mould resistant materials should be applied to affected areas to prevent any subsequent water damage that is likely to occur. Regular maintenance and replacement of damage or missing or damaged sealant and grout is highly recommended to the wet areas, as this is a regular wear and tear defect.

Sealant and grouting in areas that come into regular contact with water should be maintained for the long term care of your property. A sealant specialist or tiling contractor should be appointed to complete these works as soon as possible

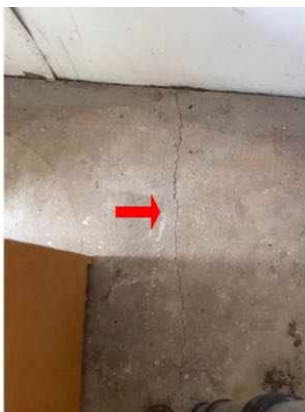
Defects 3.08

Building:	Building 1
Location:	Garage
Finding:	Crack in concrete slab - Category 1
Information:	A crack coded as Category 1 was identified in the slab. A Category 1 crack is described as a fine but noticeable crack, with the slab at an otherwise reasonable level.

To be considered Category 1, the approximate width of the crack is less than 1.0mm, or a less than 10mm change in offset when a 3m straight edge is placed over the defect.

Category 1 cracks should be monitored for a period of 12 months. At the end of the monitoring period, identified cracks that are rated greater than Category 2 are considered defects, and require rectification.

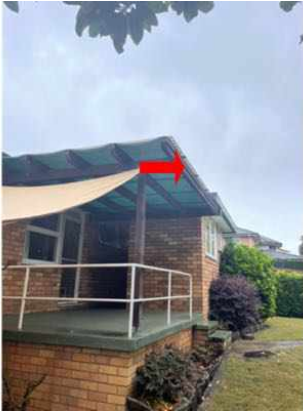
Defects 3.09

Building:	Building 1
Location:	Yard - Back
Finding:	Roof plumbing - Missing
Information:	Some sections of the roof are not adequately drained via gutters and downpipes. Gutters and downpipes that are not installed adequately are likely to result in excessively damp conditions against the exterior surfaces and around the base perimeter of the building.

Excessive moisture creates an environment which accelerates the deterioration of building elements in the area, as well as being conducive to termite and pest infestation. Such an environment is likely to necessitate repair and/or replacement of building elements, which are prone to sustaining wood rot, rust or corrosion.

A roofing plumber should be appointed as soon as possible to install relevant roof plumbing materials. Depending on the extent of the damage, repair and/or replacement of damaged building elements may be required.

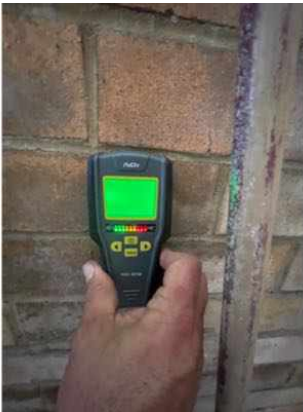
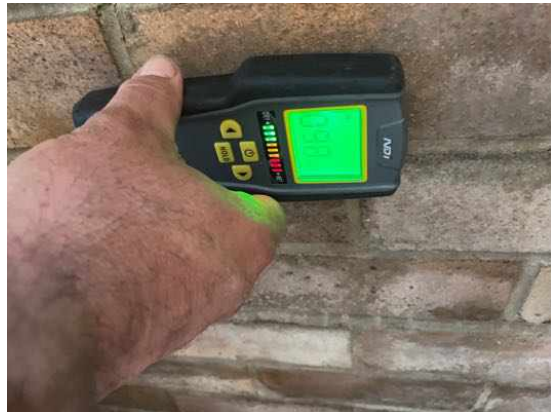
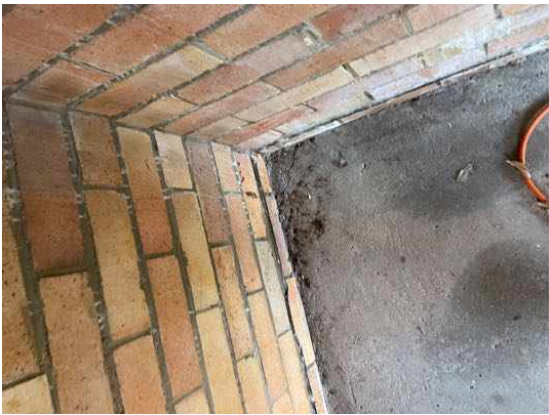
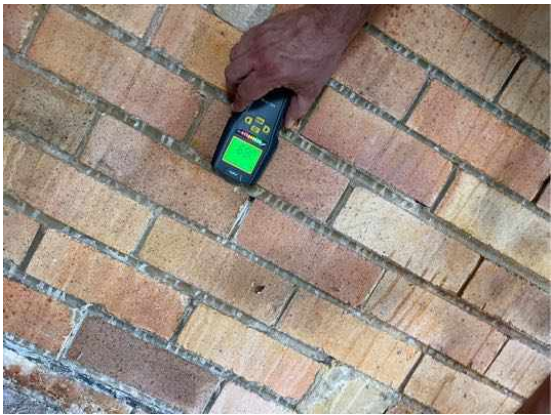
Defects 3.10

Building:	Building 1
Location:	Garage
Finding:	Evidence of excessive moisture was present at the time of inspection
Information:	Excessive moisture can attract termites and produce conditions that promote termite attack fungal growth and wood decay.

Excessive moisture is generally caused by deteriorated inadequate or missing roof drainage leaking plumbing pipes or fixtures poorly plumbed HWS overflows or condenser units and poor site drainage.

It is highly recommended that all plumbing and drainage fixtures and fittings be maintained regularly in order to prevent excessive moisture being present in the external / internal property.

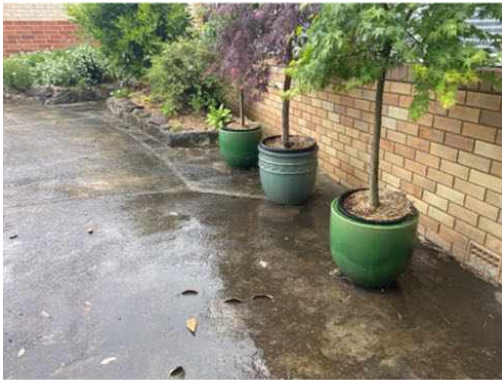
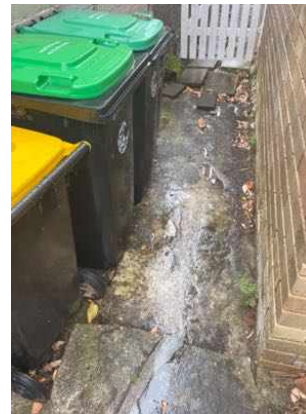
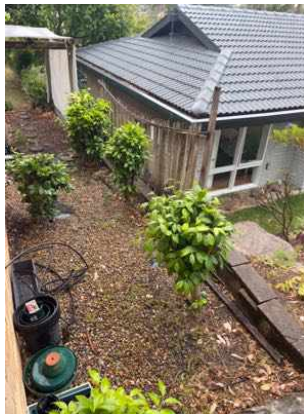
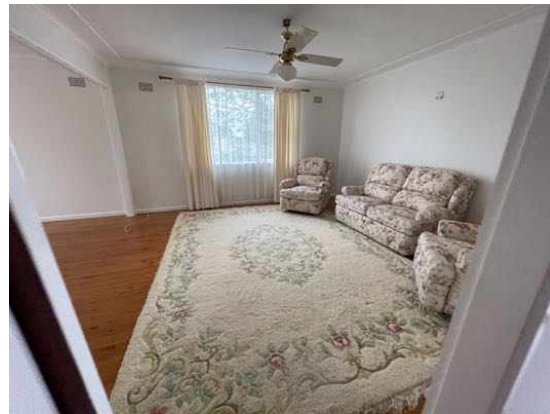
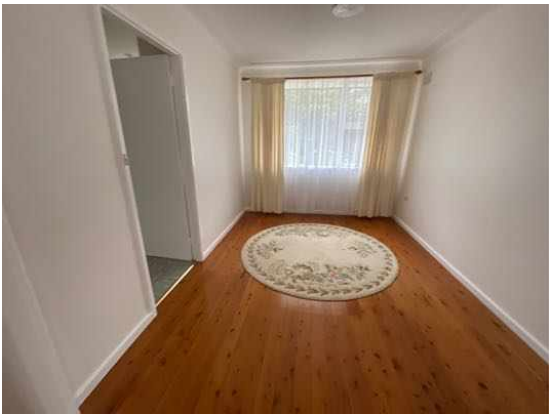
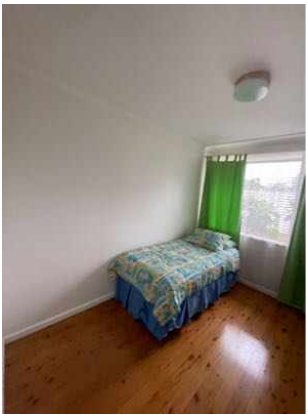
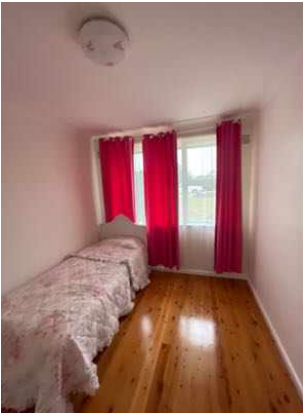
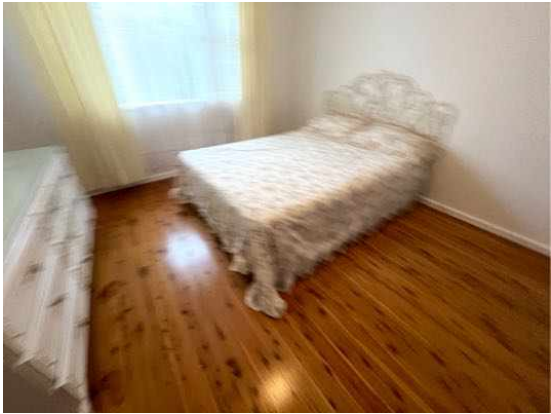
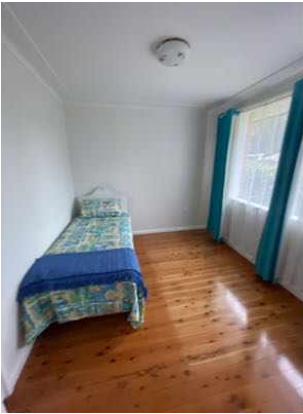
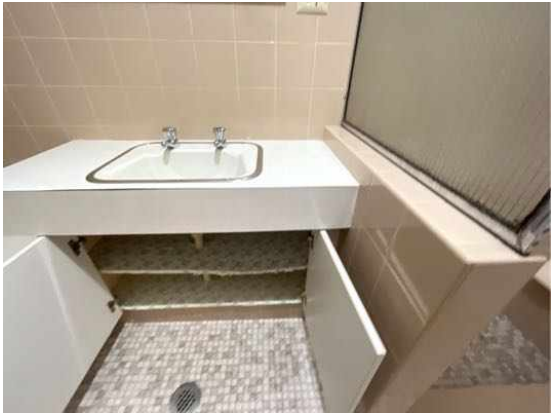
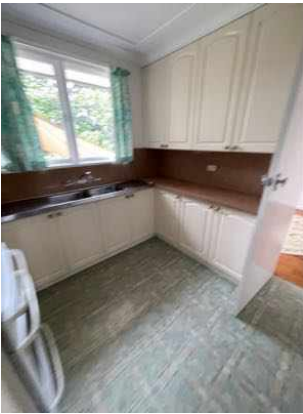
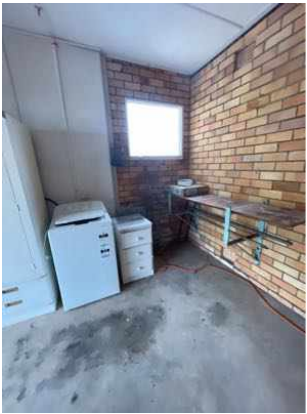
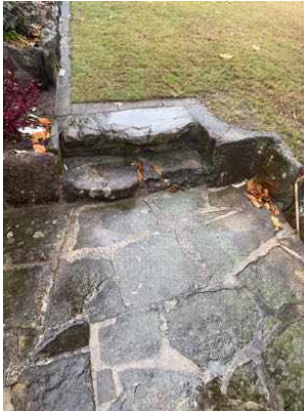
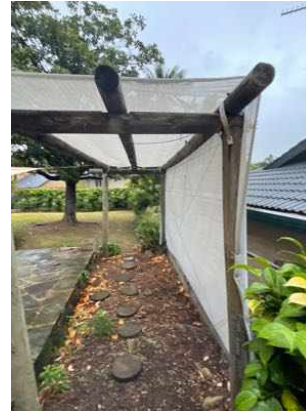
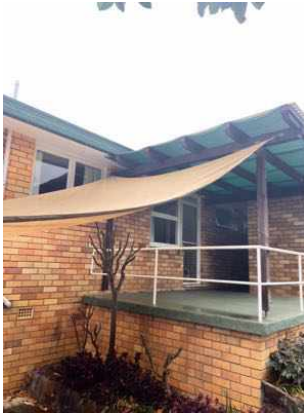
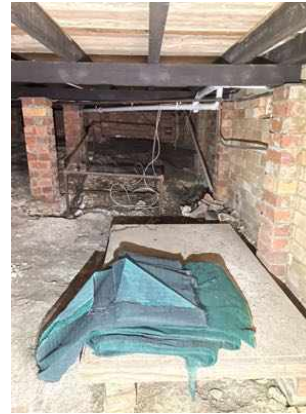
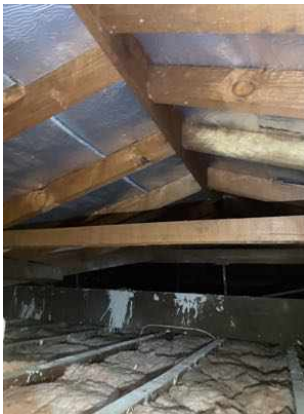
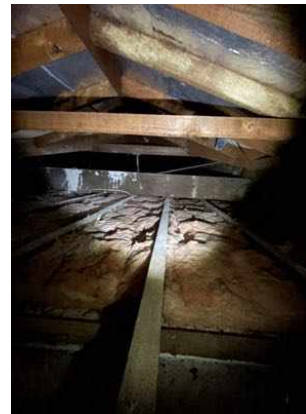
Building: Building 1
Location: All Areas
Finding: Additional Photos - Obstructions and Limitations
Information: These photographs are an indication of the obstructions and limitations which impeded full inspection of the property at the time of inspection. These obstructions can hide an array of defects and should be removed to allow full inspection to be carried out. A re-inspection is recommended once the areas are made accessible.

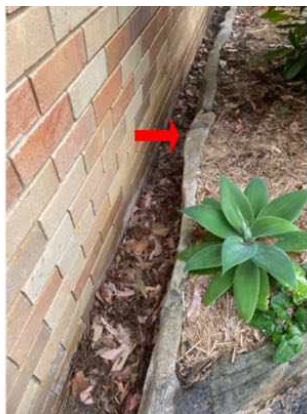
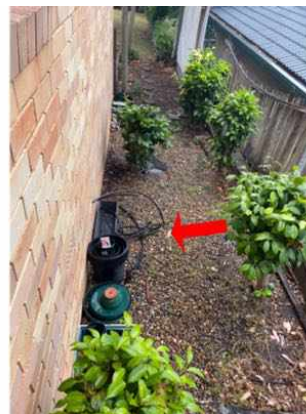
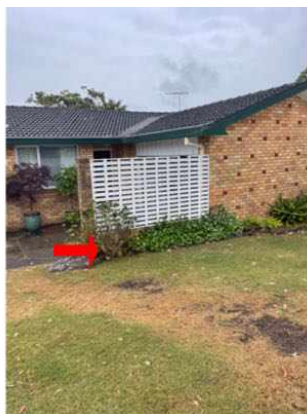
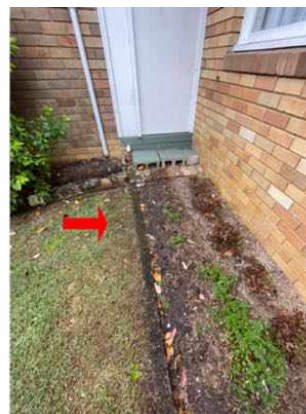
Building:	Building 1
Location:	All External Areas
Finding:	Garden Beds - Conditions Conducive to Termites
Information:	Garden beds were found to be evident in the garden area. These garden beds can include untreated timber, and with a combination of moisture from watering hosing can make conditions conducive to termite activity and termite ingress.

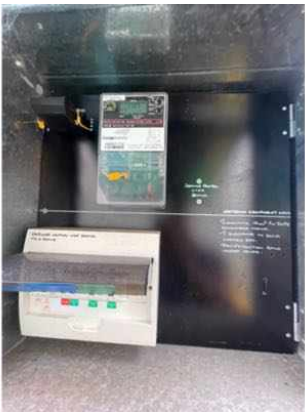
Building:	Building 1
Location:	Yard - Side
Finding:	Termite Management System - no evidence of a chemical installation
Information:	The application of a post-construction chemical termite barrier is highly recommended for all properties, particularly if live termite activity has been found on the site previously. Such barriers are highly effective in preventing termite attack on any timber building elements throughout the property.

A durable notice should be placed in the switchboard unit to indicate current termite barriers. At the time of inspection, it appeared as though no termite management system has been installed, with no evidence to suggest preventative works taking place.

The client may consider gaining further advice from a pest controller as to the costs and procedures involved with this application. It is recommended that obtaining such advice be a short-term priority.
