## **VISUAL BUILDING & PEST INSPECTION REPORT**

Complies with Australian Standard 4349.1 & 4349.6

**Inspected Property:  
5 Cotswold Close Belrose**

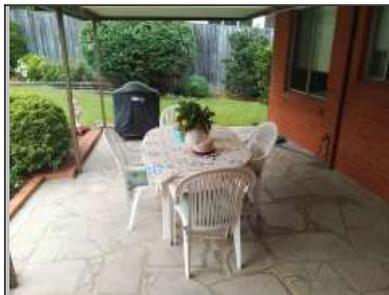
Rear elevation.

Constructed from concrete or masonry. The general condition of this structure is fair.

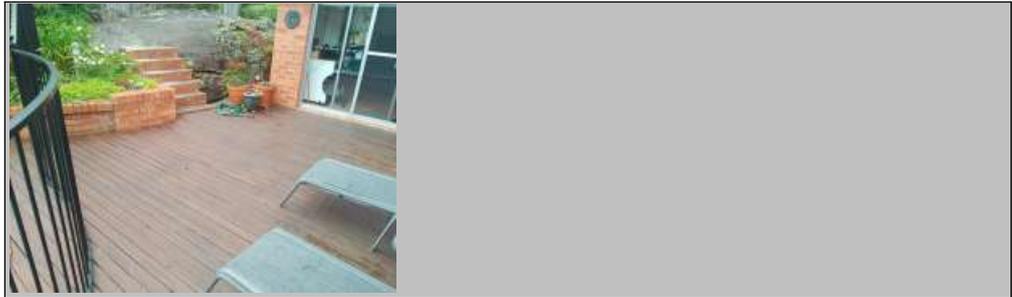
Rear elevation.

Where an external structure is constructed from timber or has significant timber components, and exposed to the elements, a suitably qualified engineer should inspect the structure to determine if it is structurally sound. We cannot determine or advise what weight the structure can hold, The general condition of this structure is fair.

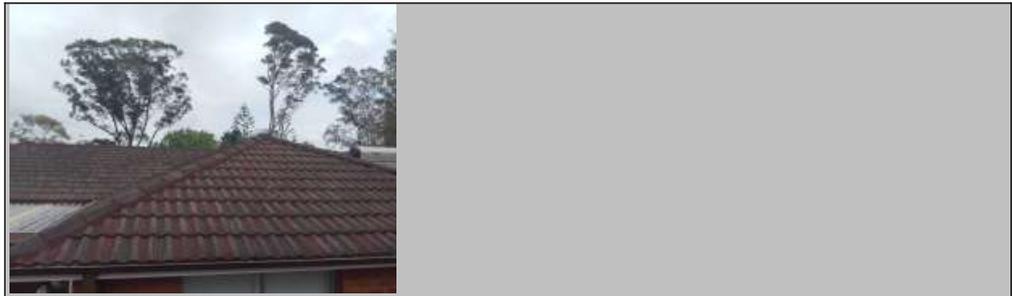
The overall condition of the roof coverings is fair. Mortar beds to the hip and ridge capping are cracked and require maintenance or re bedding and pointing in areas.

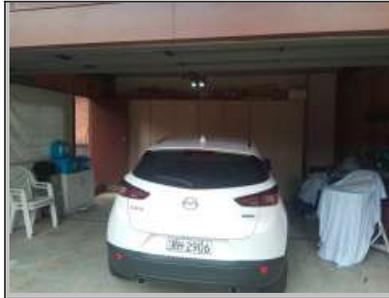
Garage.

The structure is generally in fair condition.

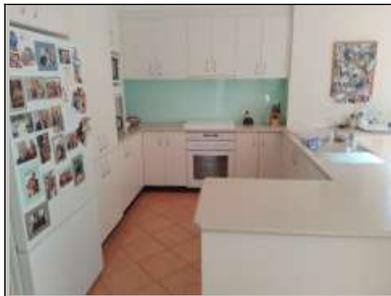
The condition of the fixtures is generally fair. A glass splashback is located over the benchtop area. Glass appears to be in serviceable condition.

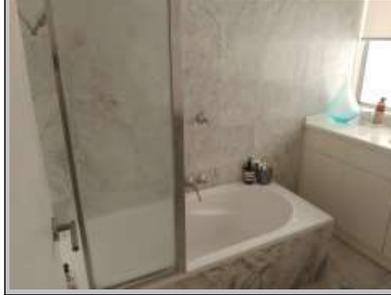
Rear.

The shower is located over the bathtub. The area will need to be kept well sealed to prevent water penetration to surrounding areas.

The toilet appears to be in working order. Toilet area is restrictive and the door swings inwards. In case of an emergency the door cannot be readily removed from the outside. Recommend liftoff hinges be installed to the door to comply with current Standards.

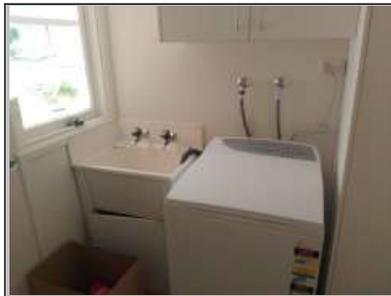
Rear.

The tub and taps appear serviceable. Drain appears serviceable.

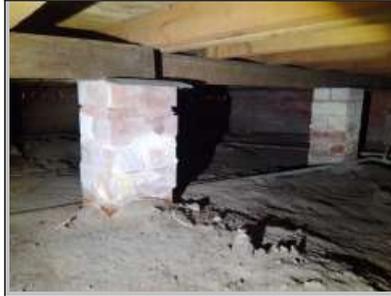
The building is constructed on a combination of strip footings and piers. The footings appear to be generally sound.

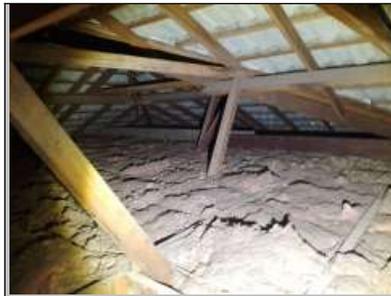
Insulation is present in the roof cavity. This restricted inspection to some roofing timbers. Removal of insulation is not within the scope of a standard visual inspection report, however as in accordance with "industry best standard" the inspector will lift insulation in 3 areas in roof void.

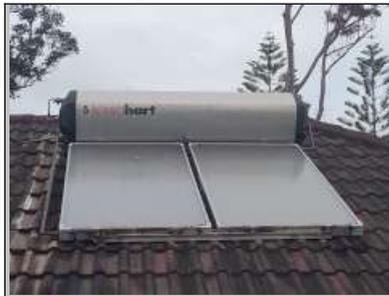
Solar collector and tank hot water system: Mains pressure: Located on the roof: The hot water system appears to be in working condition. No specific tests other than running the hot water tap were carried out. No determination has been made as to the suitability or adequacy of the hot water system in relation to capacity or otherwise.

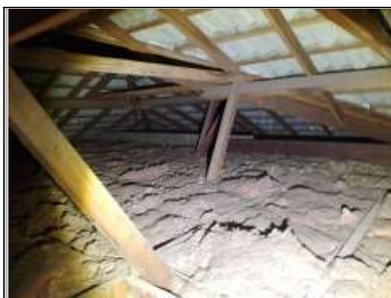
Insulation is present in the roof cavity. This restricted inspection to some roofing timbers. Removal of insulation is not within the scope of a standard visual inspection report, however as in accordance with "industry best standard" the inspector will lift insulation in 3 areas in roof void.
