## **BUILDING & TIMBER PEST** **INSPECTION REPORT**

11065

49 Nareen Parade, North Narrabeen NSW 2101

02 November 2021

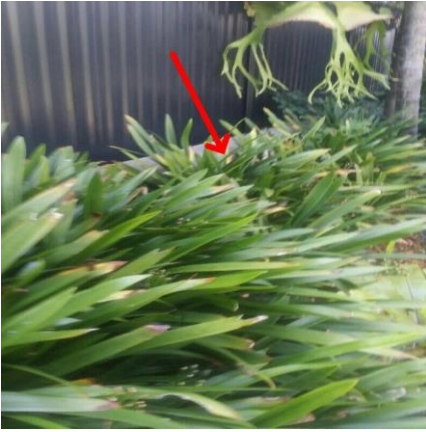
Visual inspection limited to the eastern side retaining wall due to foliage.

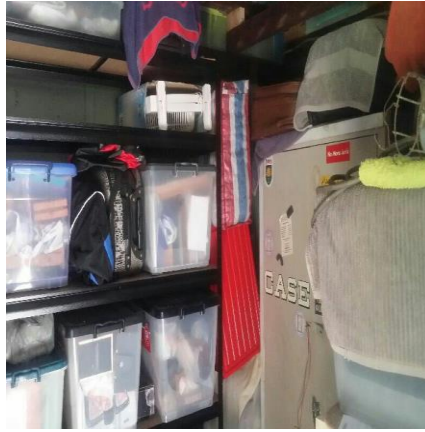
Visual inspection limited to storage shed behind the granny flat due to stored goods.

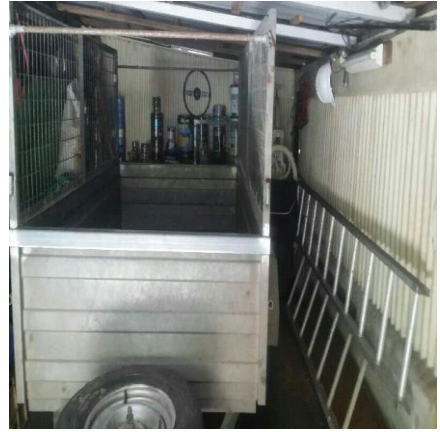
Visual inspection limited to the garage area due to stored goods.

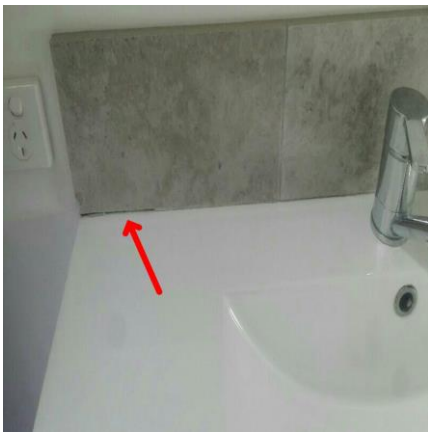
Replace sealants to granny flat vanity splash back, check and maintain sealants to all wet areas.

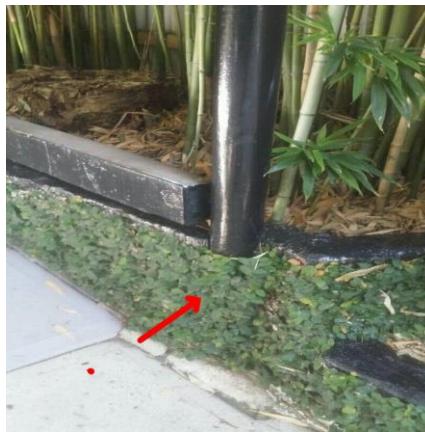
Recommend clearing vegetation from garage area steel posts to help prevent undetected corrosion.

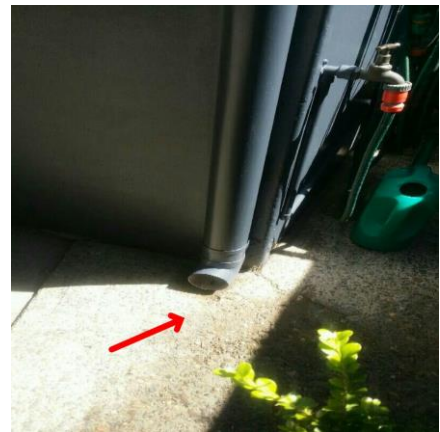
Stormwater that exits from granny flat area downpipe is diverted to drainage channel below the rear shed. This area will need to be kept clear and open at all times to help prevent stormwater build up.

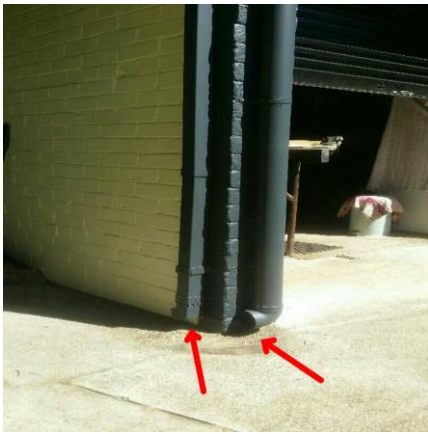
It is good building practice for roof stormwater that exits via downpipes to be piped away from buildings footings/foundations. All surface water should be diverted away from house footings/foundations. Refer to attached CSIRO Information Sheet, Section 3 in relation to this.

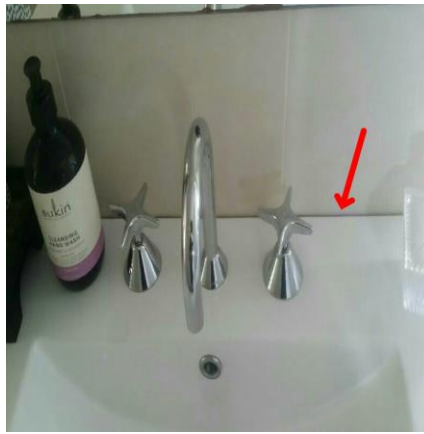
Install sealants to ensute vanity splash back, check and maintain sealants to all wet areas.

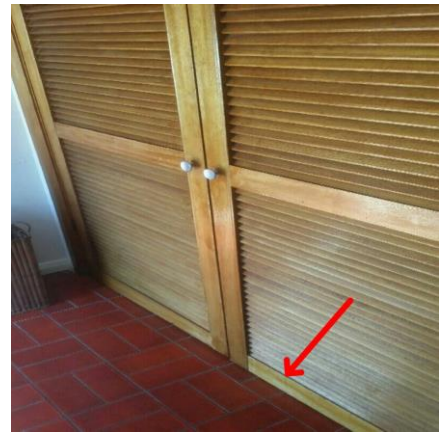
Bottom of entry area storage cupboard door requires easing to ensure smooth operation.

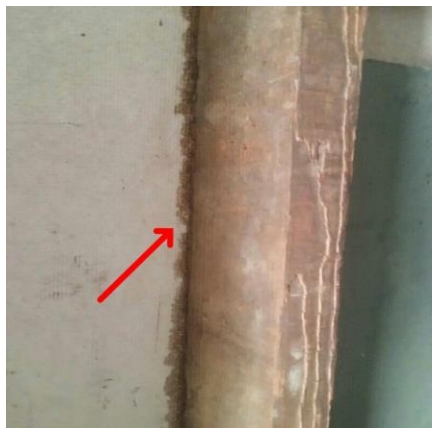
Termite mudding detected to storage shed framework. No active termites were detected in this area on the day of inspection.

Termite damage or workings were located in the following: **Termite mudding was detected in the storage shed behind the granny flat and to ground level storage area door jamb.**

**RECOMMENDATION;** Where evidence of damage to building timbers exists or is undetermined, competent advice (e.g. from a licensed and practicing building contractor) should be obtained to determine the extent of any structural damage and as to the need or otherwise for rectification or repair work. See also Item 3.5 'Frequency of Future Inspections' recommendation

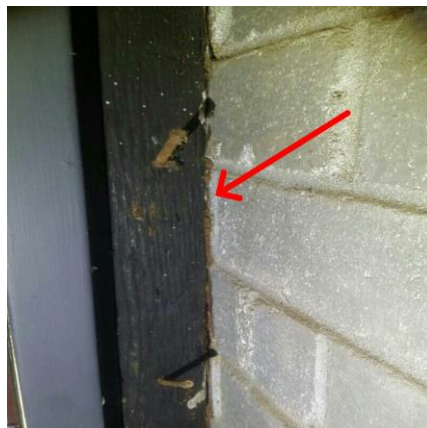
Termite mudding to ground level storage area door jamb. No active termites were detected in this area on the day of inspection.

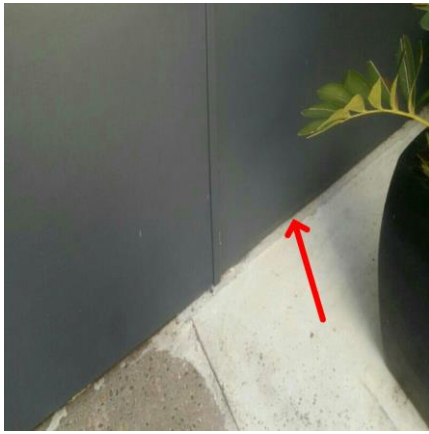
A 75mm ground clearance is required below the external cladding of the granny flat/ storage area to help prevent undetected termite entry.

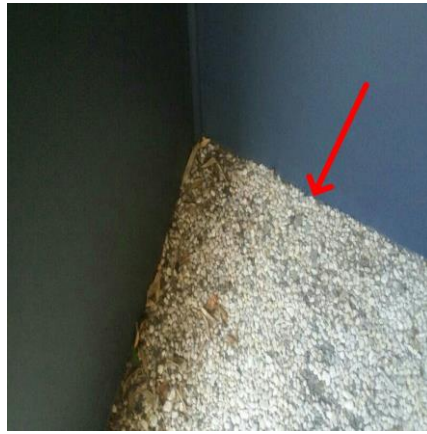
The external cladding is in direct ground contact at various locations around the dwelling and granny flat and is required to have 75mm ground clearance. If cladding does not have this clearance it is considered essential to install a termite management system as a matter of urgency to control any undetected termite entry.

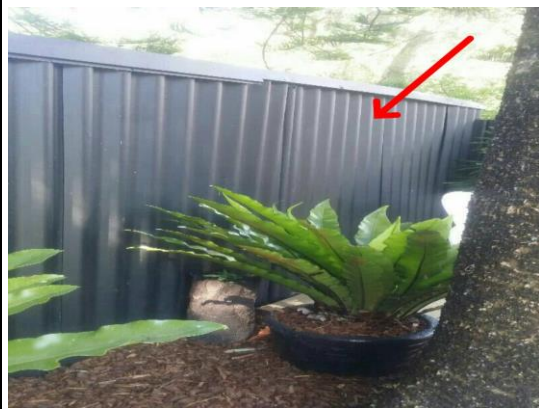
Asbestos sheeting to rear boundary fence.

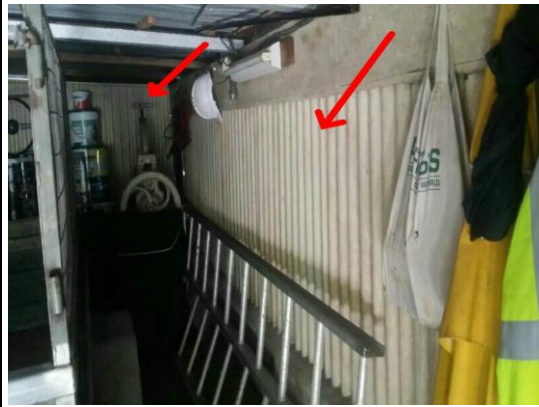
Asbestos sheeting to southern and western side garage walls.

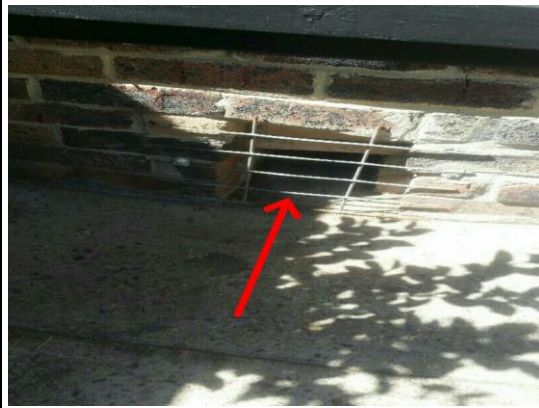
Drainage channel below the rear shed will need to be kept clear and open at all times to help prevent stormwater build up at the rear of the dwelling.
