# Building and Timber Pest Inspection Report VR

Inspection Date: Wed, 19 Jun 2024

Property Address: 8 Eclipse St, Schofields NSW 2762,  
Australia

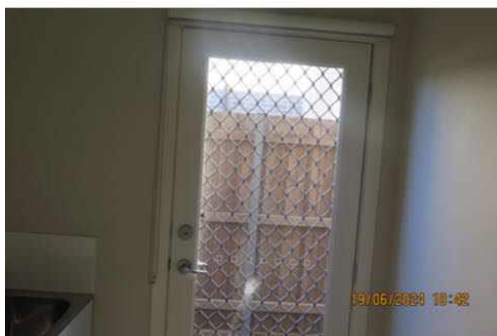
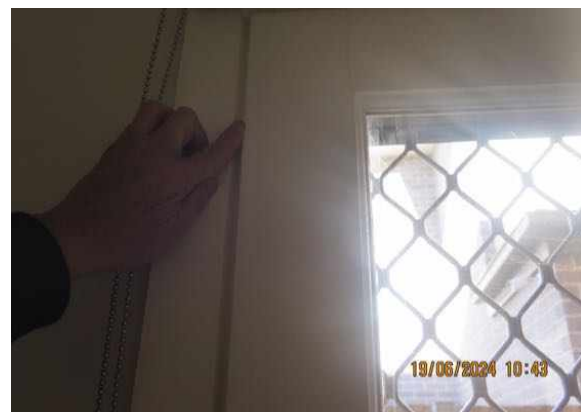
#### Finding 3.01

Building: Main Building  
 Location: Laundry  
 Finding: Door - Binding/jamming  
 Information: Binding and/or jamming of this door is evident during standard operation. This defect inhibits the functionality of the affected door as well as creating potential for secondary defects to associated building elements, such as damage to the floor covering.

A door that binds to flooring or to the associated door frame may have several causes, ranging from minor defects, such as poor installation of the door or deteriorated hinges, through to major structural issues, such as damage to subfloor structures.

Where door binding/jamming appears to indicate major structural issues, a registered builder specialising in re-stumping should be appointed to provide an estimate on the cost of rectification.

For minor causes, a qualified carpenter or general handyperson should be appointed to perform minor rectification works at client discretion.

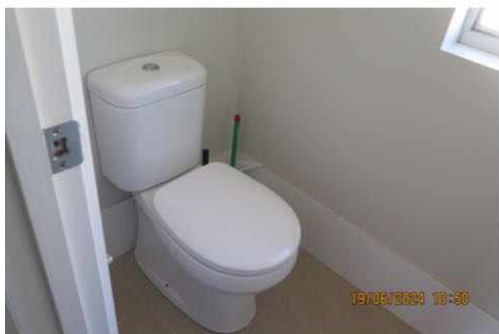
#### Finding 3.02

Building: Main Building  
 Location: Toilet (WC)  
 Finding: Door handle - Not latching and lock requires tightening  
 Information: It was noted that the door in this area was not latching during operation at the time of inspection. Whilst detracting from the functionality of this building element, this minor defect may also be a security risk, and may therefore have serious implications if left unattended.

It is suspected that this defect has occurred due to minor issues with the associated hinges. Such damage is identified as general wear and tear, which is expected for building elements of this age.

A qualified carpenter or general handyperson may be appointed to perform rectification works as necessary, at client discretion. If left unattended, further functional impairment is likely to occur.

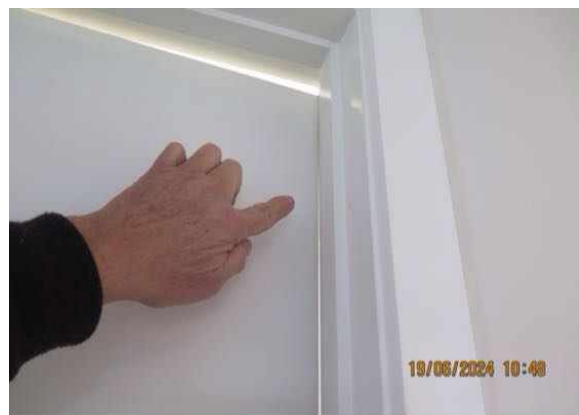
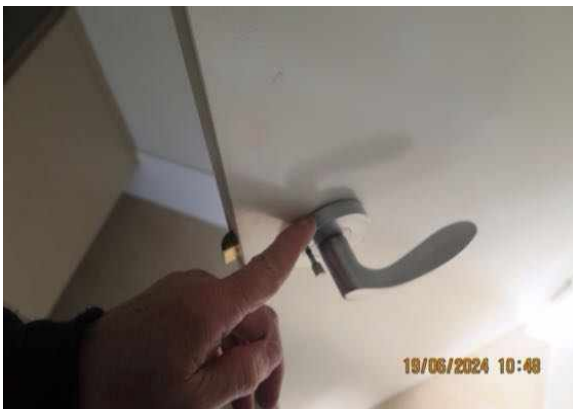
### Finding 3.03

Building: Main Building  
 Location: Bathroom  
 Finding: Door - Binding/jamming and lock requires tightening  
 Information: Binding and/or jamming of this door is evident during standard operation. This defect inhibits the functionality of the affected door as well as creating potential for secondary

defects to associated building elements, such as damage to the floor covering.

A door that binds to flooring or to the associated door frame may have several causes, ranging from minor defects, such as poor installation of the door or deteriorated hinges, through to major structural issues, such as damage to subfloor structures.

Where door binding/jamming appears to indicate major structural issues, a registered builder specialising in re-stumping should be appointed to provide an estimate on the cost of rectification.

For minor causes, a qualified carpenter or general handyman should be appointed to perform minor rectification works at client discretion.

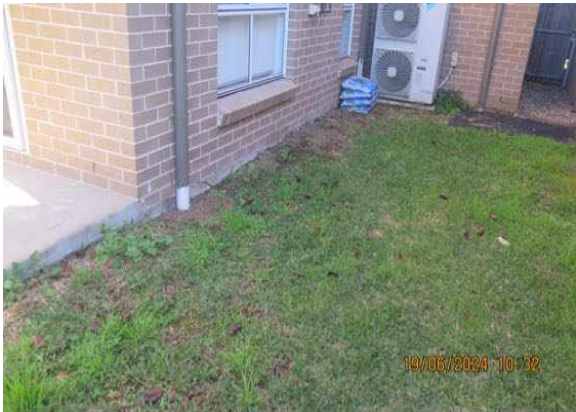
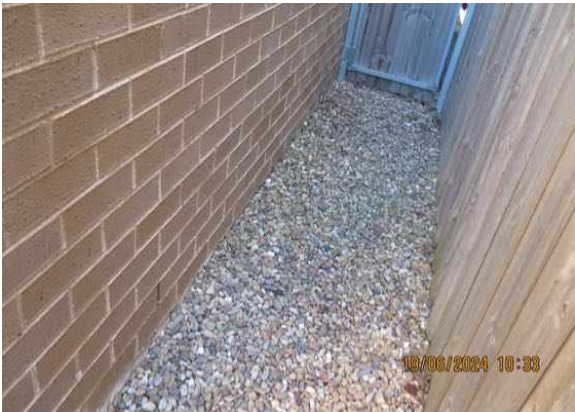
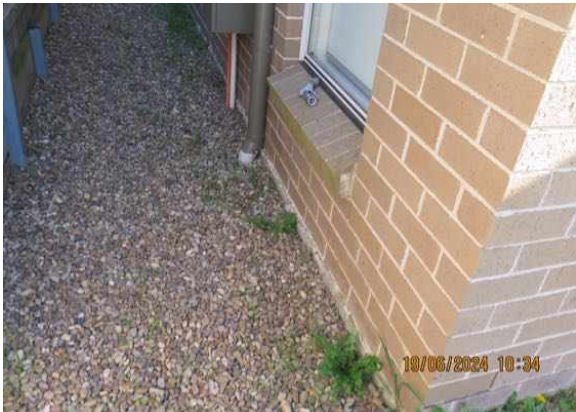
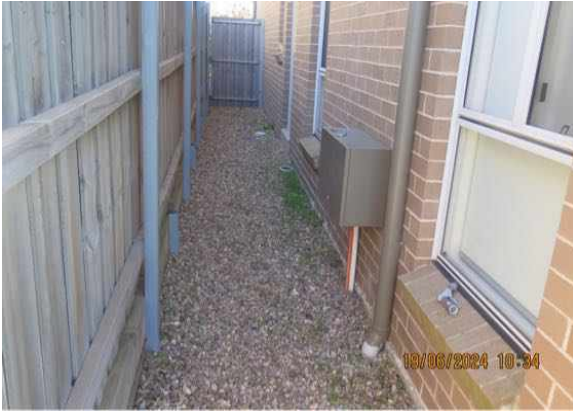
### Finding 6.01

Building: Main Building  
Location: All Areas  
Finding: Slab Edge - Exposure  
Information: An inspection zone of at least 75mm in relation to the exposed slab edge, between the bottom brick and the perimeter pavement, is required. This inspection zone should be maintained in order to force termites into the open where they can be detected more readily during regular inspections. The slab edge should not be concealed by anything that may prevent inspection of the area, including render, landscaping, soil, turf, paving, concrete cladding or other structures.

If the slab edge is not properly exposed there is a high risk of termite attack. Sometimes, in order to determine the type of slab, a suitably qualified person such as an architect or builder may be required to consult the construction plans.

Where the slab edge cannot be properly inspected, it is highly recommended that termite or timber pest inspections be carried out every 6-12 months to aid protection of the property against infestation.
