**COMPREHENSIVE
BUILDING
INSPECTIONS**

VISUAL VENDOR MAINTENANCE BUILDING INSPECTION REPORT **33108-2017**

Date Inspection carried out: Wednesday, 09th AUGUST 2017

**10 Springvale Avenue,
FRENCHS FOREST NSW 2086
9453 5024 - 0410 529 347**

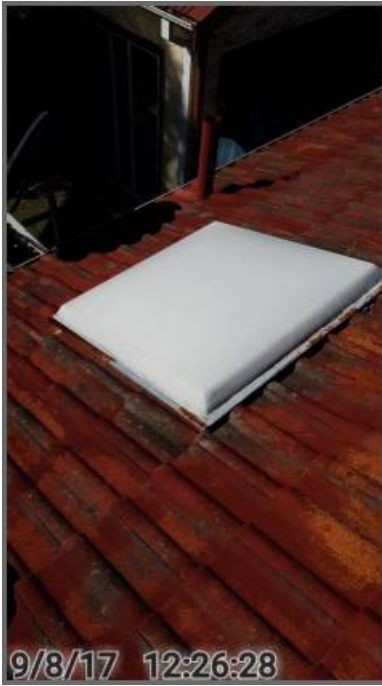
Moderate degradation / corrosion is evident to the sky-light panel framework. Early treatment of corrosion and application of a suitable protective paint finish is recommended. This may prevent further premature degradation, extend service life and delay expensive full replacement costs.

Evidence was seen of past application of a coloured surface coating and re-pointing of bedding to the ridge and hip capping tiles. No opinion can be offered on the long term durability of this non-original coating.

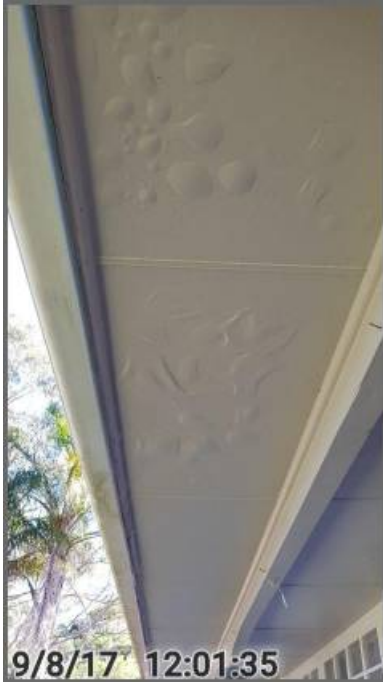
The eaves are lined with asbestos cement sheeting. The overall condition of the eaves lining is acceptable. The paint work to the eaves is deteriorating; consider maintenance as well as a cosmetic upgrade.

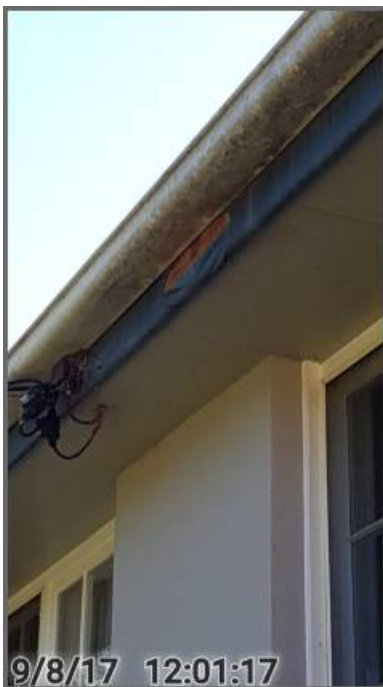
The overall condition of the fascias / barge boards is acceptable. Minor wet rot decay is present to timber fascias and barge boards. The paint work is deteriorating; consider maintenance as well as a cosmetic upgrade.

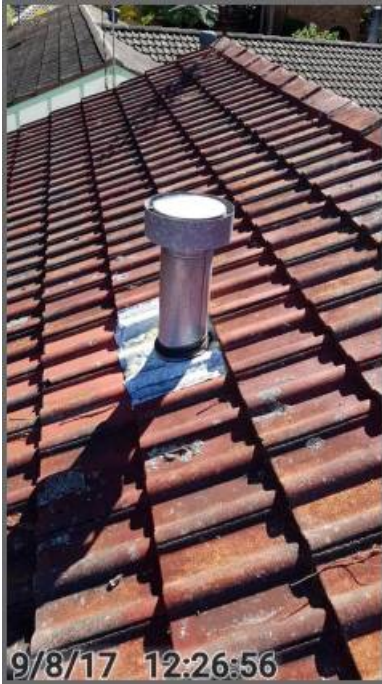
Flashings / seals to chimney penetrations are a potential source of water leakage. Early and then periodical checking for defects will be required. A further detailed investigation (by a competent person e.g. a licensed roofing contractor) is recommended to determine as to the need or otherwise rectification or repair works.

The chimney should be tested and cleaned prior to being put into use by a suitably qualified person.

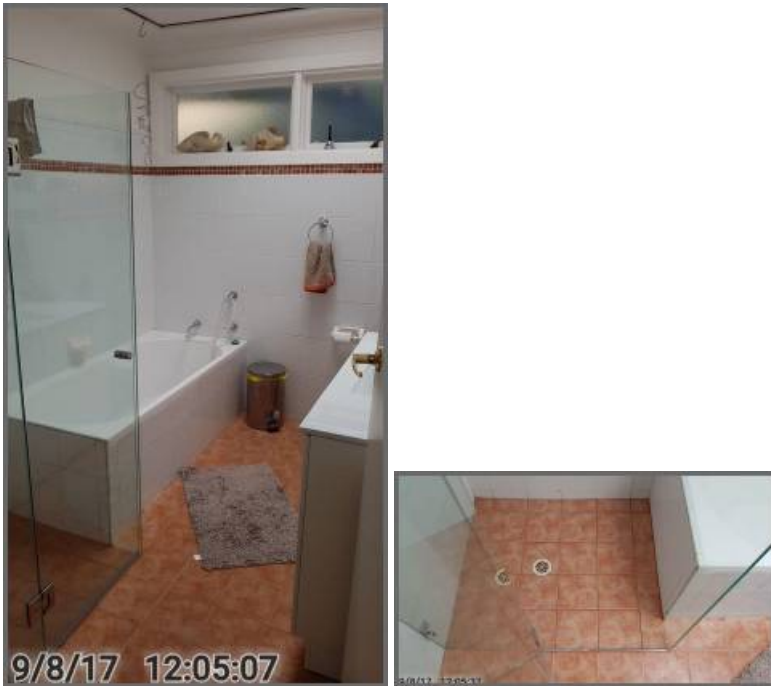
Bathroom facility appears to have been upgraded since original.

The most common cause of leaking showers is due to building movement and settlement causing weakening or cracking of grout, or the waterproof membrane under the tiles fails. At the time of the inspection the shower enclosures were tiled. Accordingly it is impossible to establish if an Australian Standards approved seamless waterproofing membrane system has been installed. Neither shower flooding or water testing or the use of moisture meters can necessarily detect defective showers. It is possible that the vendor may have applied a liquid re-waterproofing system which given time or increased usage may fail. It is also possible that the shower is not in use and that previous signs or leakage have been obscured. Accordingly it is suggested that you discuss the condition of the showers with the vendor and satisfy yourself that the showers do not leak.

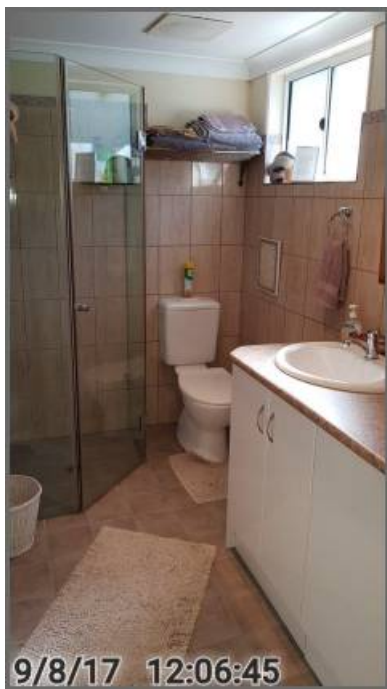
Bathroom facility appears to have been upgraded since original.

The most common cause of leaking showers is due to building movement and settlement causing weakening or cracking of grout, or the waterproof membrane under the tiles fails. At the time of the inspection the shower enclosures were tiled. Accordingly it is impossible to establish if an Australian Standards approved seamless waterproofing membrane system has been installed. Neither shower flooding or water testing or the use of moisture meters can necessarily detect defective showers. It is possible that the vendor may have applied a liquid re-waterproofing system which given time or increased usage may fail. It is also possible that the shower is not in use and that previous signs or leakage have been obscured. Accordingly it is suggested that you discuss the condition of the showers with the vendor and satisfy yourself that the showers do not leak.

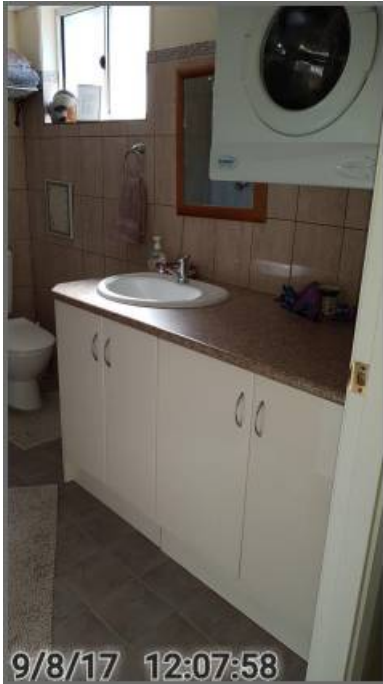
Basic laundry facility appliances have been incorporated with-in the bathroom area. General condition is considered acceptable for intended use.

Where plumbing connections are associated with washing machines and/or tubs, we cannot determine if these connections satisfy current building codes. We suggest you have these connections inspected and checked for compliance.

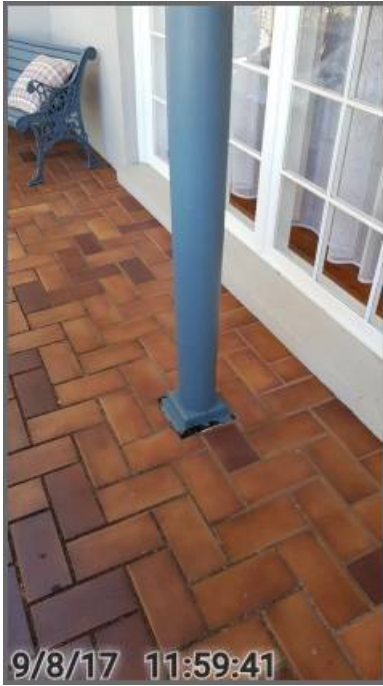
Poorly installed, weak or defective handrails, balustrades and other framing members can pose a very serious safety hazard, especially to elevated areas. Periodical checking for worn, corroded, degraded components is strongly recommended. A further detailed investigation (by a competent person e.g. a suitably qualified engineer) is recommended to determine the need or otherwise rectification or repair works. No specific tests were carried out at time of inspection.

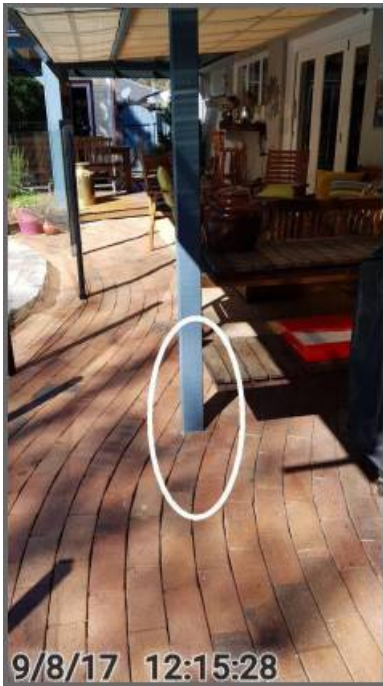
Some timbers associated with this structure are in contact with soil and/or concrete. This situation can allow concealed termite entry and we recommend that modifications be made. A licensed carpenter should be called to make a further evaluation and repairs or rectification as needed. We strongly recommend that a licensed pest inspector be engaged to inspect the dwelling.

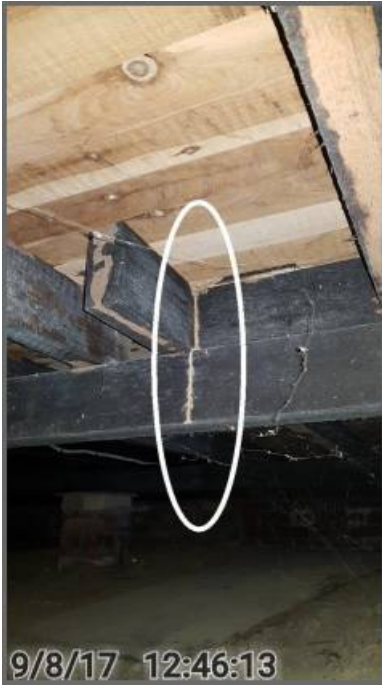
Affected subfloor timbers

Whilst we are conducting this building inspection report, we are not acting in the capacity of a qualified pest inspector. There appears to be minor damage consistent with timber pest attack to visible accessible timbers. We strongly recommend that a licensed pest inspector be engaged to inspect the dwelling. The full extent of timber replacement and/or repair can not necessarily be determined during this visual inspection and a more invasive inspection will be required.

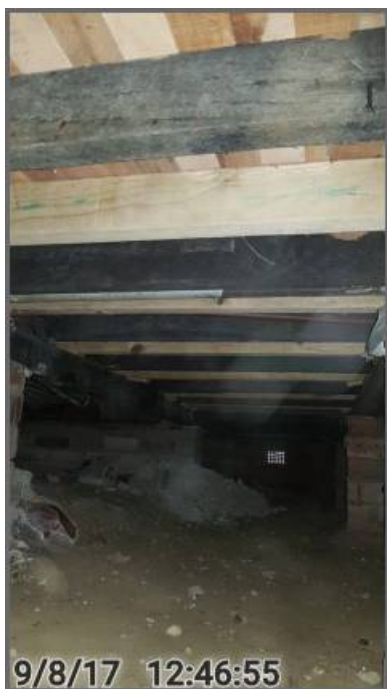
Some timbers (listed below) appear to be new or not the original timbers. This replacement may have been due to timber pest attack or some other factor. We recommend if you are using this report to purchase this property, further enquiries should be made to determine the reason for timber replacement. Floor joist/s:

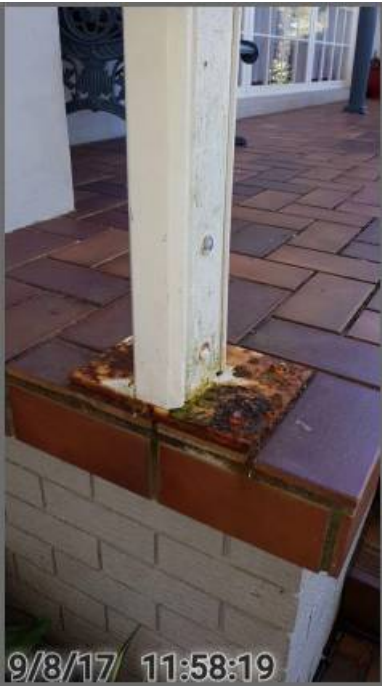
The condition of the walls is generally acceptable.

Moderate corrosion is evident to the steel sections. Early treatment of corrosion, replacement of degraded sections and application of a suitable protective paint finish is recommended to reduce risk of further premature degradation and extend service life.

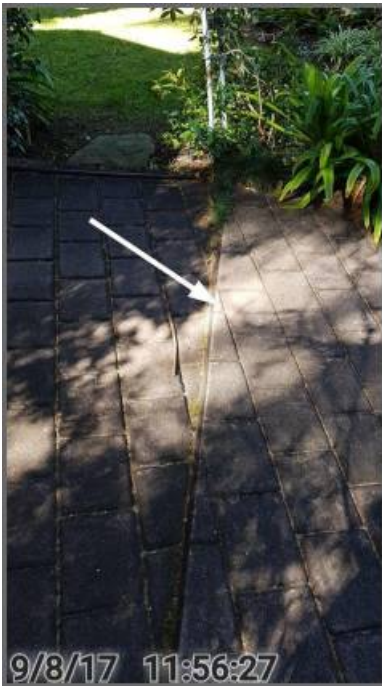
The concrete driveway stands in acceptable condition for age and type.

The concrete driveway has subsided in some areas and may require repair. Recommend consult licensed building contractor.

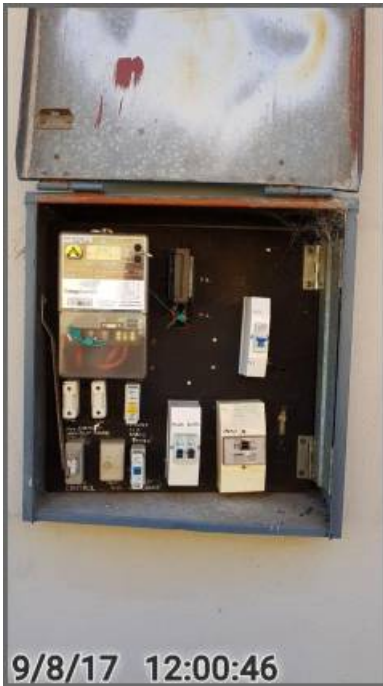
Air-conditioning is installed in the premises but has not been inspected. It may be possible that the current Vendor has the owners / operation manual. This manual should be left with the sale of the property.

Main electrical supply meters and fittings appear to have been modestly upgraded since original, however allowance could be made for further general upgrading and installation of approved "Safety" devices (R.C.D Residual Current Device) and "Hard-Wired" "Smoke-detectors" in the short term to satisfy current building codes. A further detailed investigation (by a competent person e.g. a licensed electrical contractor) is recommended to determine the rectification or repair work costs.

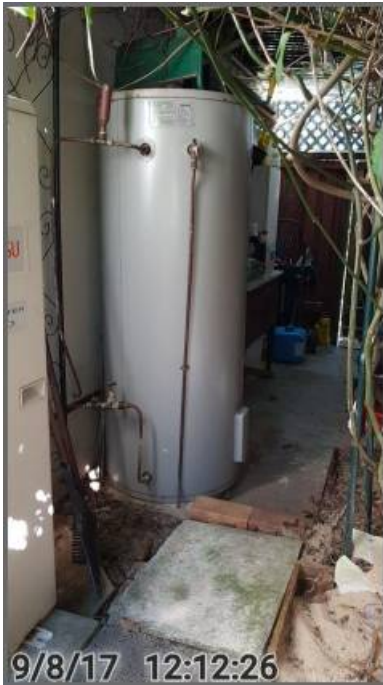
Mains electric hot water system: Mains pressure: Located externally: The hot water system appears to be in working condition. No specific tests other than running the hot water from a tap was carried out. No determination has been made as to the suitability or adequacy of the hot water system in relation to capacity or otherwise.

Pressure relief valve should be connected into suitable piping to divert water (from excess pressure in system) away from the main house structure. Moisture in close proximity to the house or surrounding areas is considered conducive to timber pest attack. Recommend consult suitably qualified person to advise further.
