Building Inspection Report

Inspection Date: Mon, 5 Jun 2023

Property Address: 8 Cotswold Cl, Belrose NSW 2085, Australia

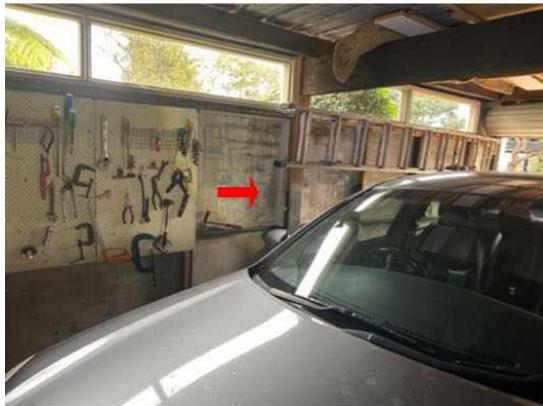
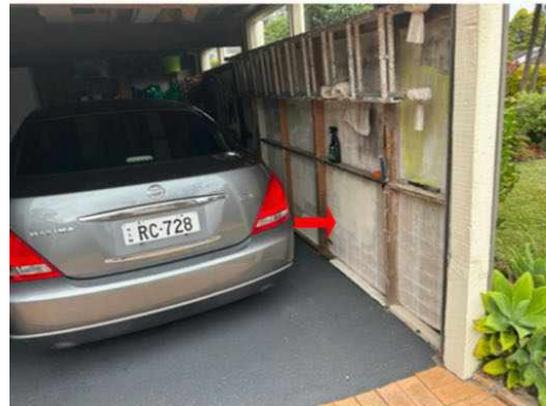
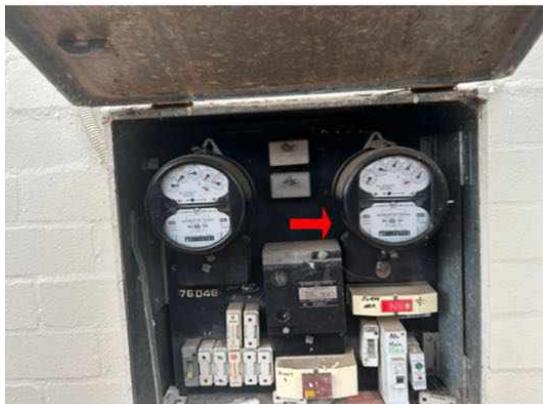
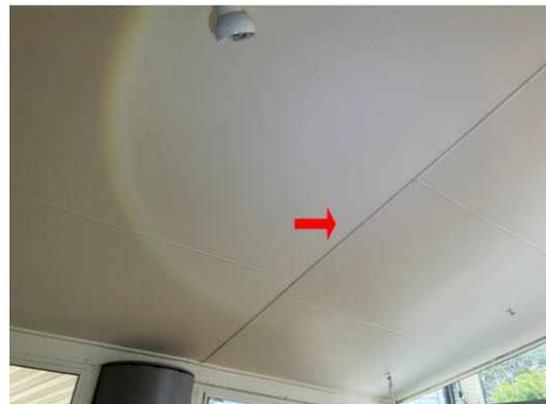
Defects 1.01

Building:	Building 1
Location:	All Areas
Finding:	Asbestos - Suspected ACM Identified on Site
Information:	As Asbestos Reporting is outside the scope of this report, we advise that you consider a separate Asbestos Inspection and Condition Audit, which can include the taking of samples for definitive confirmation of the presence of Asbestos.

In the interim, the client is advised to act with caution, especially when considering any damage to building materials general wear and tear renovations extensions demolition and general maintenance activities due to the suspected presence of Asbestos.

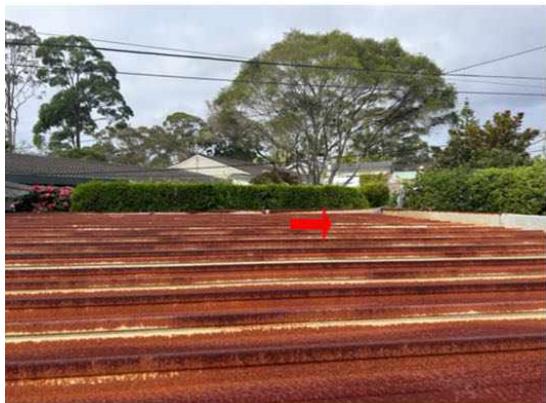
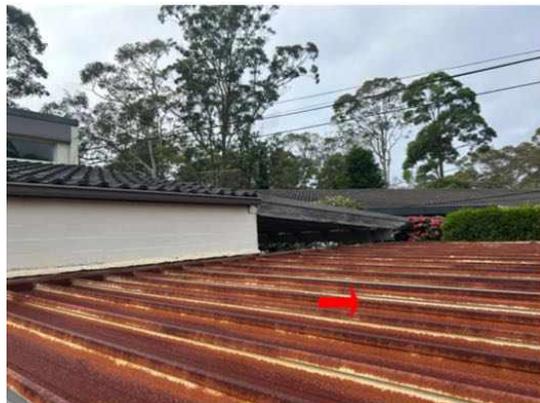
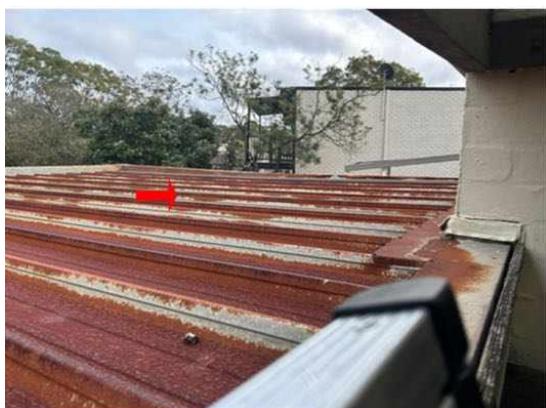
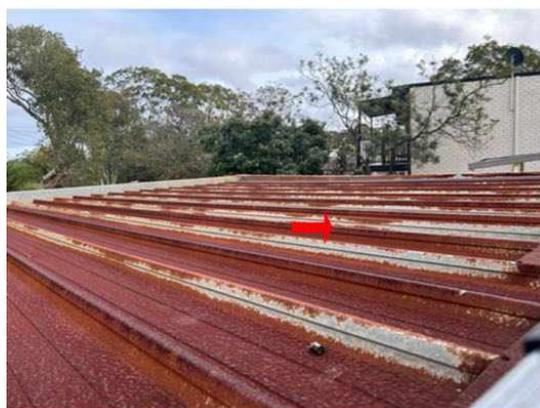
Defects 3.01

Building:	Building 1
Location:	Garage
Finding:	Roof sheets - Rusted
Information:	Metal roofs generally comprise numerous individual sheets, which join and overlap. These intersections are particularly prone to lift at the edge and consequently rust at these points.

Upon inspection of the exterior roofing structure, evidence of rust to these sections was identified. If left unmanaged, these degrading joins can allow water ingress to the internal roofing structures, potentially leading to secondary damage of building elements. Accelerated deterioration of the roofing sheets and any associated building elements is also likely to occur.

A roofing contractor should be appointed immediately to assess the damage to the roofing sheets and to perform remedial works as necessary. Works may include

replacement of severely affected roofing sheets or minor works such as the application of rust-retardant surface protectors.

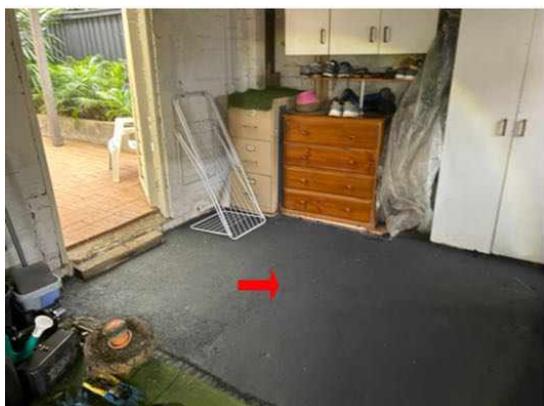
Defects 3.02

Finding: Crack in concrete slab - Category 0

Information: A crack coded as Category 0 was identified in the slab. A Category 0 crack is described as a hairline crack, representing insignificant movement of slab from level.

The approximate width of the crack to be considered Category 0 is 0.3mm, or change in offset of less than 8mm when a 3m straight edge is placed over the defect.

No rectification is required at this time. However, all cracking should be monitored over a 12 month period to identify any further damage in the area.

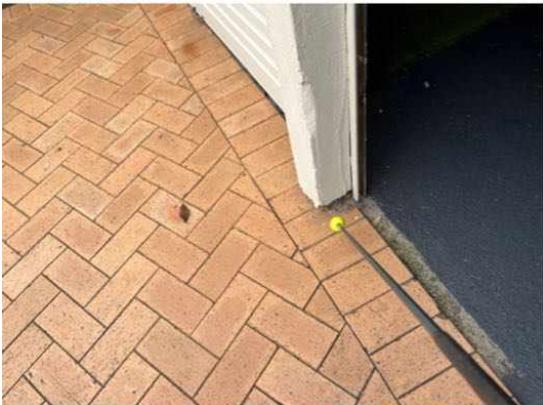
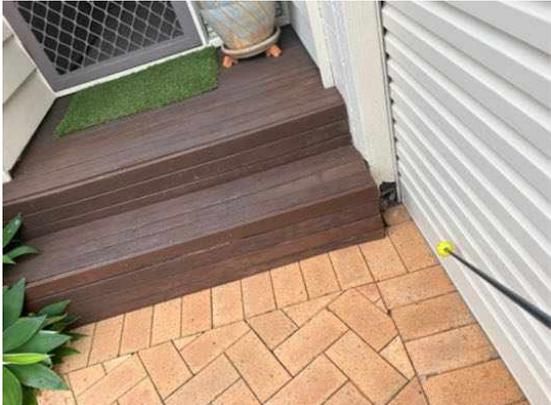
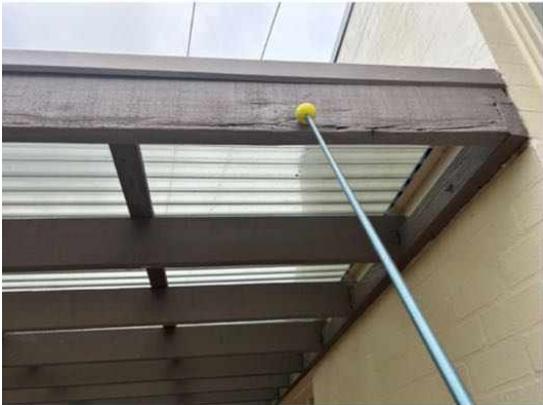
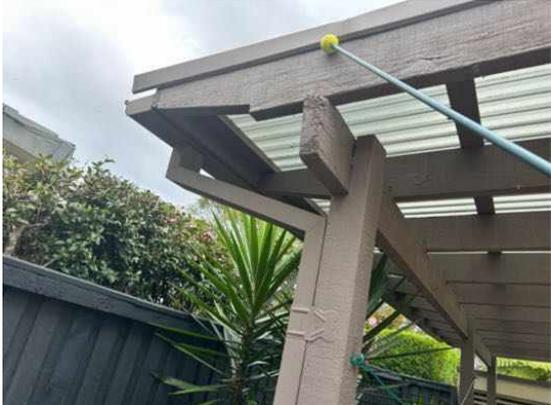
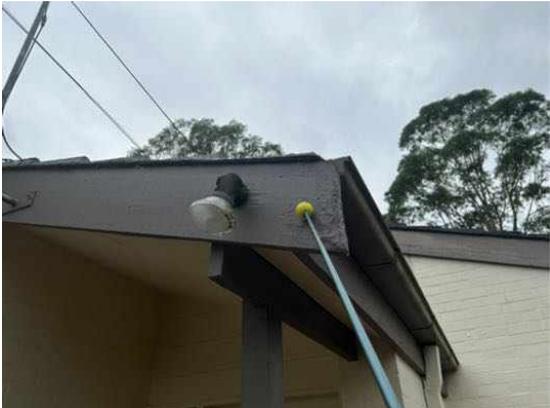
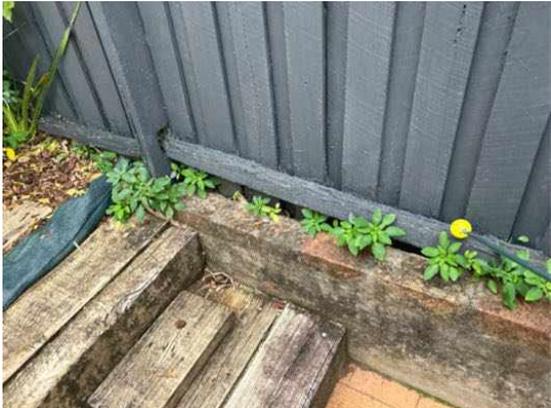
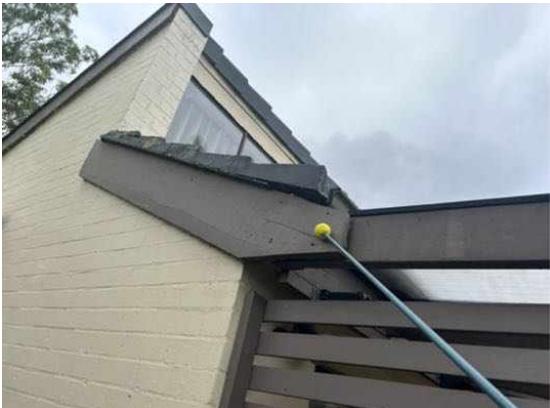
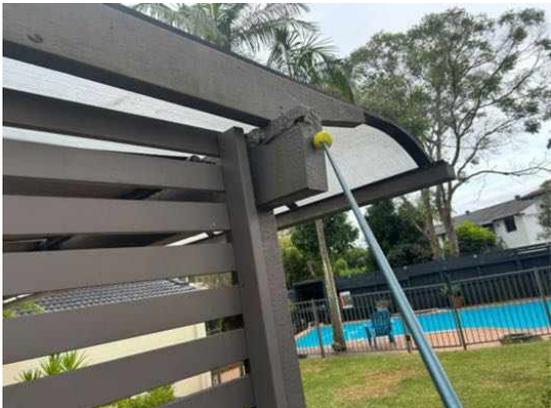
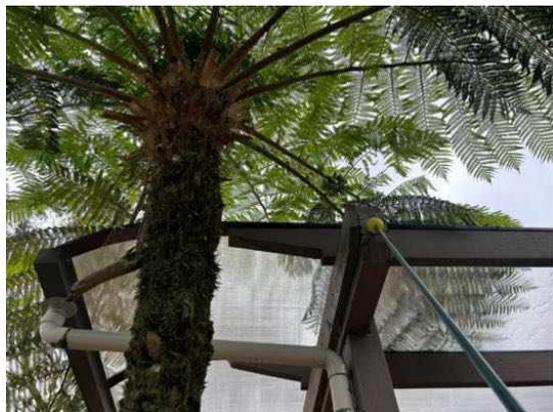
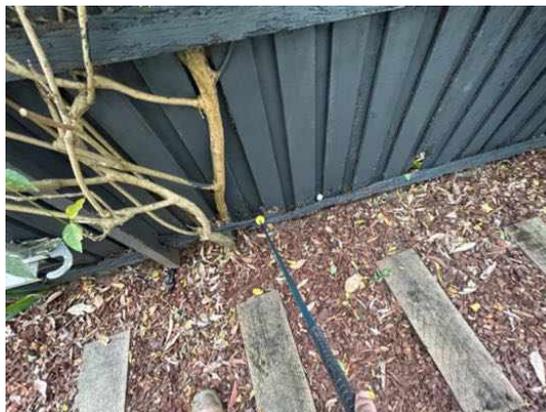
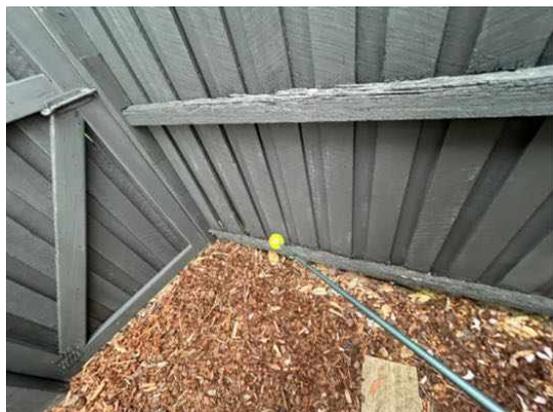
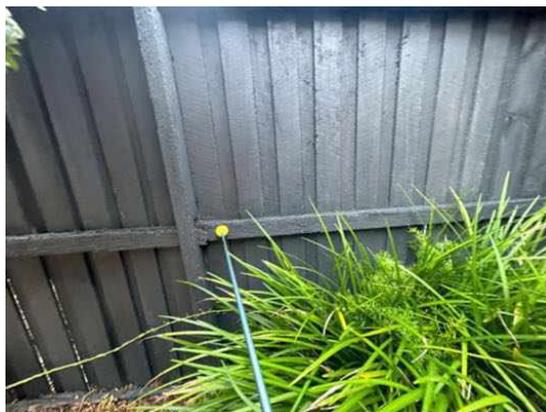
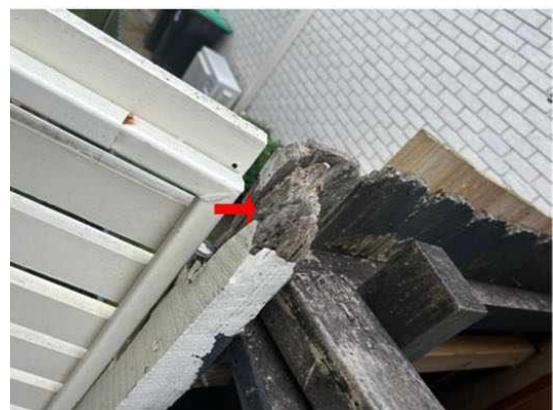
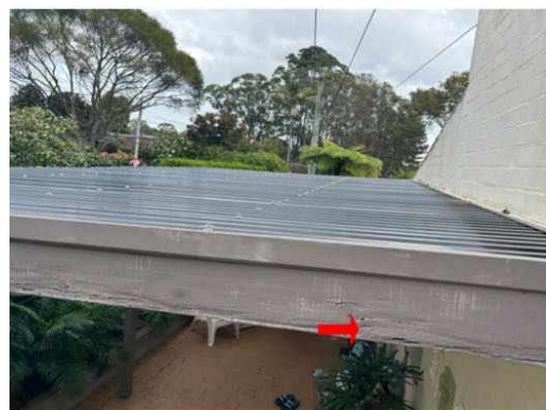
Defects 3.03

Building:	Building 1
Location:	All External Areas
Finding:	Wood rot
Information:	This building element shows evidence of wood rot. Wood rot, also known as Fungal Decay, occurs when timbers and other cellulose building materials are exposed to damp conditions on an ongoing basis. This could be the result of exposure to weathering over a prolonged period of time, or the attraction of excessive moisture from other abutting building materials. Contributing factors also include poor air ventilation in the area.

Wood rot is often associated with general damp problems and is evidenced by a 'musty' smell or mould and mildew occurring on surfaces. If left unmanaged, damp conditions can lead to further health problems and the decay of timbers will continue.

Early intervention and regular maintenance, particularly of exterior timbers, will prolong the useful life of these building elements. Prior to any works being performed, the cause of the moisture that has created the visible wood rot should be identified and addressed in a suitable manner. Replacement of affected timbers may then be a necessary step in protecting surrounding building elements from such deterioration.

A qualified plumber may be appointed to assess the cause of excessive moisture and to provide advice on any remedial works as required. A qualified carpenter or registered builder may also be required to replace affected building materials.

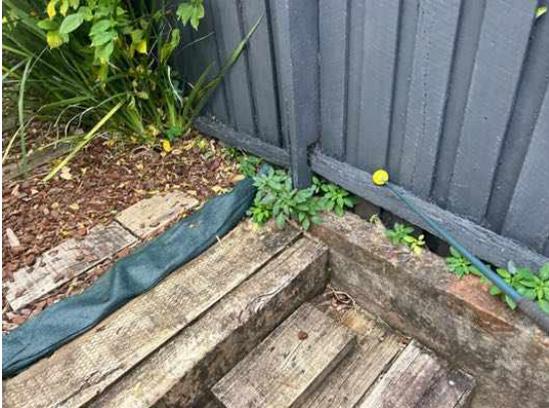
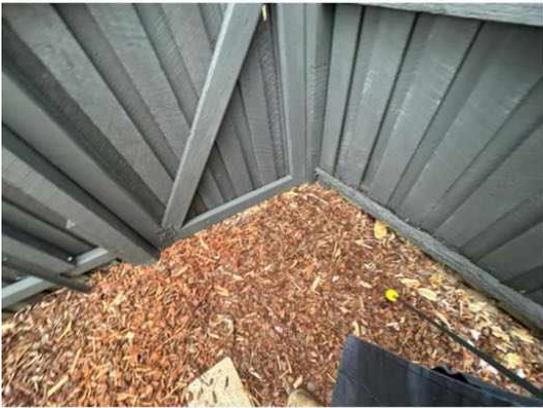
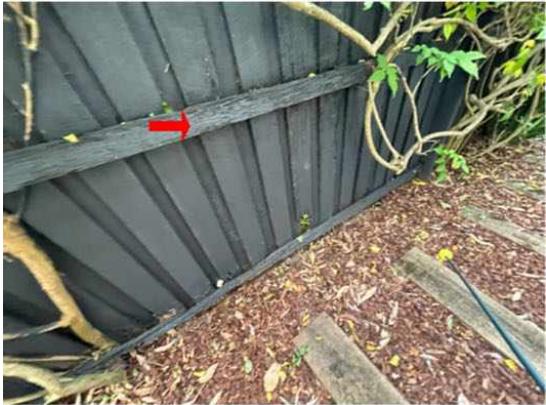
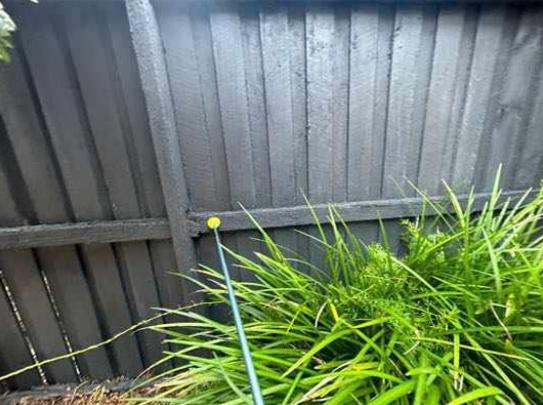
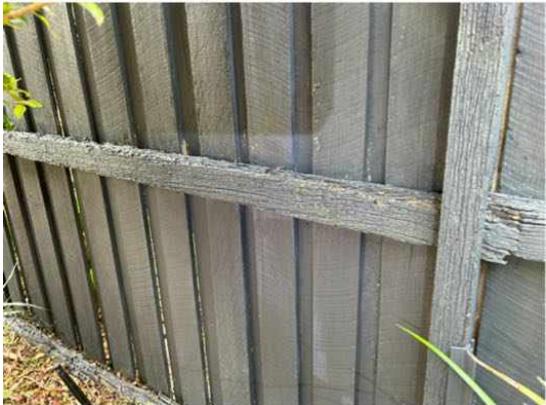
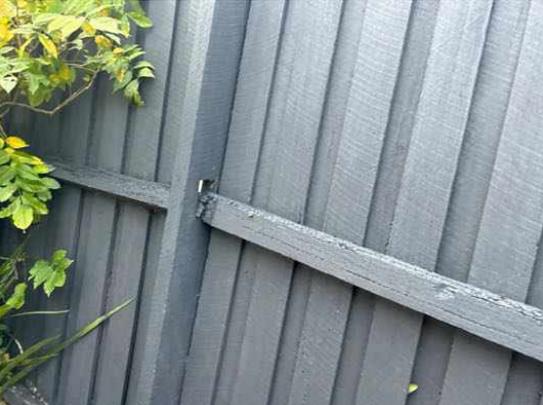
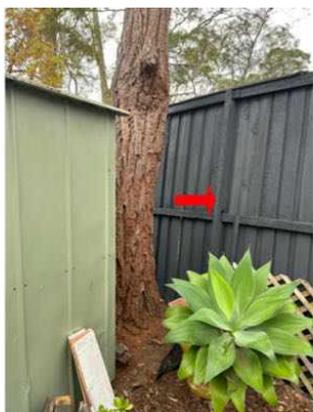
Defects 3.04

Finding: Fencing - Deteriorated

Information: It was noted at the time of inspection that sections of the fencing throughout the property have deteriorated. Typically fencing deteriorates due to age and or wear, rot and or rust which is generally expected for a structure of this age, due to prolonged exposure to weather conditions. Sometimes inadequate installation or maintenance can be to blame.

If left unattended, it is likely that further damage will occur. It is suspected that repair of several elements of the fencing may be required however replacement may be a

A licensed fencing contractor should be appointed to provide further advice and perform rectification works as necessary.

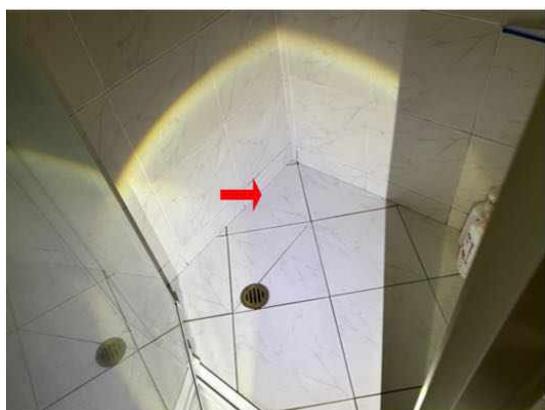
Defects 3.05

Building:	Building 1
Location:	Bathroom
Finding:	Sealant - missing/ deteriorated
Information:	Flexible and mould resistant materials should be applied to affected areas to prevent any subsequent water damage that is likely to occur. Regular maintenance and replacement of damage or missing or damaged sealant and grout is highly recommended to the wet areas, as this is a regular wear and tear defect.

Sealant and grouting in areas that come into regular contact with water should be maintained for the long term care of your property. A sealant specialist or tiling contractor should be appointed to complete these works as soon as possible

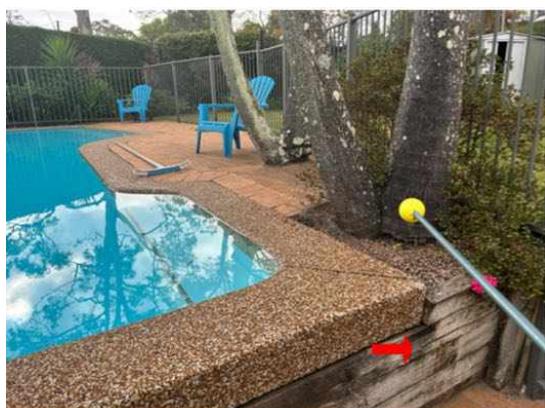
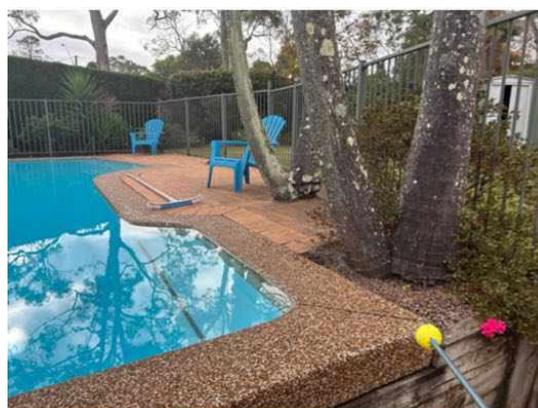
Defects 3.06

Building:	Building 1
Location:	Yard - Back
Finding:	Subsidence - Local trees and vegetation
Information:	Trees and other vegetation can have a significant local effect on drying of soils. Over a number of years, especially during drought conditions, adjacent trees and vegetation may draw excessive moisture from the soils. The opposite may also occur, where swelling of the soil results when the trees decline or are removed.

As the cumulative moisture deficient is reversed, the surface level around the tree (and adjoining subfloor) will rise and expand laterally. This is often damaging to buildings unless the foundations have been strengthened or designed to cope with the effect.

Subsidence can have complex and varying causes, which will influence the required remedial works. It is advised to begin by consulting a structural engineer to determine the required scope of works. This generally includes some form of underpinning, as well as addressing the underlying cause. Consultation with a geotechnical engineer may also be necessary.

A registered builder specialising in subsidence would then generally carry out works as advised by an Engineer.

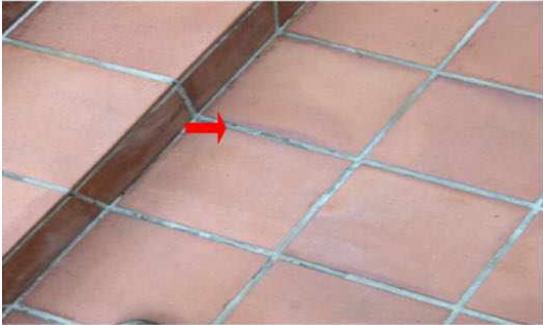
Defects 3.07

Building:	Building 1
Location:	All Areas
Finding:	Grout - Missing/ deteriorated
Information:	Grout is missing/ deteriorated in this area. Grout is used to protect gaps and crevices in building materials to ensure that they are water-tight and prevent water penetration to the associated structures.

Where grout is missing, a tiling contractor should be appointed to apply grout and re-apply any silicone where necessary. Failure to do so is likely to lead to water damage to the surrounding area.

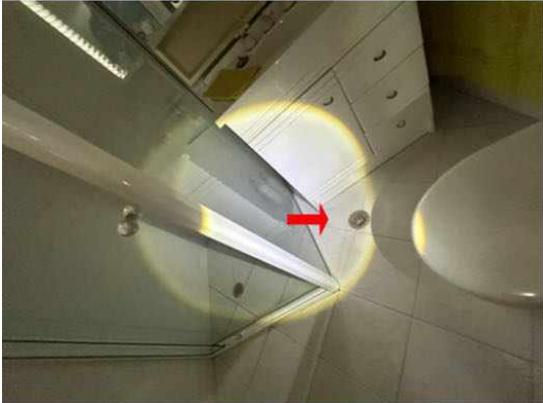
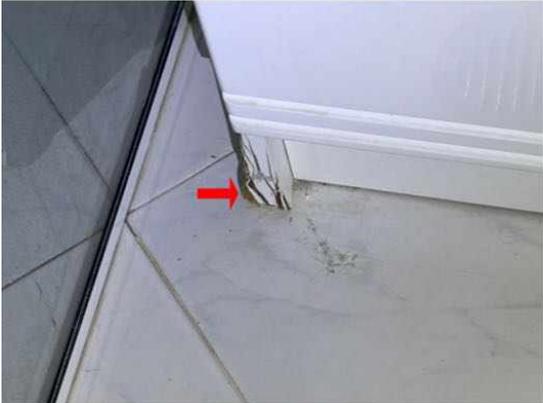
Defects 3.08

Building: Building 1
Location: All Areas
Finding: Cabinetry- Evidence of damaged
Information: Rectification works may include replacement of cabinetry depending on the extent of the damage.

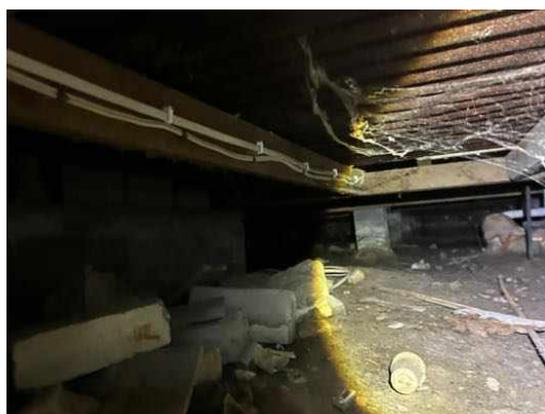
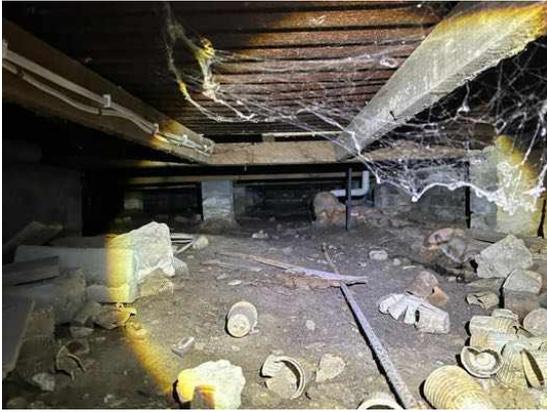
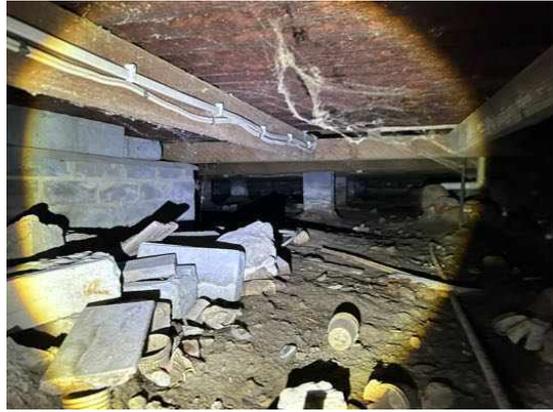
Building: Building 1
Location: Subfloor
Finding: Subfloor - Debris
Information:

An array of debris was found in the subfloor area at the time of inspection. Debris in this area restricts subfloor ventilation and creates potential for concealed pest entry. Stored timbers and other materials may also make the area susceptible to termite activity and wood rot.

A clear and empty subfloor will be better ventilated and easier to maintain in a dry condition. The removal of any timber debris is vital in minimising the risk of termite or wood borer activity.

Debris in the subfloor should be removed as soon as possible. Depending on the location and amount of debris and stored items, the homeowner may elect to undertake this task. Alternatively there are a large number of rubbish removal subcontractors that could undertake these works.

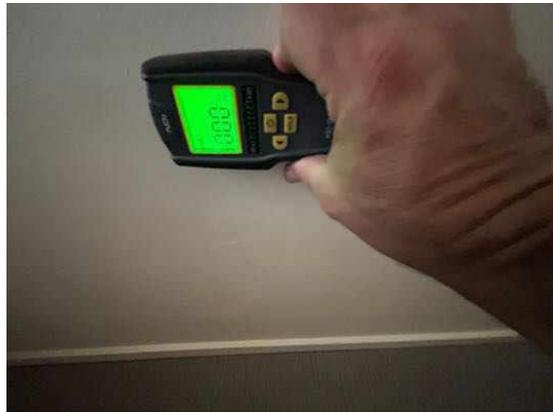
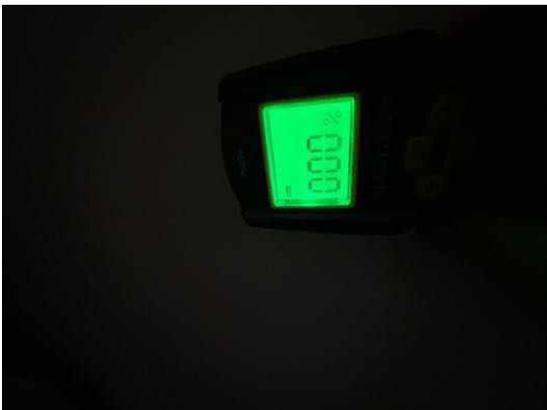
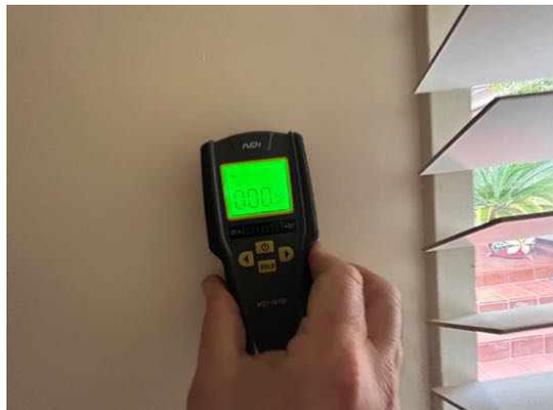
Building: Building 1
Location: All Areas
Finding: Moisture meter readings - low
Information: The moisture meter result for the areas inspected.

The moisture reading of 0-15% is quite normal and gives no cause for concern. However, moisture readings in excess of 15% indicate the need for further inspection.

Levels between 25-30% indicate that there may be water ingress, meaning that remedial work could be required.

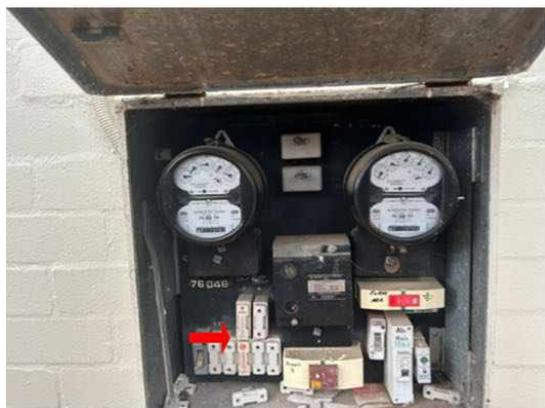
Building: Building 1
 Location: Yard - Side
 Finding: Electrical switchboard - Old ceramic fuses
 Information: The electrical switchboard while appearing to have adequate safety switches installed has old ceramic fuses in place.

While this on its own on is not considered a defect it is noted for the clients consideration that a switchboard upgrade may be required in the short to mid term to improve the functionality of the electrical system.

A licensed electrician could be appointed to provide quotation for the works at the client's discretion which may in turn expose other required works to bring the system up to a compliant state.

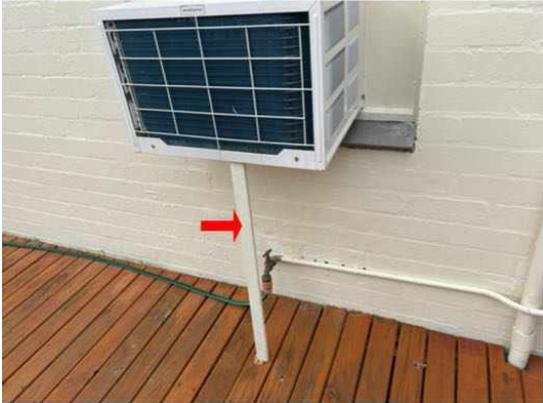
Building: Building 1
 Location:
 Finding: Unconventional handyman work
 Information:
