Building Inspection Report

Inspection Date: Wed, 28 Sep 2022

Property Address: 6 Ocean View Way, Belrose NSW 2085,
Australia

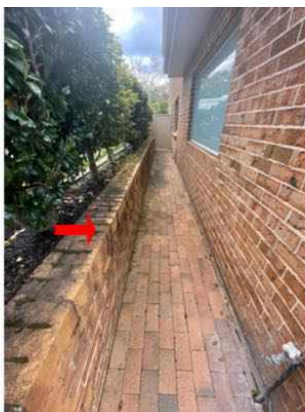
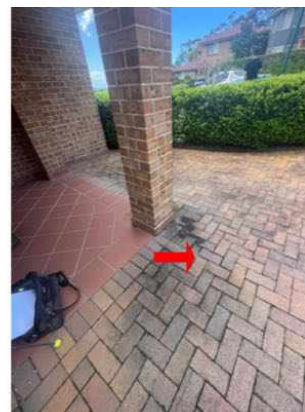
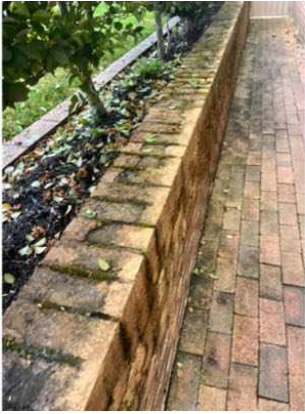
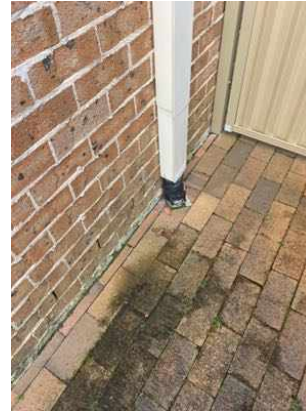
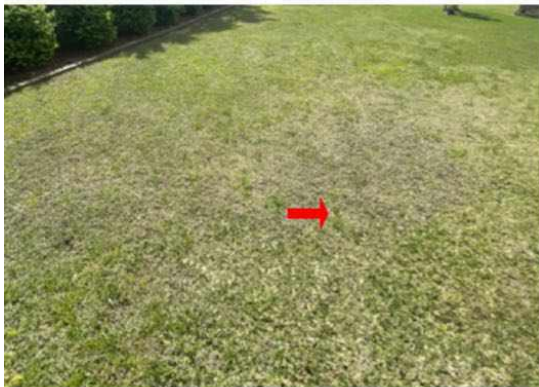
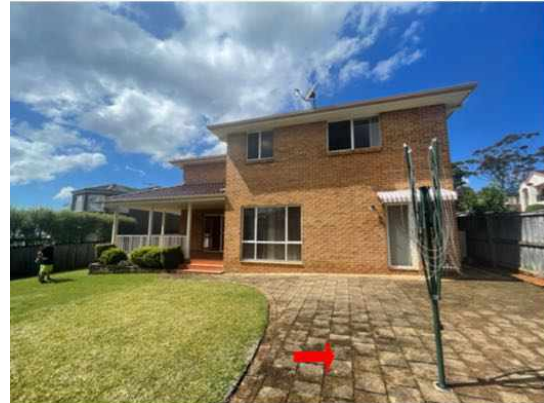
Defects 3.01

Building: Building 1
Location: All Areas
Finding: Site drainage - suspected Inadequate
Information: The site drainage in this area was found to be inadequate at the time of inspection, creating potential for subsequent water damage to associated building elements.

It is important that water does not lie against the base of walls; surrounding paths and ground levels should be sloped to drain water away from walls. Downpipes should not discharge stormwater onto lower walls or plinths. Stormwater should be carried away by large, regularly cleaned drains. Ground levels may need to be lowered to expose a buried DPC.

Where site drainage is inadequate, installation of an Agricultural (Aggie) Drain may be required. A qualified plumber should be appointed to further inspect the property and perform any remedial works as necessary. Water damage and secondary defects are likely to occur if left unmanaged.

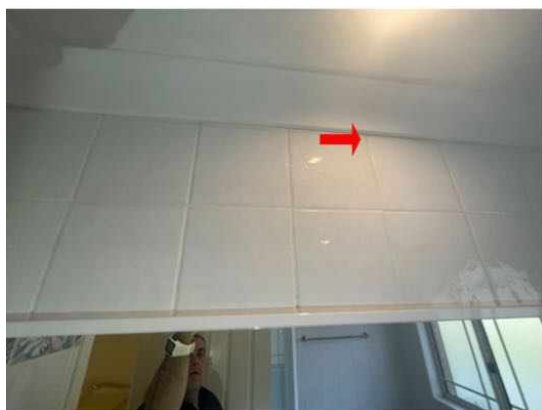
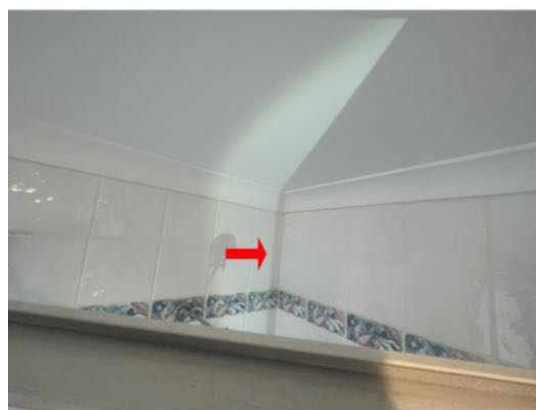
Defects 3.02

Building:	Building 1
Location:	All Areas
Finding:	Sealant - missing/ deteriorated
Information:	Flexible and mould resistant materials should be applied to affected areas to prevent any subsequent water damage that is likely to occur. Regular maintenance and replacement of damage or missing or damaged sealant and grout is highly recommended to the wet areas, as this is a regular wear and tear defect.

Sealant and grouting in areas that come into regular contact with water should be maintained for the long term care of your property. A sealant specialist or tiling contractor should be appointed to complete these works as soon as possible

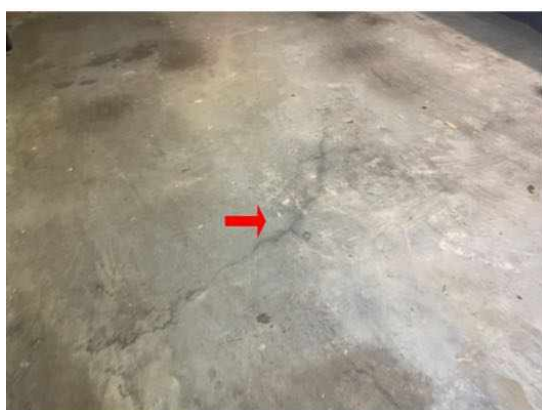
Defects 3.03

Building:	Building 1
Location:	Garage
Finding:	Cracking - Damage Category 1 - Fine (up to 1mm)
Information:	Although fine cracks are quite noticeable, they are often only considered to be an appearance defect, and usually do not indicate any structural damage. Generally, the cause of a fine crack is indicative of a separation between building materials and finishes (e.g. paint, plaster, etc.) along joints.

Cracking of this nature can generally be repaired with minor sanding, filling and/or repainting. Such works should be performed by a qualified painter or a general handyman.

Monitoring of all cracking should be conducted frequently. Always contact a building inspector should cracks widen, lengthen, or become more numerous.

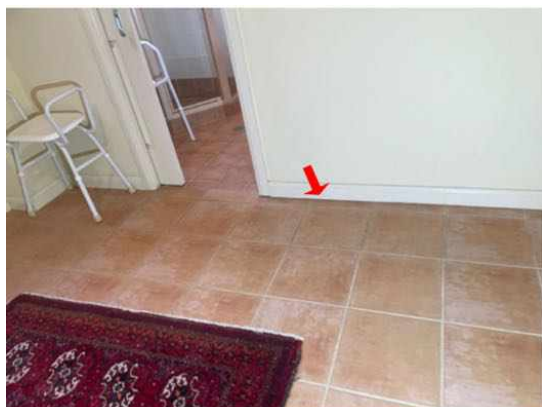
Defects 3.04

Building:	Building 1
Location:	All Areas
Finding:	Gaps on Skirting to floor
Information:	Gaps between skirting and flooring are defective if they exceed 2 mm and are visible

from a normal viewing position.

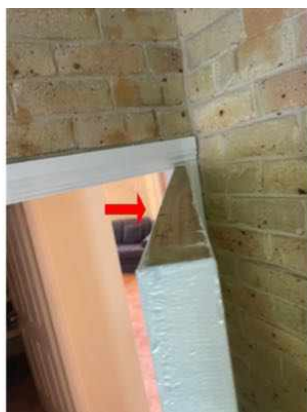
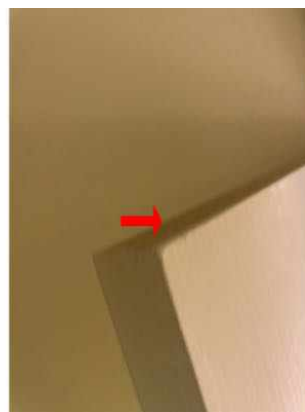
Defects 3.05

Building:	Building 1
Location:	All Areas
Finding:	Door finish - incomplete on top and bottom of door
Information:	The paint finish in this area was identified as being incomplete at the time of inspection.

Whilst incomplete or missing paint finish is generally an appearance defect, it can also lead to the development of secondary building defects over time. Incomplete areas of paint finish exposes the area to moisture, potentially accelerating the deterioration of underlying building materials.

A painting contractor should be appointed to perform necessary works to aid the appearance of the affected area and to ensure the area is protected against further deterioration. Alternatively, the homeowner following manufacturer instructions may perform these works.

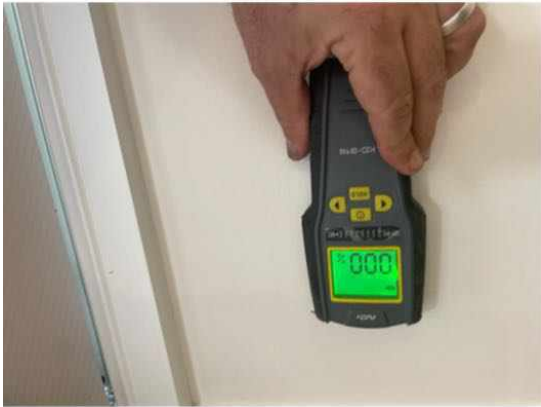
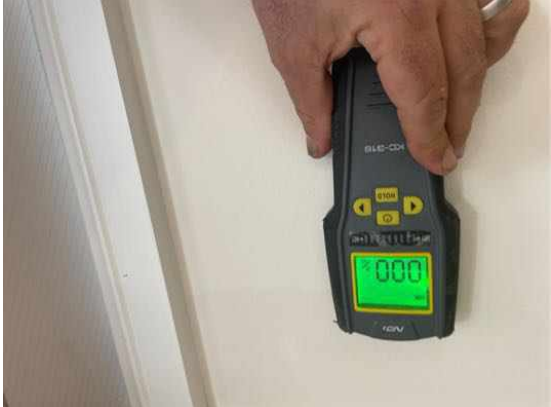
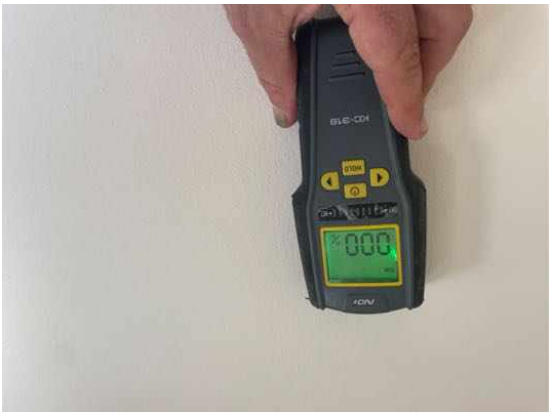
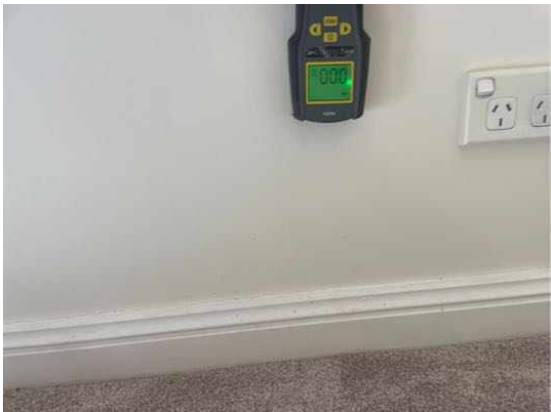
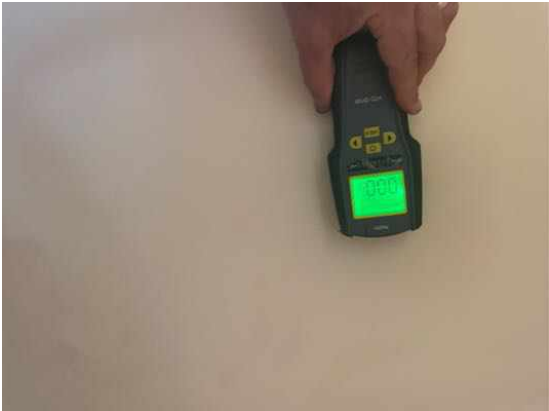
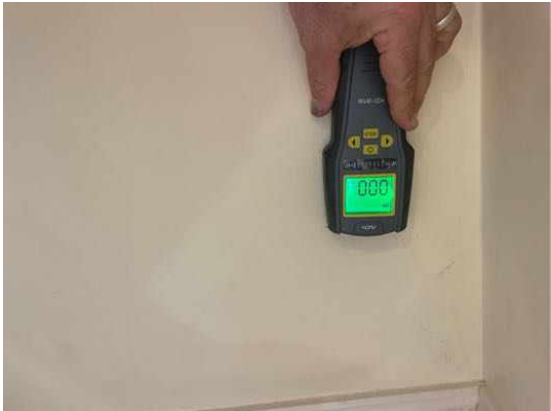
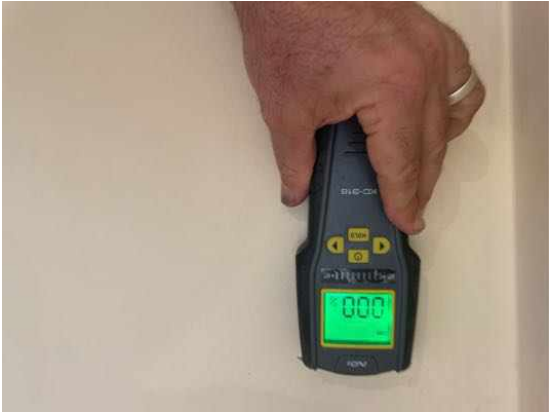
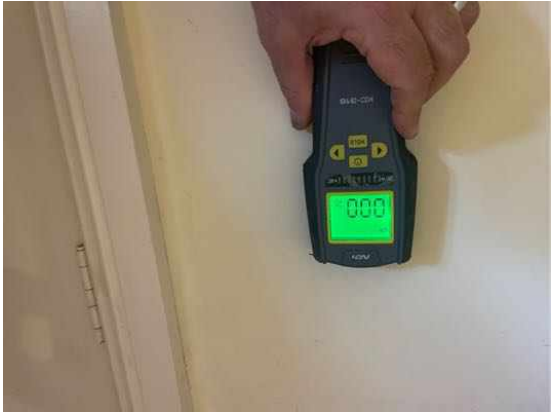
Building: Building 1
 Location: All Areas
 Finding: Moisture meter readings
 Information: The moisture meter result for the areas inspected.

The moisture reading of 0-15% is quite normal and gives no cause for concern. However, moisture readings in excess of 15% indicate the need for further inspection.

Levels between 25-30% indicate that there may be water ingress, meaning that remedial work could be required.

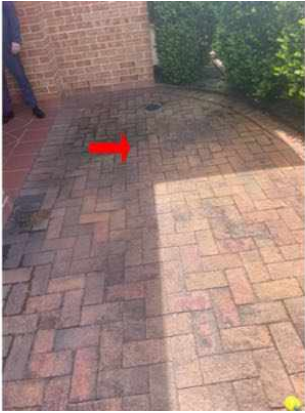
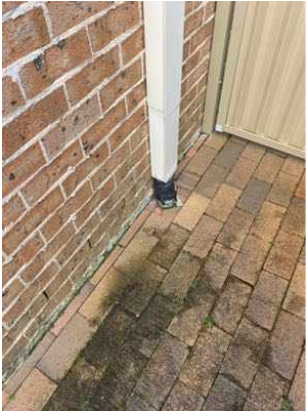
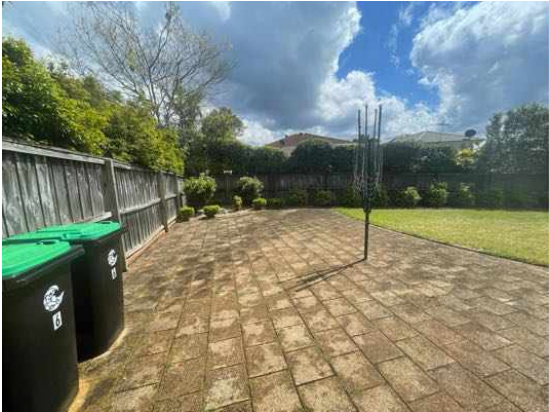
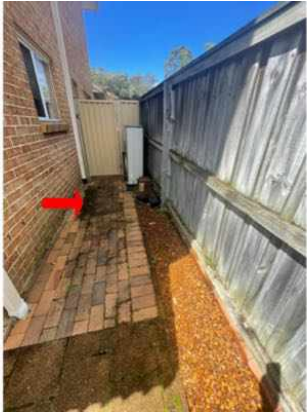
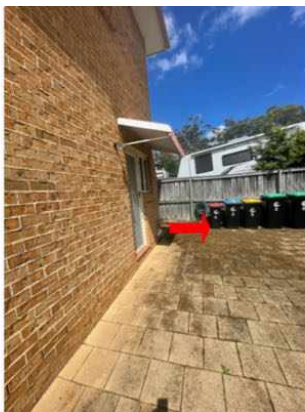
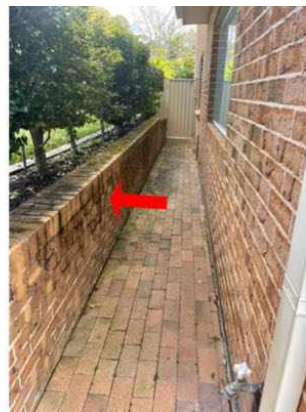
Building: Building 1
Location: All Internal Areas
Finding: Surface - Requires cleaning
Information: Regular cleaning and maintenance improves the longevity of all building elements. A build up of dirt and debris can reduce the useful life of building materials and may result in earlier replacement of items being required.

Excessive dirt is also likely to lead to secondary hazards, including potential health hazards, as the building elements begin to harbour bacteria and/or mould.

Remedial cleaning is recommended in order to improve the appearance of this area as well as to counteract the development of bacteria. Such works can be performed by a cleaning contractor and should be completed at the discretion of the client.

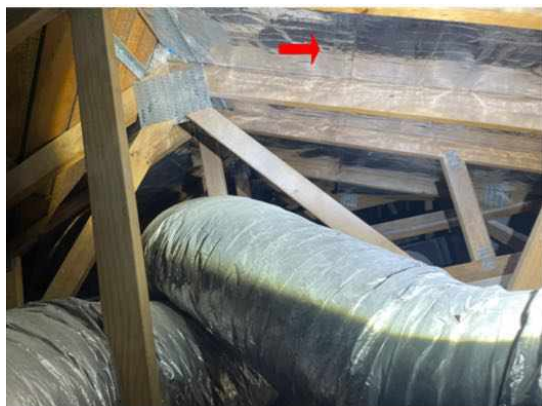
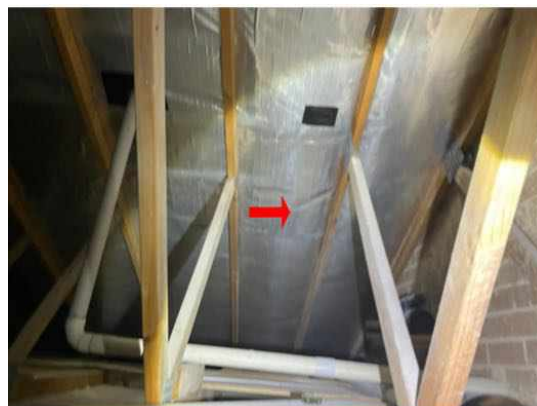
Building:	Building 1
Location:	Roof Void
Finding:	Sarking - installed
Information:	Sarking is under the roof sheeting. Sarking acts as an insulator that helps with noise reduction and protects against water penetration. Sarking plays a key role in the operation and function of the overall roofing structure and its performance.

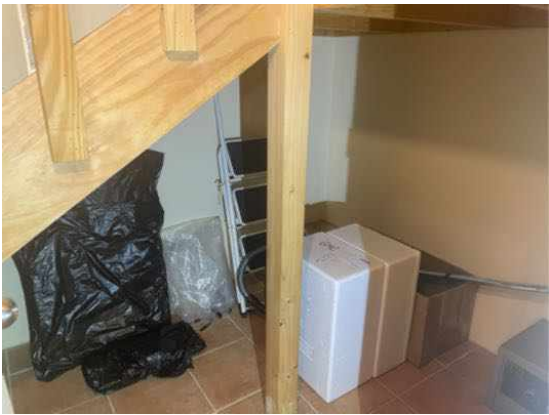
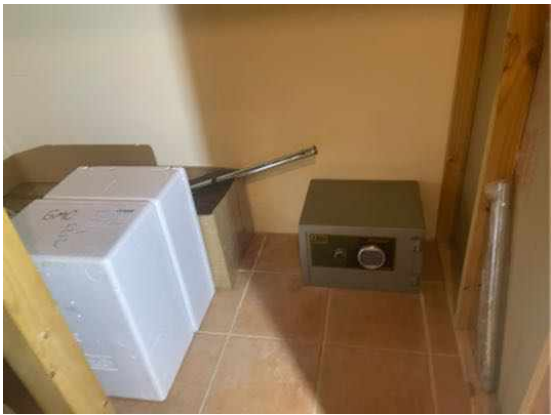
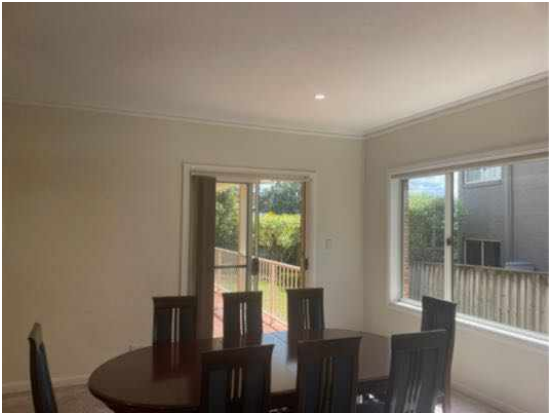
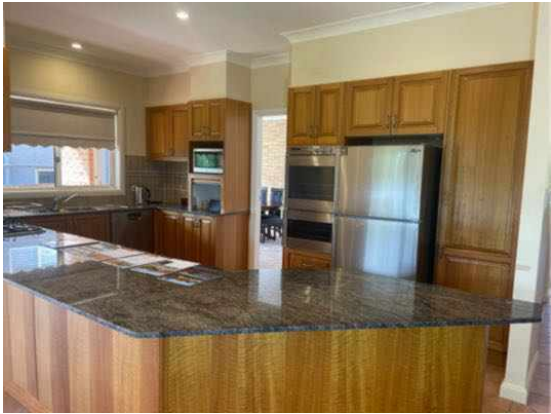
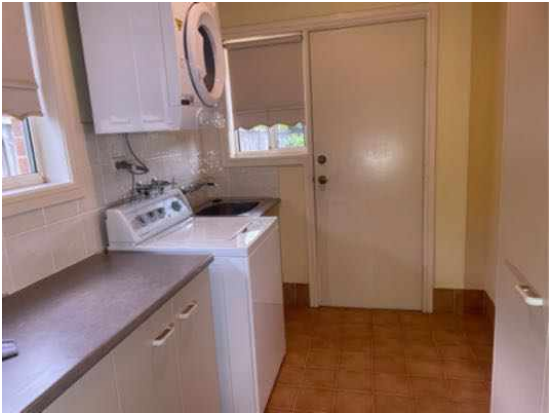
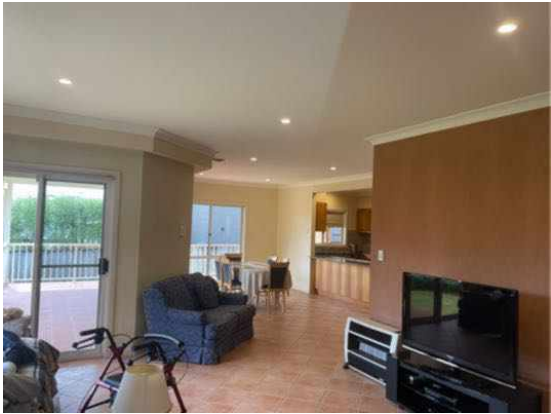
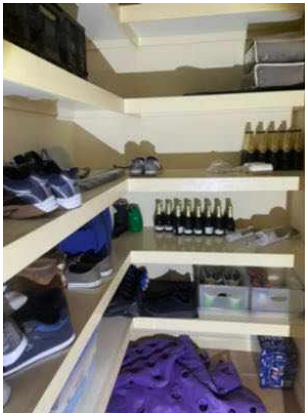
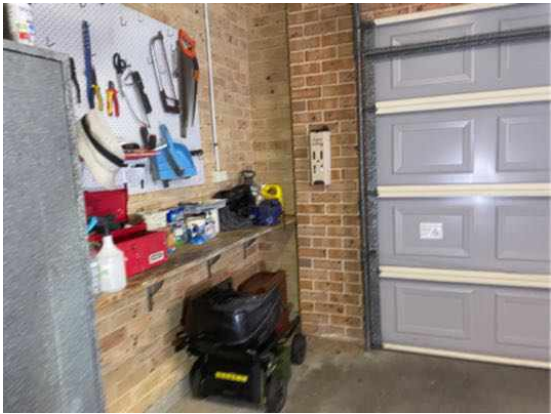
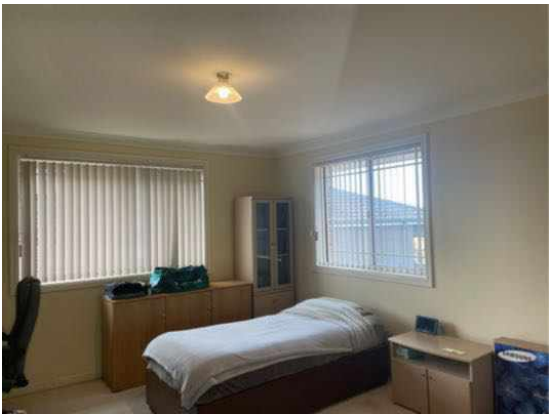
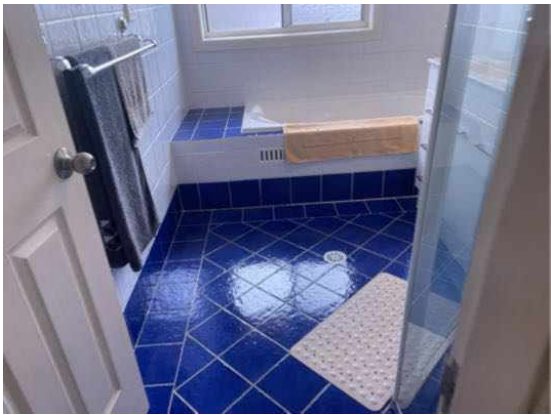
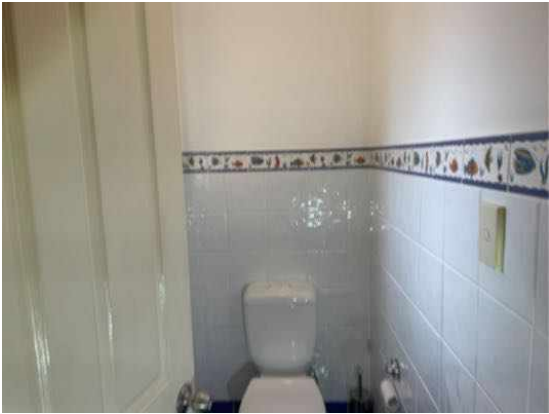
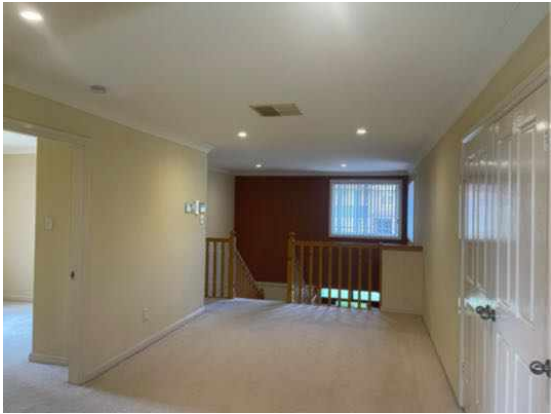
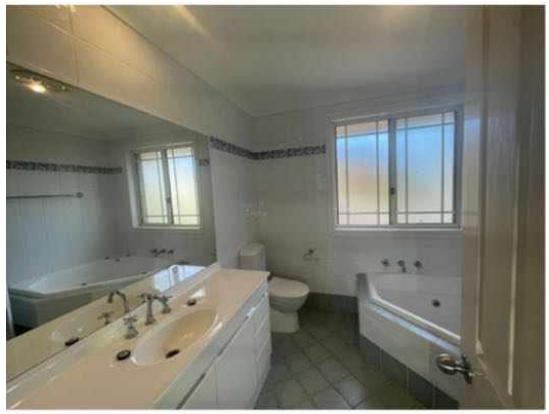
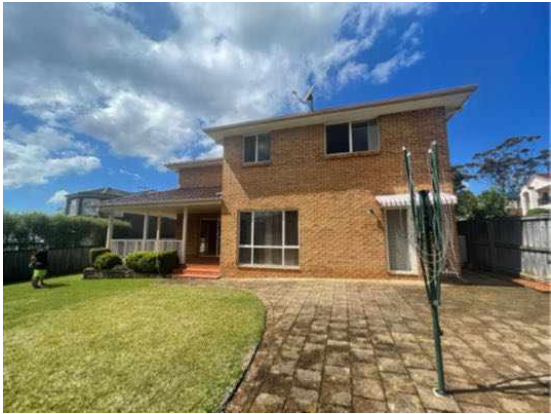
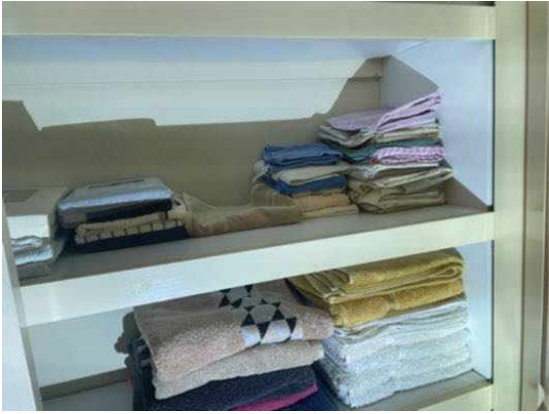
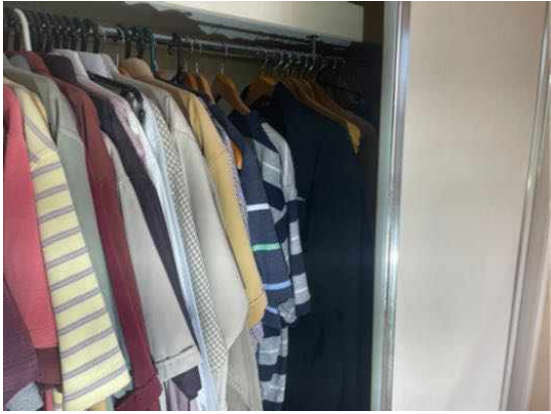
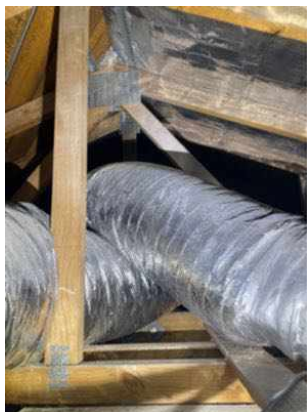
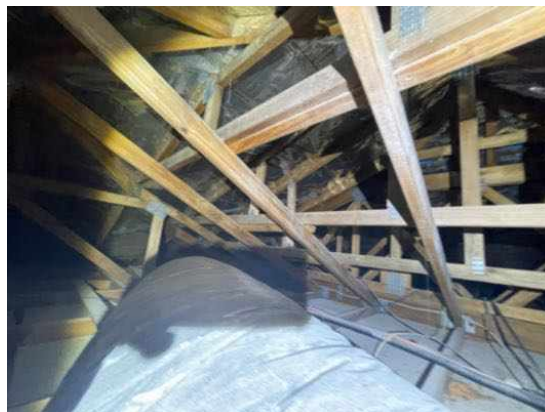
Building:	Building 1
Location:	All Areas
Finding:	Additional Photos - Obstructions and Limitations
Information:	These photographs are an indication of the obstructions and limitations which impeded full inspection of the property at the time of inspection. These obstructions can hide an array of defects and should be removed to allow full inspection to be carried out.

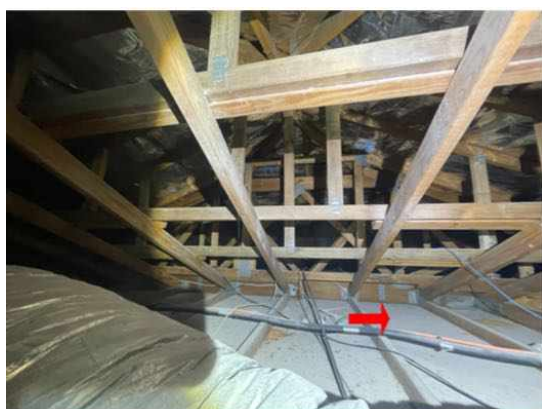
Building:	Building 1
Location:	Roof Void
Finding:	Insulation - not present
Information:	Upon inspection of the roof void it was noted that there is was no insulation.

No insulation will result in a comparatively higher cost to heat and cool a property as there is a lack of Insulation (or uneven coverage of insulation) which works as a barrier to heat transfer. This helps to keep out unwanted heat in summer and preserves warmth inside your home in winter. It can also help soundproof your home from unwanted airborne noise transfer.
