## Timber Pest Inspection Report

Inspection Date: Fri, 7 Jul 2023

Property Address: 81 Dareen St, Frenchs Forest NSW 2086,  
Australia

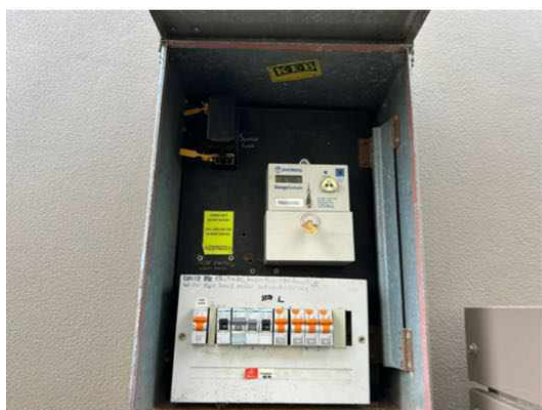
#### Termite and Timber Pest 1.01

Building:	Building 1
Location:	All Areas
Finding:	Termite durable notice not present
Information:	The application of a post-construction chemical termite barrier is highly recommended for all properties. Such barriers are highly effective in preventing termite attack on any timber building elements throughout the property.

A durable notice has been placed in the switchboard unit to indicate current termite barriers. At the time of inspection, it appeared as though there is only a physical termite management system has been installed.

The client may consider gaining further advice from a pest controller as to the costs and procedures involved with this application. It is recommended that obtaining such advice be a short-term priority.

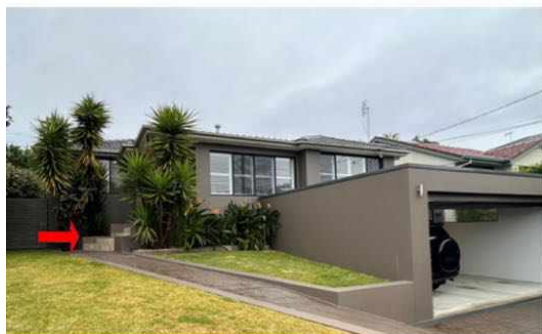
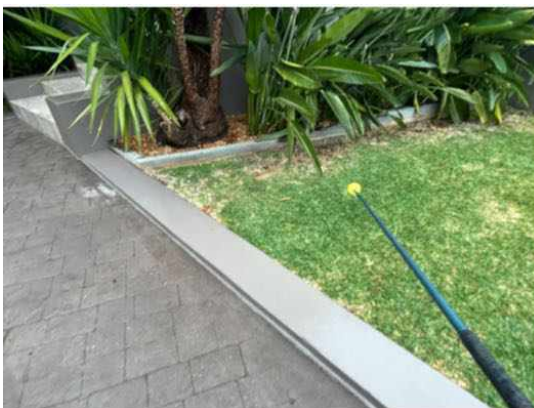
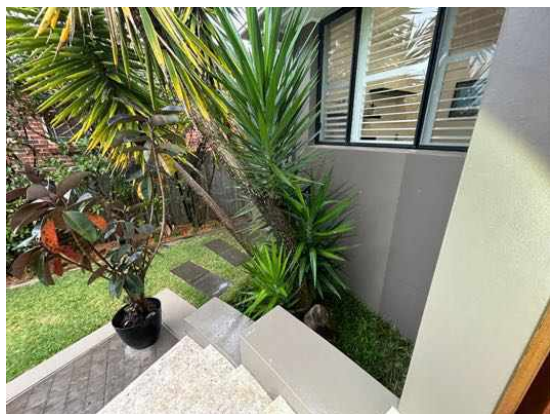
#### Termite and Timber Pest 1.02

Building:	Building 1
Location:	All Areas
Finding:	Garden Beds - Conditions Conducive to Termites
Information:	Garden beds were found to be evident in the garden area. These garden beds can include untreated timber, and with a combination of moisture from watering hosing can make conditions conducive to termite activity and termite ingress.

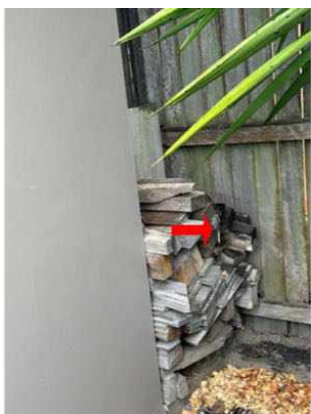
### Termite and Timber Pest 1.03

Building:	Building 1
Location:	Yard - Back
Finding:	Stored timbers - external area
Information:	<p>The storing of timbers around the external property increases the risk of termite activity being present. As they are likely to come into contact with weather conditions or excessive moisture wood rot is likely to develop on timbers that are not treated.</p> <p>It is highly recommended that any stored timbers be immediately removed from areas in which they may attract any termite / timber pest attack. Minimisation of risk / prevention of termite attack is far more adequate than dealing with the presence of termite activity.</p>

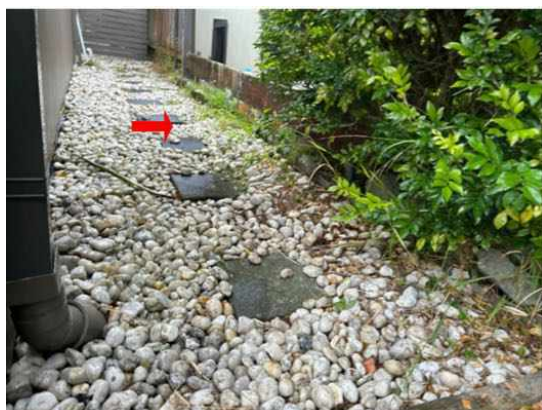
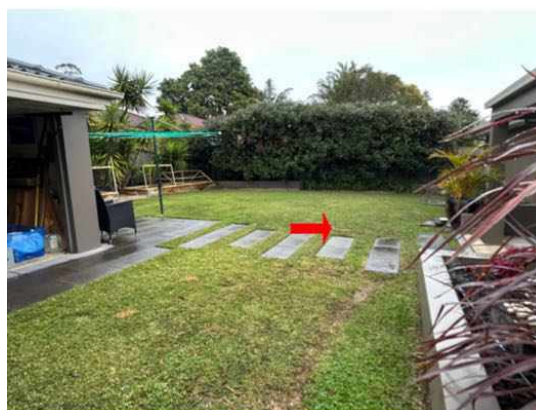
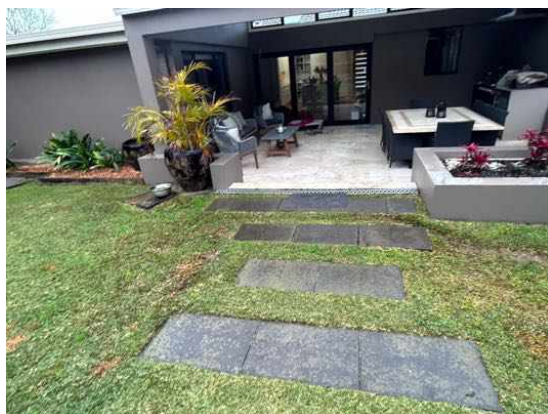
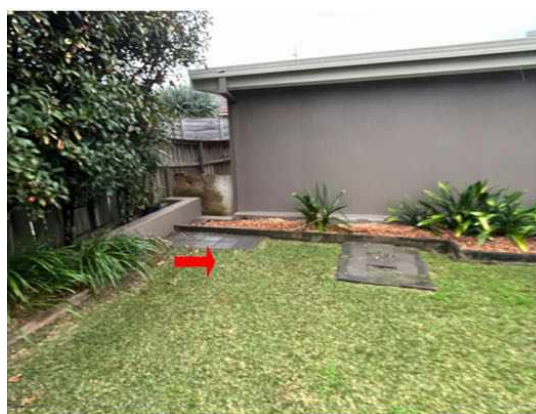
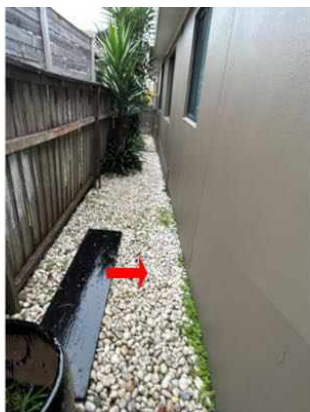
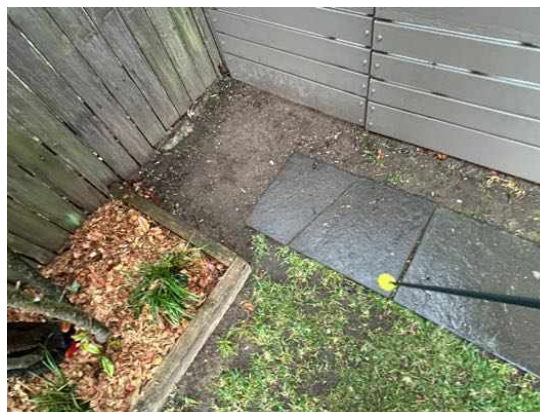
### Termite and Timber Pest 1.04

Building:	Building 1
Location:	All External Areas
Finding:	Site drainage - suspected Inadequate
Information:	It is important that water does not lie against the base of walls; surrounding paths and ground levels should be sloped to drain water away from walls. Downpipes should not discharge stormwater onto lower walls or plinths. Stormwater should be carried away by large, regularly cleaned drains. Ground levels may need to be lowered to expose a buried DPC.

The site drainage in this area was found to be inadequate at the time of inspection, creating potential for subsequent water damage to associated building elements.

Where site drainage is inadequate, installation of an Agricultural (Aggie) Drain may be required. A qualified plumber should be appointed to further inspect the property and perform any remedial works as necessary. Water damage and secondary defects are likely to occur if left unmanaged.

The current site drainage should be assessed by a qualified plumber.

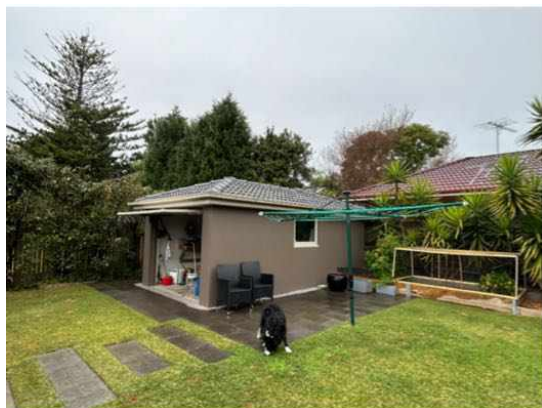
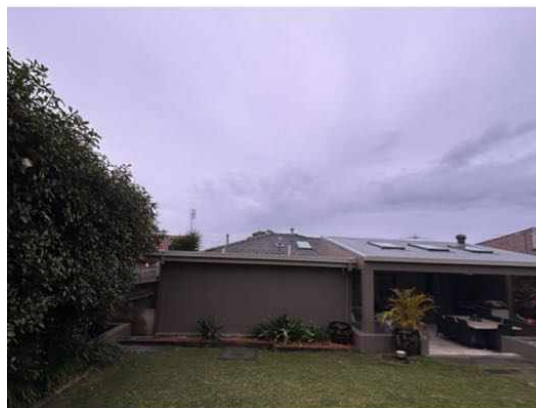
### Termite and Timber Pest 1.05

Building:	Building 1
Location:	All Areas
Finding:	Trees - Overhanging and filling gutters
Information:	Overhanging trees often result in excessive amounts of leaf debris accumulating in gutters.

Gutters are a critical part of the building's management of storm water and rain. It is therefore important that they be kept clear to prevent secondary damage to associated building elements, including exterior and interior walls, ceiling linings and any adjoining building elements. Where gutters are blocked, pooling of rainwater is likely to occur, fast-tracking rust and corrosion of the roof plumbing elements.

It is highly advised that all overhanging tree branches be removed as soon as possible to prevent any further damage. Repair and/or replacement of sections of damaged guttering may also be required where the extent of the damage necessitates.

Such works should be performed by the homeowner; however, appointment of a landscape contractor or an arborist may be required. Consultation with a licensed roof plumber is required where guttering has been damaged.

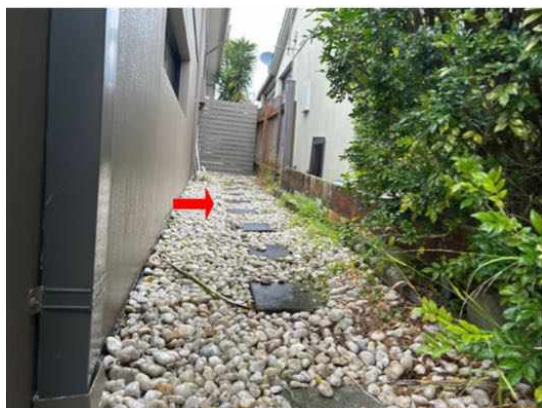
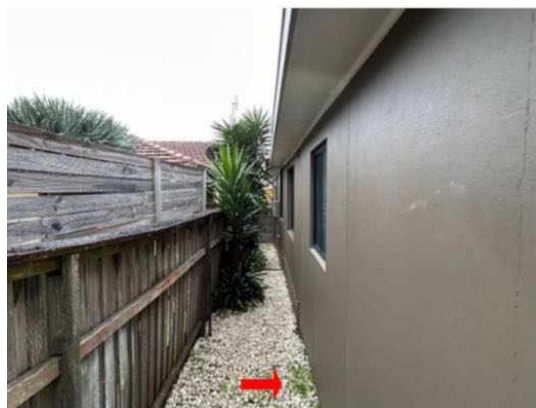
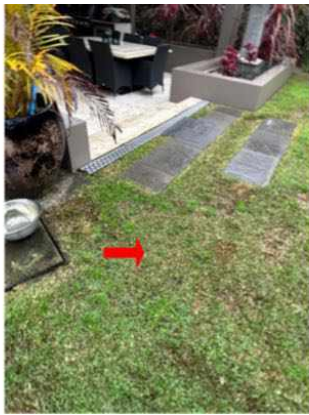
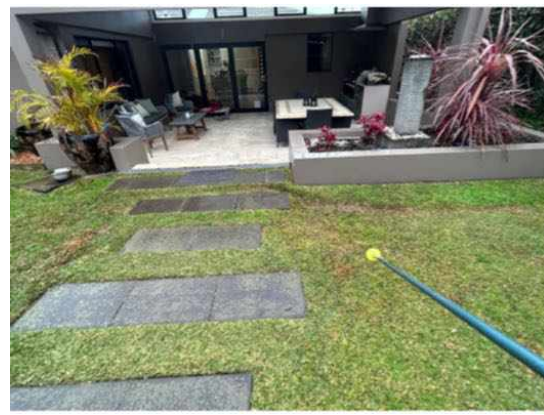
## Termite and Timber Pest 1.06

Building:	Building 1
Location:	All Areas
Finding:	Evidence of excessive moisture was present at the time of inspection
Information:	Excessive moisture can attract termites and produce conditions that promote termite attack fungal growth and wood decay.

Excessive moisture is generally caused by deteriorated inadequate or missing roof drainage leaking plumbing pipes or fixtures poorly plumbed HWS overflows or condenser units and poor site drainage.

It is highly recommended that all plumbing and drainage fixtures and fittings be maintained regularly in order to prevent excessive moisture being present in the external / internal property.

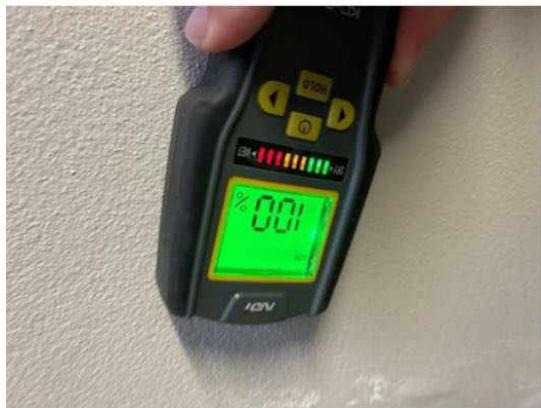
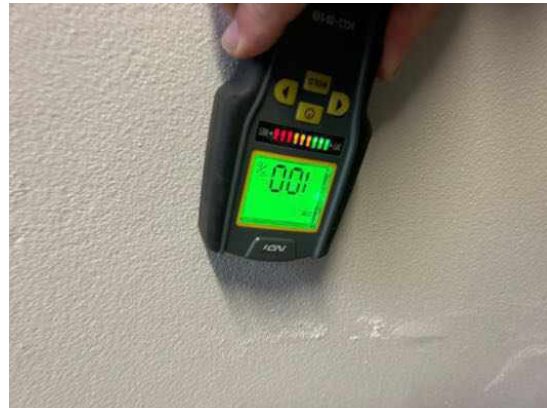
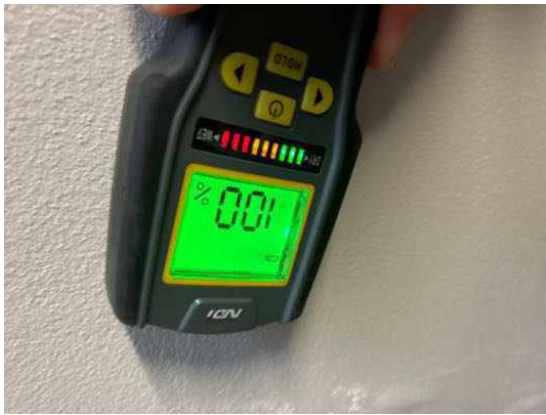
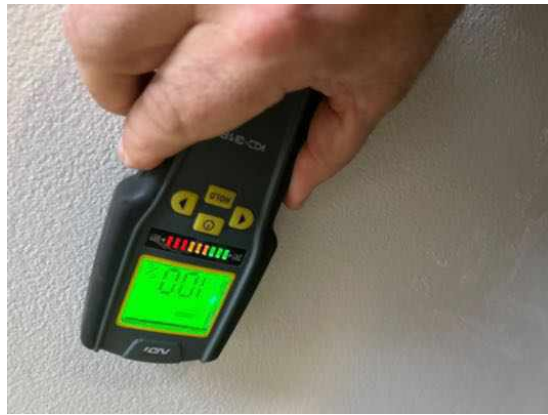
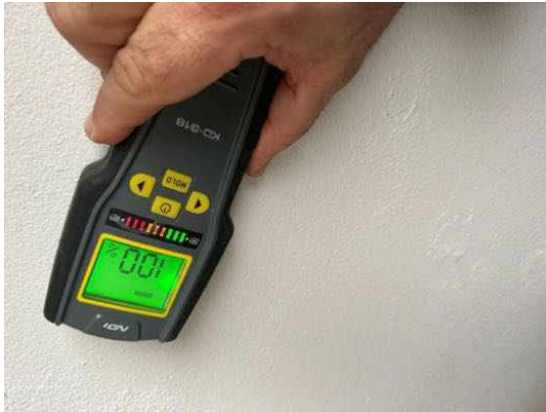
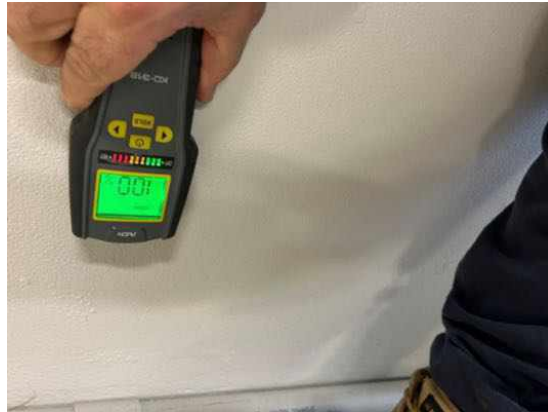
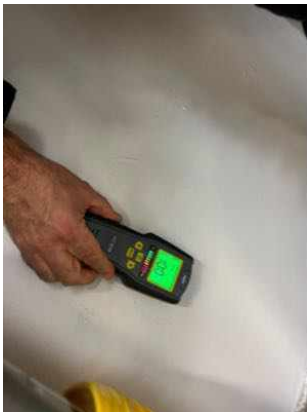
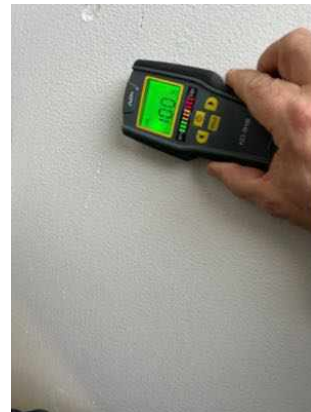
### Termite and Timber Pest 1.07

Building:	Building 1
Location:	Garage
Finding:	Evidence of excessive moisture was present at the time of inspection
Information:	Excessive moisture can attract termites and produce conditions that promote termite attack fungal growth and wood decay.

Excessive moisture is generally caused by deteriorated inadequate or missing roof drainage leaking plumbing pipes or fixtures poorly plumbed HWS overflows or condenser units and poor site drainage.

It is highly recommended that all plumbing and drainage fixtures and fittings be maintained regularly in order to prevent excessive moisture being present in the external / internal property.

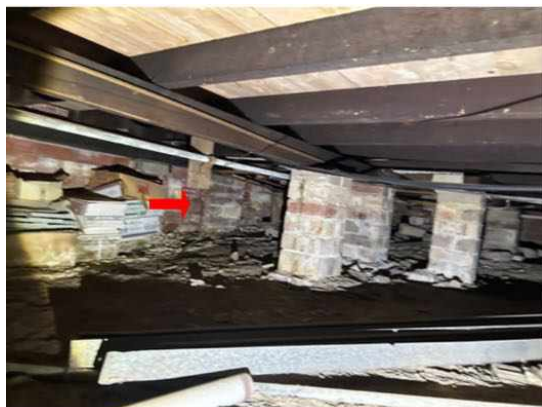
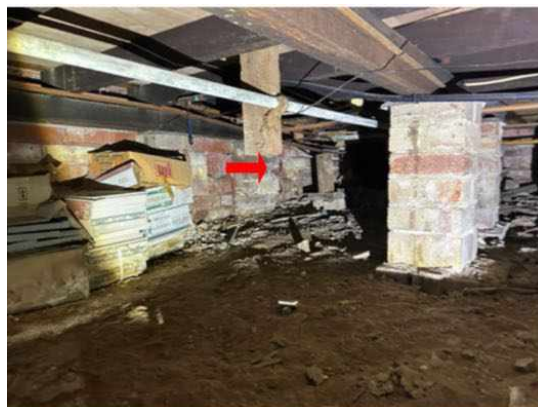
### **Termite and Timber Pest 7.01**

Building:	Building 1
Location:	Subfloor
Finding:	Mould - Present
Information:	Generally, the client is advised to ensure that the general environment is free of moisture and humidity to aid in the prevention of mould formation and development. Any mould found during the inspection should be cleaned immediately by a cleaning contractor or the homeowner as applicable.

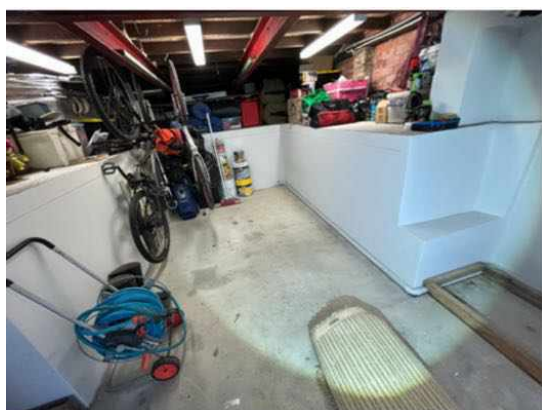
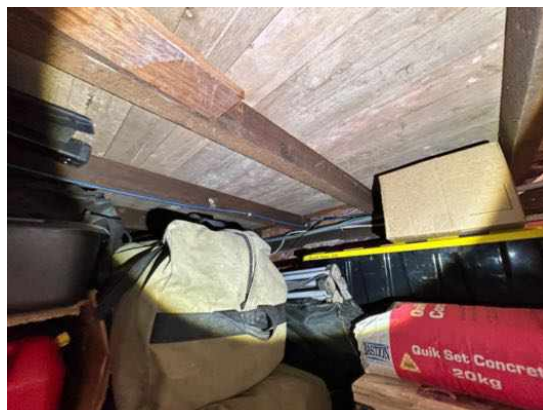
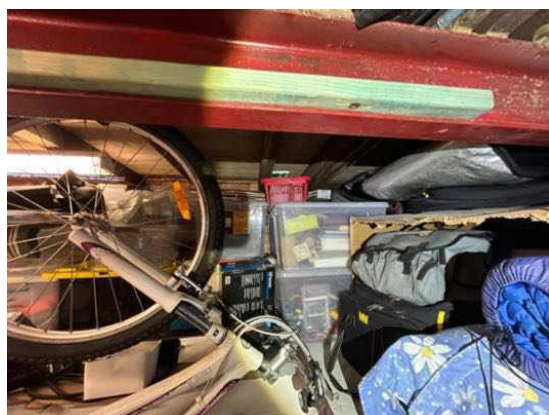
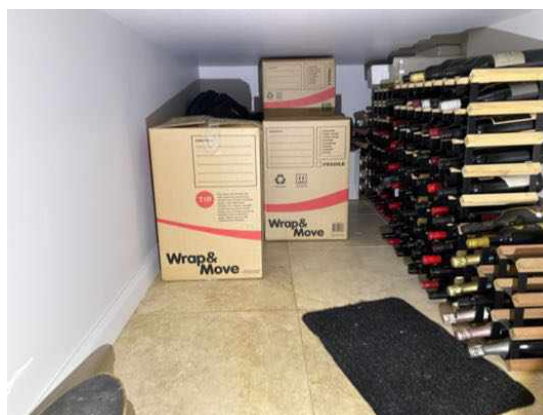
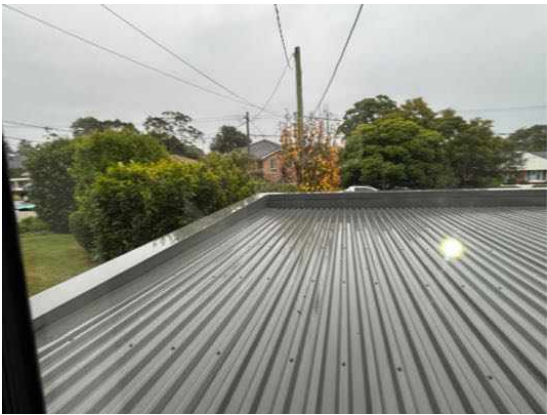
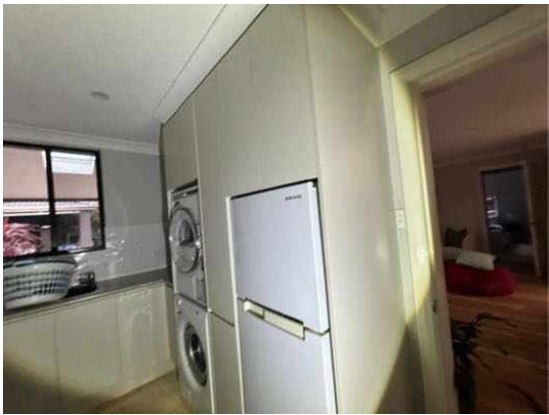
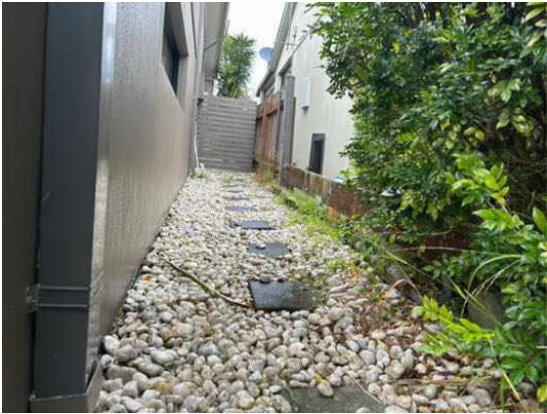
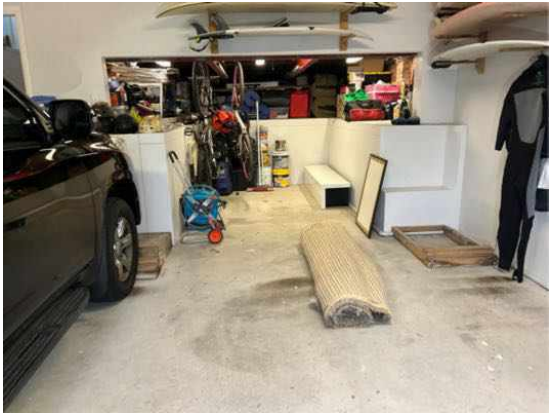
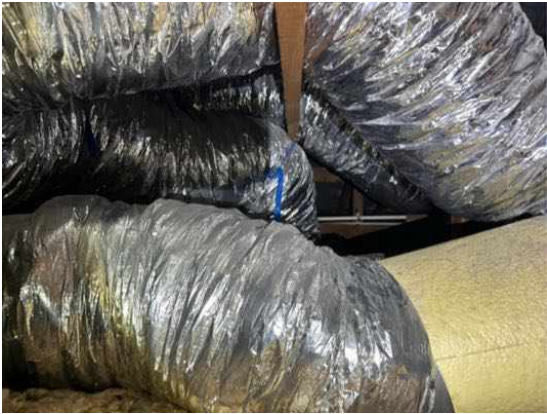
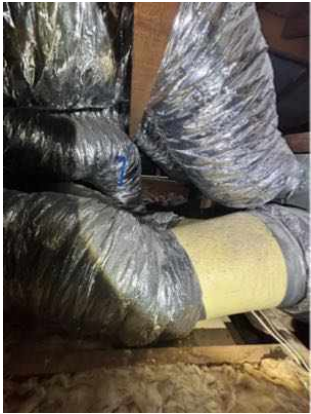
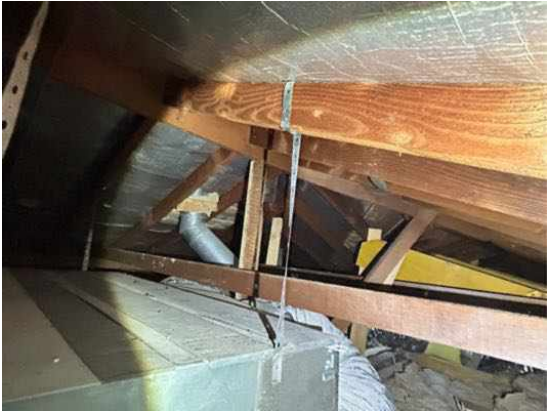
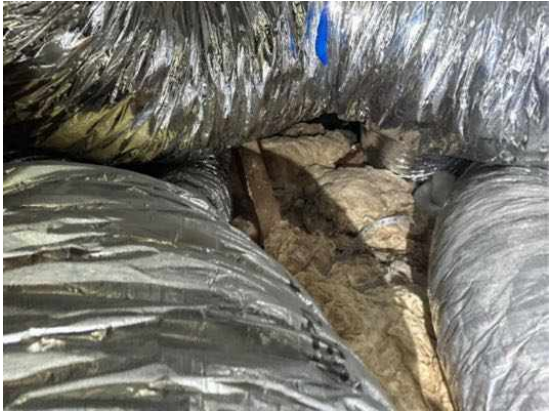
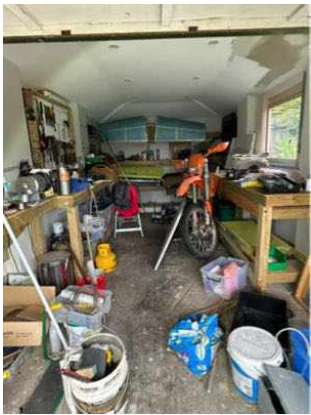
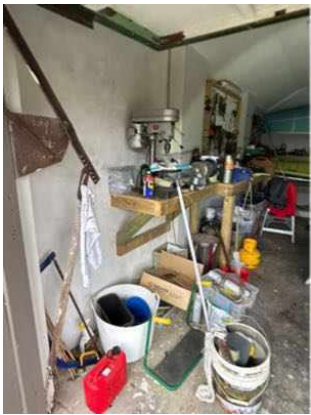
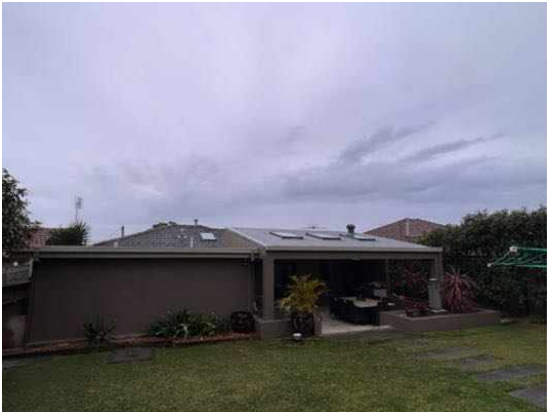
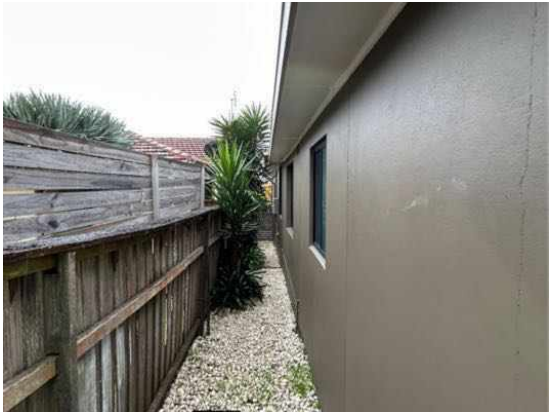
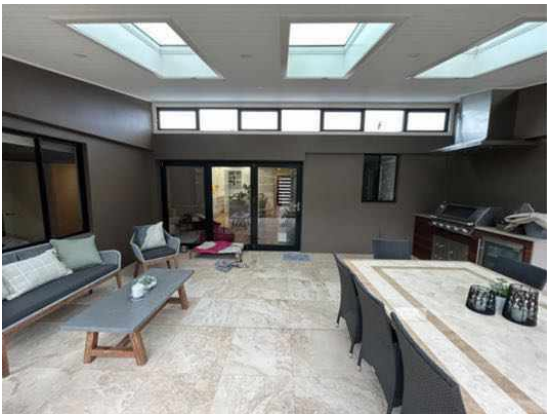
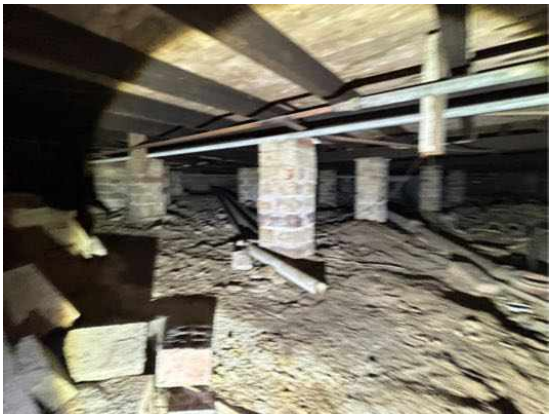
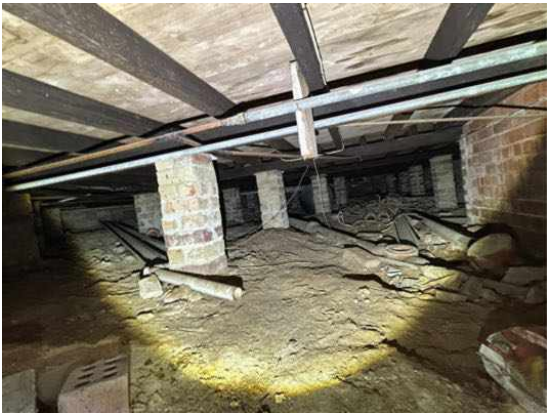
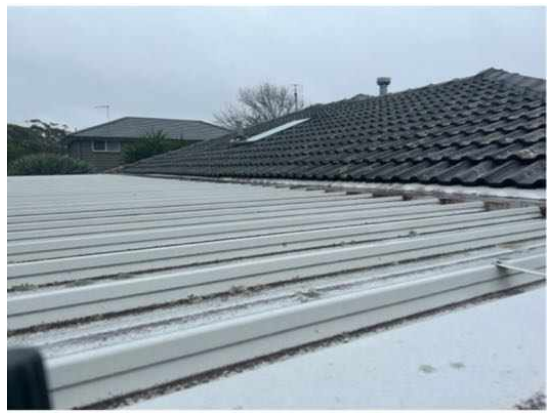
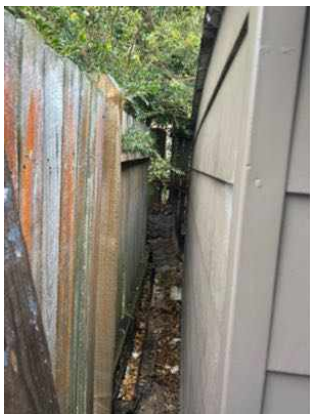
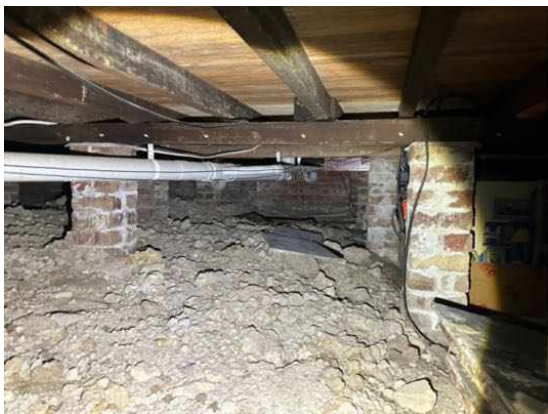
### Noted Item

Building: Building 1  
 Location: All Areas  
 Finding: Additional Photos - Obstructions and Limitations  
 Information: These photographs are an indication of the obstructions and limitations which impeded full inspection of the property at the time of inspection. These obstructions can hide an array of defects and should be removed to allow full inspection to be carried out. A re-inspection is recommended once the areas are made accessible.
