Pre-Purchase Timber Pest Detection Report

Jim's Pest Control - Hornsby

Name of client:	Vendor report
Address of client:	
Address of property inspected:	35 Parni Place Frenchs forest
Date of inspection:	13-05-2024
Duration of inspection:	1hrs 11min
Name of principal (where applicable):	Vendor report

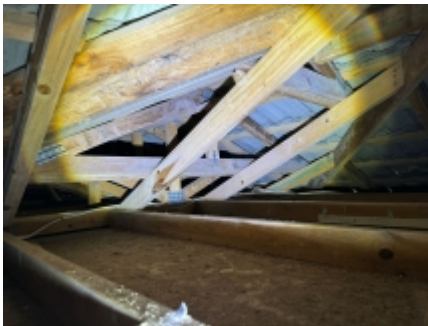
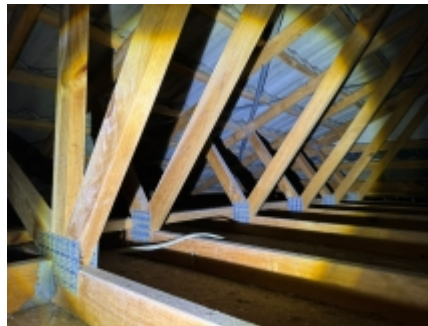
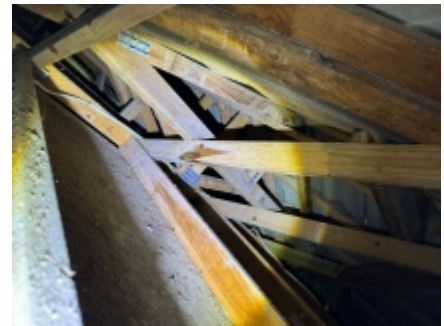
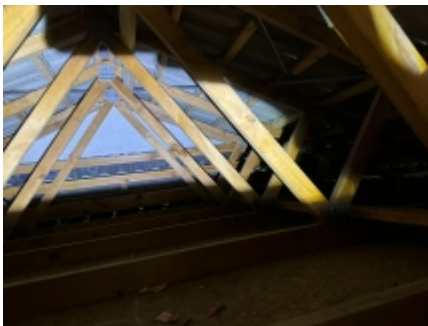
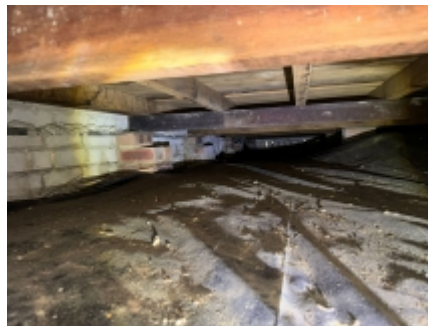
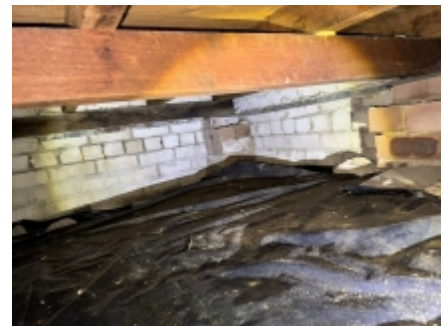
2.2.2 Obstructions (cont.) - Photos

Obstruction photos at the time of inspection

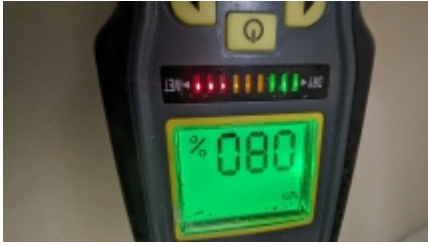
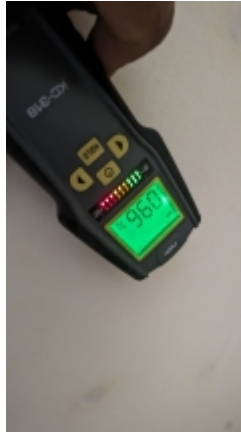
Excessive moisture was found in the internal wall of one of the bedroom.
