Timber Pest Inspection Report

Inspection Date: Thu, 16 Mar 2023

Property Address: 17 Kurrajong Rd, Frenchs Forest NSW
2086, Australia

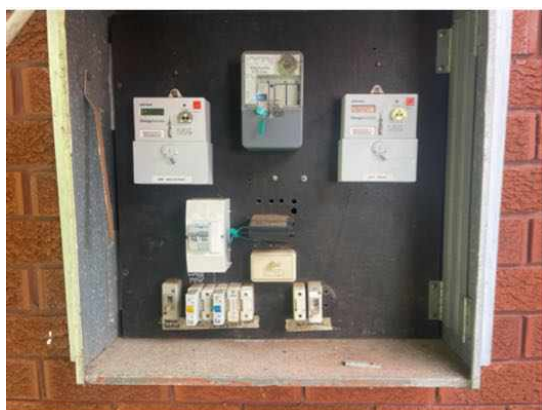
Termite and Timber Pest 1.01

Building:	Building 1
Location:	All External Areas
Finding:	Termite Management System - no evidence of a Termite Management System installation
Information:	The application of a post-construction chemical termite barrier is highly recommended for all properties, particularly if live termite activity has been found on the site previously. Such barriers are highly effective in preventing termite attack on any timber building elements throughout the property.

A durable notice should be placed in the switchboard unit to indicate current termite barriers. At the time of inspection, it appeared as though no termite management system has been installed, with no evidence to suggest preventative works taking place.

The client may consider gaining further advice from a pest controller as to the costs and procedures involved with this application. It is recommended that obtaining such advice be a short-term priority.

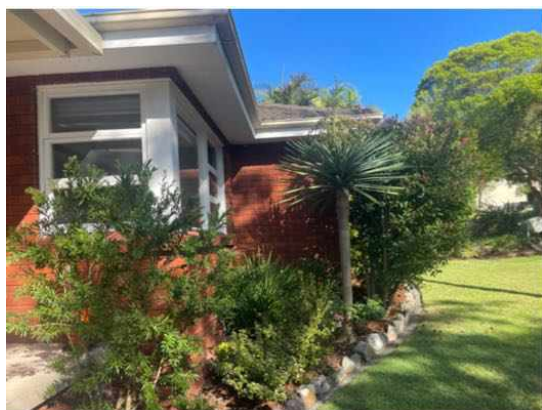
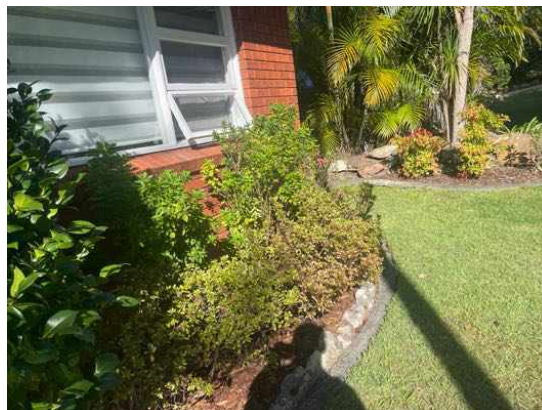
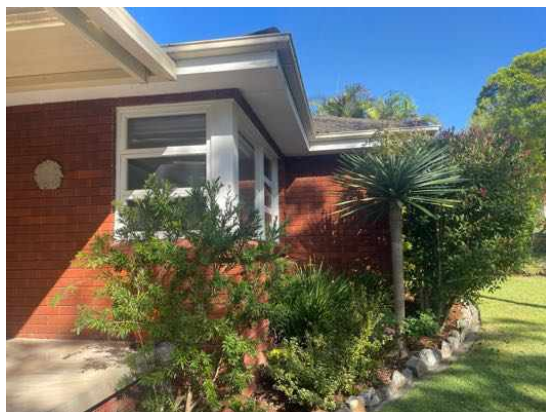
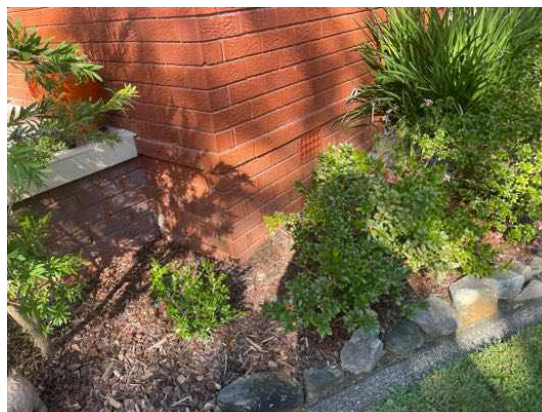
Termite and Timber Pest 1.02

Building:	Building 1
Location:	All External Areas
Finding:	Garden Beds - Conditions Conducive to Termites
Information:	Garden beds were found to be evident in the garden area. These garden beds can include untreated timber, and with a combination of moisture from watering hosing can make conditions conducive to termite activity and termite ingress.

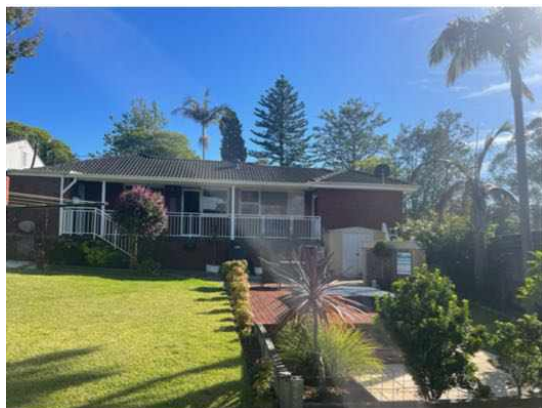
Termite and Timber Pest 1.03

Building:	Building 1
Location:	All External Areas
Finding:	Trees - Overhanging and filling gutters
Information:	Overhanging trees often result in excessive amounts of leaf debris accumulating in gutters.

Gutters are a critical part of the building's management of storm water and rain. It is therefore important that they be kept clear to prevent secondary damage to associated building elements, including exterior and interior walls, ceiling linings and any adjoining building elements. Where gutters are blocked, pooling of rainwater is likely to occur, fast-tracking rust and corrosion of the roof plumbing elements.

It is highly advised that all overhanging tree branches be removed as soon as possible to prevent any further damage. Repair and/or replacement of sections of damaged guttering may also be required where the extent of the damage necessitates.

Such works should be performed by the homeowner; however, appointment of a landscape contractor or an arborist may be required. Consultation with a licensed roof plumber is required where guttering has been damaged.

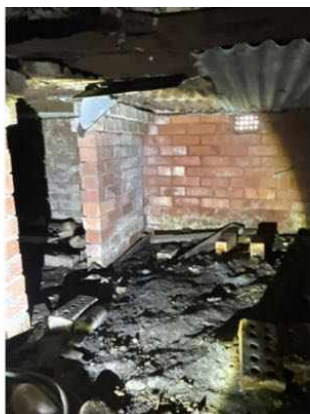
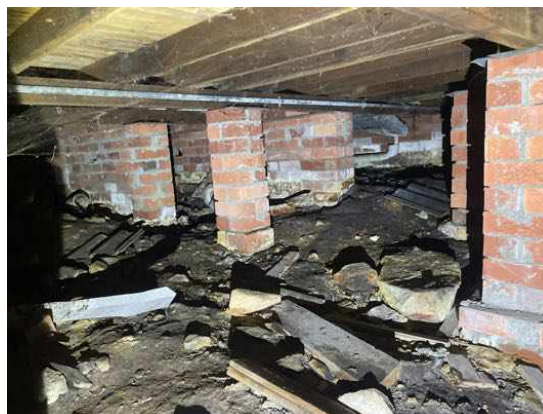
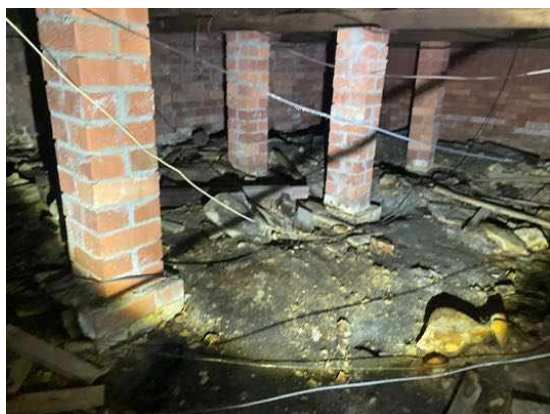
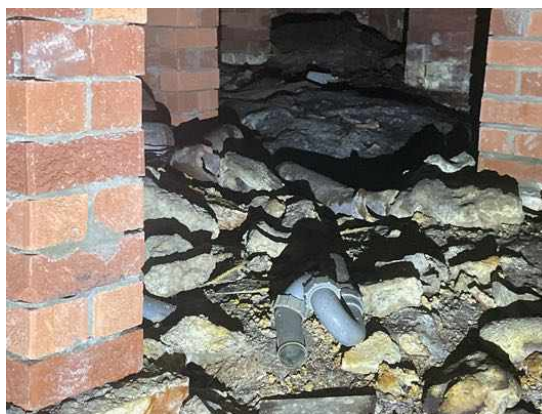
Termite and Timber Pest 1.04

Building:	Building 1
Location:	Subfloor
Finding:	Evidence of excessive moisture was present at the time of inspection
Information:	Excessive moisture can attract termites and produce conditions that promote termite attack fungal growth and wood decay.

Excessive moisture is generally caused by deteriorated inadequate or missing roof drainage leaking plumbing pipes or fixtures poorly plumbed HWS overflows or condenser units and poor site drainage.

It is highly recommended that all plumbing and drainage fixtures and fittings be maintained regularly in order to prevent excessive moisture being present in the external / internal property.

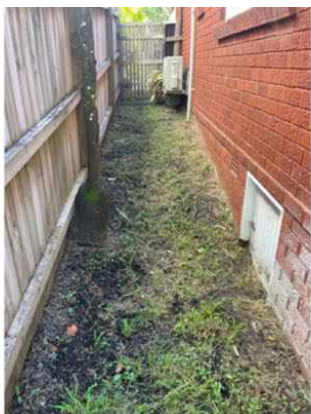
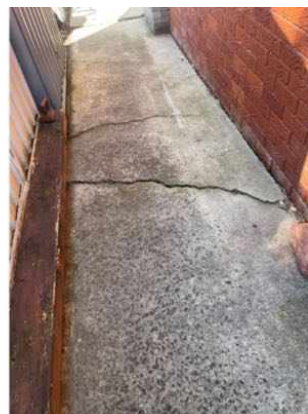
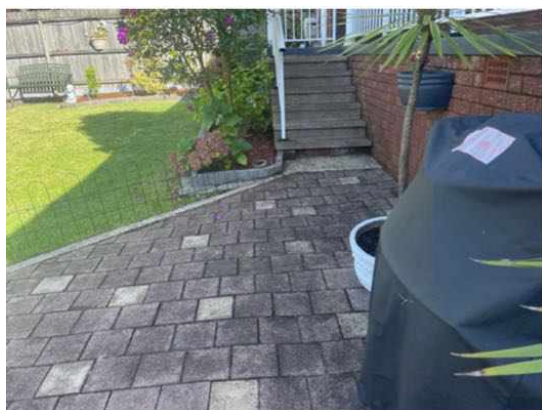
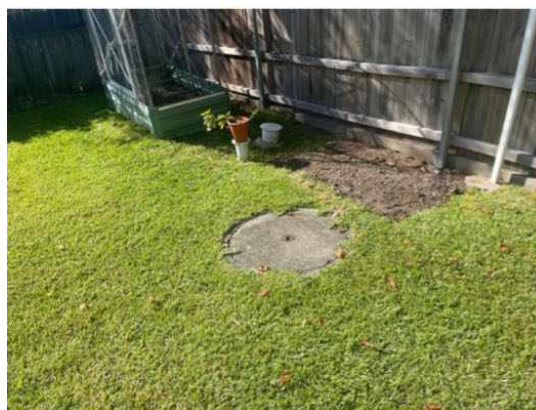
Termite and Timber Pest 1.05

Building:	Building 1
Location:	All Areas
Finding:	Evidence of excessive moisture was present at the time of inspection
Information:	Excessive moisture can attract termites and produce conditions that promote termite attack fungal growth and wood decay.

Excessive moisture is generally caused by deteriorated inadequate or missing roof drainage leaking plumbing pipes or fixtures poorly plumbed HWS overflows or condenser units and poor site drainage.

It is highly recommended that all plumbing and drainage fixtures and fittings be maintained regularly in order to prevent excessive moisture being present in the external / internal property.

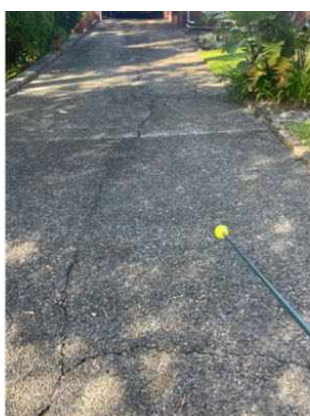
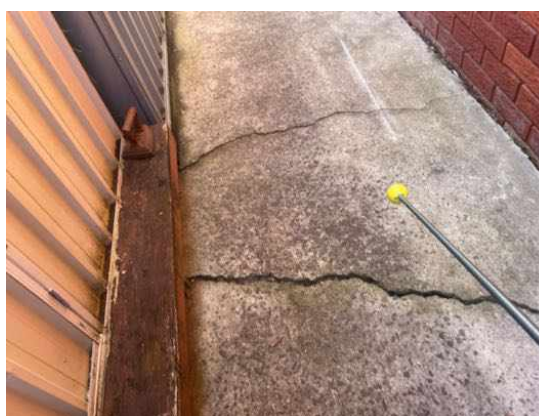
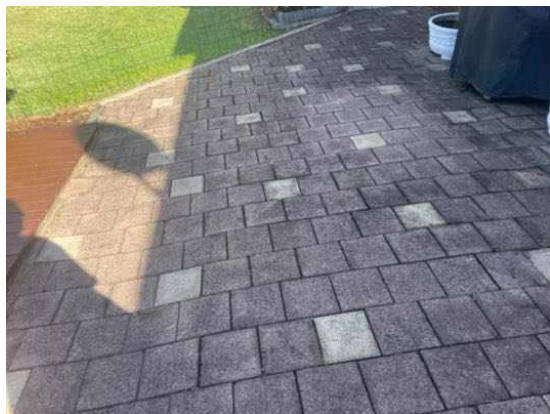
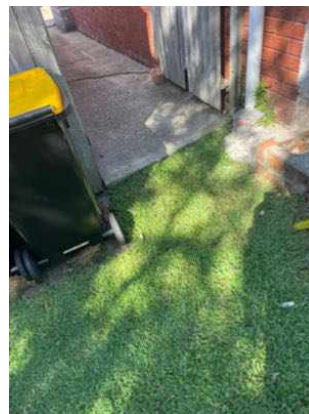
Termite and Timber Pest 1.06

Building:	Building 1
Location:	All External Areas
Finding:	Site drainage - suspected Inadequate
Information:	The site drainage in this area was found to be inadequate at the time of inspection, creating potential for subsequent water damage to associated building elements.

It is important that water does not lie against the base of walls; surrounding paths and ground levels should be sloped to drain water away from walls. Downpipes should not discharge stormwater onto lower walls or plinths. Stormwater should be carried away by large, regularly cleaned drains. Ground levels may need to be lowered to expose a buried DPC.

Where site drainage is inadequate, installation of an Agricultural (Aggie) Drain may be required. A qualified plumber should be appointed to further inspect the property and perform any remedial works as necessary. Water damage and secondary defects are likely to occur if left unmanaged.

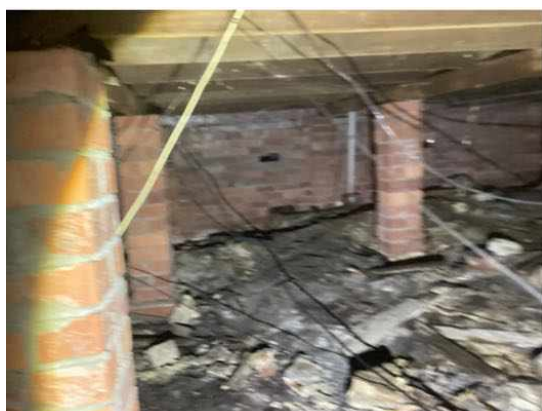
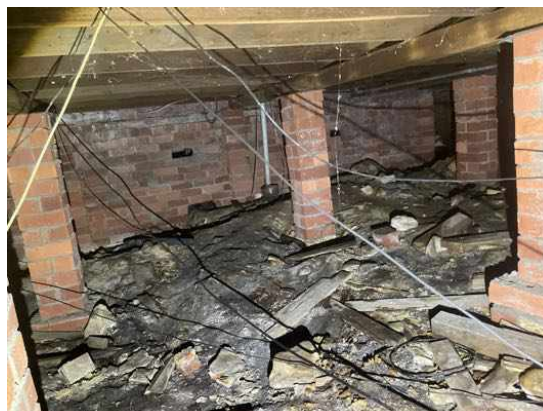
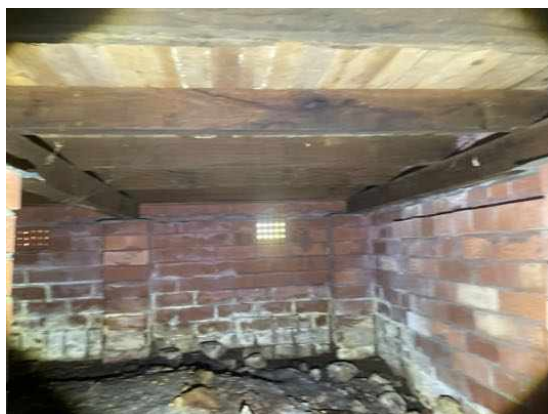
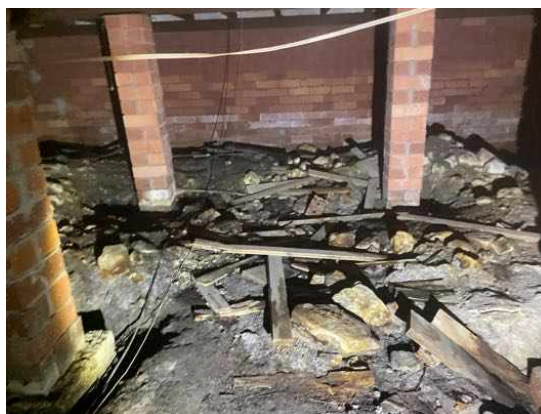
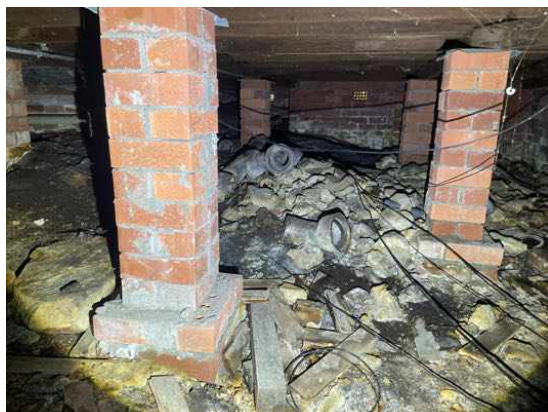
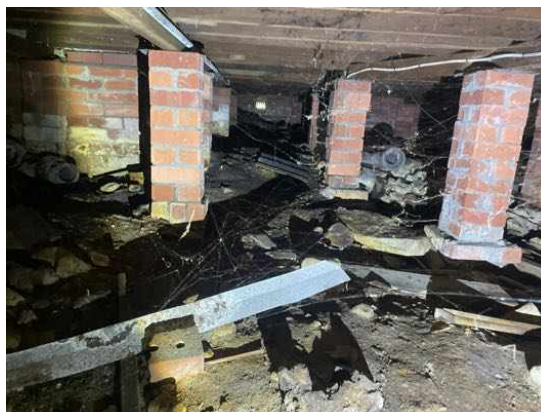
Termite and Timber Pest 1.07

Building:	Building 1
Location:	Subfloor
Finding:	Subfloor ventilation - Inadequate
Information:	Adequate subfloor ventilation aids in preventing excessive moisture wood rot and termite activity by ensuring a dry subfloor environment.

Where ventilation is substandard it is usually caused by factors such as failure to install adequate vents during construction subsequent building works or earth and vegetation covering over vents low subfloor clearance and items or debris in the subfloor restricting airflow.

Subfloor ventilation can be improved in most cases by addressing the causes such as exposing subfloor vents installing additional new vents installing mechanical (forced airflow) ventilation and removing debris from the subfloor.

A registered builder should be appointed as soon as possible to perform these works as necessary.

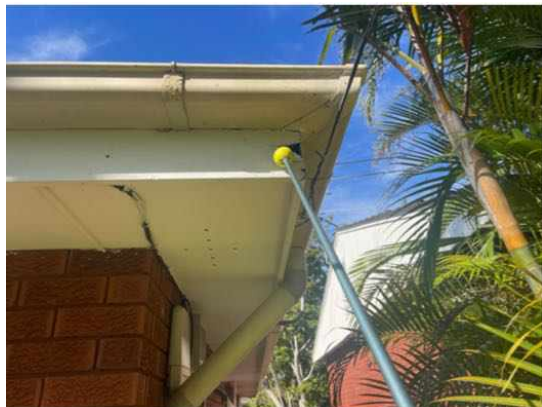
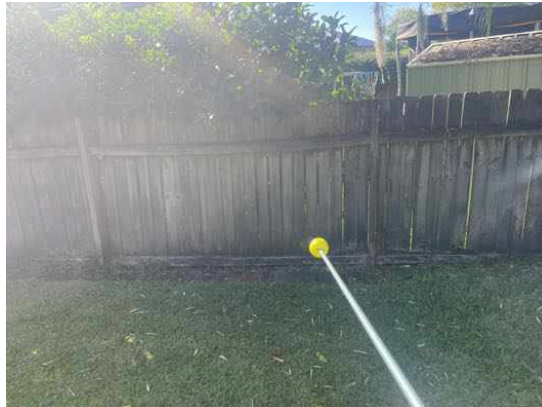
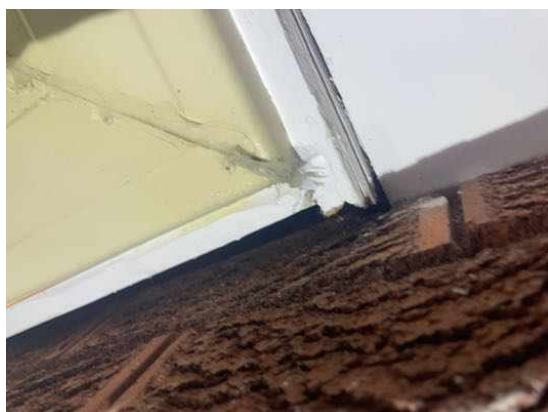
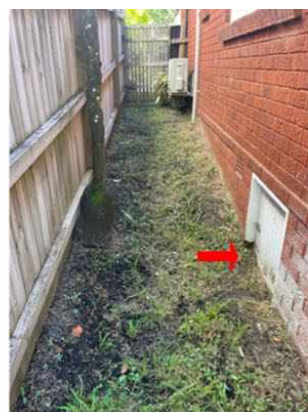
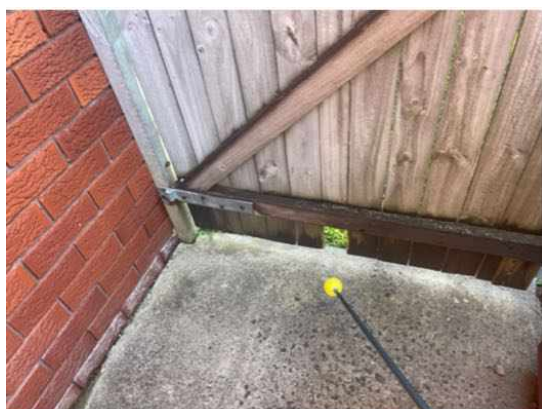
Termite and Timber Pest 7.01

Building:	Building 1
Location:	All External Areas
Finding:	Wood rot
Information:	This building element shows evidence of wood rot. Wood rot, also known as Fungal Decay, occurs when timbers and other cellulose building materials are exposed to damp conditions on an ongoing basis. This could be the result of exposure to weathering over a prolonged period of time, or the attraction of excessive moisture from other abutting building materials. Contributing factors also include poor air ventilation in the area.

Early intervention and regular maintenance, particularly of exterior timbers, will prolong the useful life of these building elements. Prior to any works being performed, the cause of the moisture that has created the visible wood rot should be identified and addressed in a suitable manner. Replacement of affected timbers may then be a necessary step in protecting surrounding building elements from such deterioration.

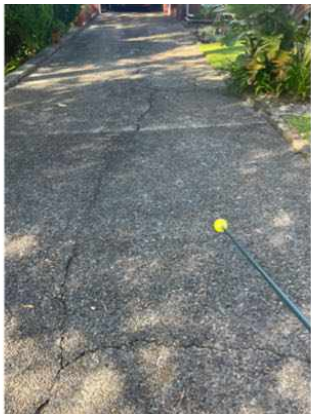
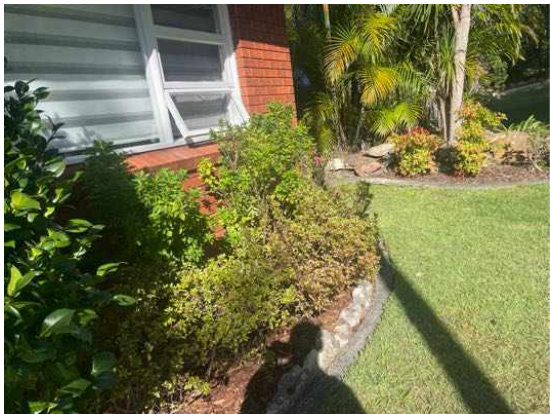
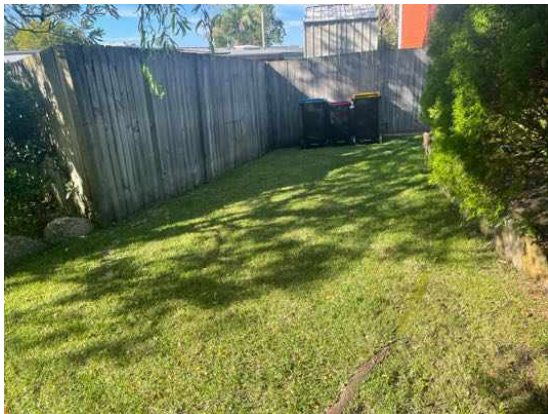
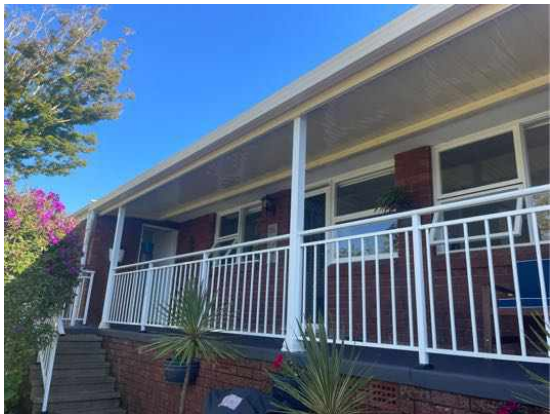
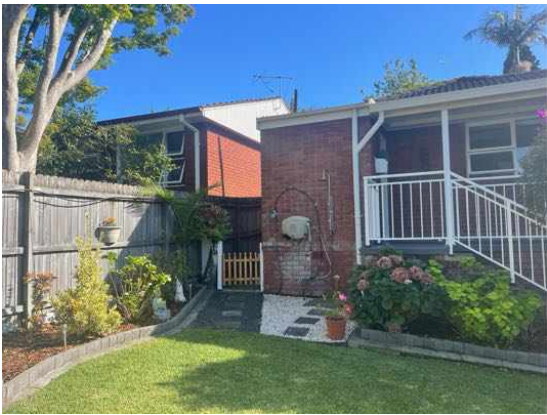
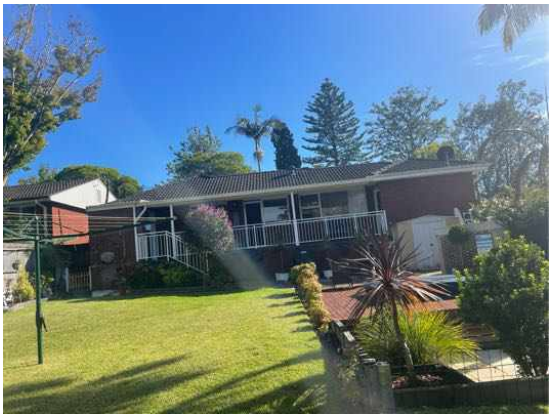
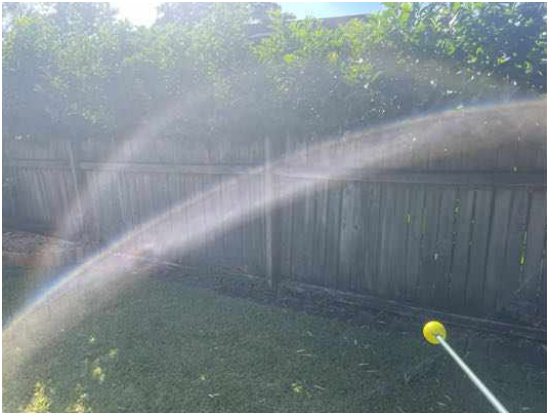
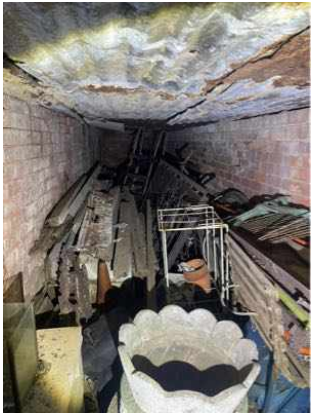
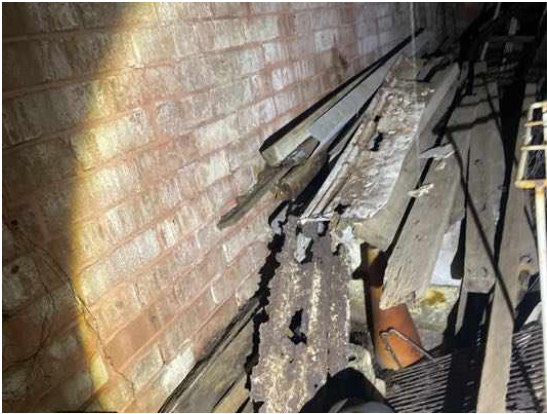
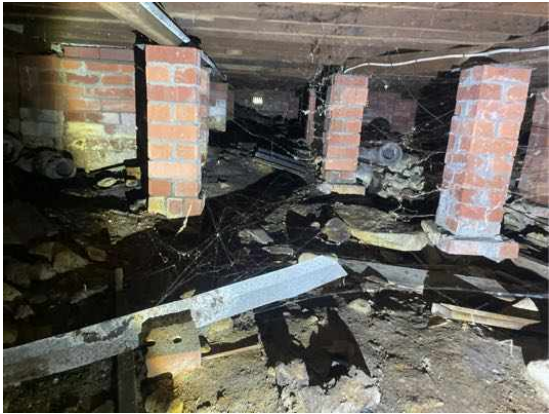
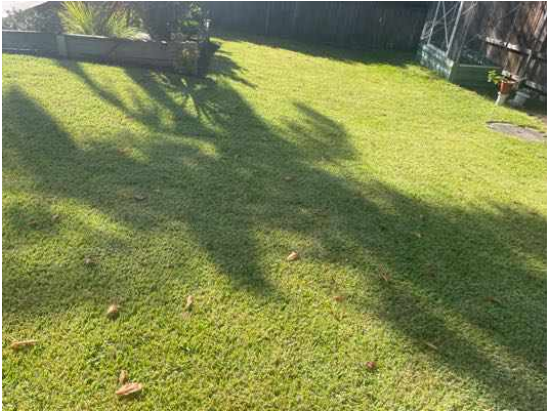
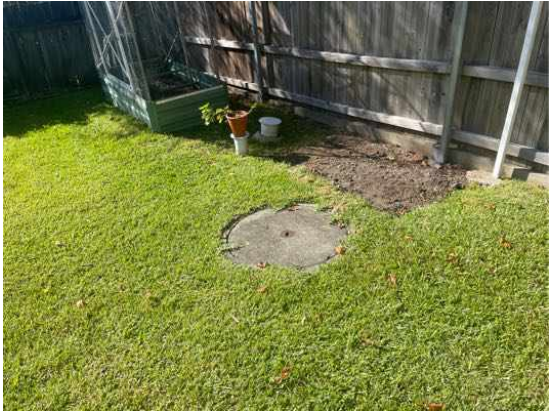
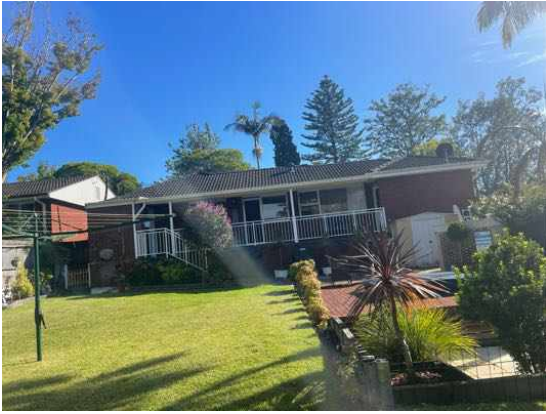
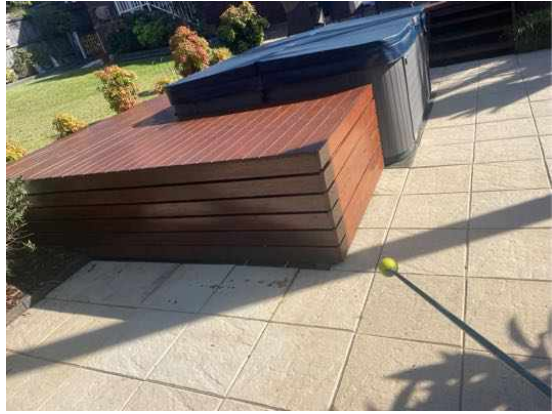
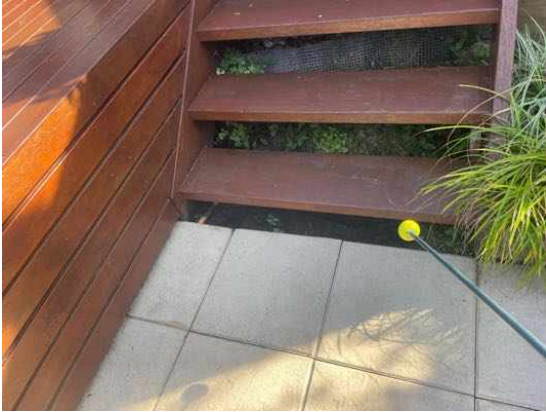
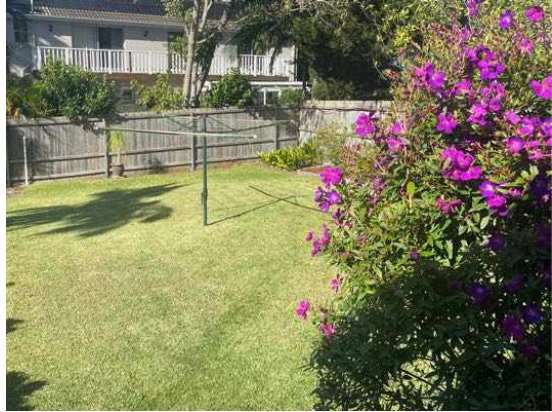
Noted Item

Building: Bungalow
Location: All Areas
Finding: Additional Photos - Obstructions and Limitations
Information: These photographs are an indication of the obstructions and limitations which impeded full inspection of the property at the time of inspection. These obstructions can hide an array of defects and should be removed to allow full inspection to be carried out. A re-inspection is recommended once the areas are made accessible.
