VISUAL BUILDING & PEST INSPECTION REPORT

Complies with Australian Standard 4349.1 & 4349.6

Inspected Property:

37 Iris Street, Frenchs Forest

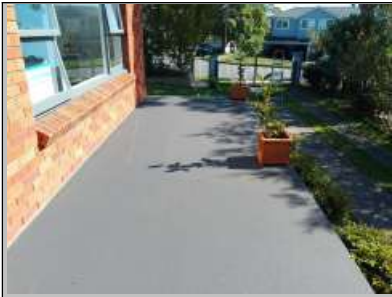
Front elevation.

Constructed from concrete or masonry. The condition of the structure is generally acceptable.

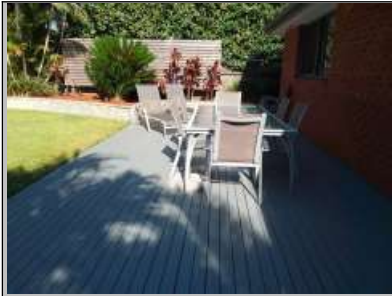
Rear elevation.

The general condition of this structure is fair.

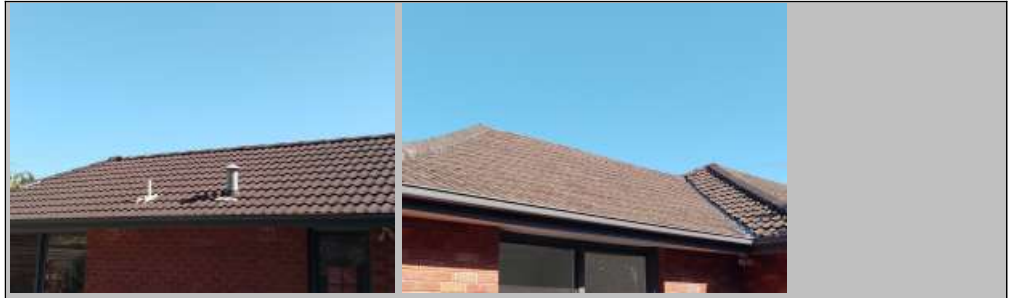
The overall condition of the roof coverings is fair. Mortar beds to the hip and ridge capping are cracked and require maintenance or re bedding and pointing in areas. Surface of the concrete tiles is deteriorating and the area requires sealing.

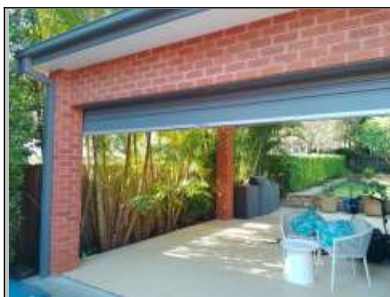
Carport.

The structure is generally in good condition.

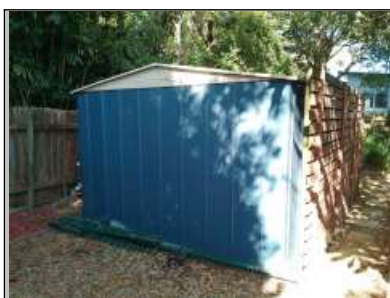
Metal garden shed.

The structure is generally in fair condition.

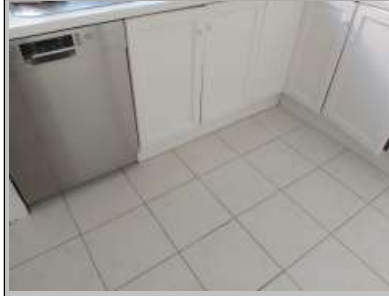
The condition of the fixtures is generally good.

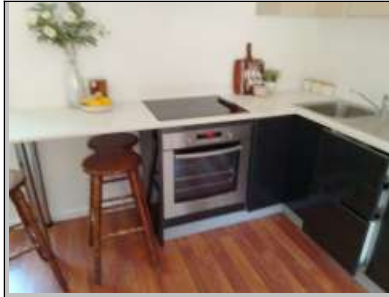
The condition of the fixtures is generally good.

Sink and taps appear in serviceable condition. Drain appears serviceable.

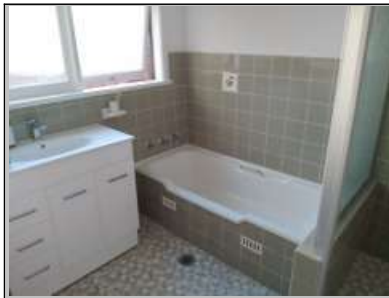
Adjacent to hall.

The shower recess was tested and there was no visible water penetration to surrounding areas. IMPORTANT NOTE: This test may not reveal water leaks until the shower is put into constant use and surrounding areas monitored over a period of time.

The condition of the tiles is generally fair.

The condition of the vanity unit is generally fair.

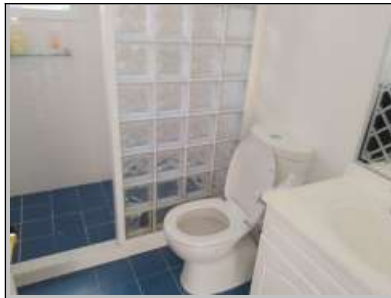
Rear.

The shower recess was tested and there was no visible water penetration to surrounding areas. IMPORTANT NOTE: This test may not reveal water leaks until the shower is put into constant use and surrounding areas monitored over a period of time.

The condition of the tiles is generally fair.

The condition of the vanity unit is generally fair.

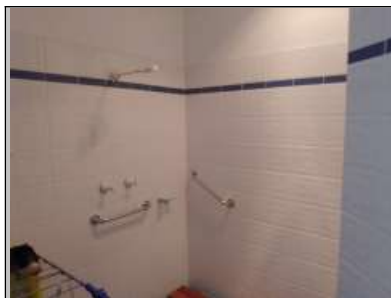
Rear.

The shower recess was not tested as there is no hob to contain the water during testing.

The condition of the tiles is generally fair. Tiles appear to have minimal fall to waste.

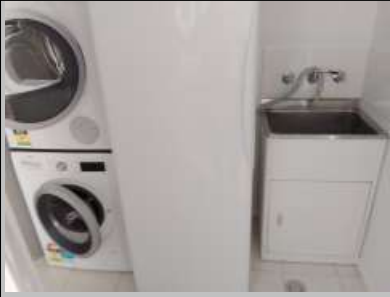
Adjacent to the kitchen.

The tub and taps appear serviceable. Drain appears serviceable.

The condition of the tiles is generally good.

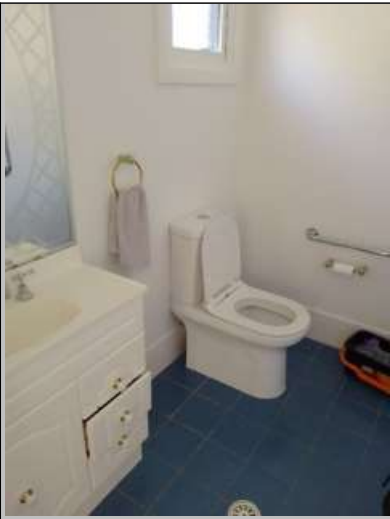
Rear.

The toilet appears to be in working order.

The condition of the vanity unit is generally fair.

The condition of the tiles is generally fair.

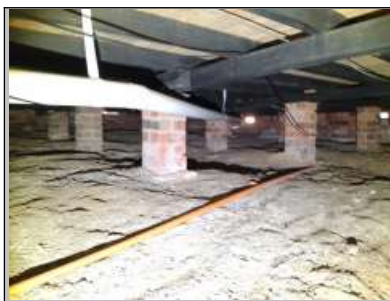
The building is constructed on a combination of strip footings, piers and concrete slab. The footings appear to be generally sound.

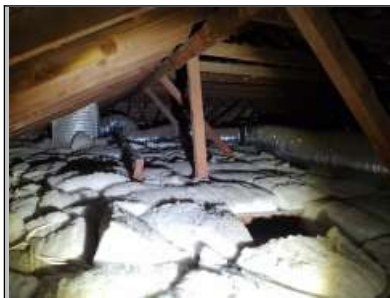
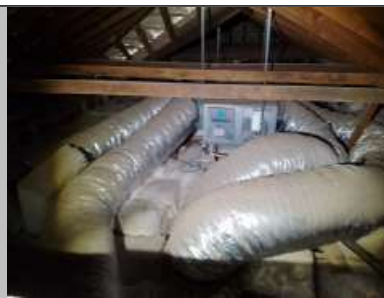
Insulation is present in the roof cavity. This restricted inspection to some roofing timbers. Removal of insulation is not within the scope of a standard visual inspection report, however as in accordance with "industry best standard" the inspector will lift insulation in 3 areas in roof void.

Ducting associated with air-conditioning or heating restricted inspection.

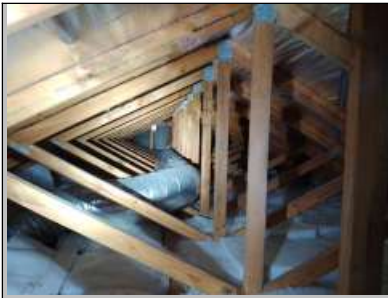
The truss and cut and pitched roof timbers appear to provide adequate support.

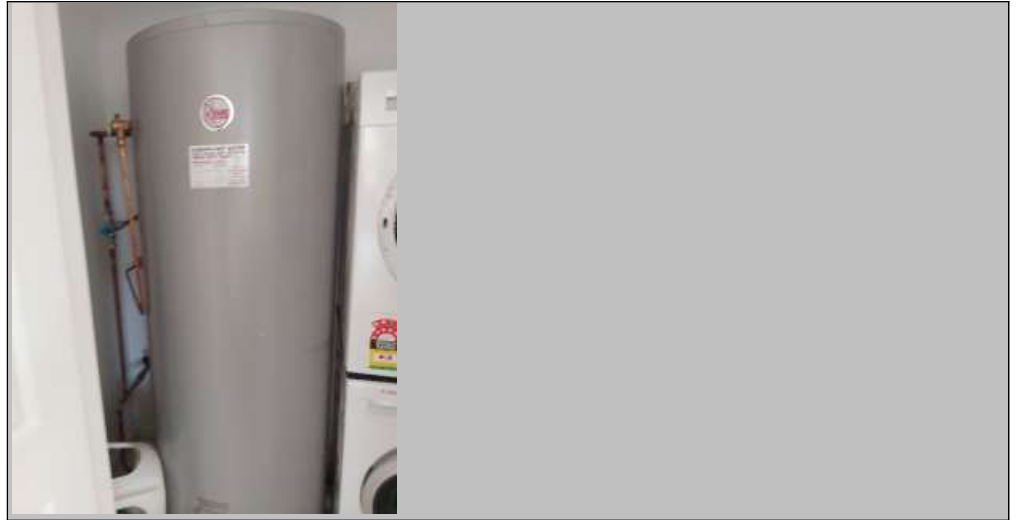
Mains electric hot water system: Mains pressure: Located in the laundry: The hot water system appears to be in working condition. No specific tests other than running the hot water tap were carried out. No determination has been made as to the suitability or adequacy of the hot water system in relation to capacity or otherwise.

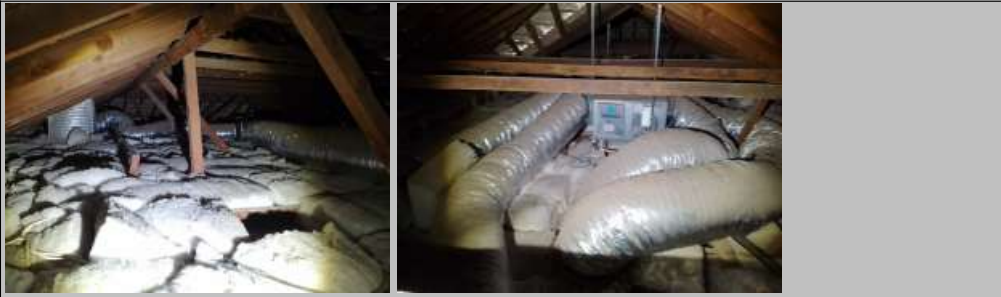
Insulation is present in the roof cavity. This restricted inspection to some roofing timbers. Removal of insulation is not within the scope of a standard visual inspection report, however as in accordance with "industry best standard" the inspector will lift insulation in 3 areas in roof void.

Ducting associated with air-conditioning or heating restricted inspection.
