Building and Timber Pest Inspection Report

Inspection Date: Wed, 10 Feb 2021

Property Address: 34 Romford Rd, Frenchs Forest NSW 2086, Australia

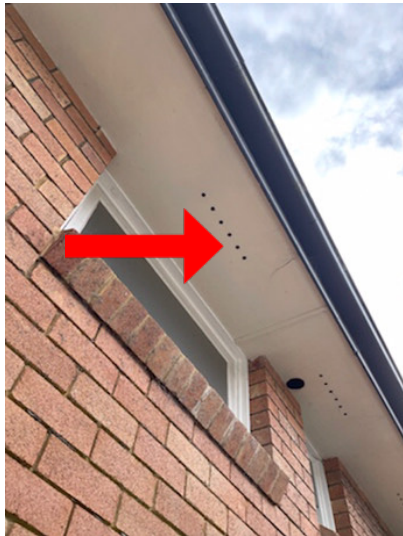
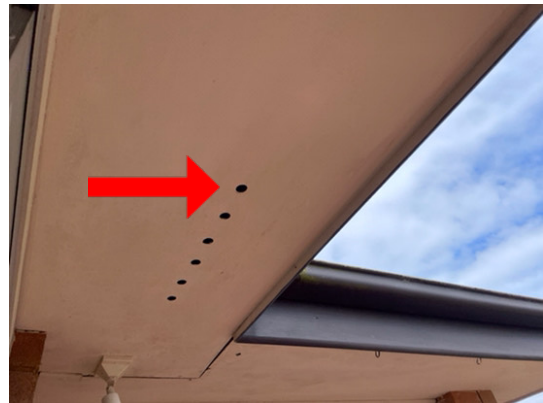
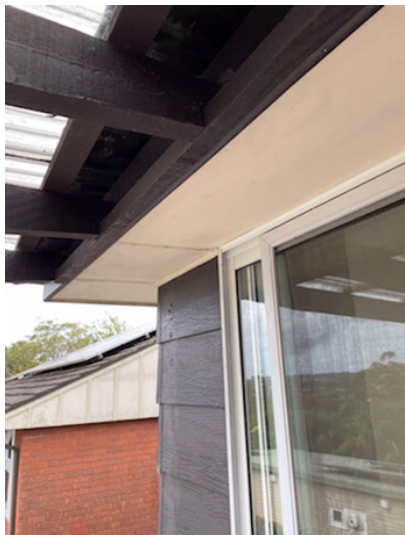
Finding 1.01

Building: Building 1
Location: All Areas
Finding: Asbestos - Suspected ACM Identified on Site
Information: Reporting on Asbestos is outside the Scope of this Report. This suspected defect is highlighted as a caution only. We suspect, based on our experience in the building industry, that there is a higher risk of the identified building element containing asbestos.

As Asbestos Reporting is outside the scope of this report, we advise that you consider a separate Asbestos Inspection and Condition Audit, which can include the taking of samples for definitive confirmation of the presence of Asbestos.

In the interim, the client is advised to act with caution, especially when considering any damage to building materials general wear and tear renovations extensions demolition and general maintenance activities due to the suspected presence of Asbestos.

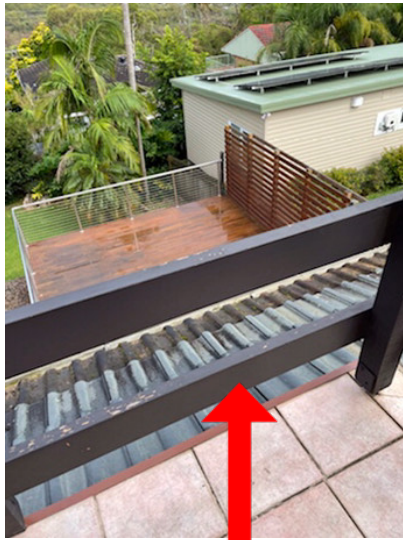
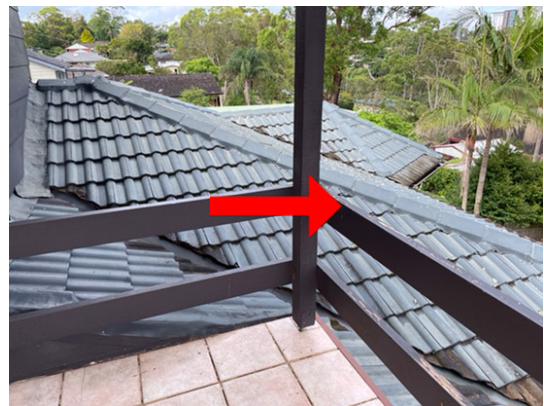
Finding 1.02

Building: Building 1
Location: Balcony
Finding: Balcony - suspected to be non compliant
Information: The balcony balustrade is suspected to be non compliant.

For further clarification please contact a Surveyor or the local council.

A builder could be appointed to provide necessary works to the balcony.

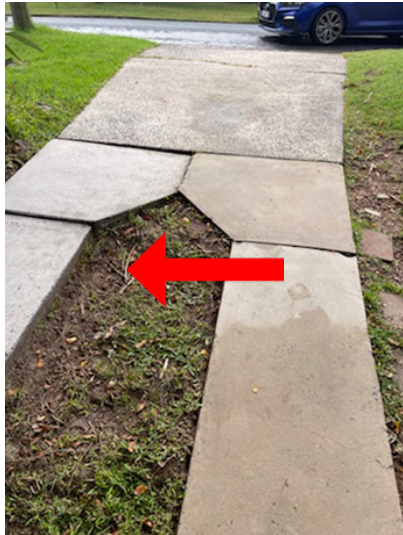
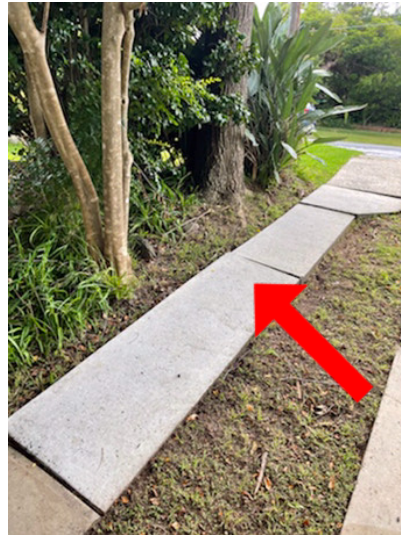
Finding 3.01

Building: Building 1
Location: Driveway
Finding: Subsidence - Local trees and vegetation
Information: Trees and other vegetation can have a significant local effect on drying of soils. Over a number of years, especially during drought conditions, adjacent trees and vegetation may draw excessive moisture from the soils. The opposite may also occur, where swelling of the soil results when the trees decline or are removed.

As the cumulative moisture deficient is reversed, the surface level around the tree.

A Builder will generally carry out works as advised by an Engineer.

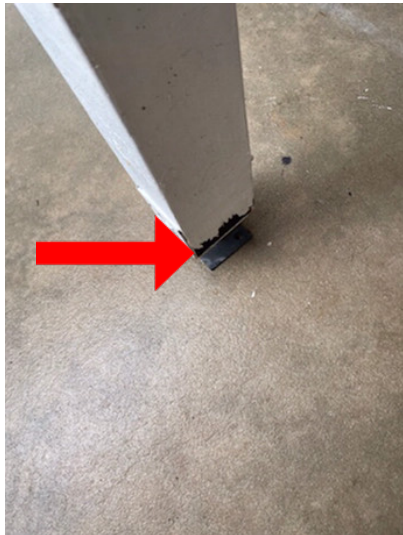
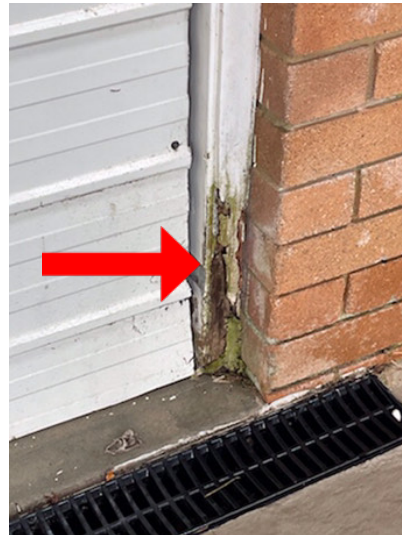
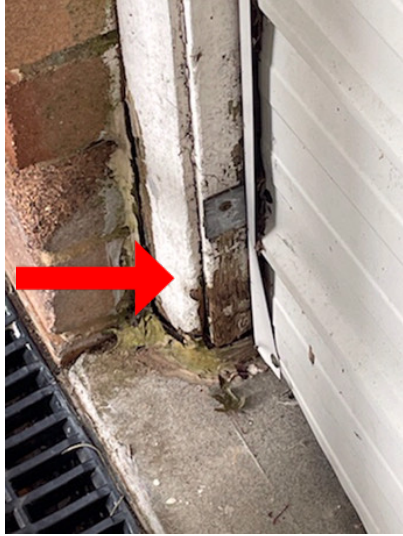
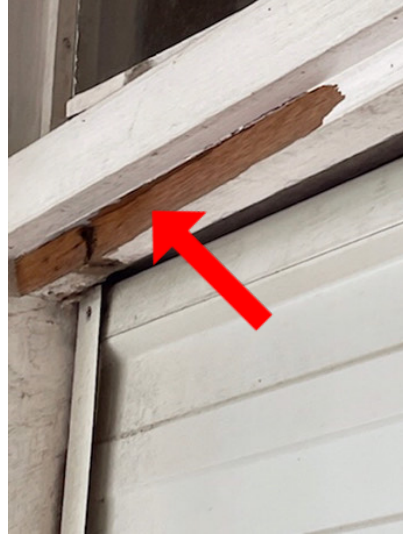
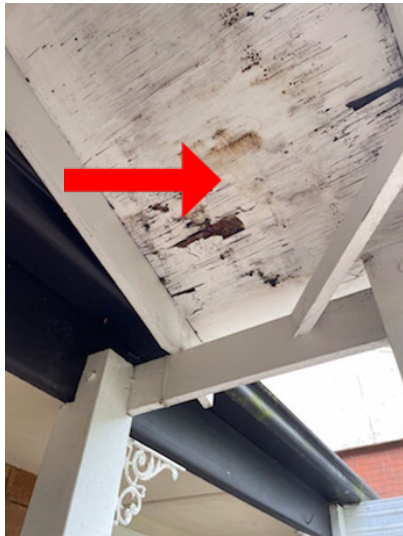
Finding 3.02

Building: Building 1
Location: Yard - Front
Finding: Wood rot
Information:

This building element shows evidence of wood rot. Wood rot, also known as Fungal Decay, occurs when timbers and other cellulose building materials are exposed to damp conditions on an ongoing basis. This could be the result of exposure to weathering over a prolonged period of time, or the attraction of excessive moisture from other abutting building materials.

Early intervention and regular maintenance, particularly of exterior timbers, will prolong the useful life of these building elements. Prior to any works being performed, the cause of the moisture that has created the visible wood rot should be identified and addressed in a suitable manner. Replacement of affected timbers may then be a necessary step in protecting surrounding building elements from such deterioration.

A qualified plumber may be appointed to assess the cause of excessive moisture and to provide advice on any remedial works as required. A qualified carpenter or registered builder may also be required to replace affected building materials.

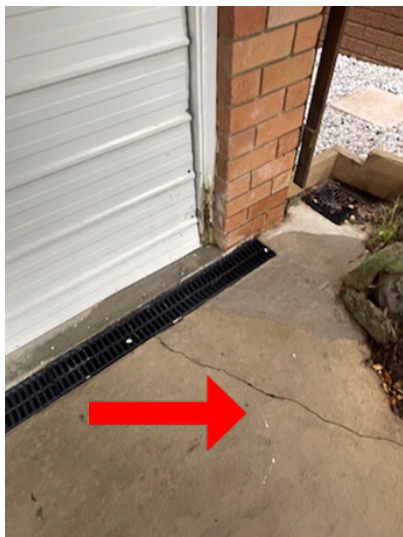
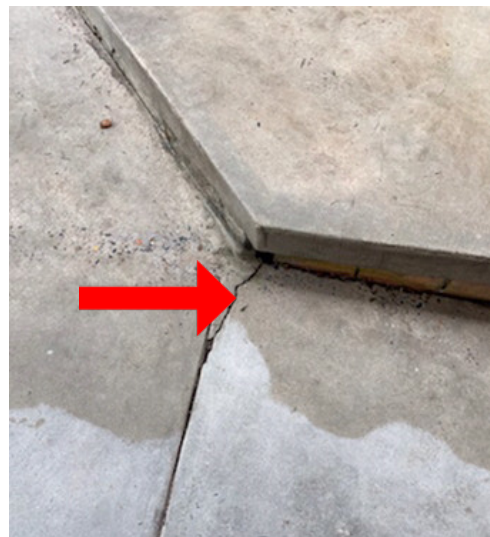
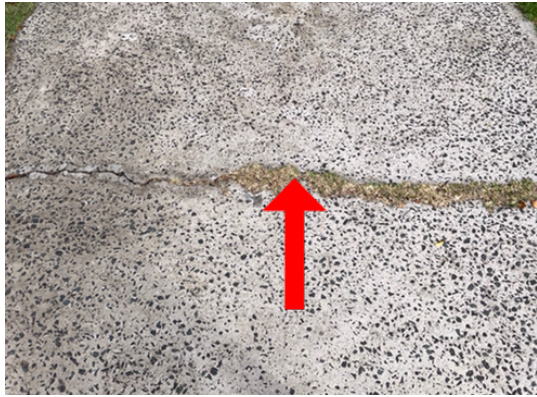
Finding 3.03

Building: Building 1
Location: Yard - Front
Finding: Cracking - External Concrete Paving Damage Category 2 - Distinct (less than 3mm)
Information: Distinct cracks were identified in external concrete paving. Distinct cracks are generally found in older concrete paving, and may also present as a trip hazard as consequence of an uneven or curved surface.

General age and expected deterioration of the paved areas is a common cause of this type of cracking. However, expansion and contraction of the slab may also have occurred due to environmental factors. Such factors include variable moisture and weather conditions, the presence of trees and their roots having a settling or lifting affect on the soil, or the effect of load bearing, e.g. heavy vehicles over a sustained period of time.

Cracking to this degree may also be due to poor original installation of the concrete. Factors such as poor compaction of the sub surface and/or inadequate reinforcing of the slab may create cracking and other secondary defects.

Repairs are likely to be required to prevent further cracking and to reduce hazards associated with cracking, such as tripping. Monitoring of all cracking should be conducted frequently. Always contact a building inspector should cracks widen, lengthen, or become more numerous.

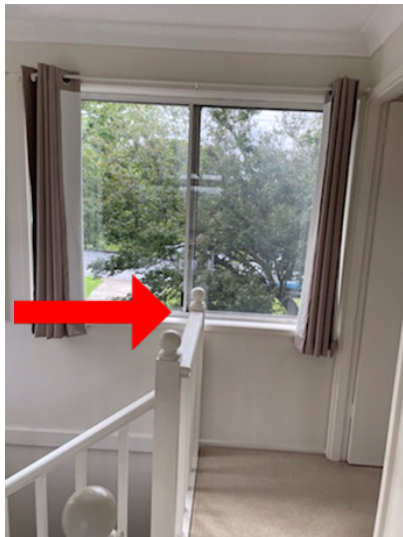
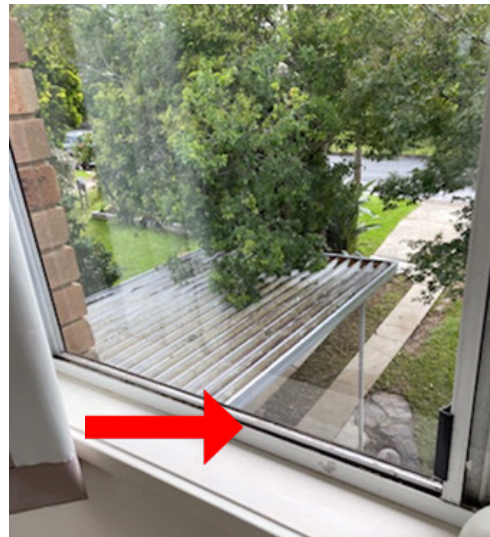
Finding 3.04

Building: Building 1
Location: All Areas
Finding: Window frames coating - deteriorated
Information: The window frames coating have deteriorated and are in a generally poor condition. Due to frequent exposure to weather conditions and subsequent moisture in a property of this condition and age.

It is recommended that all deteriorated window be replaced or repaired.

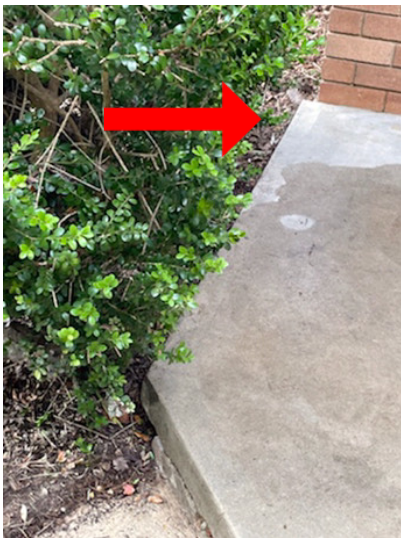
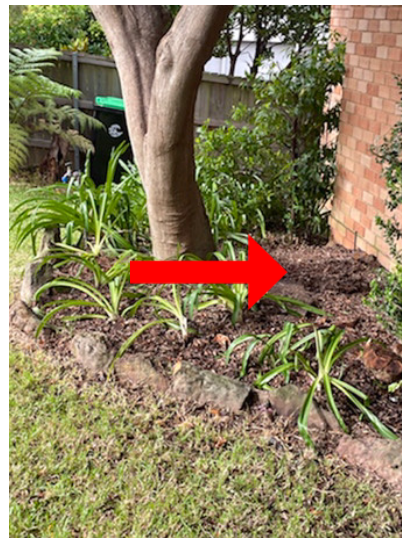
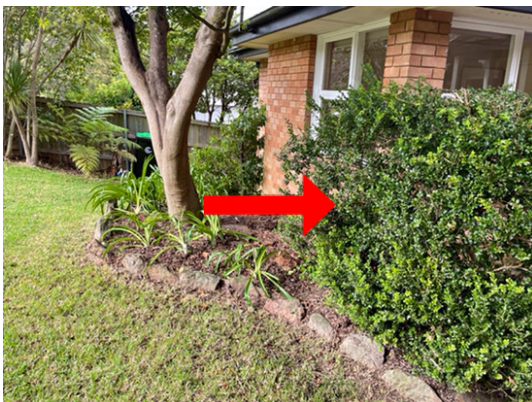
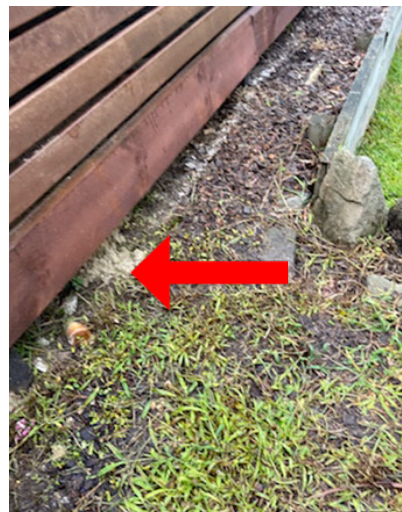
Finding 6.01

Building: Building 1
Location: All Areas
Finding: Garden Beds - Conditions Conducive to Termites
Information: Garden beds were found to be evident in the garden area. These garden beds can include untreated timber, and with a combination of moisture from watering hosing can make conditions conducive to termite activity and termite ingress.

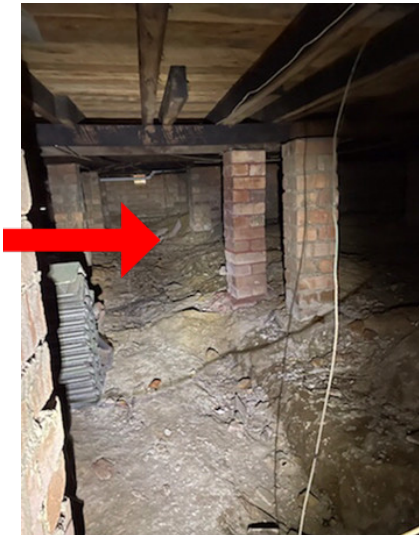
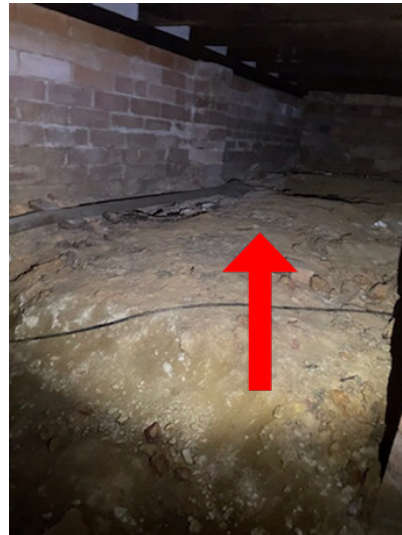
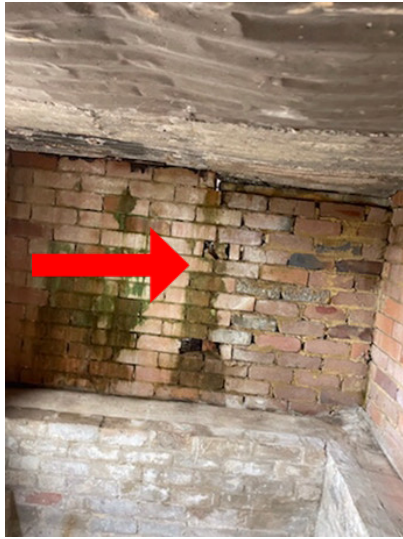
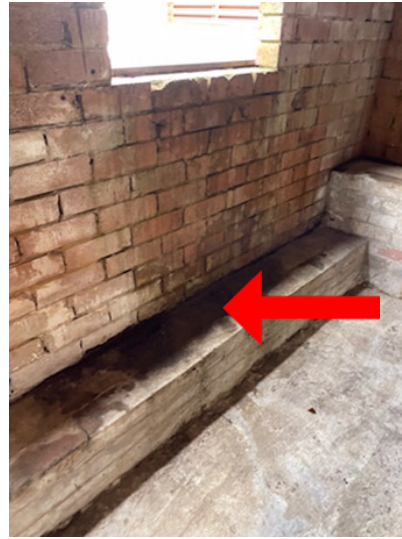
Finding 6.02

Building: Building 1
Location: Subfloor
Finding: Excessive moisture - identified
Information: Excessive moisture can attract termites and produce conditions that promote fungal growth and wood decay.

Excessive moisture is generally caused by deteriorated inadequate or missing roof drainage leaking plumbing pipes or fixtures poorly plumbed HWS overflows or condenser units and poor site drainage.

If mould growth has been found there may be environmental biological or health issues involved. In these cases an appropriately qualified inspector should also be contacted.

Prior to any remedial works being performed a qualified plumber should be appointed to further inspect the property and to identify the cause of the excessive moisture. Works to remove affected building elements may then be necessary and should be performed by an appropriate tradesperson.

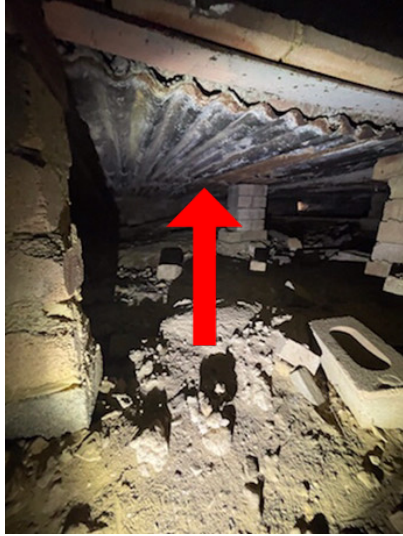
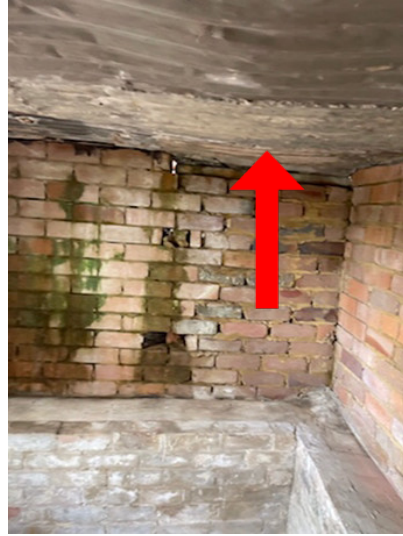
Finding 6.03

As they are likely to come into contact with weather conditions or excessive moisture wood rot is likely to develop on timbers that are not treated.

It is recommended that any formwork timbers be immediately removed from areas in which they may attract any termite / timber pest attack. Minimisation of risk / prevention of termite attack is far more adequate than dealing with the presence of termite activity.

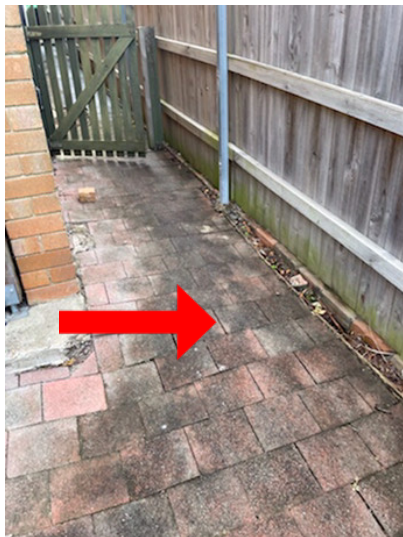
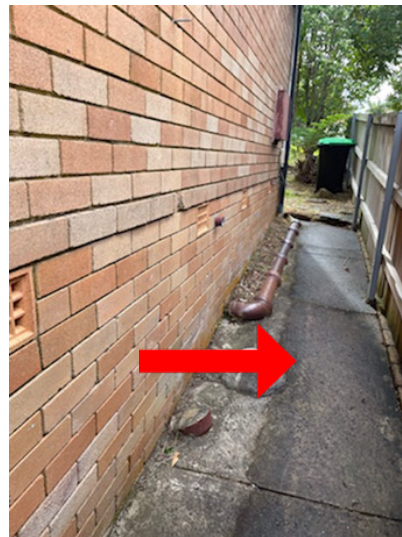
Finding 6.04

Building: Building 1
Location: Yard - Side
Finding: Site drainage - suspected Inadequate
Information: The site drainage in this area was suspected to be inadequate at the time of inspection, creating potential for subsequent water damage to associated building elements.

It is important that water does not lie against the base of walls; surrounding paths and ground levels should be sloped to drain water away from walls. Downpipes should not discharge stormwater onto lower walls or plinths. Stormwater should be carried away by large, regularly cleaned drains. Ground levels may need to be lowered to expose a buried DPC.

Where site drainage is inadequate, installation of an Agricultural (Aggie) Drain may be required. A qualified plumber should be appointed to further inspect the property and perform any remedial works as necessary. Water damage and secondary defects are likely to occur if left unmanaged.
