# Building and Timber Pest Inspection Report

Inspection Date: Thu, 12 Sep 2024

Property Address: 16 Gozo St, Schofields NSW 2762, Australia

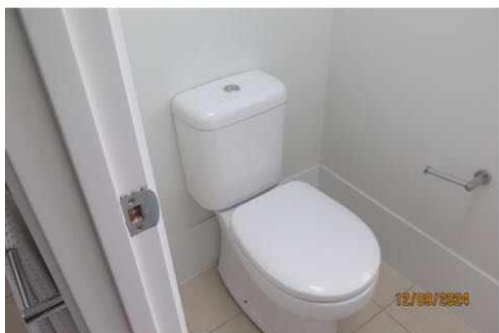
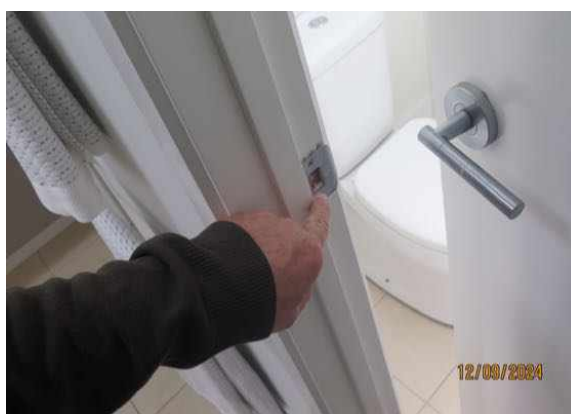
#### Finding 3.01

Building: Main Building  
 Location: Toilet (WC)  
 Finding: Door handle - Not latching  
 Information: It was noted that the door in this area was not latching during operation at the time of inspection. Whilst detracting from the functionality of this building element, this minor defect may also be a security risk, and may therefore have serious implications if left unattended.

It is suspected that this defect has occurred due to minor issues with the associated hinges. Such damage is identified as general wear and tear, which is expected for building elements of this age.

A qualified carpenter or general handyperson may be appointed to perform rectification works as necessary, at client discretion. If left unattended, further functional impairment is likely to occur.

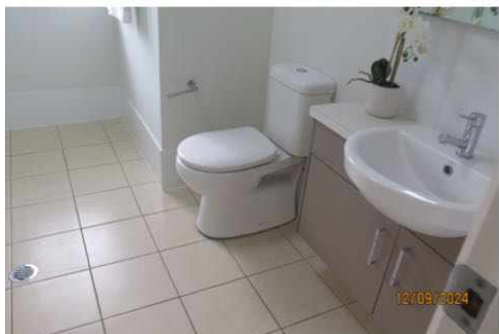
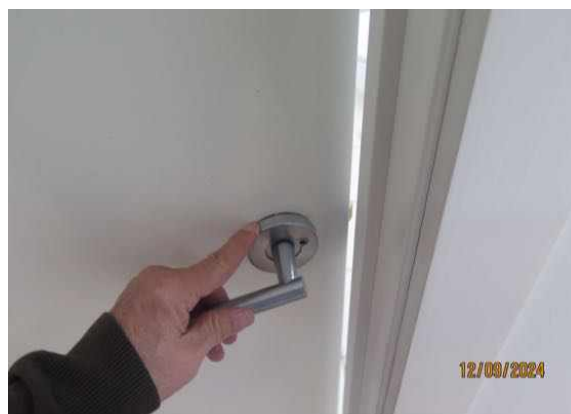
#### Finding 3.02

Building: Main Building  
 Location: Bathroom

Finding: Door lock - Loose  
 Information: The fitting in this area is loose and requires adjustment to tighten.

If left unmanaged, the fitting may further deteriorate, causing potential for the development of other minor secondary defects.

A relevant tradesperson should be appointed to perform these rectification works at discretion of the client.

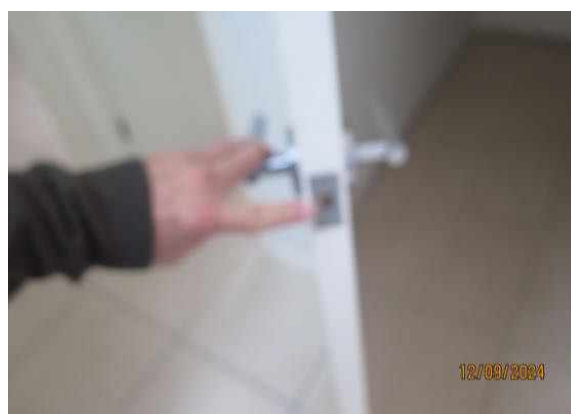
### Finding 3.03

Building: Main Building  
 Location: Toilet (WC) - 2  
 Finding: Lock - Not operating  
 Information: Non-operational items should be addressed to ensure that the full function of the building structure is available. Where some building elements are not operating as intended, it is possible that secondary building defects could arise due to their non-operation.

Repair and/or replacement of the faulty building element is recommended. It is highly recommended that the relevant tradesperson be engaged to perform any necessary works.
