Timber Pest Inspection Report

32 Greygum Avenue, Rouse Hill, NSW 2155
Inspection prepared for: Wen Yuan Rui
Real Estate Agent: Mandeep Singh - Urban Land Housing - Box Hill

Date of Inspection: 15/8/2023 Time: 10:00AM
Weather: Sunny, 13C

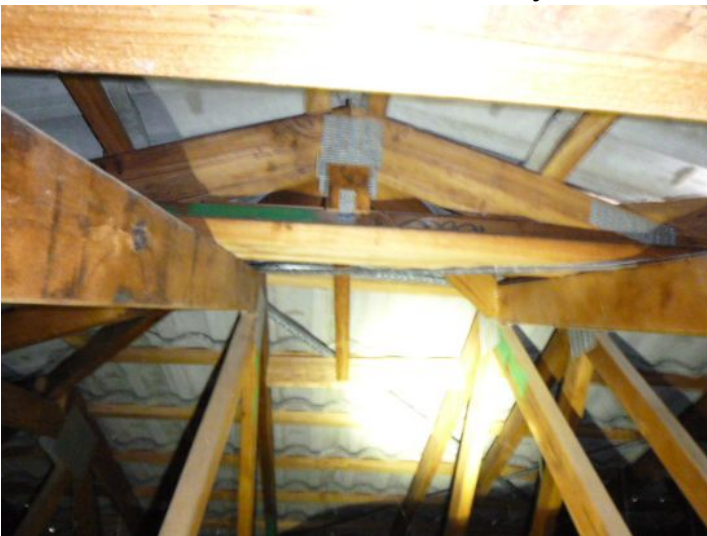
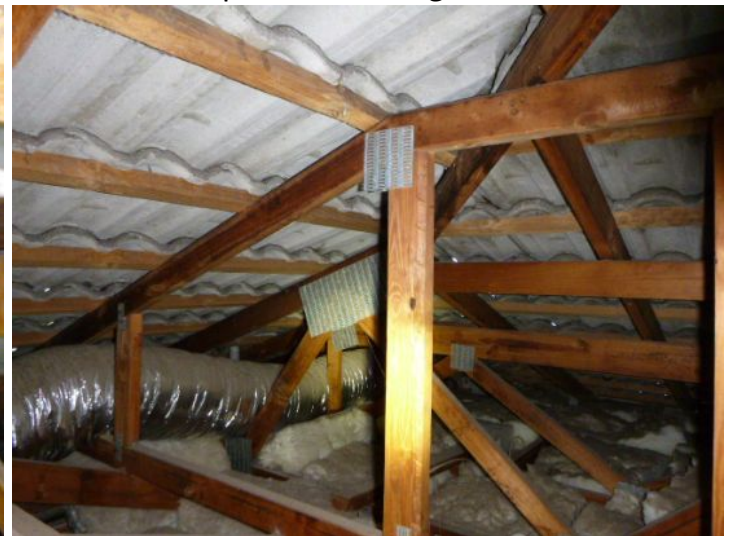
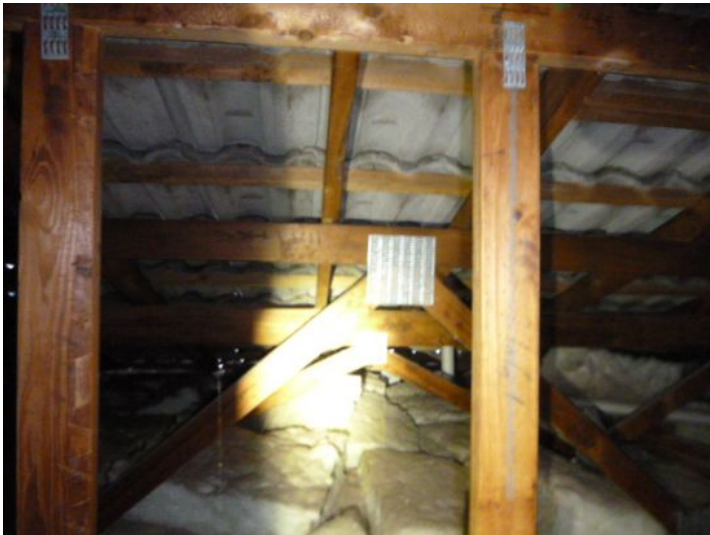
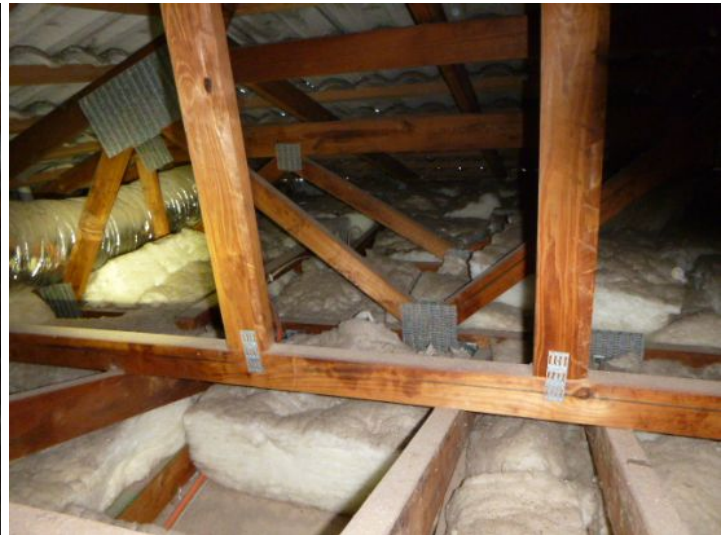
- Access was available through a manhole in the main bedroom WIR.
- Due to the roof structure configuration some areas of the roof space were inaccessible and restricted from view.
- Due to space constraints the inspection of the internal roof space was undertaken from the manhole.
- Limited visibility and access due to insulation, pitch and ducting.

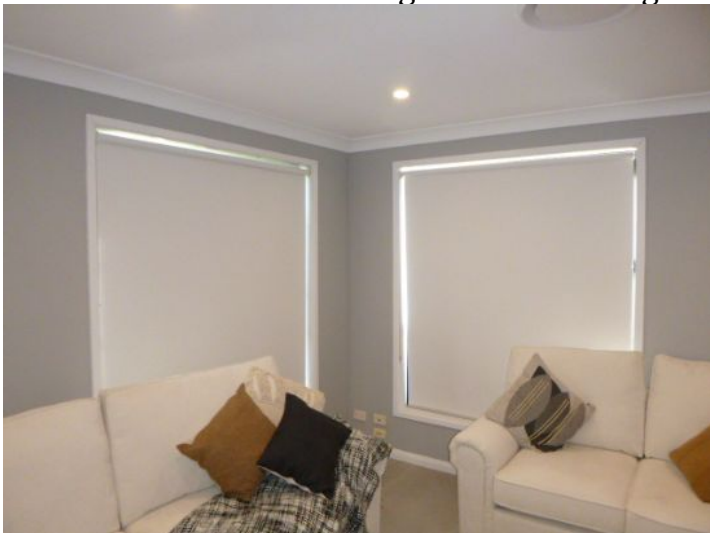
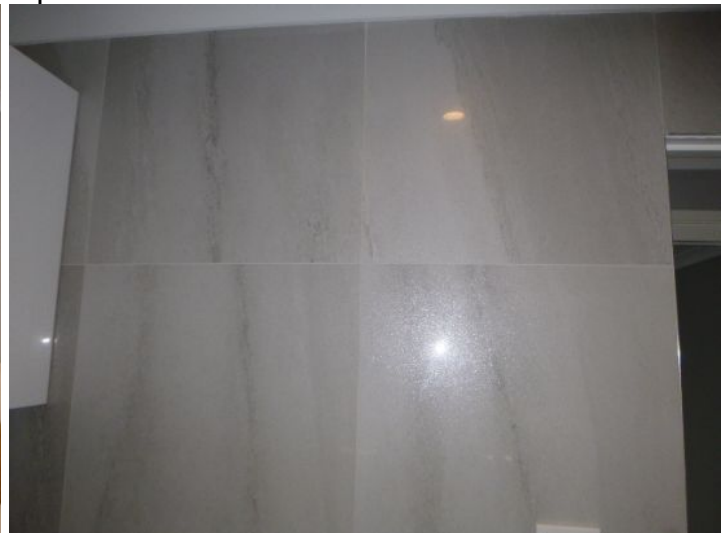
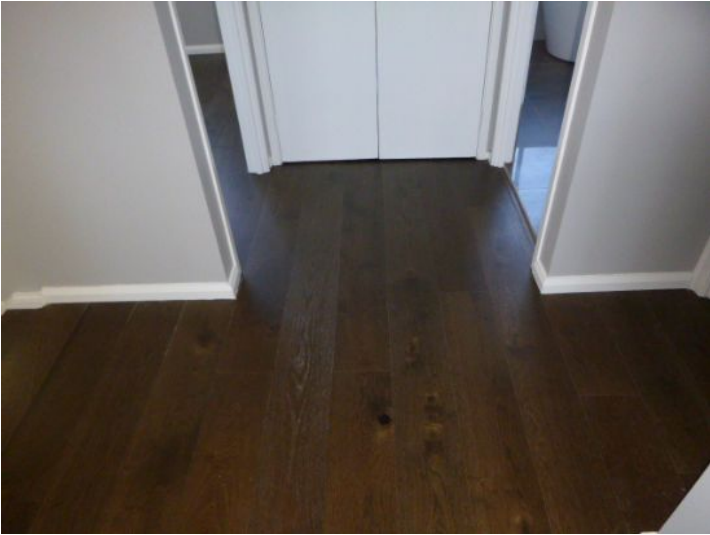
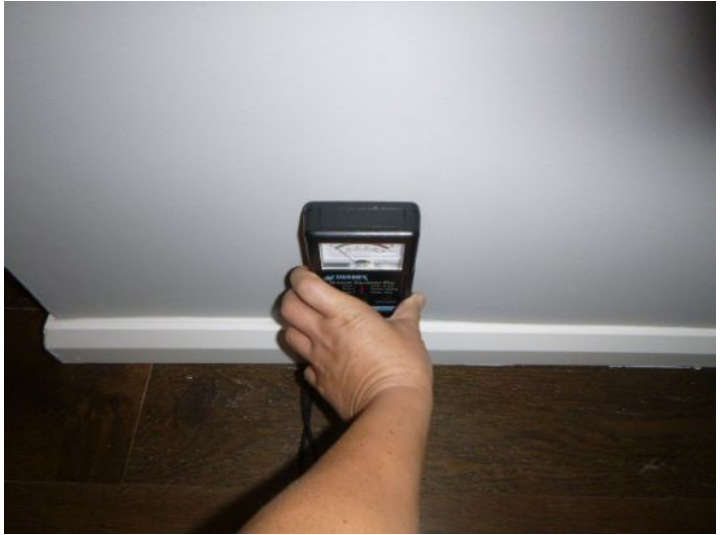
- Plasterboard/gyprock walls noted which appeared functional where visible.
- Tiled walls noted which appeared functional.
- Some areas not accessible due to stored items.

- Timber skirting and door frames appear functional.
- The moisture meter indicated low moisture level along the perimeter interior walls at the time of inspection. No bubbling/peeling paint, or excessive staining/moisture damage was noted during the inspection.

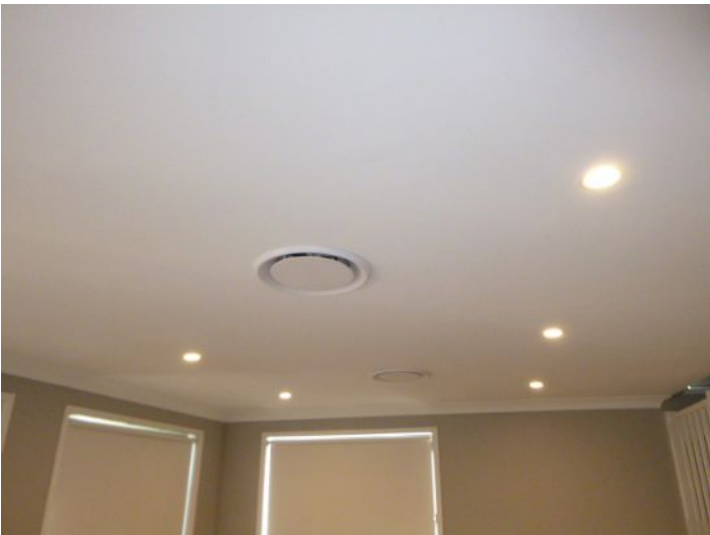
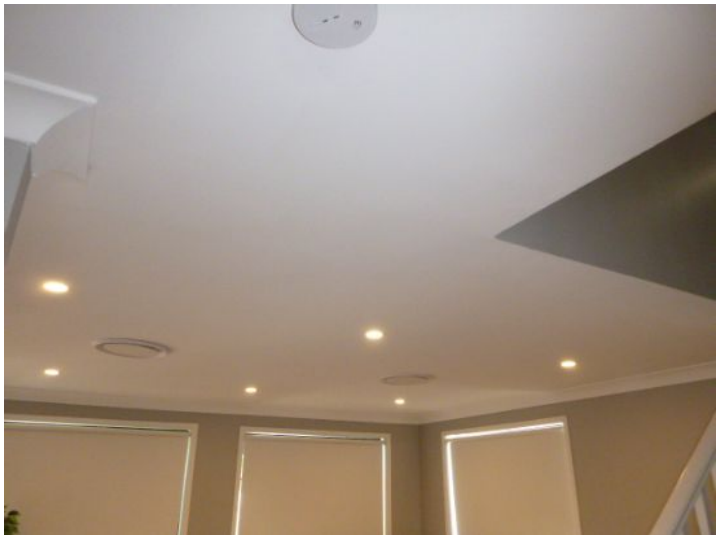
- There are plasterboard/gyprock ceilings in the property which appear functional at the time of inspection.

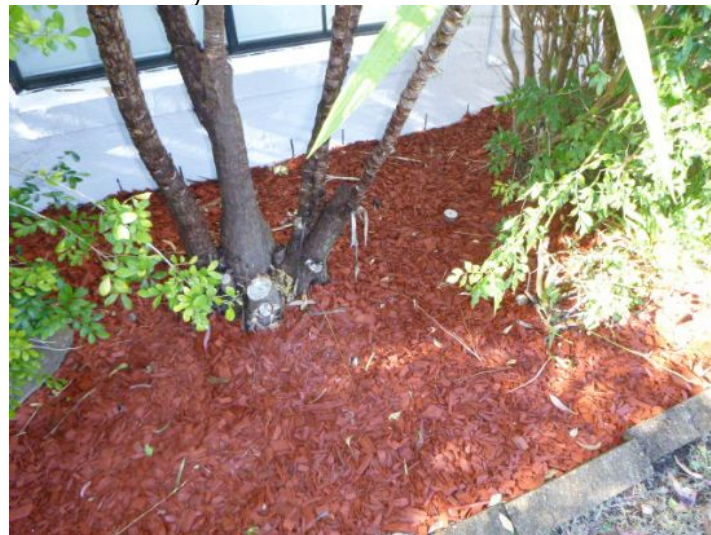
- There is landscaping/stored timber, or old tree stumps in contact with the ground that provides possible breeding grounds for subterranean termites. Monitor this area for termite activity in the future.

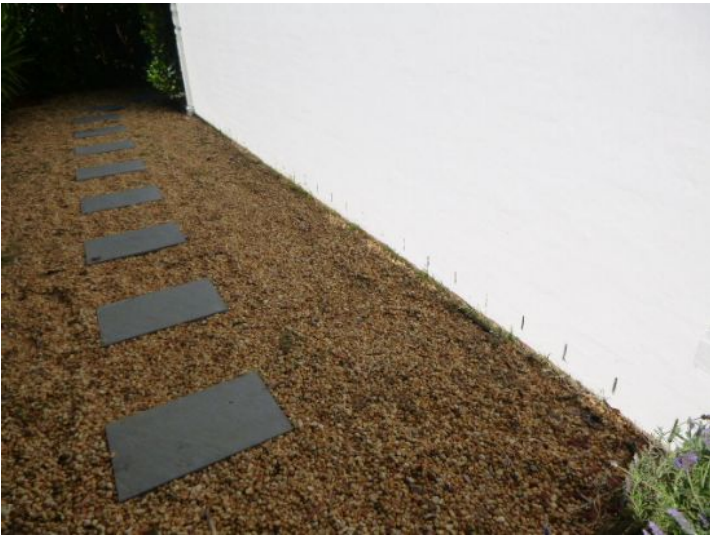
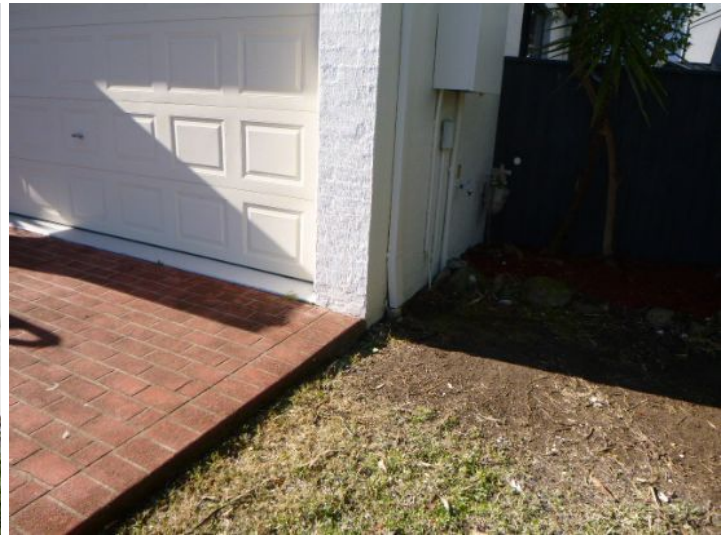
- There appears to be a small opening in the downpipe joints along the side of the property. Maintenance is required. Dampness provides a conducive environment for timber pest attack.

- The hot water system overflow pipe discharges on the foundations. This should ideally be directed into the stormwater drain or at least 3 metres away from the building. Dampness provides a conducive environment for timber pest attack.

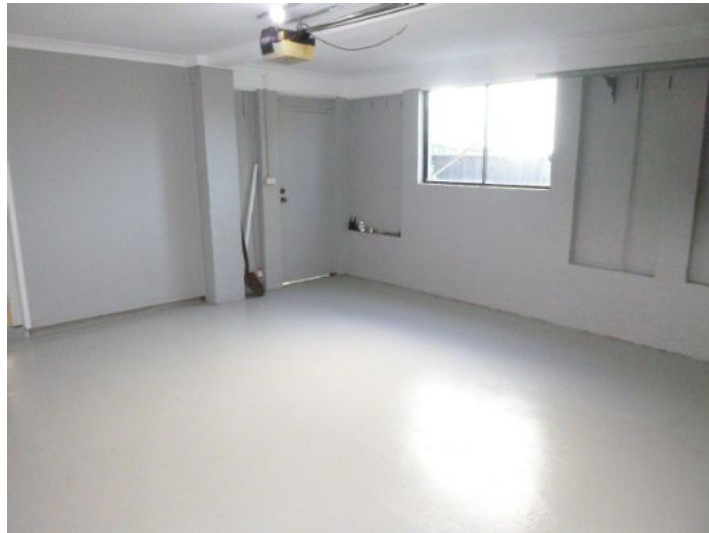
- Often the gap between the slab in the garage and the slab for the home can be a susceptible area for attack. Monitor this area for termite activity in the future.

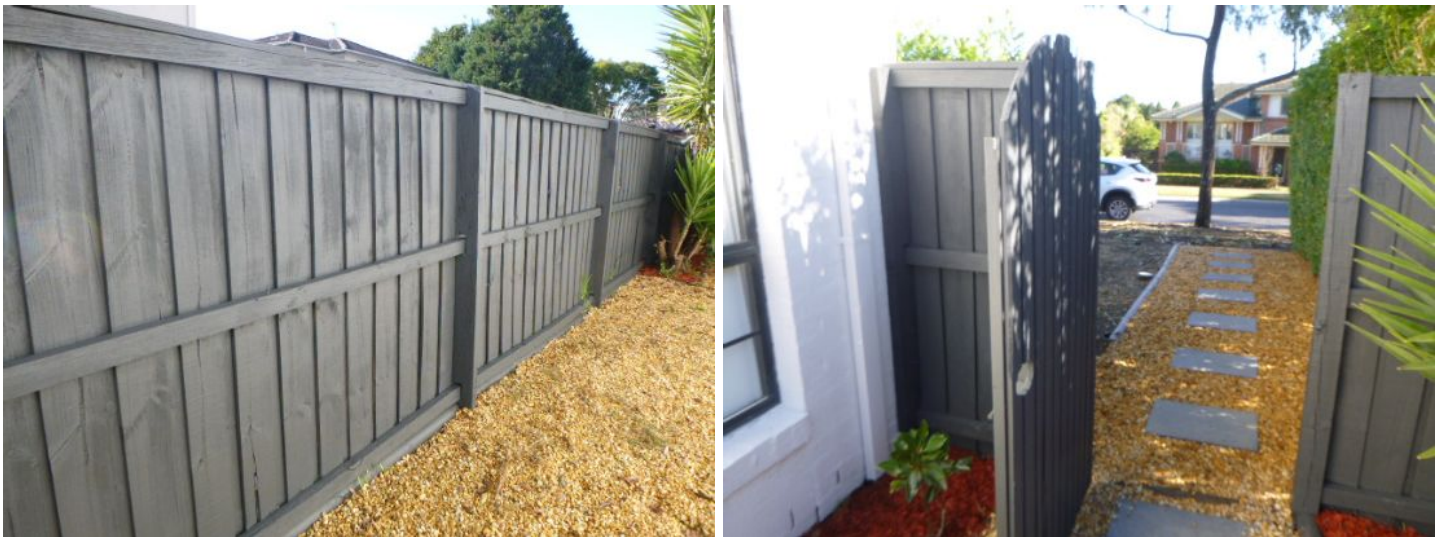
- Wood decay/ fungus was detected in the timber fence.

- Minor wood deterioration observed. Suggest repairs as needed at some point.
- The fence/gate is contact with the ground which may allow termite access to the structure. It is recommended that the fence/gate should be isolated from attaching to the property, or the soil under and next to the fence/gate should be treated. Monitor this area for termite activity in the future.

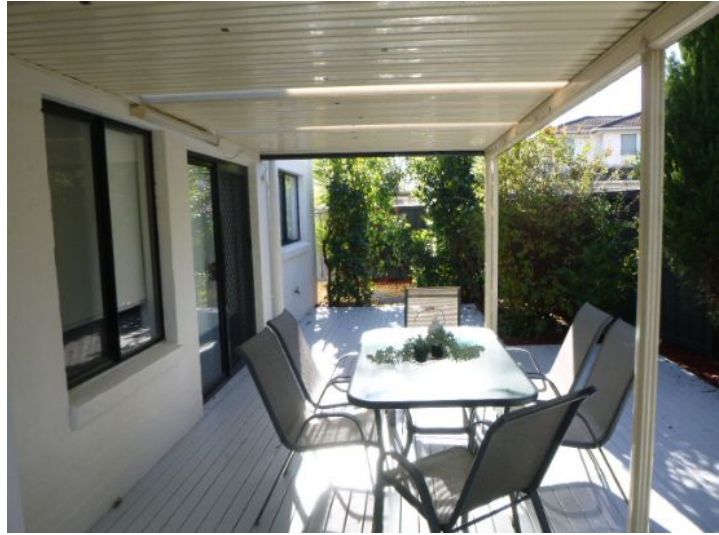
- The patio/pergola is contact with the ground which may allow termite access to the structure. Monitor this area for termite activity in the future.

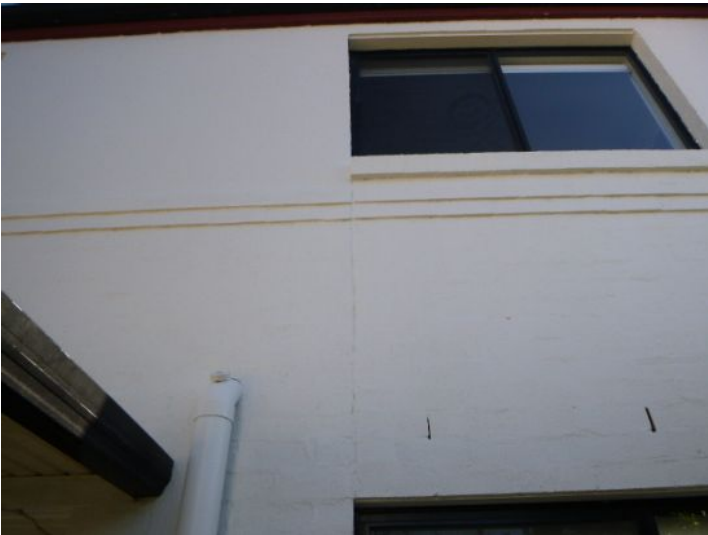
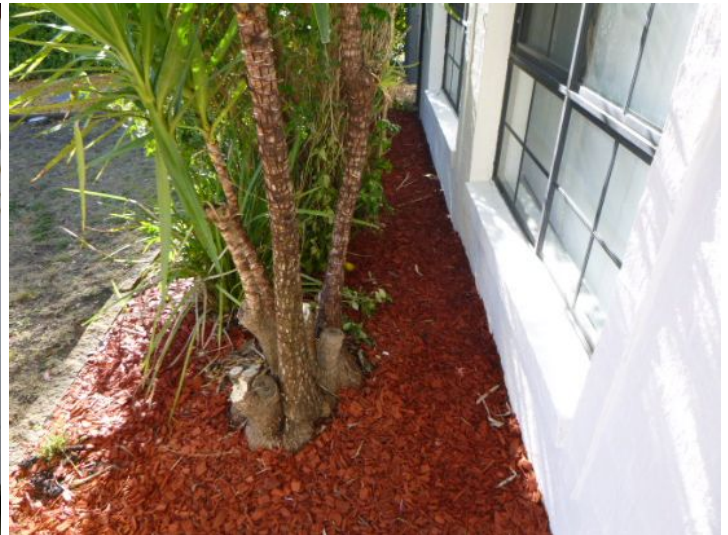
- There are garden beds which are abutting external walls. This can result in water moisture affecting the structure over time. It is recommended that either the beds be removed or a water barrier be place between the flower bed and the external walls. If these beds are retained it is important that any watering is directed away from the building and kept to an absolute minimum and is controlled. These are risk area for termite activity.

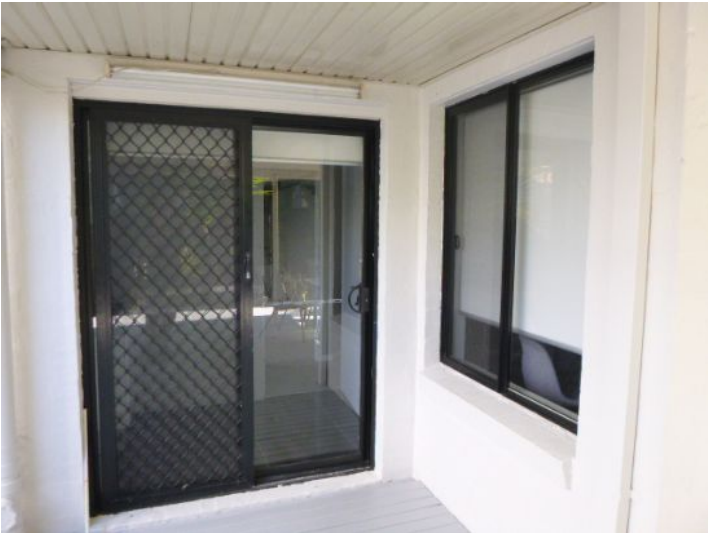
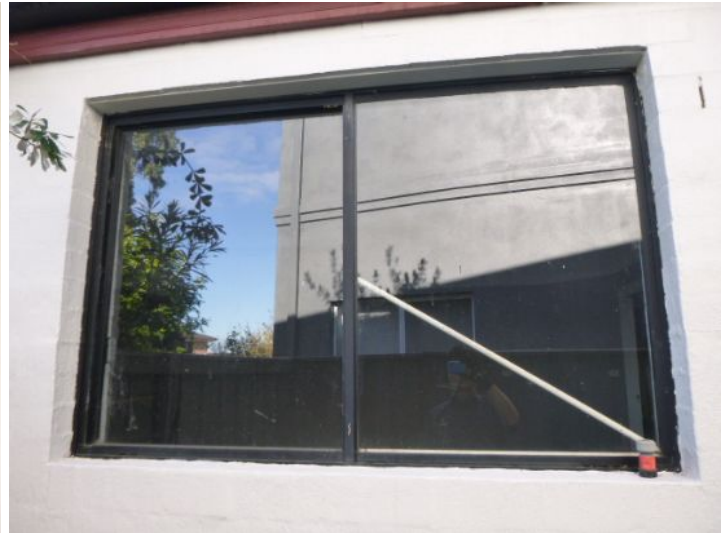
- Ensure all windows gaps are sealed, and all seals are well maintained to prevent water intrusion.
