## Building Inspection Report

Inspection Date: Thu, 25 May 2023

Property Address: 8 Dresden Ave, Beacon Hill NSW 2100,  
Australia

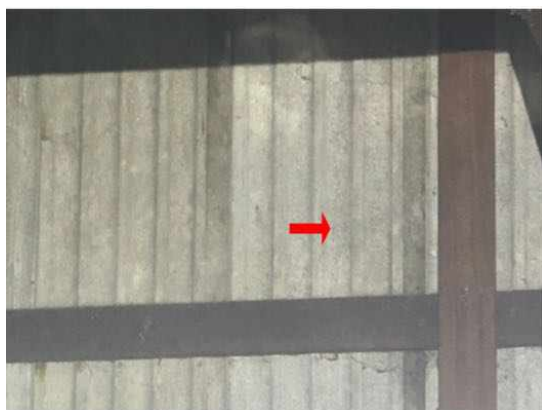
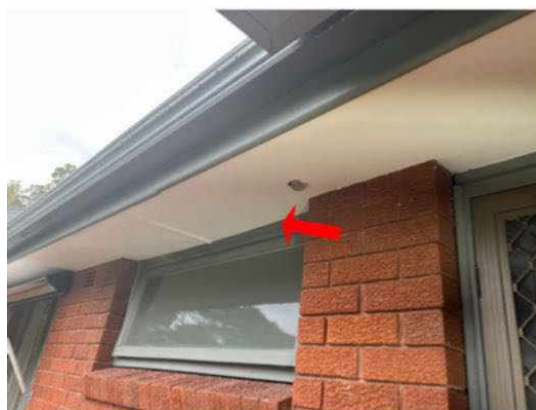
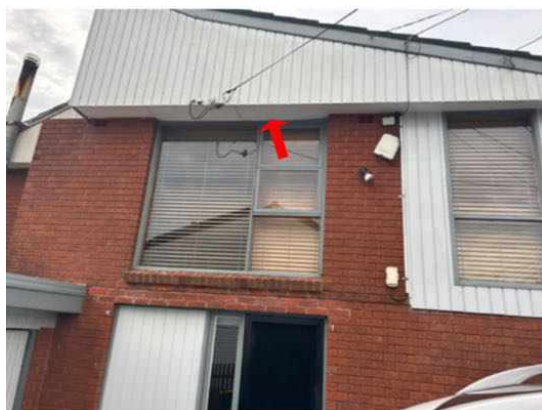
#### Defects 1.01

The material appears to have no obvious signs of damage or deterioration, indicating that the asbestos is currently encapsulated and contained.

Removal by a Licensed Asbestos Removal firm would be recommended.

No works should be carried out to the ACM or associated building elements without further specialist advice. Furthermore, areas with suspected ACMs should be avoided by all persons to minimise potential for health safety risk.

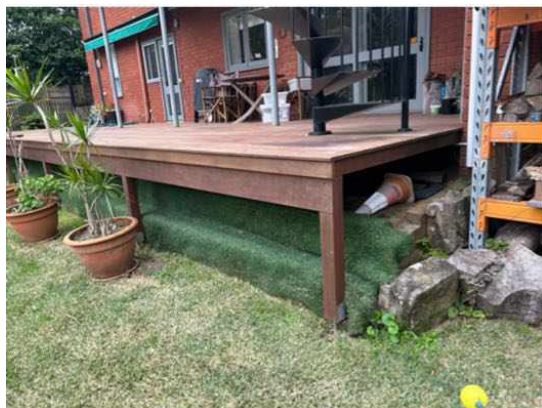
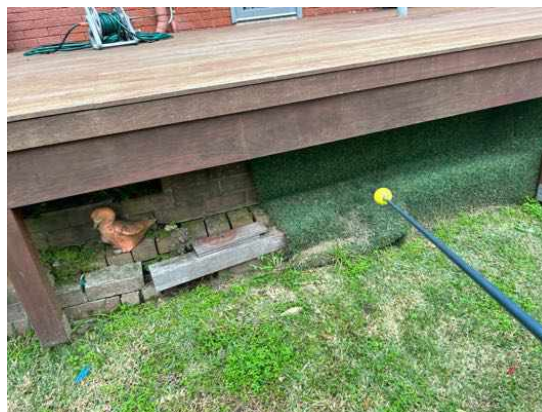
## Defects 1.02

Building: Building 1  
 Location: Yard - Back  
 Finding: Balustrade - Suspected Non-Compliance (fall distance)  
 Information: A balustrade or barrier is required whenever there is a "fall distance" of over 1m (where there is a difference of 1m or more between the floor and platform height).

This defect creates a potential safety hazard and should be rectified as soon as possible to ensure the safety of the area and to meet present building standards and regulations.

A builder/ carpenter should be contacted to discuss possible rectification solutions.

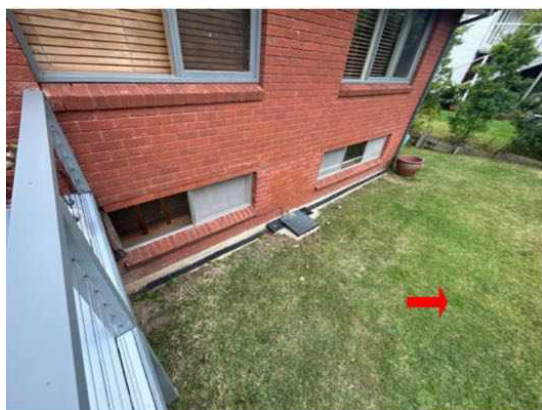
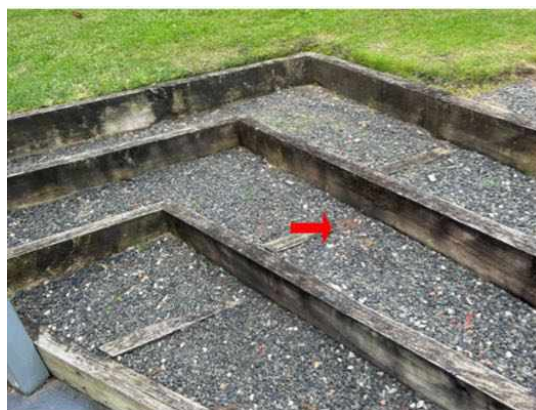
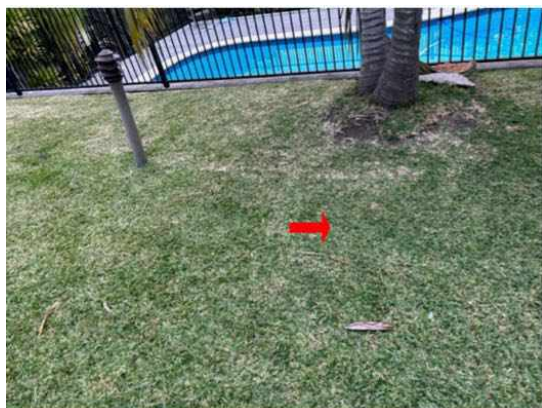
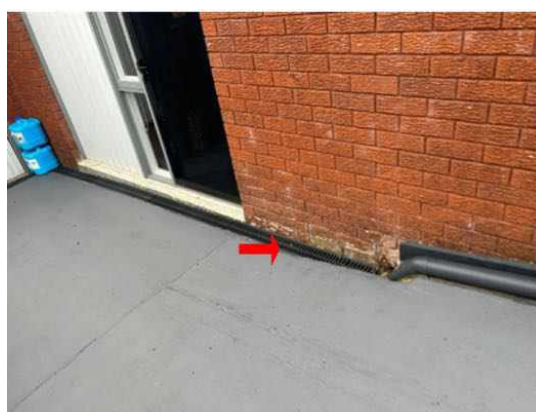
### Defects 3.01

Building:	Building 1
Location:	All Areas
Finding:	Evidence of excessive moisture was present at the time of inspection
Information:	Excessive moisture can attract termites and produce conditions that promote termite attack fungal growth and wood decay.

Excessive moisture is generally caused by deteriorated inadequate or missing roof drainage leaking plumbing pipes or fixtures poorly plumbed HWS overflows or condenser units and poor site drainage.

It is recommended that all plumbing and drainage fixtures and fittings be maintained regularly in order to prevent excessive moisture being present in the external / internal property.

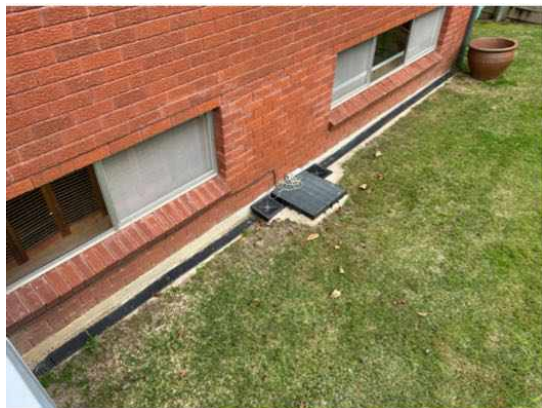
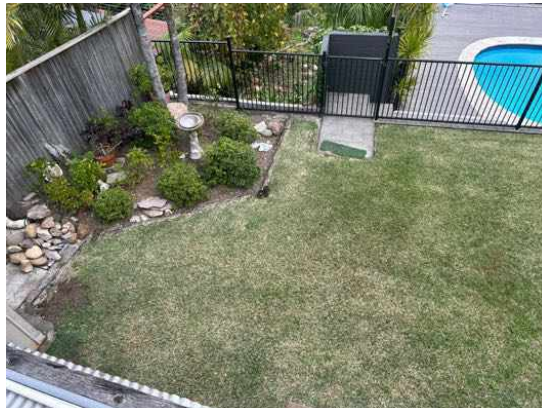
### Defects 3.02

Building:	Building 1
Location:	All External Areas
Finding:	Site drainage - suspected Inadequate
Information:	The site drainage in this area was found to be inadequate at the time of inspection, creating potential for subsequent water damage to associated building elements.

It is important that water does not lie against the base of walls; surrounding paths and ground levels should be sloped to drain water away from walls. Downpipes should not disgorge stormwater onto lower walls or plinths. Stormwater should be carried away by large, regularly cleaned drains. Ground levels may need to be lowered to expose a buried DPC.

Where site drainage is inadequate, installation of an Agricultural (Aggie) Drain may be required. A qualified plumber should be appointed to further inspect the property and perform any remedial works as necessary. Water damage and secondary defects are likely to occur if left unmanaged.

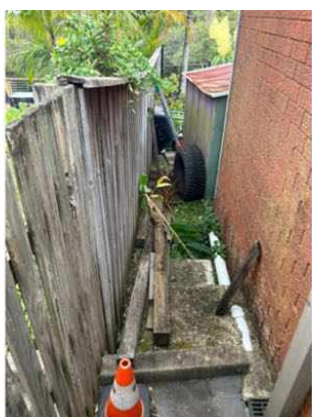
### Defects 3.03

Building:	Building 1
Location:	All Areas
Finding:	Fencing - Deteriorated
Information:	It was noted at the time of inspection that sections of the fencing throughout the

property have deteriorated. Typically fencing deteriorates due to age and or wear, rot and or rust which is generally expected for a structure of this age, due to prolonged exposure to weather conditions. Sometimes inadequate installation or maintenance can be to blame.

If left unattended, it is likely that further damage will occur. It is suspected that repair of several elements of the fencing may be required however replacement may be a consideration of the client also.

A licensed fencing contractor should be appointed to provide further advice and perform rectification works as necessary.

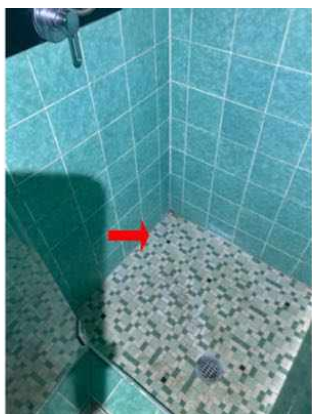
### Defects 3.04

Building:	Building 1
Location:	Bathroom
Finding:	Sealant - missing/ deteriorated
Information:	Flexible and mould resistant materials should be applied to affected areas to prevent any subsequent water damage that is likely to occur. Regular maintenance and replacement of damage or missing or damaged sealant and grout is highly recommended to the wet areas, as this is a regular wear and tear defect.

Sealant and grouting in areas that come into regular contact with water should be maintained for the long term care of your property. A sealant specialist or tiling contractor should be appointed to complete these works as soon as possible

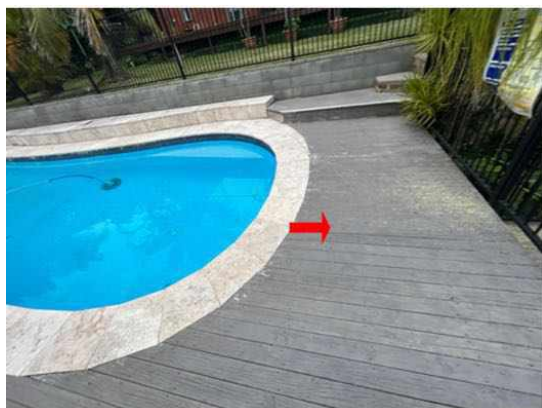
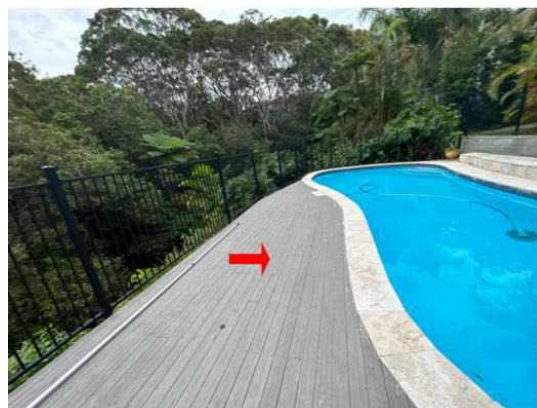
### Defects 3.06

Building:	Building 1
Location:	All Areas
Finding:	External painting deteriorated- deck
Information:	Some of the external paintwork has been neglected and require attention to prepare and re-paint.

Degraded paint finishes should be sanded back, filled, leveled and painted, as applicable. Where inadequate or missing paint protection has led to the deterioration of the associated building element, repair and/or replacement of this building element may be required.

A painting contractor should be appointed as soon as possible to perform necessary works to aid the appearance of the affected area and to ensure the area is protected against further deterioration. Alternatively, the homeowner following manufacturer instructions may perform these works.

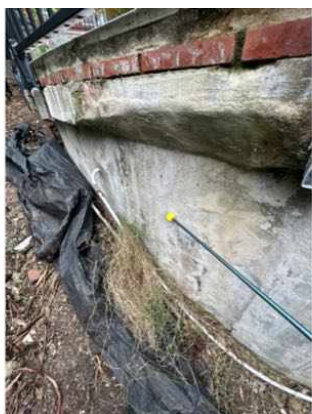
### Defects 3.07

Building:	Building 1
Location:	Pool Area
Finding:	Render - Drummy
Information:	<p>Drummy rendered areas were identified at the time of inspection. The term 'drummy' refers to render that has become detached from its fixing, despite it still being solid. Such defects are generally caused by physical or moisture damage to the area. Drummy render may also be a direct result of poor workmanship during the construction process.</p>

Render may swell and shrink with changes in air humidity if the area has sustained moisture damage. Any exposure to moisture is capable of causing rendered areas to become drummy and/or cracked over a prolonged period of time. Drummy render generally requires chipping off and re-rendering or painting.

Specialist trades are available for these types of services. A builder may be required to undertake works if damage is extensive, or if secondary building defects have resulted. Immediate action is recommended to ensure that no further damage is sustained in the affected area.

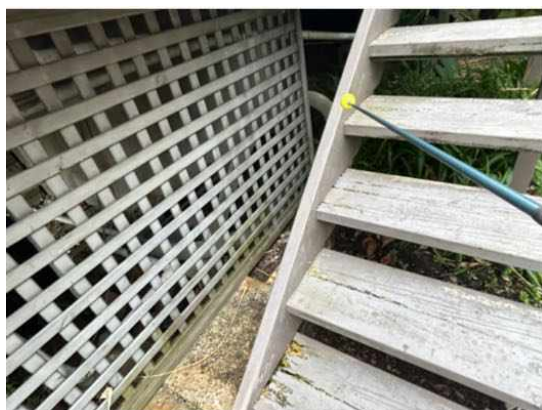
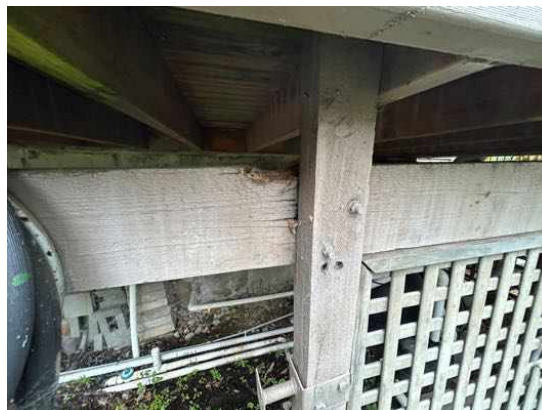
### Defects 3.08

Finding: Wood rot

Information: This building element shows evidence of wood rot. Wood rot, also known as Fungal Decay, occurs when timbers and other cellulose building materials are exposed to damp conditions on an ongoing basis. This could be the result of exposure to weathering over a prolonged period of time, or the attraction of excessive moisture from other abutting building materials. Contributing factors also include poor air ventilation in the area.

Prior to any works being performed, the cause of the moisture that has created the visible wood rot should be identified and addressed in a suitable manner. Replacement of affected timbers may then be a necessary step in protecting surrounding building elements from such deterioration.

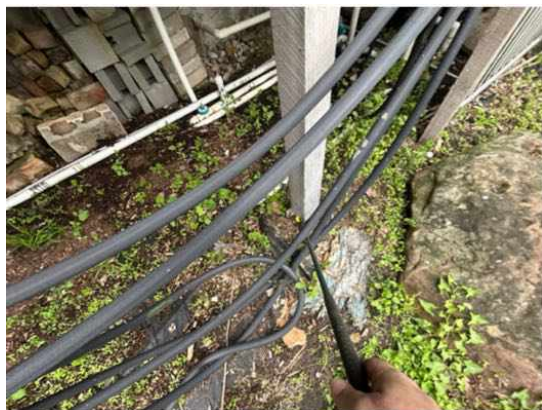
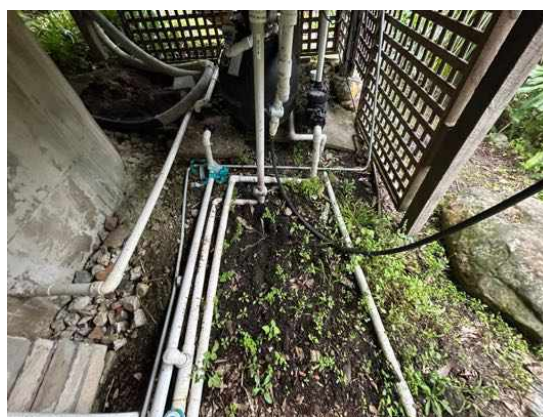
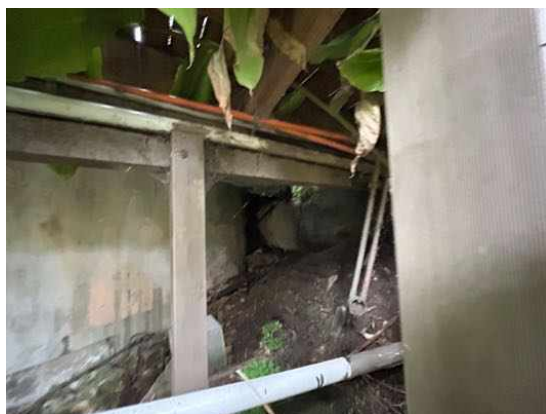
### Defects 3.09

Building:	Building 1
Location:	Pool Area
Finding:	Evidence of excessive moisture was present at the time of inspection
Information:	Excessive moisture can attract termites and produce conditions that promote termite attack fungal growth and wood decay.

Excessive moisture is generally caused by deteriorated inadequate or missing roof drainage leaking plumbing pipes or fixtures poorly plumbed HWS overflows or condenser units and poor site drainage.

It is highly recommended that all plumbing and drainage fixtures and fittings be

maintained regularly in order to prevent excessive moisture being present in the external / internal property.

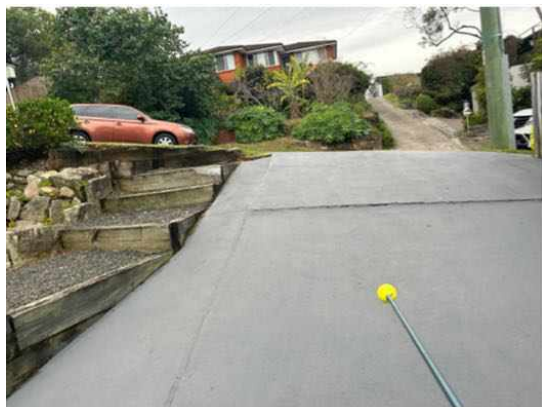
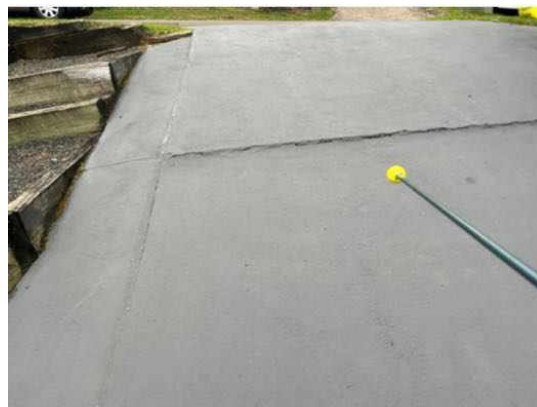
### Defects 3.10

Building:	Building 1
Location:	All Areas
Finding:	Subsidence suspected- Local trees and vegetation
Information:	Trees and other vegetation can have a significant local effect on drying of soils. Over a number of years, especially during drought conditions, adjacent trees and vegetation may draw excessive moisture from the soils. The opposite may also occur, where swelling of the soil results when the trees decline or are removed.

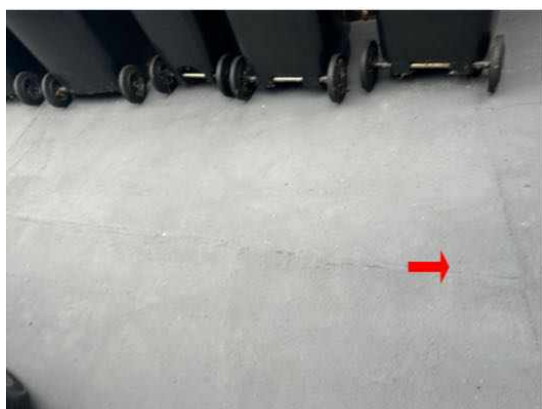
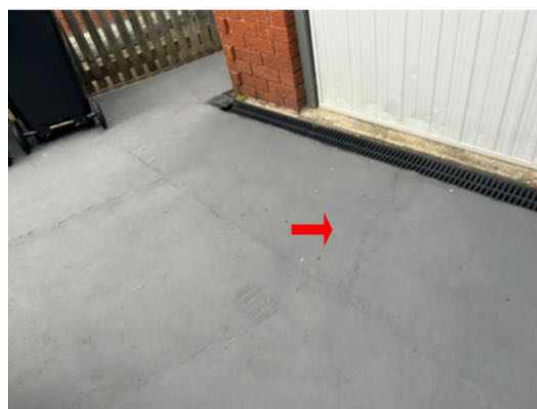
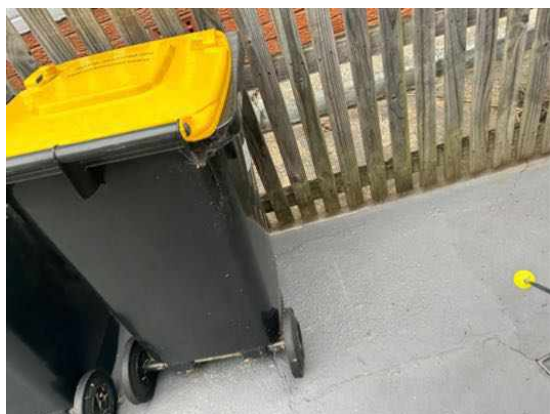
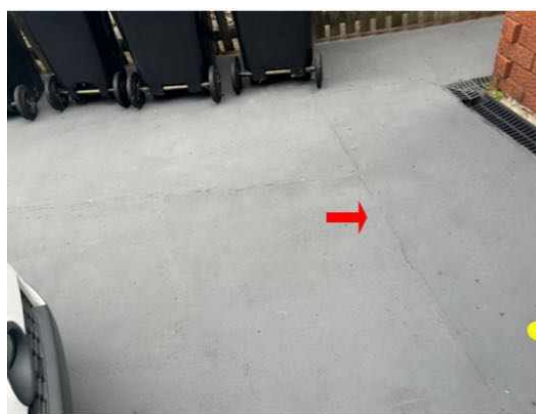
### Defects 3.11

Building:	Building 1
Location:	All Areas
Finding:	Cracking - External Concrete Paving Damage Category 1 - Fine (less than 2mm)
Information:	Fine cracks were identified in external concrete paving. Although fine cracks are quite noticeable, they are often only considered to be an appearance defect, and usually do not indicate any structural damage. To be considered a Category 1 or fine crack, the crack is found to be less than 2mm in width.

Generally the cause of a hairline crack in existing concrete paving such as driveways and pathways is indicative of the expansion and contraction of the concrete. Such causes are generally due to environmental factors, such as moisture levels, weather conditions, root systems of nearby trees or the soil types on which they are laid.

Fine cracks may also be due to poor original installation of the concrete. Factors such as poor compaction of the sub surface and/or inadequate reinforcing of the slab may create cracking and other secondary defects.

Monitoring of all cracking should be conducted frequently. Always contact a building inspector should cracks widen, lengthen, or become more numerous.

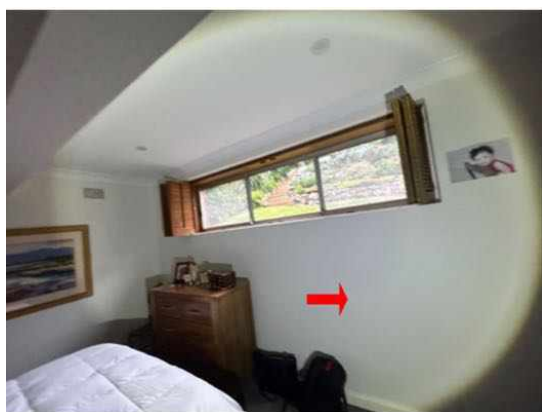
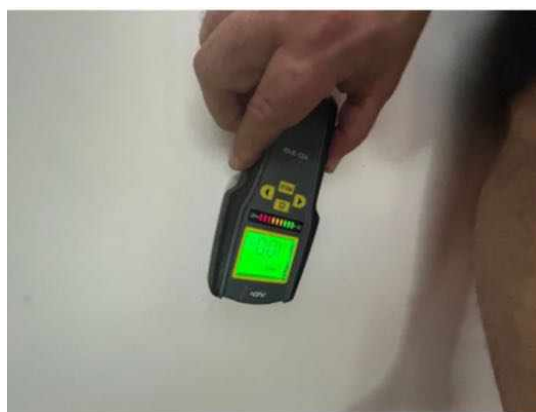
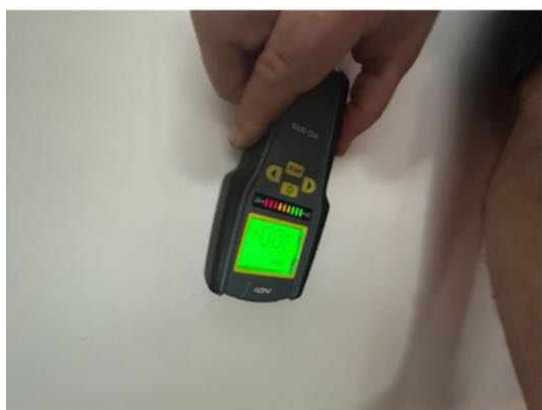
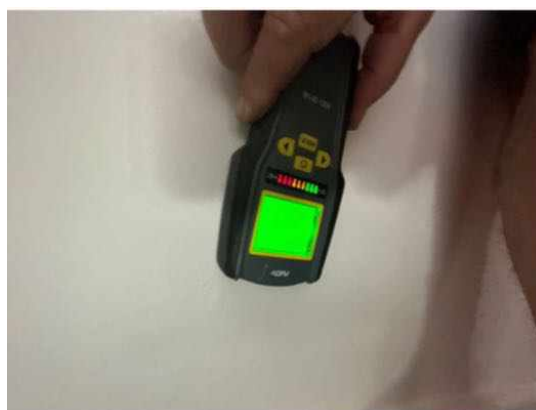
### Defects 3.12

Building: Building 1  
 Location: All Areas  
 Finding: Moisture meter readings - high  
 Information: The moisture meter result for the areas inspected.

The moisture reading of 0-15% is quite normal and gives no cause for concern. However, moisture readings in excess of 15% indicate the need for further inspection.

Levels between 25-30% indicate that there may be water ingress, meaning that remedial work could be required.

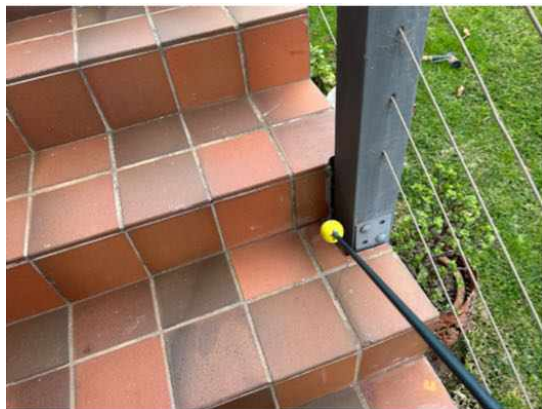
### Defects 3.13

Building:	Building 1
Location:	Yard - Front
Finding:	Tile- Cracked or damaged
Information:	Cracking was evident to the tiling in this area at the time of inspection.

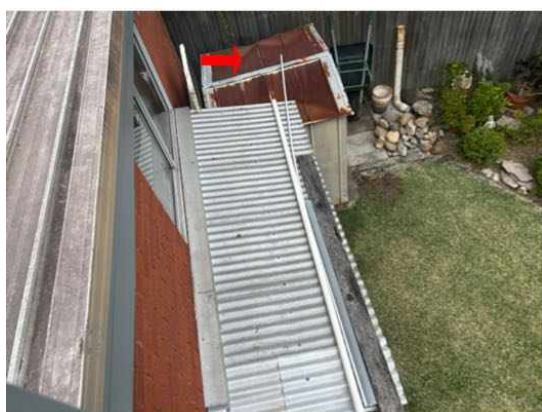
### Defects 3.14

Building:	Building 1
Location:	Shed
Finding:	Roof sheets - Rusted
Information:	Upon inspection of the exterior roofing structure, evidence of rust to these sections was identified. If left unmanaged, these degrading joins can allow water ingress to the internal roofing structures, potentially leading to secondary damage of building elements. Accelerated deterioration of the roofing sheets and any associated building elements is also likely to occur.

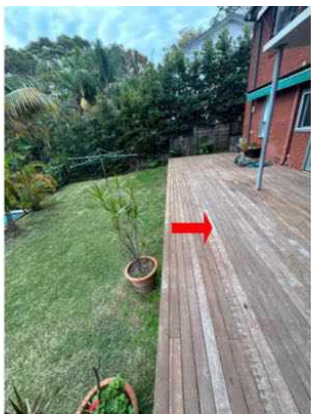
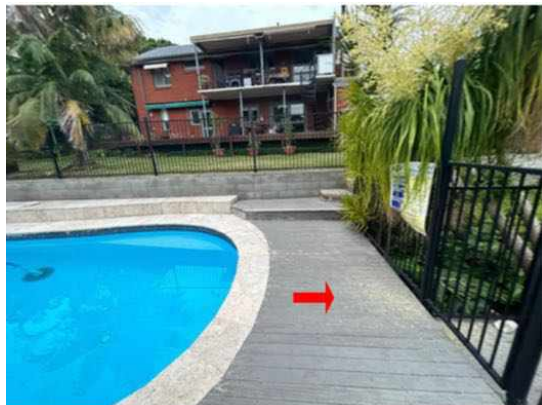
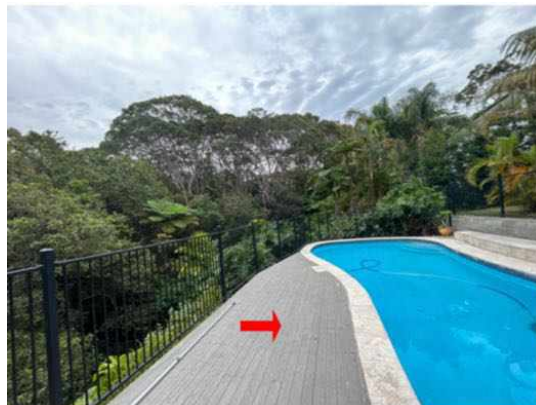
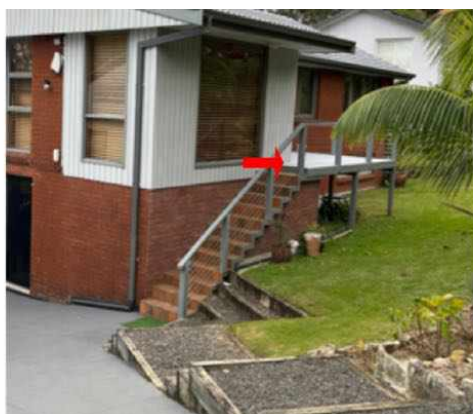
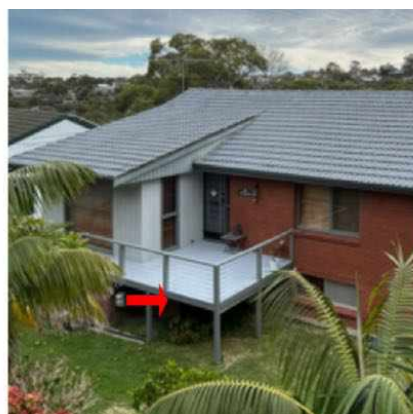
### Noted Item

Building: Building 1  
 Location: All External Areas  
 Finding: External Timber Balcony or Deck - Structural Stability  
 Information: The load capacity of the external balcony or deck could not be verified during the inspection.

External timber structures are also constantly exposed to weather elements and can deteriorate in an accelerated manner, ongoing assessments are required.

It is highly recommended that a Structural Engineer further assess the external timber balcony or deck to inform the client of its load capacity. Regular maintenance inspections by competent practitioners is needed.
