Building Inspection Report

Inspection Date: Tue, 26 Nov 2019

Property Address: 7 Stirling Pl, Belrose NSW 2085, Australia

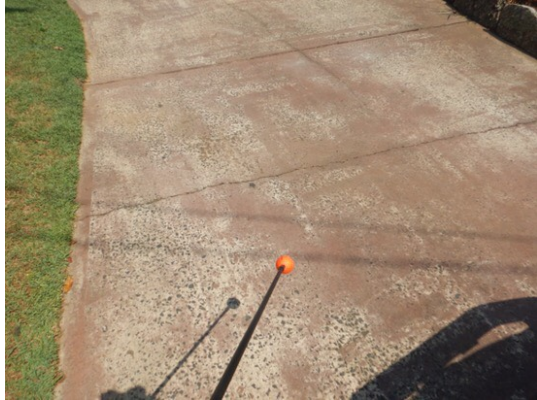
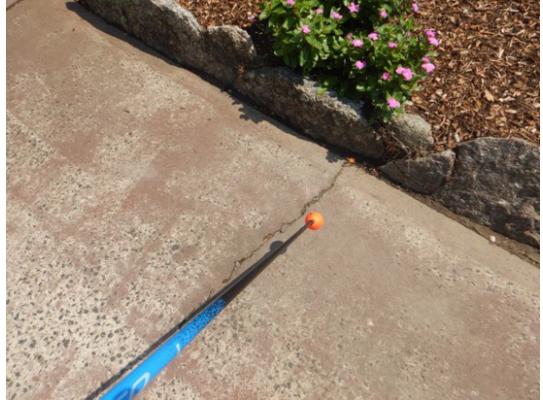
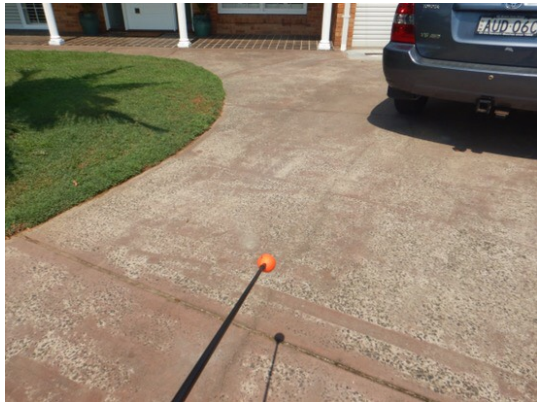
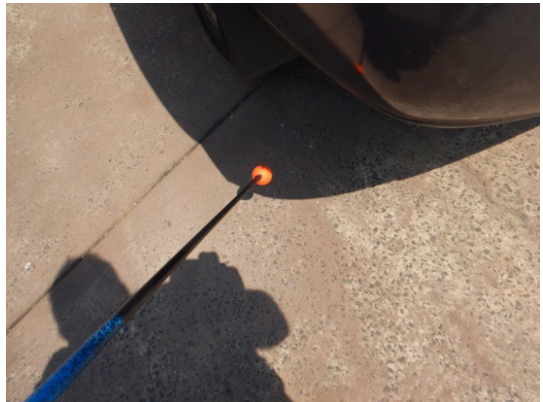
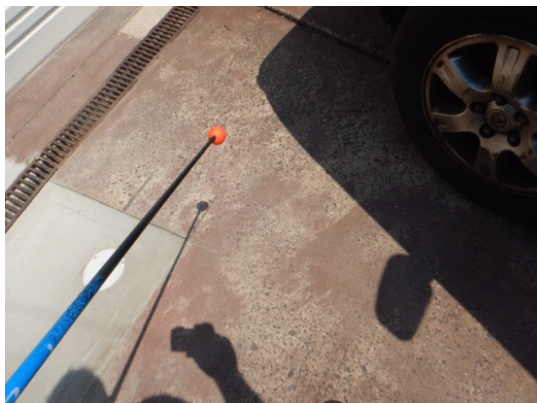
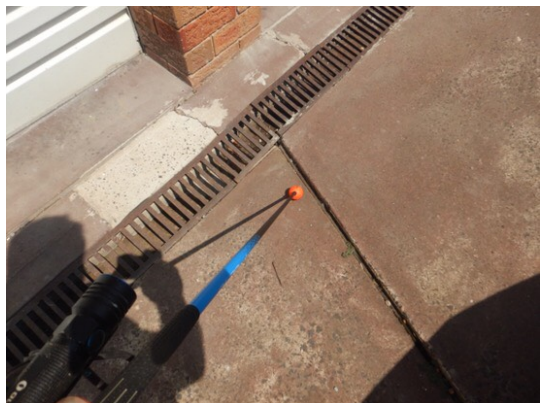
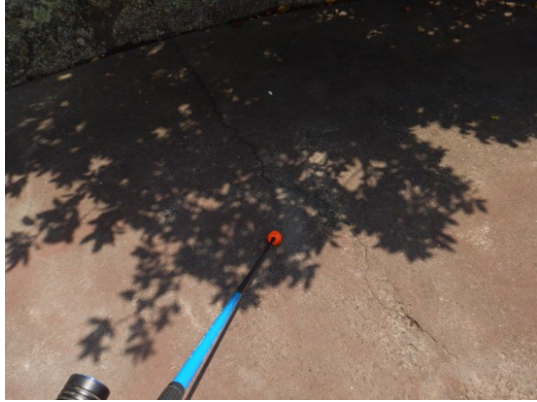
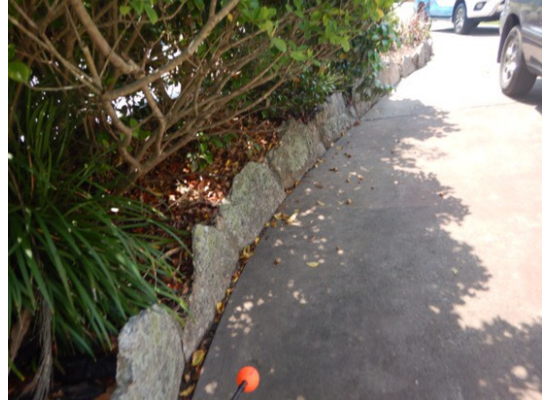
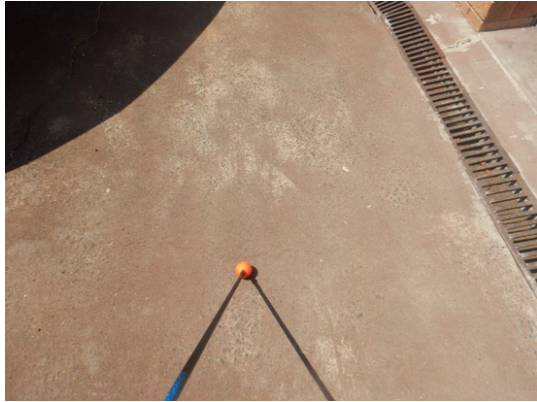
Defects 3.01

Building: Main Building
Location: Yard - Front
Finding: Cracking - External Concrete Paving Damage Category 1 - Fine (less than 2mm)
Information: Fine cracks were identified in external concrete paving. Although fine cracks are quite noticeable, they are often only considered to be an appearance defect, and usually do not indicate any structural damage. To be considered a Category 1 or fine crack, the crack is found to be <2mm in width.

Generally the cause of a hairline crack in existing concrete paving such as driveways and pathways is indicative of the expansion and contraction of the concrete. Such causes are generally due to environmental factors, such as moisture levels, weather conditions, root systems of nearby trees or the soil types on which they are laid.

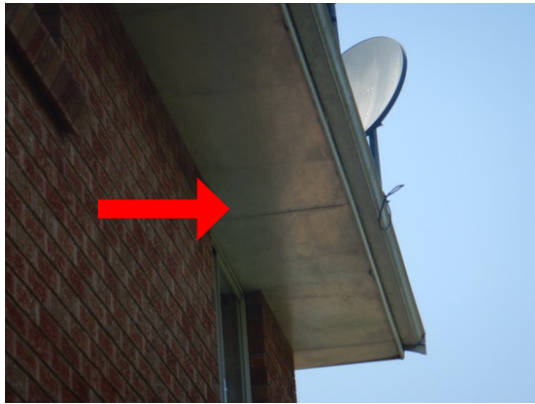
Defects 3.02

Building: Main Building

Location: Eaves

Finding: Mould - Present

Information: Generally, the client is advised to ensure that the general environment is free of moisture and humidity to aid in the prevention of mould formation and development. Any mould found during the inspection should be cleaned immediately by a cleaning contractor or the homeowner as applicable.

Please note that severely affected building elements may require replacement by a registered builder or qualified carpenter.

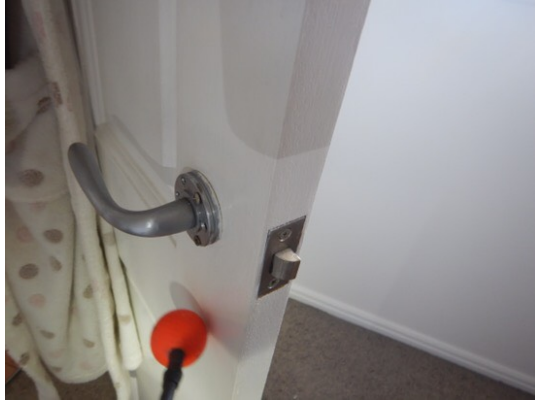
Defects 3.03

Building: Main Building

Location: Bedroom

Finding: Door hardware - Missing

Information: The door hardware is missing for this door.

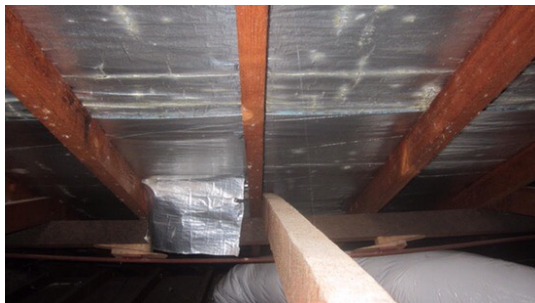
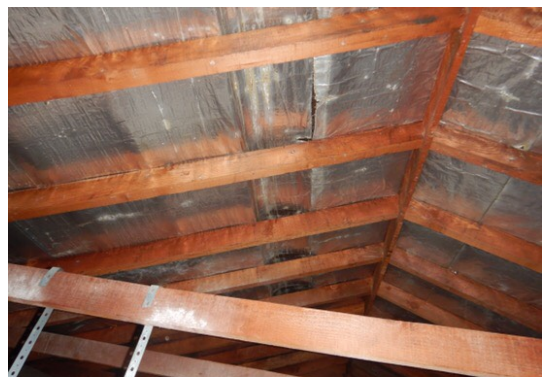
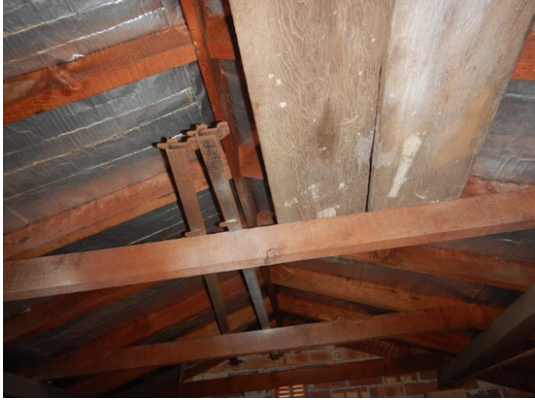
Defects 3.04

Building:	Main Building
Location:	Roof Void
Finding:	Sarking - Damaged
Information:	Sarking, a laminated aluminium foil applied to the interior of the roof covering, assists in insulating the property and acting as a vapour-barrier to the roof void and, subsequently, to the household.

Where sarking is damaged, both insulation and moisture protection of the property are inhibited. This creates a loss of energy and thus negatively impacts the energy efficiency of the property, allowing potential for moisture ingress from condensation or leaking roof tiles.

It is important to repair any holes or damaged sections of sarking to ensure that the building material is fully functional. A registered builder or qualified carpenter should be consulted to provide further advice on this defect and to perform rectification works at client discretion.

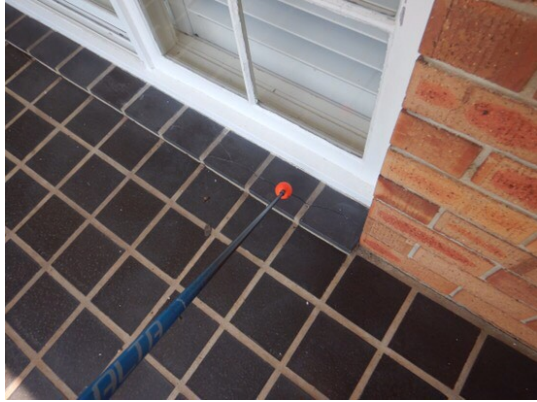
Defects 3.05

Building: Main Building

Location: Yard - Front

Finding: Tiles - Cracked or damaged

Information: Cracking was evident to the tiling in this area at the time of inspection. While the cracking appears to be minor, this area is frequently exposed to water, allowing potential for water penetration into adjoining sections of walls or flooring.

If left unmanaged, water penetration to these areas may lead to subsequent water damage, which is likely necessitate repair work to affected building elements.

A tiling contractor should be appointed to ensure that no further water damage occurs. The re-application of silicone and grouting throughout remaining tile work is also advised, to further protect the area against water penetration.

Where water penetration has led to water damage, appointment of a relevant tradesperson may be required to repair damaged building elements.

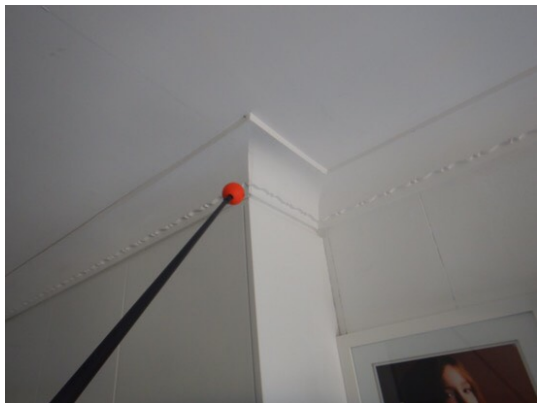
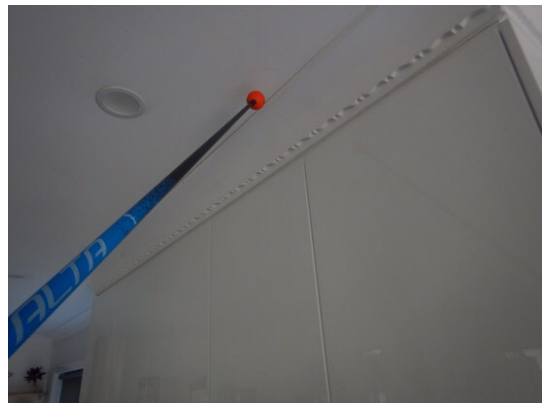
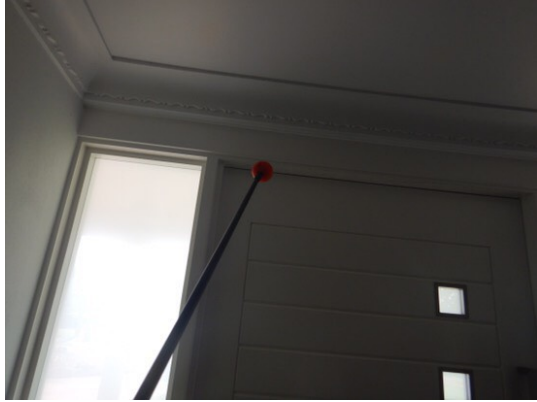
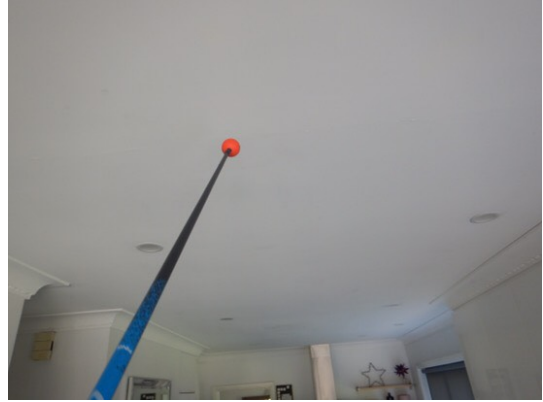
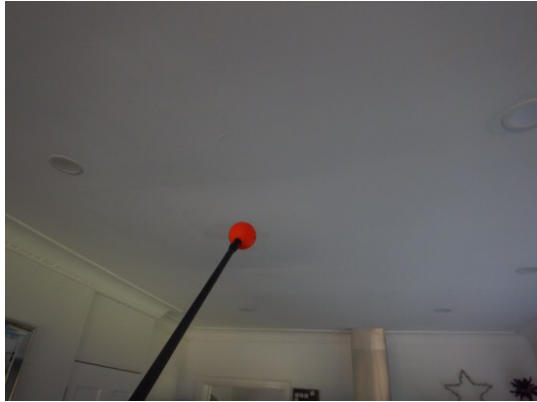
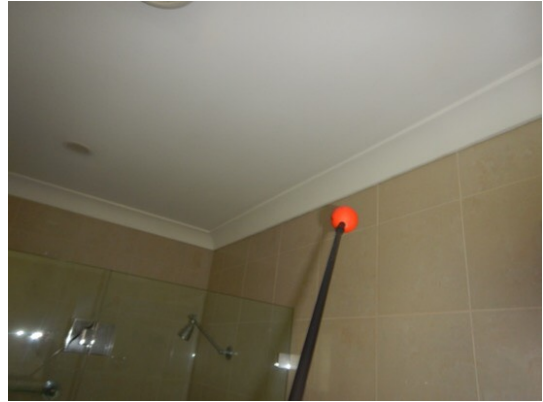
Defects 3.06

Building:	Main Building
Location:	All Internal Areas
Finding:	Cracking - Damage Category 0 - Hairline (less than 1mm)
Information:	Hairline cracks are very minor in nature and generally are only ever an appearance defect. While such cracking may be noticeable in some cases, it is quite common and does not indicate any structural damage.

Cracking of this nature can generally be repaired with minor sanding, filling and/or repainting. Such works should be performed by a qualified painter or a general handyman.

Monitoring of all cracking should be conducted frequently. Always contact a building inspector should cracks widen, lengthen, or become more numerous.

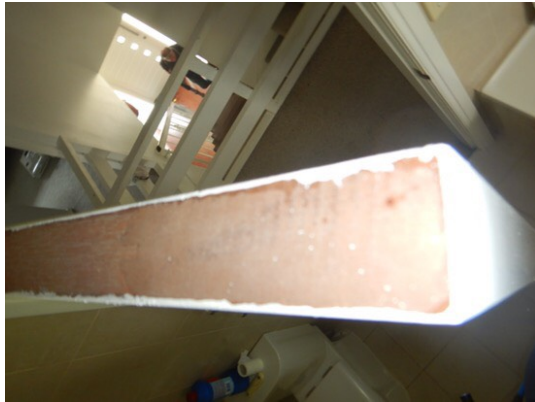
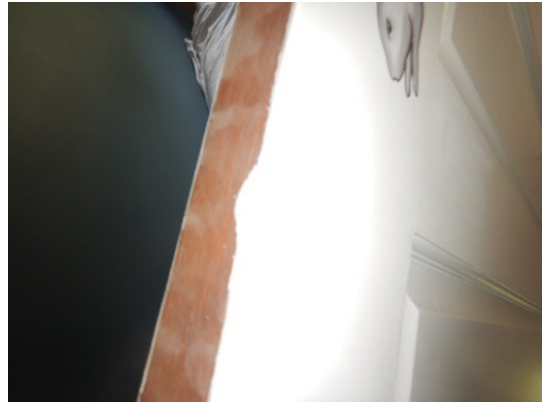
Defects 3.07

Building: Main Building
Location: Hallway
Finding: Door finish - incomplete on top and bottom of
Information:

The paint finish in this area was identified as being incomplete at the time of inspection.

Whilst incomplete or missing paint finish is generally an appearance defect, it can also lead to the development of secondary building defects over time. Incomplete areas of paint finish exposes the area to moisture, potentially accelerating the deterioration of underlying building materials.

A painting contractor should be appointed to perform necessary works to aid the appearance of the affected area and to ensure the area is protected against further deterioration. Alternatively, the homeowner following manufacturer instructions may perform these works.

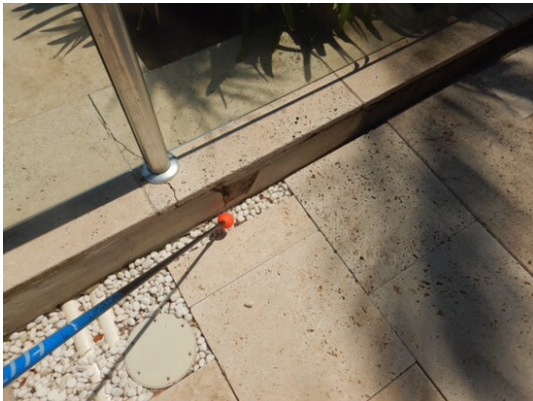
Defects 3.08

Building: Main Building

Location: Yard - Back

Finding: Cracked floor tiles

Information: Cracking in the floor tiles was evident in this area at the time of inspection. It is suspected that this cracking has occurred as a result of minor settlement or shrinkage of the slab.

Cracked tiles throughout the household detract from the overall appearance of the affected areas however it is unlikely to create or lead to any secondary defects.

While not considered a matter of urgency, replacement of cracked floor tiles is recommended at the clients discretion. A tiling contractor may be appointed to perform these works. Where cracks become more numerous, contact a licensed building inspector for further investigation.

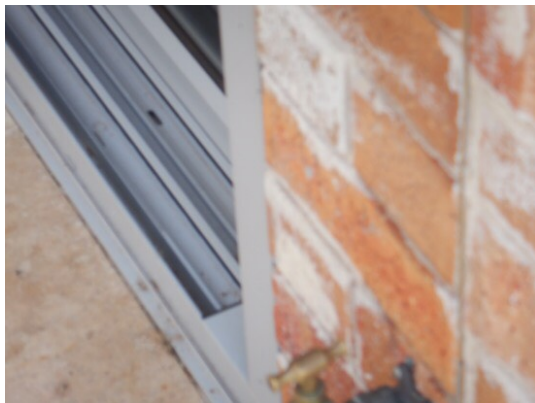
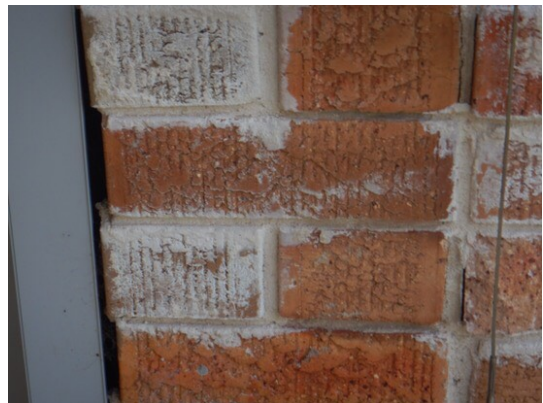
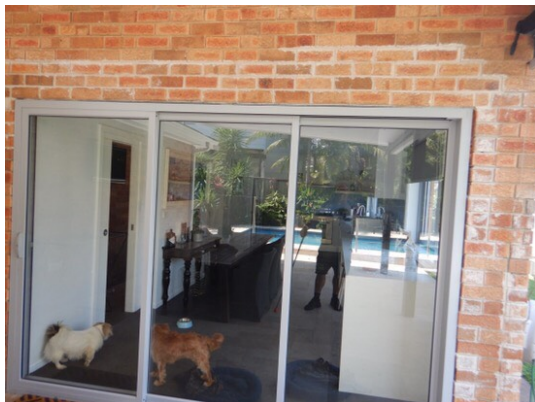
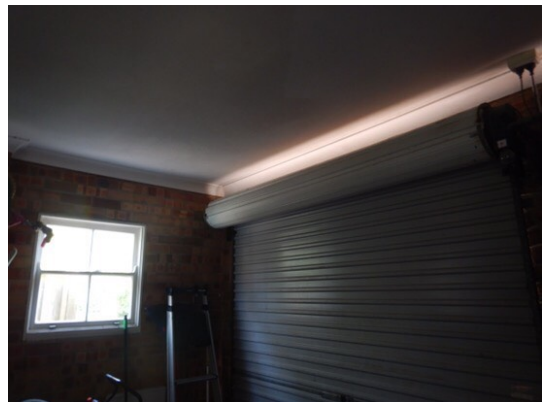
Defects 3.09

Building: Main Building

Location: Pergola

Finding: Surface - Requires cleaning

Information: Regular cleaning and maintenance improves the longevity of all building elements. A build up of dirt and debris can reduce the useful life of building materials and may result in earlier replacement of items being required.

Excessive dirt is also likely to lead to secondary hazards, including potential health hazards, as the building elements begin to harbour bacteria and/or mould.

Remedial cleaning is recommended in order to improve the appearance of this area as well as to counteract the development of bacteria. Such works can be performed by a cleaning contractor and should be completed at the discretion of the client.

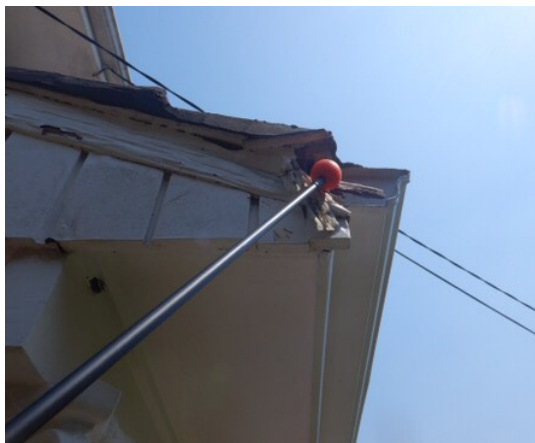
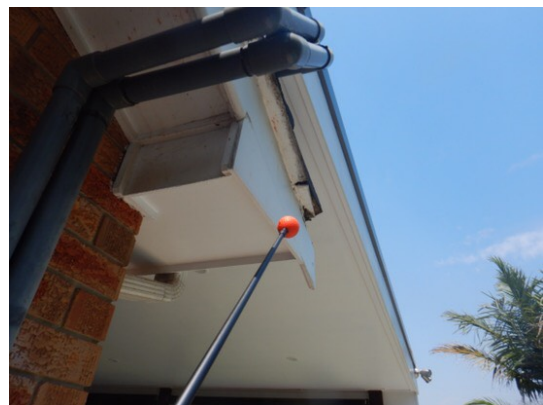
Defects 3.1

Building:	Main Building
Location:	All External Areas
Finding:	Fascias - Wood rot
Information:	Wood rot was found to be affecting fascias and barges in this area, evidenced by the presence of mould on the surface in some areas. Wood rot, also known as Fungal Decay, occurs when timbers and other cellulose building materials are exposed to damp conditions on an ongoing basis.

It is likely that this wood rot has developed as a result of faults in the roof plumbing, creating excessive moisture in this areas. Frequent exposure to rain and other weather conditions also make fascias and barges susceptible to accelerated deterioration.

Early intervention and regular maintenance will prolong the useful life of these building elements. Prior to any works being performed, the cause of the moisture that has created the visible wood rot should be identified and addressed in a suitable manner.

It is advised that a roof plumber be appointed to inspect all roof plumbing and subsequently identify the cause of the wood rot. Replacement of affected fascias and barges may then be a necessary step in protecting surrounding building elements from such deterioration.

A qualified plumber may be appointed to assess the cause of excessive moisture and to provide advice on any remedial works as required. A qualified carpenter or registered builder may also be required to replace affected building materials.

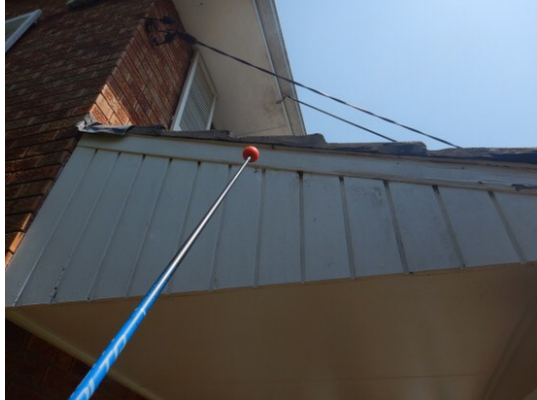
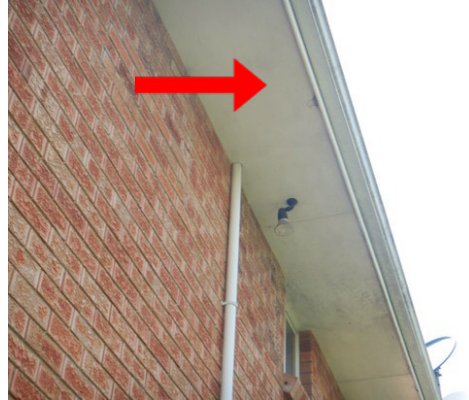
Noted Item

Building: Main Building
Location: Yard - Side
Finding: Asbestos - Suspected ACM Identified on Site
Information: Reporting on Asbestos is outside the Scope of this Report. This suspected defect is highlighted as a caution only. We suspect, based on our experience in the building industry, that there is a higher risk of the identified building element containing asbestos.

As Asbestos Reporting is outside the scope of this report, we advise that you consider a separate Asbestos Inspection and Condition Audit, which can include the taking of samples for definitive confirmation of the presence of Asbestos.

In the interim, the client is advised to act with caution, especially when considering any damage to building materials general wear and tear renovations extensions demolition and general maintenance activities due to the suspected presence of Asbestos.
