Timber Pest Inspection Report

Inspection Date: Tue, 08 Oct 2019

Property Address: 5 Riverhill Ave, Forrestville

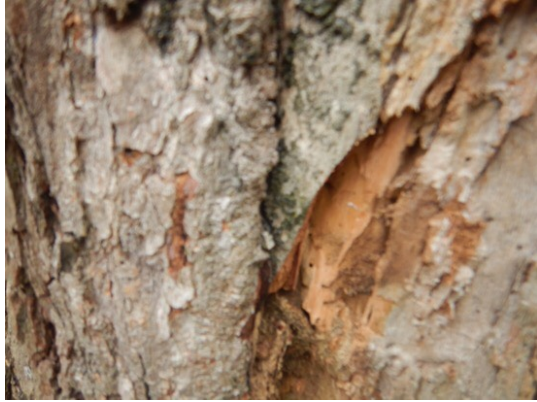
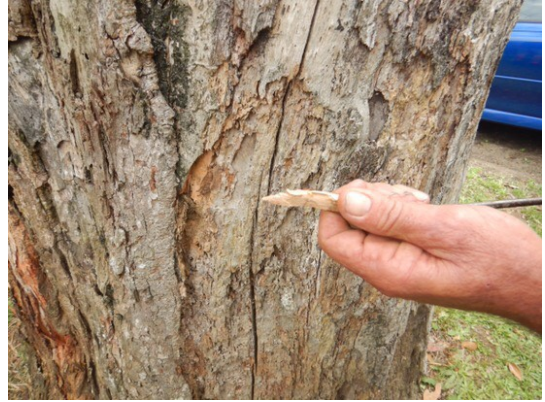
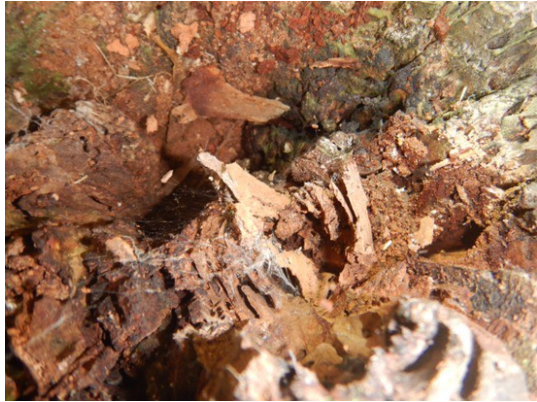
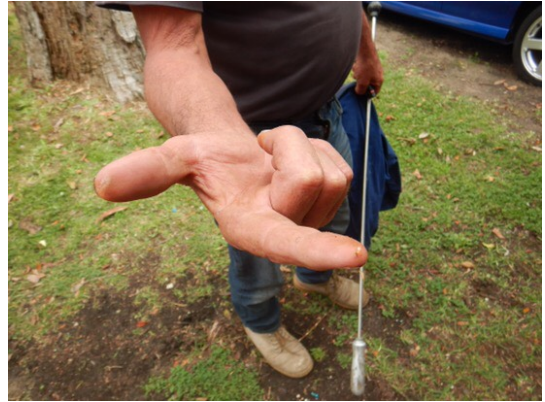
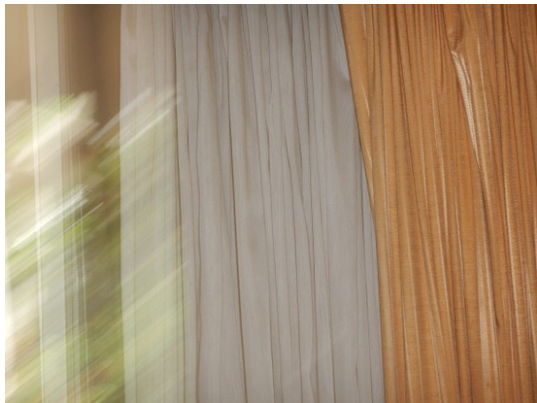
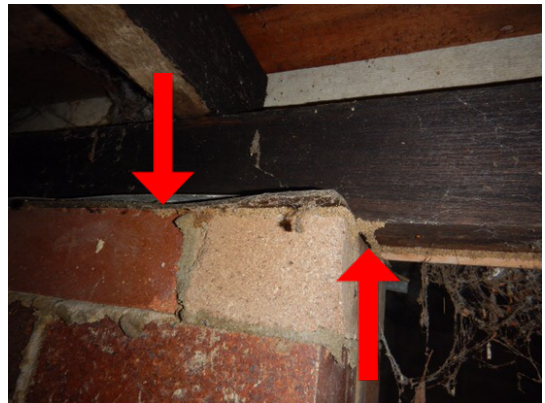
Building:	Main Building
Location:	Yard - Back
Finding:	Evidence of live <i>Coptotermes</i> Spp termite activity was identified
Information:	Confirmation of species must be made by a lab. Based on in field observations the species identification is preliminary in nature only.

Coptotermes Spp are a common termite family that are generally distributed Australia-wide. The presence of these termite species is typically difficult to detect by the untrained eye as nests in domestic households are usually found completely underground or within living/dead vegetation.

Coptotermes Spp are known to attack both living and/or dead trees as well as seasoned timber that may be used throughout the external area of a property. The most common form of attack is on sleeper retaining walls that are in direct contact with the ground. If these timbers are non-durable and/or untreated ingress is provided for *coptotermes* or other species of subterranean termites directly from the surrounding grounds and into the timber.

If evidence of live *coptotermes* spp activity is found during inspection treatment is required immediately to prevent any further damage that will inevitably ensue if left unattended. Treatment options include the installation of bait stations with the view of directly eradicating the colony or the installation of a post-construction chemical barrier which is designed to prevent the reoccurrence of termite infestation. Remedial works or replacement of affected timber builder elements may also be required.

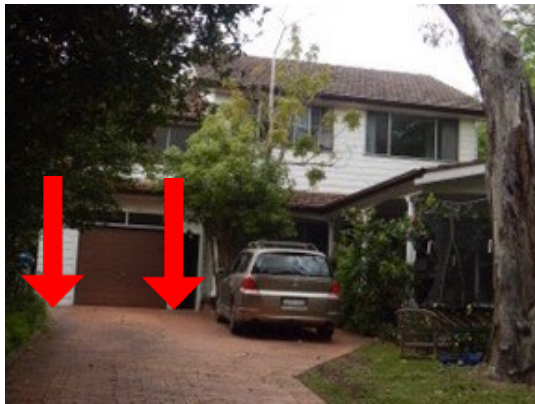
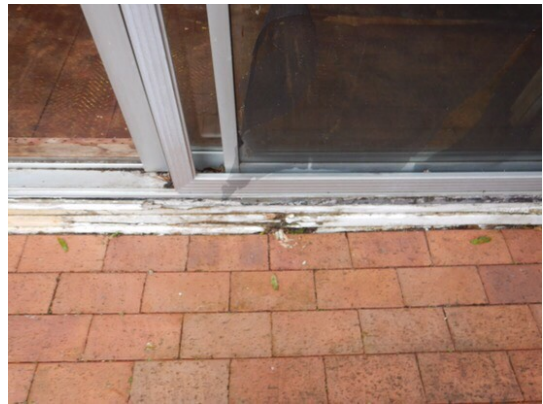
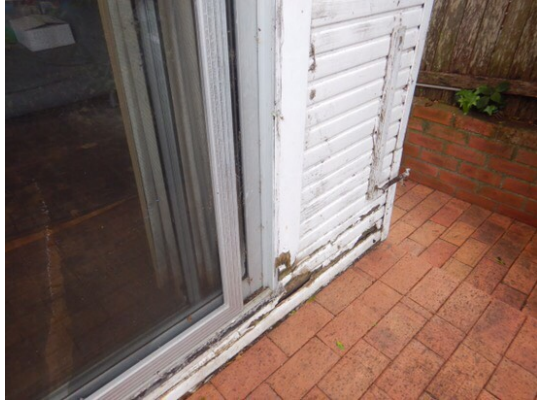
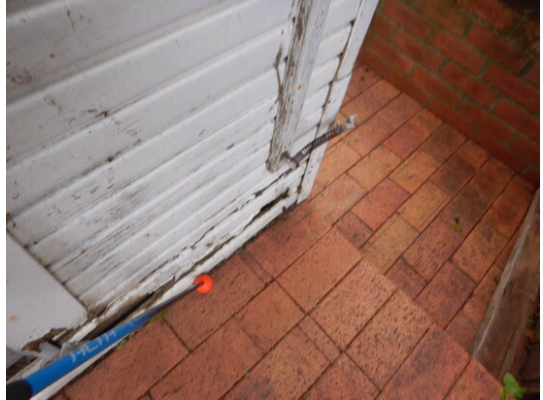
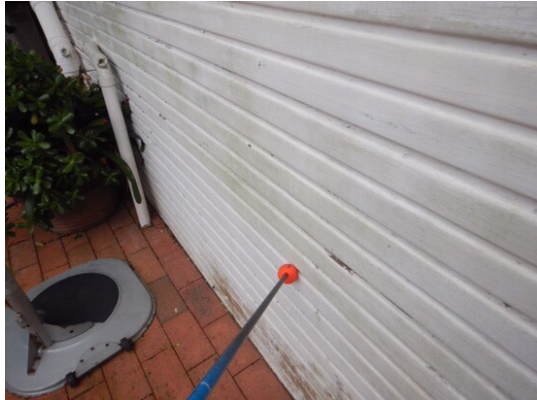
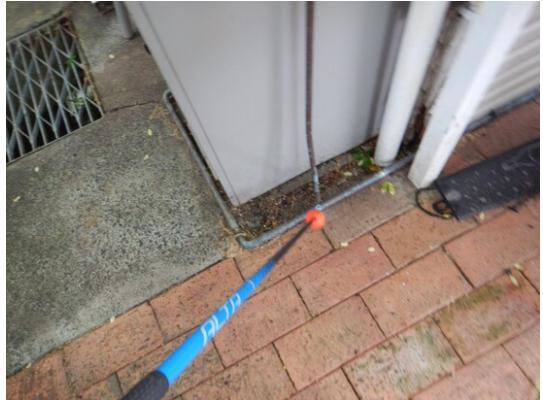
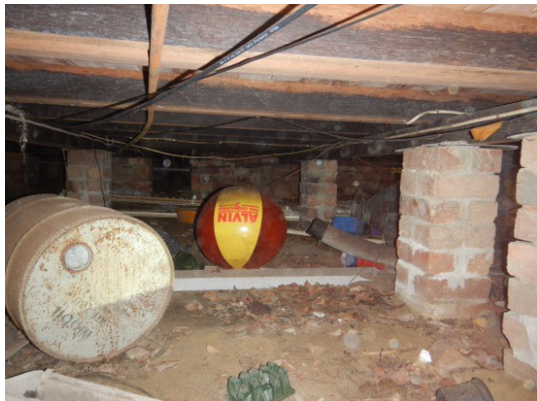
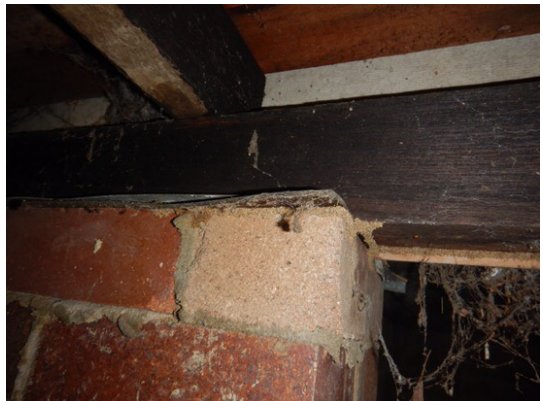
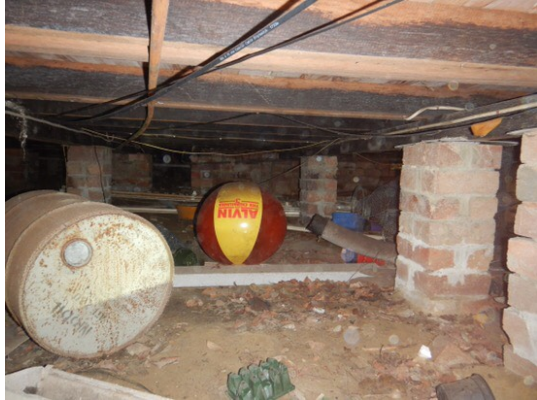
Building: Main Building
Location: All Areas
Finding: In ground contact
Information: Any timbers in direct ground contact provide opportunity for concealed termite entry and are likely to be subject to premature rot and decay as the soil retains moisture or damp conditions against the timbers.

Remove untreated timber that is in direct contact with external grounds. Consider replacement with more durable materials i.e. treated timber or non timber elements. Frequent pest inspections are advised to readily identify any termite activity in these areas.

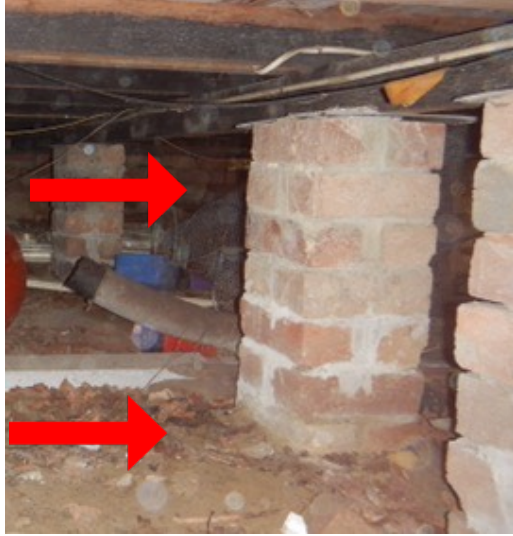
Building:	Main Building
Location:	Subfloor
Finding:	Subfloor - Lack of ventilation
Information:	It was noted at the time of inspection that the subfloor area lacks adequate ventilation. Ventilation can be restricted by a variety of minor defects, including obstructions in the subfloor space, a lack of vents or a low clearance.

A well ventilated subfloor aids in maintaining dry conditions, preventing secondary damage such as wood rot and pest activity, as well as preventing the development of mould and mildew (which can lead to respiratory safety hazards for occupants).

The initial step in improving ventilation is to ensure that the subfloor area is free of any debris or stored items. Where ventilation is still inadequate, it is advised to ensure that all vents are clear of blockages, and additional vents may be installed.

The client may also consider mechanical ventilation (powered fans) to improve subfloor airflow. Remedial works should be conducted as a matter of urgency to protect against the development of potentially harmful subfloor conditions.

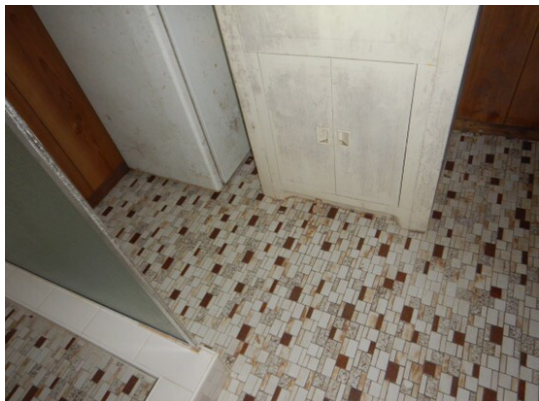
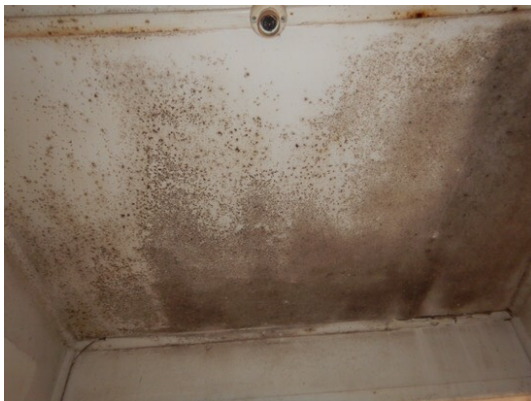
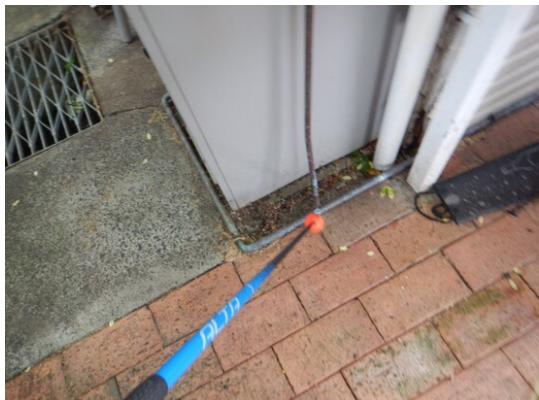
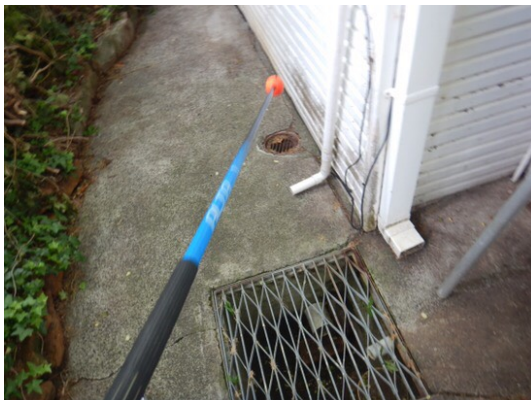
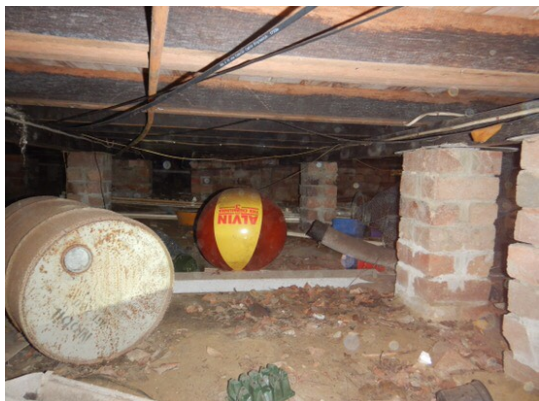
Building:	Main Building
Location:	Subfloor
Finding:	Excessive moisture - identified
Information:	Excessive moisture can attract termites and produce conditions that promote fungal growth and wood decay.

Excessive moisture is generally caused by deteriorated inadequate or missing roof drainage leaking plumbing pipes or fixtures poorly plumbed HWS overflows or condenser units and poor site drainage.

If mould growth has been found there may be environmental biological or health issues involved. In these cases an appropriately qualified inspector should also be contacted.

Prior to any remedial works being performed a qualified plumber should be appointed to further inspect the property and to identify the cause of the excessive moisture. Works to remove affected building elements may then be necessary and should be performed by an appropriate tradesperson.

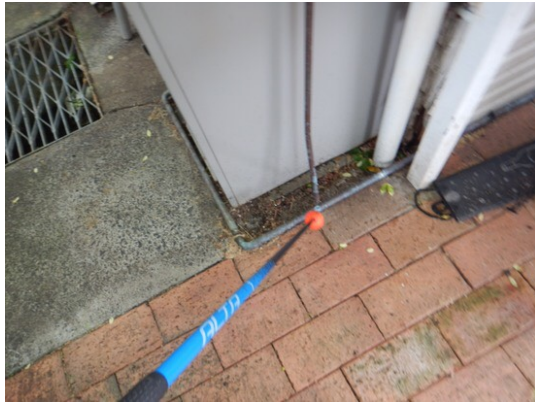
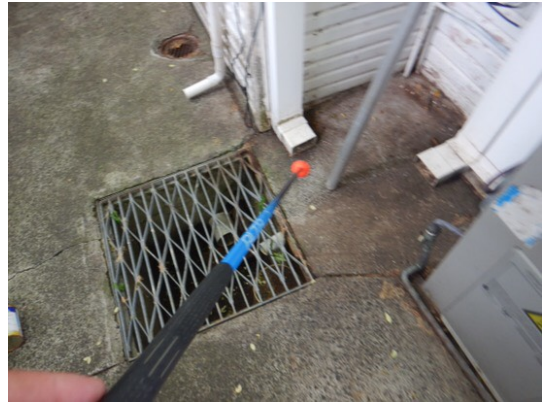
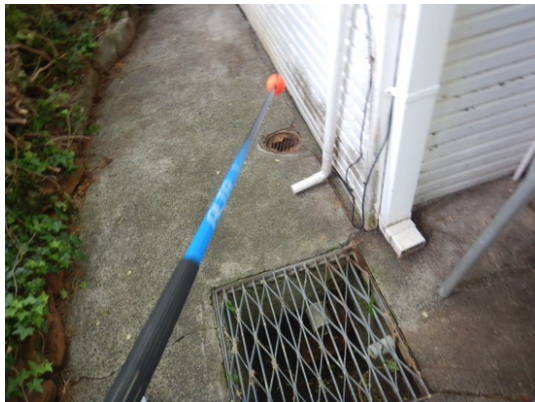
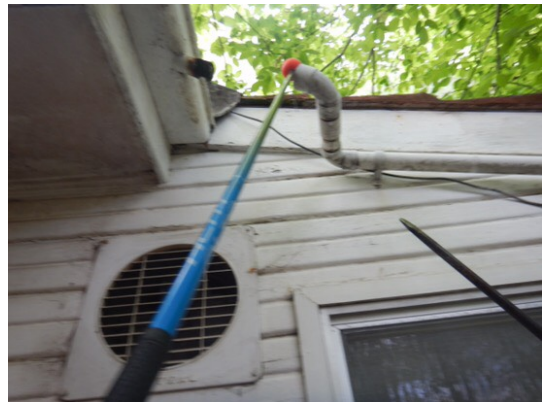
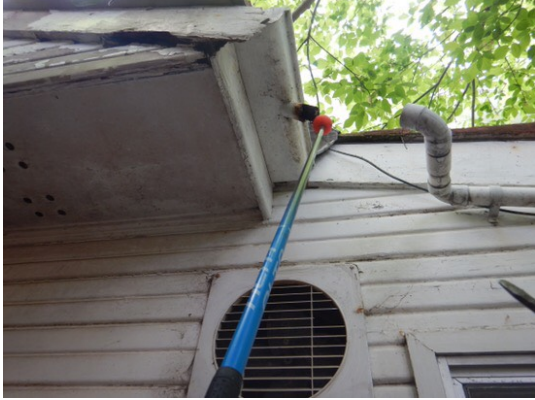
Building: Main Building
Location: Yard - Side
Finding: Overflow - Not plumbed for drainage
Information: The overflow is not plumbed or connected to suitable drainage, which has resulted in the surrounding area becoming excessively damp.

These damp conditions can lead to secondary defects such as rot, rust or corrosion of associated building elements, the formation of fungal decay, or even the creation of potential slip hazards. When coupled with poor site drainage, pooling of water may also attract termite activity to this area.

It is recommended that a qualified plumber be appointed to install adequate drainage to the overflow. These works will ensure that the area remains dry and free of any secondary defects.

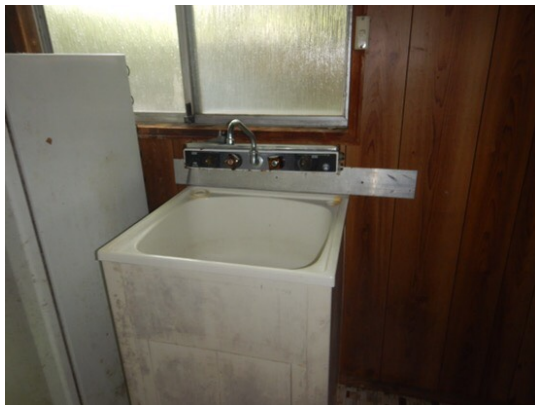
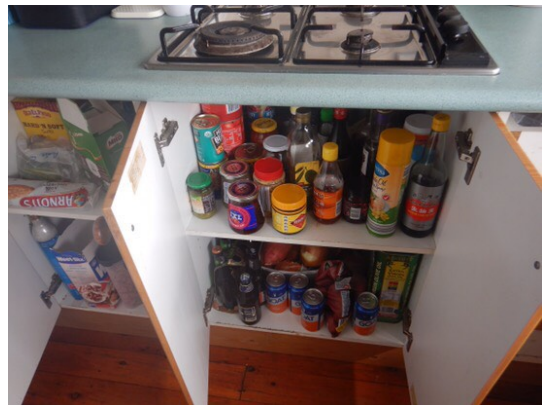
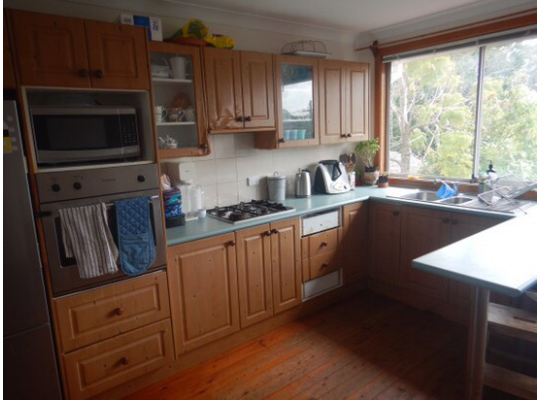
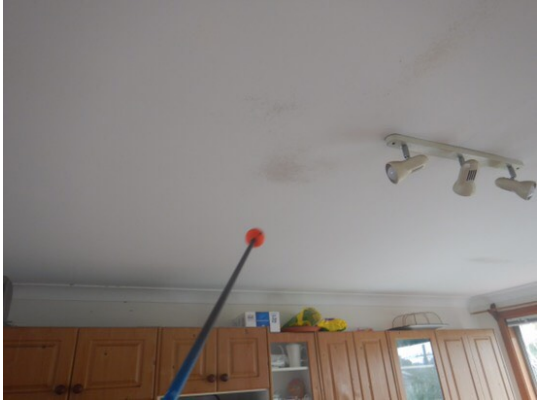
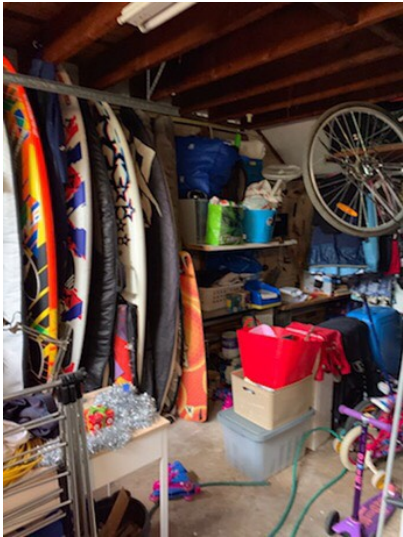
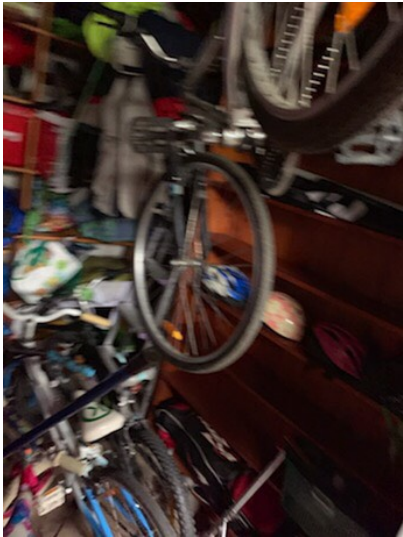
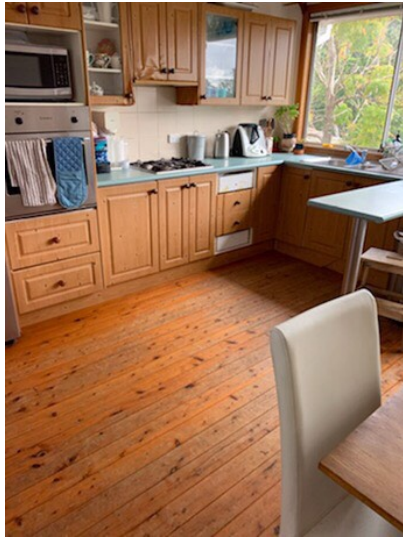
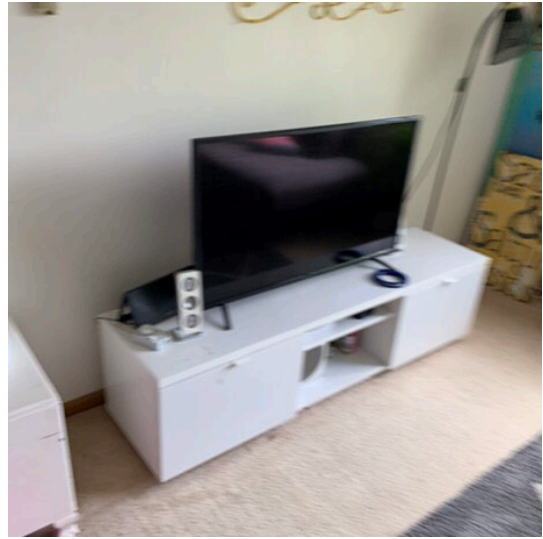
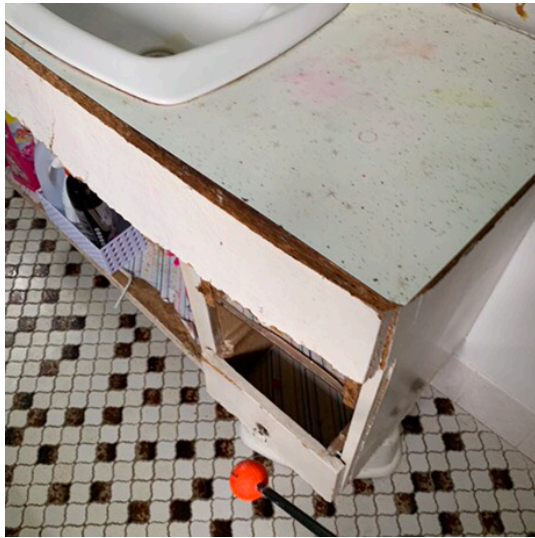
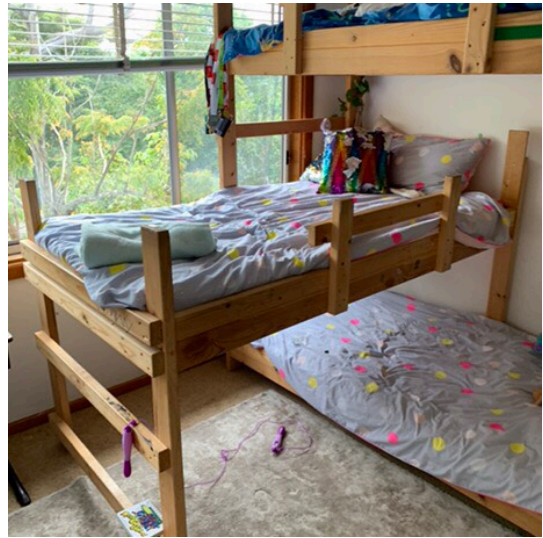
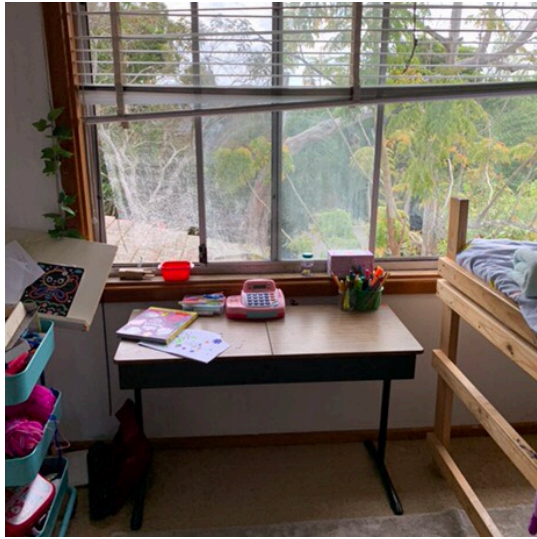
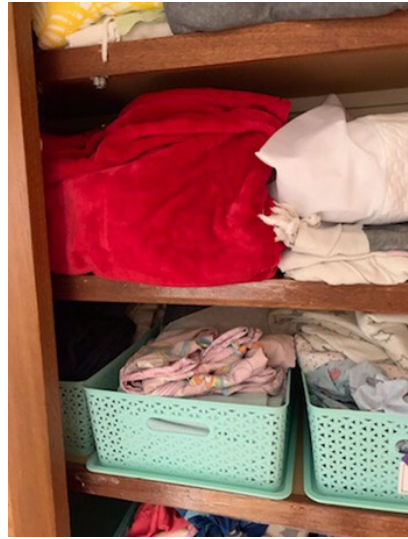
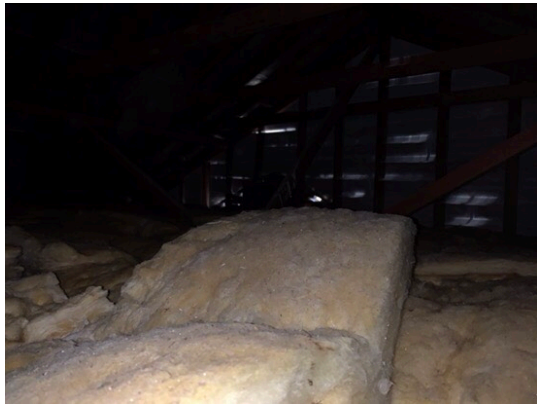
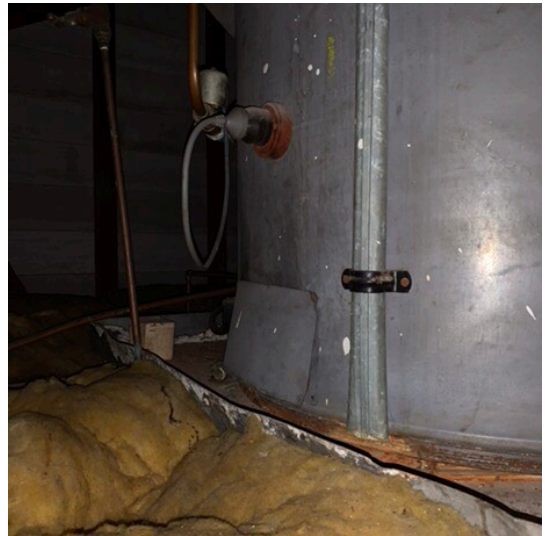
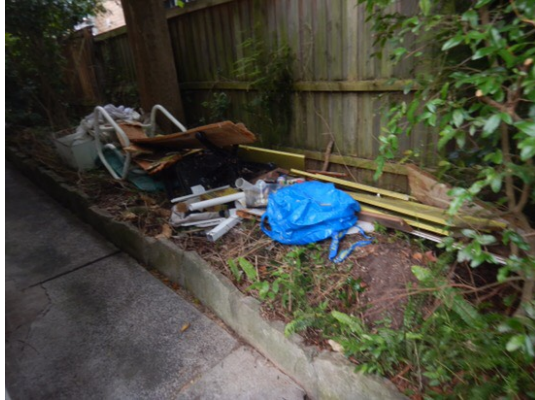
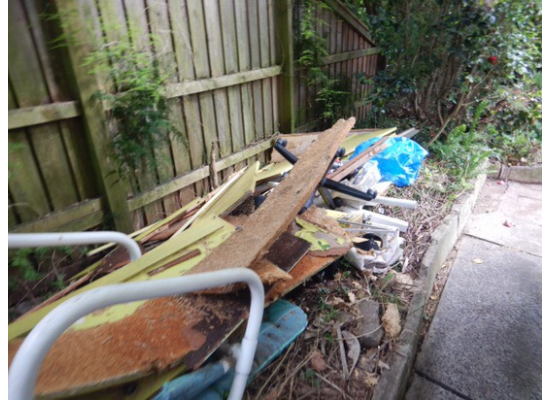
Finding: Additional Photos - Obstructions and Limitations

Information: These photographs are an indication of the obstructions and limitations which impeded full inspection of the property at the time of inspection.

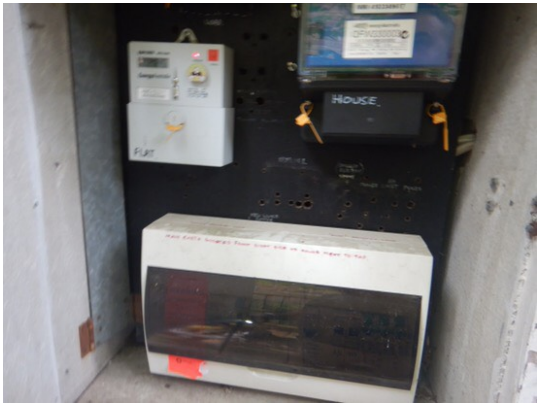
Finding: Termite Management System - no evidence of installation

Information: The application of a post-construction chemical termite barrier is highly recommended for all properties, particularly if live termite activity has been found on the site previously. Such barriers are highly effective in preventing termite attack on any timber building elements throughout the property.

A durable notice should be placed in the switchboard unit to indicate current termite barriers. At the time of inspection, it appeared as though no termite management system has been installed, with no evidence to suggest preventative works taking place.

The client may consider gaining further advice from a pest controller as to the costs and procedures involved with this application. It is recommended that obtaining such advice be a short-term priority.
