Building Inspection Report

Inspection Date: Tue, 27 Aug 2019

Property Address: 3 Tisane Avenue, Frenchs Forest NSW, Australia

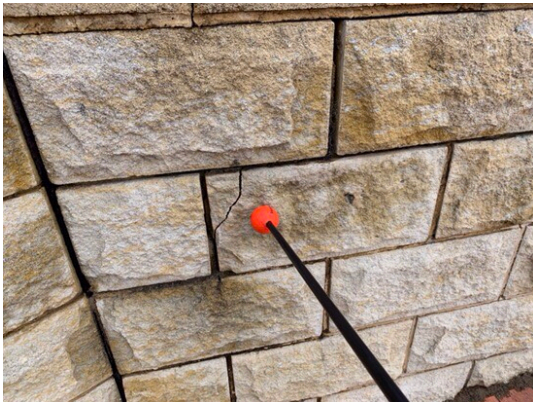
Defects 3.01

Building:	Main Building
Location:	Driveway
Finding:	Blockwork - Cracking noticeable
Information:	There was a crack evident to external block work.

Noticeable cracks are a common occurrence in external block work and are a likely result of age expected building movement, general expansion, and/or contraction of building materials in different weather conditions.

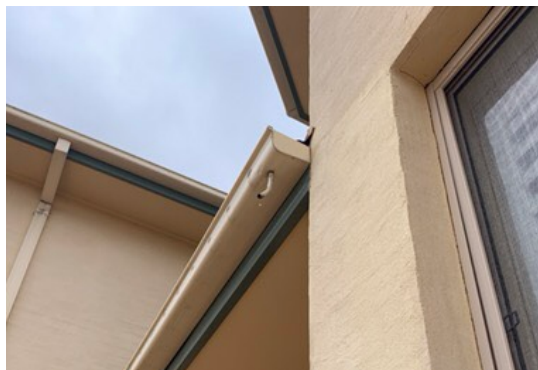
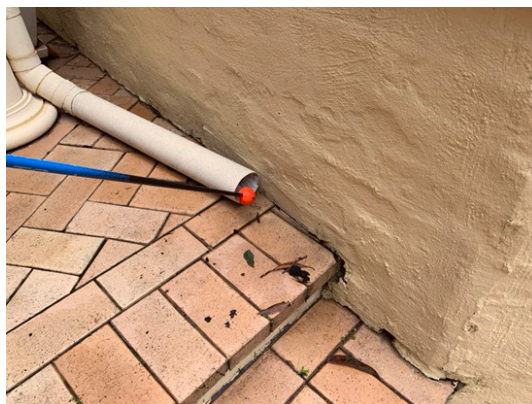
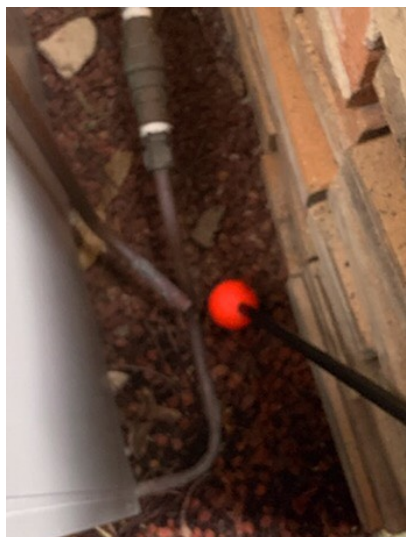
Defects 3.02

Location: Driveway

Finding: Overflow - Not plumbed for drainage

Information: The overflow is not plumbed or connected to suitable drainage, which has resulted in the surrounding area becoming excessively damp.

It is recommended that a qualified plumber be appointed to install adequate drainage to the overflow. These works will ensure that the area remains dry and free of any secondary defects.

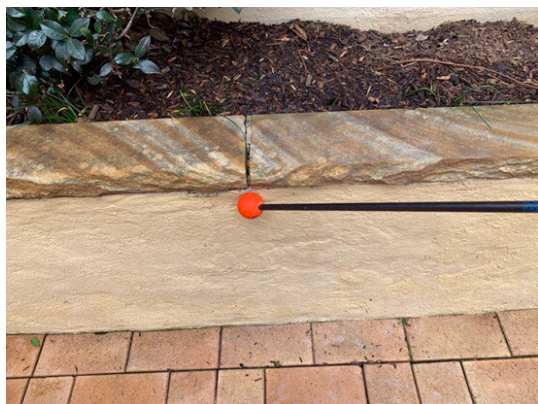
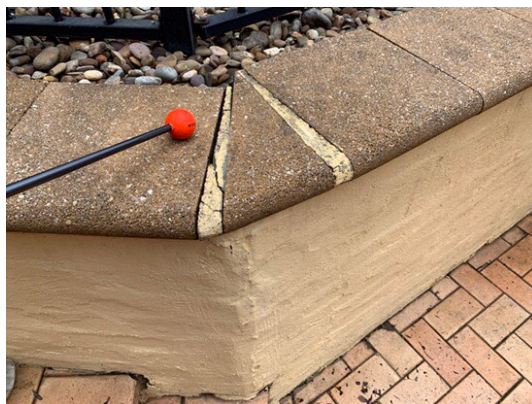
Defects 3.03

Location: Driveway

Finding: Mortar - Deterioration

Information: Mortar generally deteriorates as a result of frequent exposure to weather conditions over a prolonged period of time

Mortar deterioration can be attended to by a handyperson where areas of deterioration are localised and easily accessible.

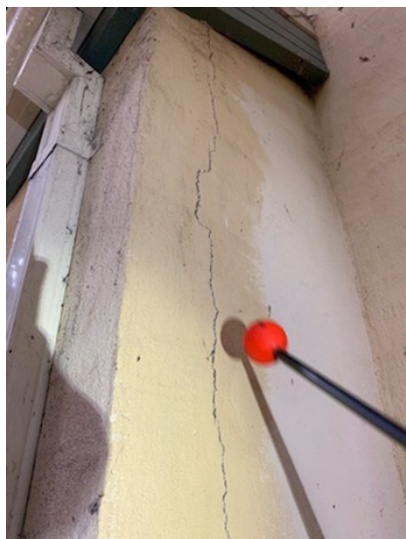
Defects 3.04

Location: Yard - Side

Finding: Cracks to external rendered surfaces - Category 2

Information: It has been observed that cracking to external rendered surfaces has occurred in this area. The degree of damage falls within Category 2, described as noticeable cracks which is easily filled. Such cracking may cause doors and/or windows to stick slightly, and are generally <5mm in width.

Damage of this category is required to be monitored for a period of 12 months, after which time a crack rated at Category 2 or above is considered a defect that requires rectification. Always contact your builder should cracks widen, lengthen, or become more numerous.

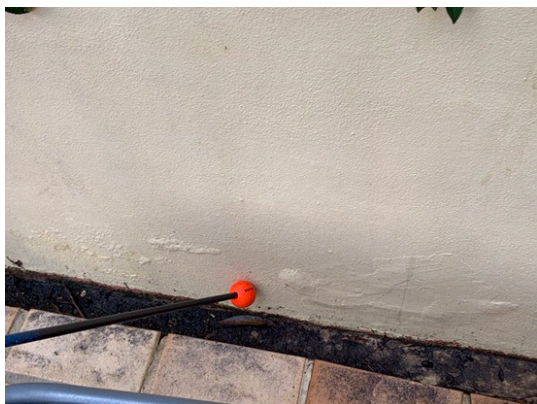
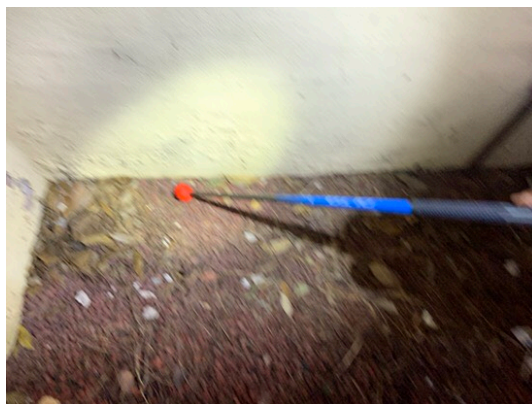
Defects 3.05

Building: Main Building
Location: Yard - Back
Finding: Painted surface - Bubbling
Information: Sections of paint in this area was found to have bubbled and deteriorated. Paint bubbling is generally an indication of excessive moisture in the area, that is currently hidden by the painted surface.

It is advised that the affected paint be cleaned and resealed.

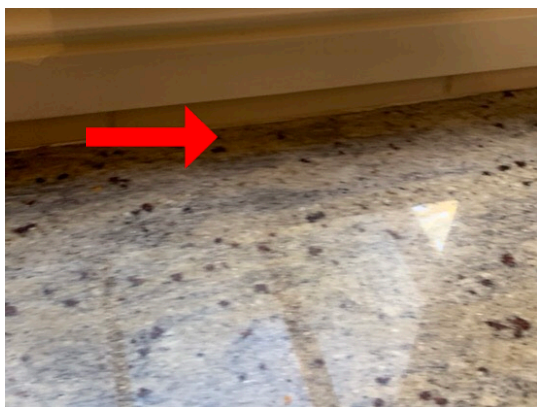
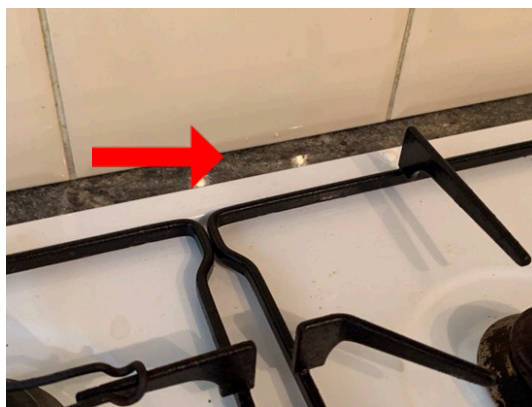
Defects 3.06

Location: Kitchen

Finding: Sealant and grouting - Missing or damaged

Information: Regular maintenance and replacement of damage or missing or damaged sealant and grout is recommended to the wet areas, as this is a regular wear and tear defect.

A sealant specialist or tiling contractor should be appointed to complete these works.

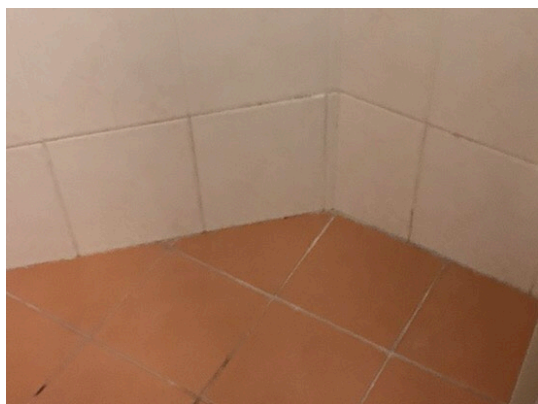
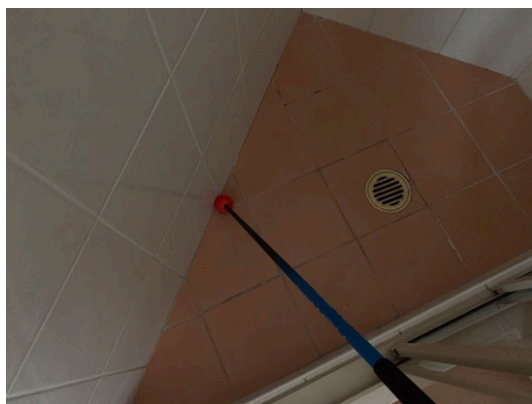
Defects 3.07

Location: Bathroom

Finding: Sealant and grouting - Missing or damaged

Information: Regular maintenance and replacement of damage or missing or damaged sealant and grout is recommended to the wet areas, as this is a regular wear and tear defect.

A sealant specialist or tiling contractor should be appointed to complete these works.

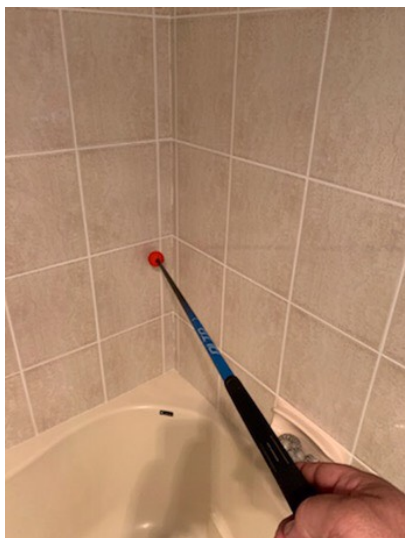
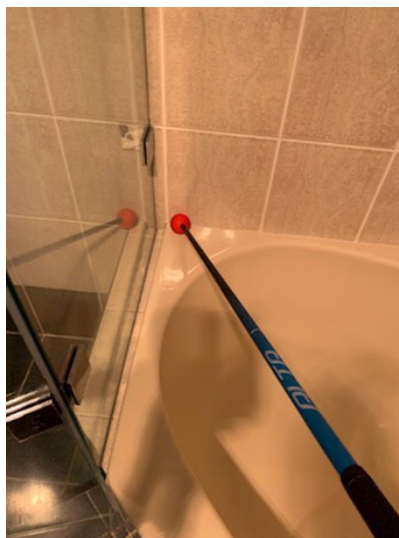
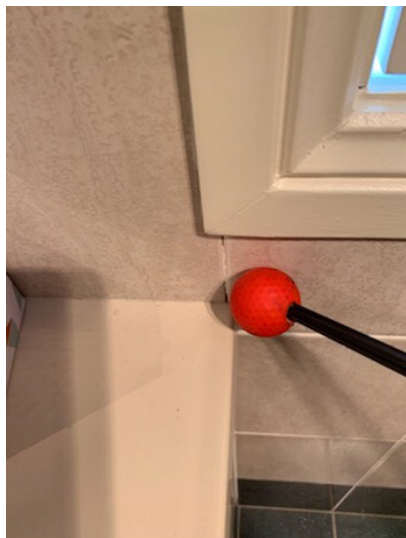
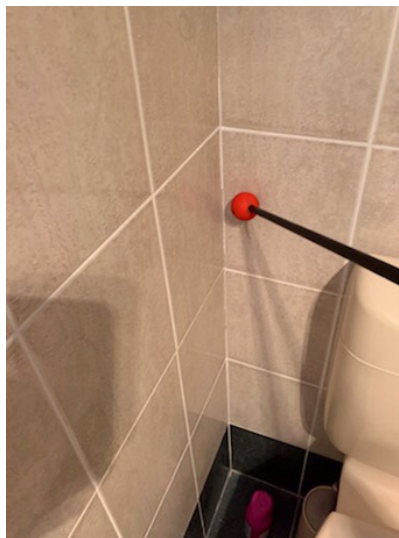
Defects 3.08

Location: Bathroom 2

Finding: Sealant and grouting - Missing or damaged

Information: Regular maintenance and replacement of damage or missing or damaged sealant and grout is recommended to the wet areas, as this is a regular wear and tear defect.

A sealant specialist or tiling contractor should be appointed to complete these works.

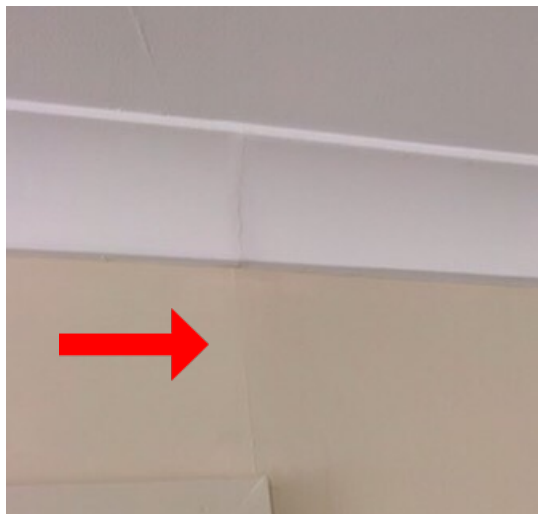
Defects 3.09

Building:	Main Building
Location:	Hallway
Finding:	Cracking - Damage Category 0 - Hairline (less than 1mm)
Information:	Hairline cracks are very minor in nature and generally are only ever an appearance defect. While such cracking may be noticeable in some cases, it is quite common and does not indicate any structural damage.

Cracking of this nature can generally be repaired with minor sanding, filling and/or repainting. Such works should be performed by a qualified painter or a general handyman.

Monitoring of all cracking should be conducted frequently. Always contact a building inspector should cracks widen, lengthen, or become more numerous.

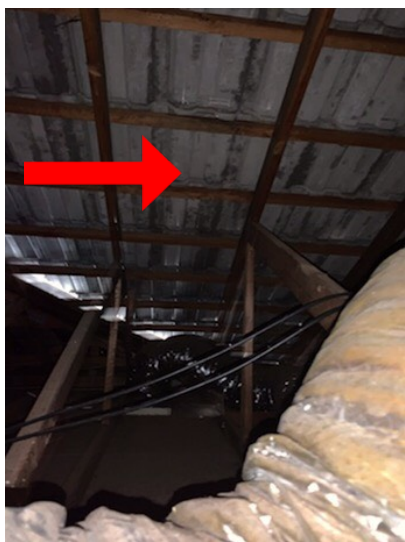
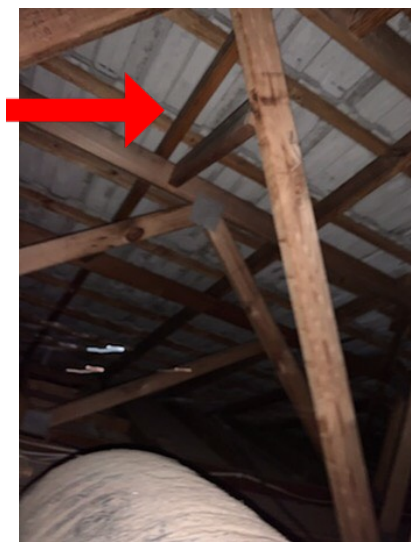
Location: Roof Void

Finding: Sarking - Missing

Information: Sarking is missing under the roof sheeting. Sarking acts as an insulator that helps with noise reduction and protects against water penetration. Sarking plays a key role in the operation and function of the overall roofing structure and its performance.

Although not a requirement at the time of construction, sarking is advisable (although this can be quite expensive to do after the time of construction).

Where sarking is missing, regular inspections of the roof tiles for cracking and potential moisture penetration is required.

Sarking may be retrospectively fitted by a registered builder at the discretion of the client.
