Building and Timber Pest Inspection Report

Inspection Date: Wed, 14 Apr 2021

Property Address: 65a Dareen st, Frenches Forest

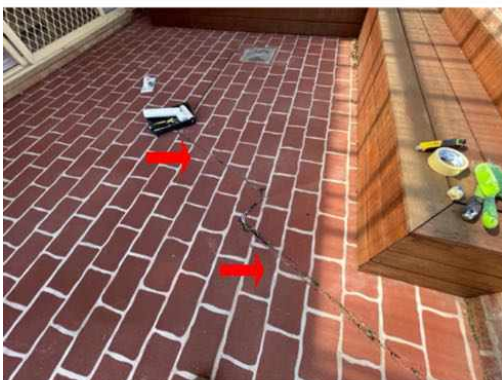
Defects 3.01

Building: Building 1
 Location: Pergola
 Finding: Sealant and grouting - Missing or damaged
 Information: Different materials and floor areas move at different rates, generally causing cracking to grout or sealant at this point. A flexible sealant is required to allow for expected expansion and contraction, while keeping the joint water tight and protective of all associated building materials.

Flexible and mould resistant materials should be applied to affected areas to prevent any subsequent water damage that is likely to occur. Regular maintenance and replacement of damage or missing or damaged sealant and grout is highly recommended to the wet areas, as this is a regular wear and tear defect. Sealant and grouting in areas that come into regular contact with water should be maintained for the long term care of your property.

A sealant specialist or tiling contractor should be appointed to complete these works.

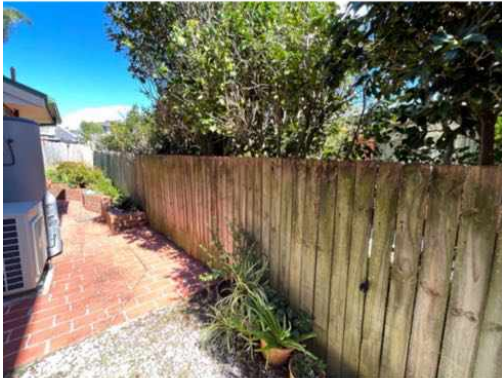
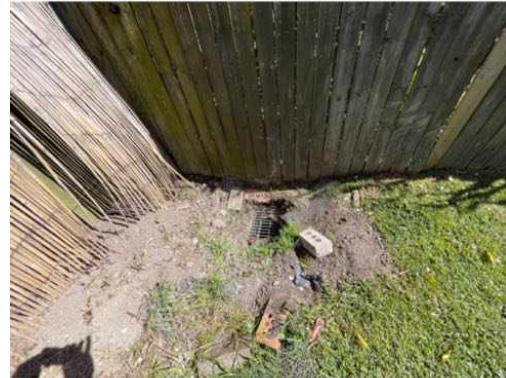
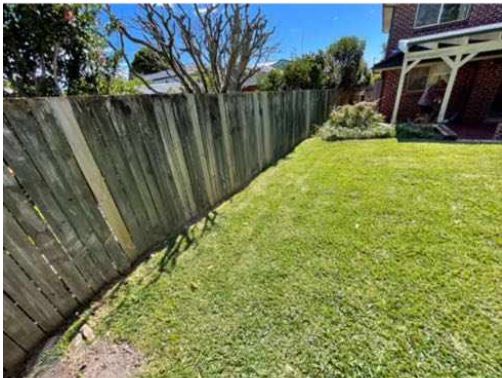
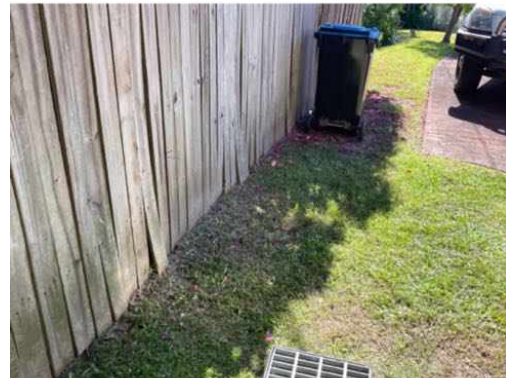
Defects 3.02

Location: All External Areas
 Finding: Fencing - Deteriorated
 Information: It was noted at the time of inspection that sections of the fencing throughout the property have deteriorated. Typically fencing deteriorates due to age and or wear, rot and or rust which is generally expected for a structure of this age, due to prolonged exposure to weather conditions. Sometimes inadequate installation or maintenance can be to blame.

If left unattended, it is likely that further damage will occur. It is suspected that repair of several elements of the fencing may be required however replacement may be a consideration of the client also.

A licensed fencing contractor should be appointed to provide further advice and perform rectification works as necessary.

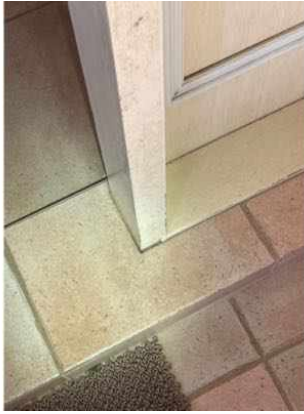
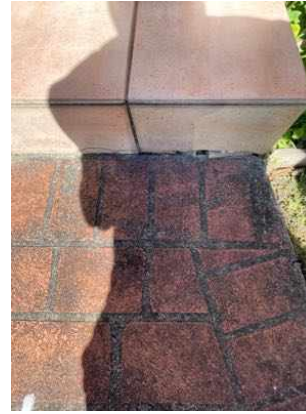
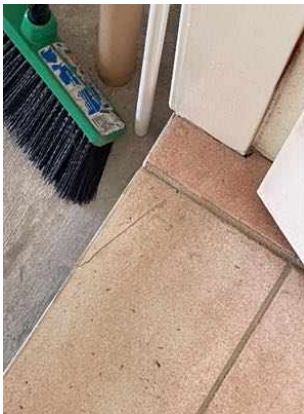
Defects 3.03

Building: Building 1
 Location: Entry
 Finding: Cracked floor tiles
 Information: Cracking in the floor tiles was evident in this area at the time of inspection. It is suspected that this cracking has occurred as a result of minor settlement or shrinkage of the slab.

Cracked tiles throughout the household detract from the overall appearance of the affected areas however it is unlikely to create or lead to any secondary defects.

While not considered a matter of urgency, replacement of cracked floor tiles is recommended at the clients discretion. A tiling contractor may be appointed to perform these works.

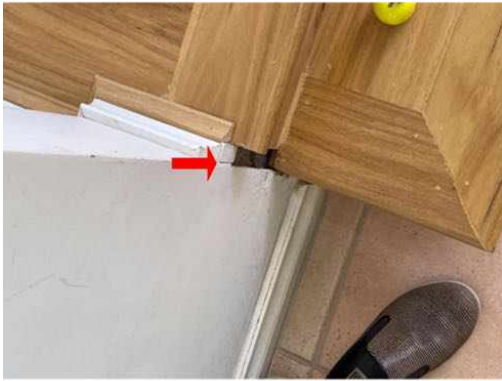
Defects 3.04

Building:	Building 1
Location:	Entry
Finding:	Timber flooring - Gap
Information:	This gaps make the adjoining building elements prone to water penetration, creating potential for the development of secondary damage.

it is recommended that these gaps be filled with a coloured caulking compound. Such works should be performed by a qualified carpenter or general handyperson, and should be completed at the discretion of the client.

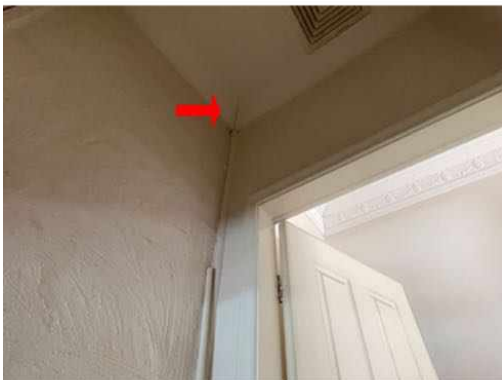
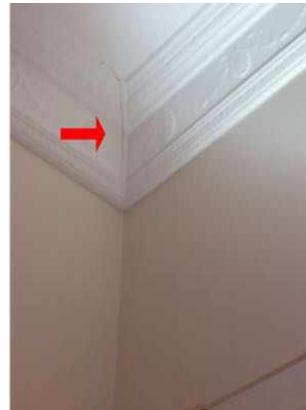
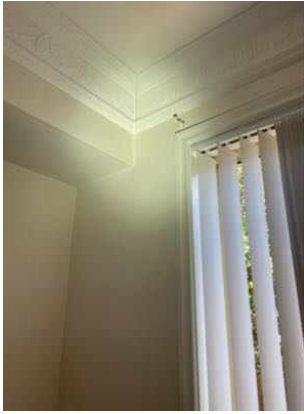
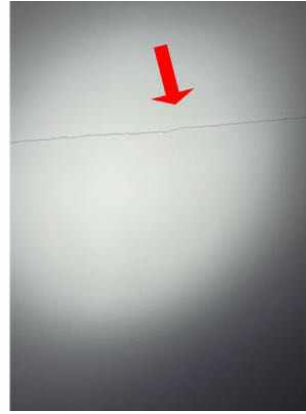
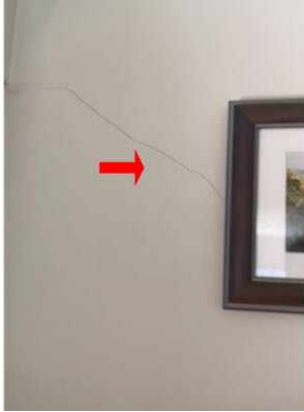
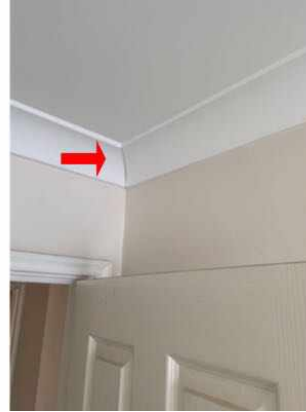
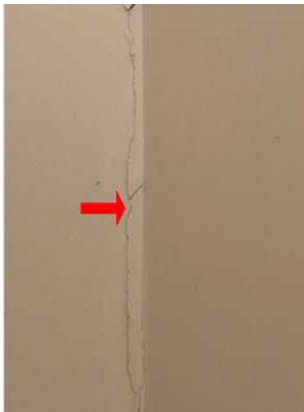
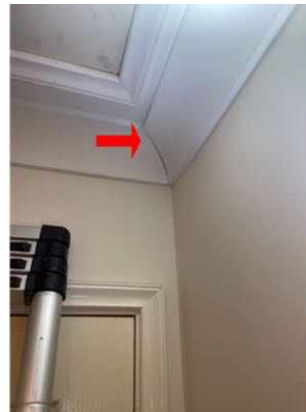
Defects 3.05

Building:	Building 1
Location:	All Internal Areas
Finding:	Cracking - Damage Category 0 - Hairline (less than 1mm)
Information:	Hairline cracks are very minor in nature and generally are only ever an appearance defect. While such cracking may be noticeable in some cases, it is quite common and does not indicate any structural damage.

Cracking of this nature can generally be repaired with minor sanding, filling and/or repainting. Such works should be performed by a qualified painter or a general handyman.

Monitoring of all cracking should be conducted frequently. Always contact a building inspector should cracks widen, lengthen, or become more numerous.

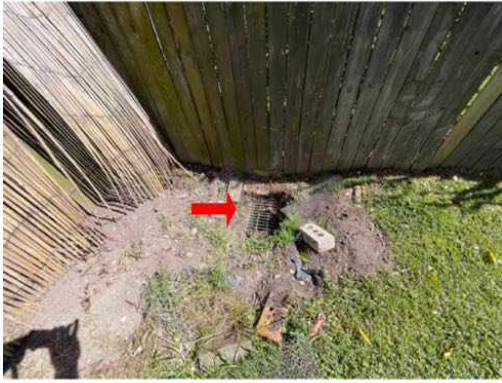
Defects 3.06

Building:	Building 1
Location:	Yard - Back
Finding:	Site drainage - suspected Inadequate
Information:	The site drainage in this area was found to be inadequate at the time of inspection, creating potential for subsequent water damage to associated building elements.

Where site drainage is inadequate, installation of an Agricultural (Aggie) Drain may be required. A qualified plumber should be appointed to further inspect the property and perform any remedial works as necessary. Water damage and secondary defects are likely to occur if left unmanaged.

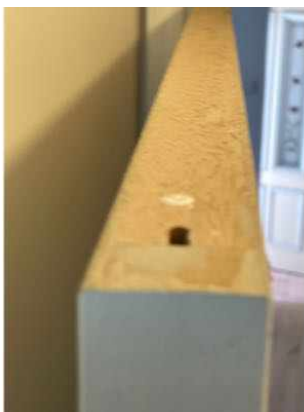
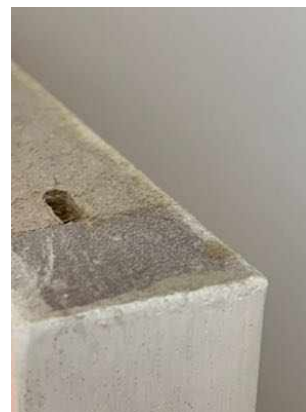
Defects 3.07

Building: Carport
 Location: All Areas
 Finding: Door finish - incomplete on top and bottom of door
 Information:

The paint finish in this area was identified as being incomplete at the time of inspection.

Whilst incomplete or missing paint finish is generally an appearance defect, it can also lead to the development of secondary building defects over time. Incomplete areas of paint finish exposes the area to moisture, potentially accelerating the deterioration of underlying building materials.

A painting contractor should be appointed to perform necessary works to aid the appearance of the affected area and to ensure the area is protected against further deterioration. Alternatively, the homeowner following manufacturer instructions may perform these works.

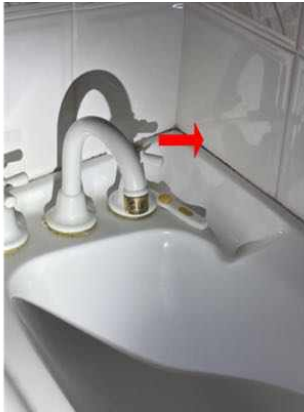
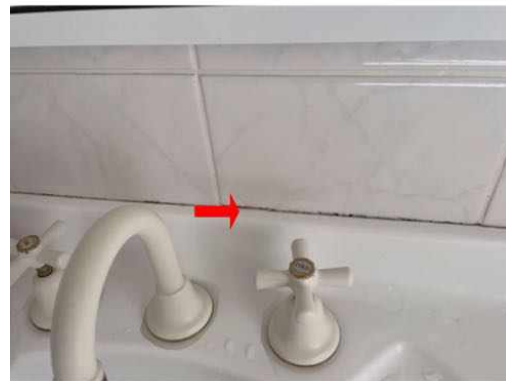
Defects 3.08

Location: Bathroom
Finding: Sealant and grouting - Missing or damaged
Information: Flexible and mould resistant materials should be applied to affected areas to prevent any subsequent water damage that is likely to occur. Regular maintenance and replacement of damage or missing or damaged sealant and grout is highly recommended to the wet areas, as this is a regular wear and tear defect. Sealant and grouting in areas that come into regular contact with water should be maintained for the long term care of your property.

A sealant specialist or tiling contractor should be appointed to complete these works as soon as possible

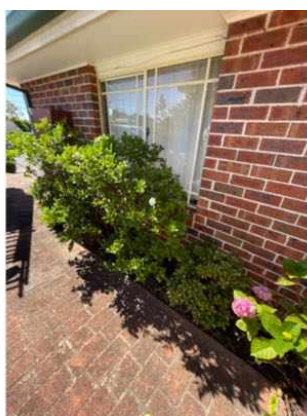
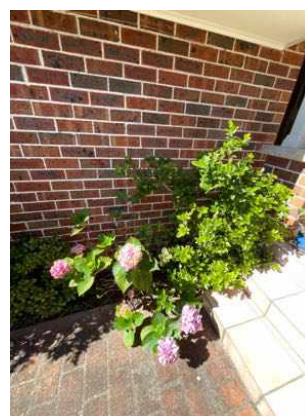
Building: Building 1
 Location: All External Areas
 Finding: Garden Beds - Conditions Conducive to Termites
 Information:

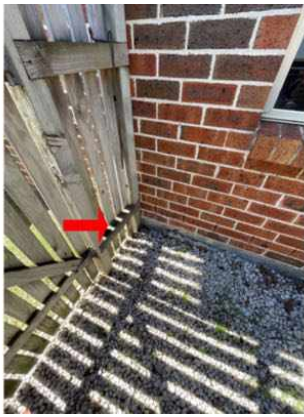
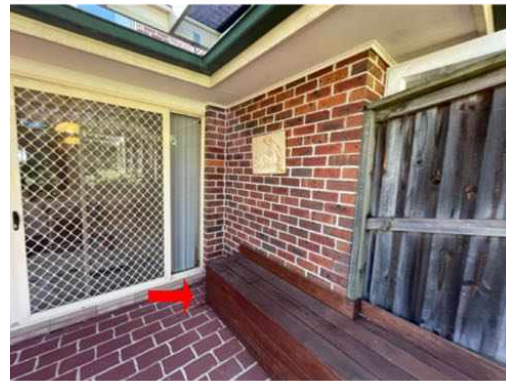
Building: Building 1
 Location: All External Areas
 Finding: Building materials in direct ground contact - conducive to termites
 Information: Where timber elements are in direct contact with the ground and consequently moisture or dampness they become conducive to termite activity. Whether timber is used as a building element part of a fencing structure or stored as an unused item they can provide an environment that is attractive to termite infestation. When met with excessive moisture timber begins to decay and develop wood rot. Any timbers that are in direct contact with external grounds especially if left untreated or non-durable also provide ingress for subterranean termites into that particular element. The removal of any such materials that may be conducive to termite activity should be removed as soon as possible to minimise the risk of termite attack.

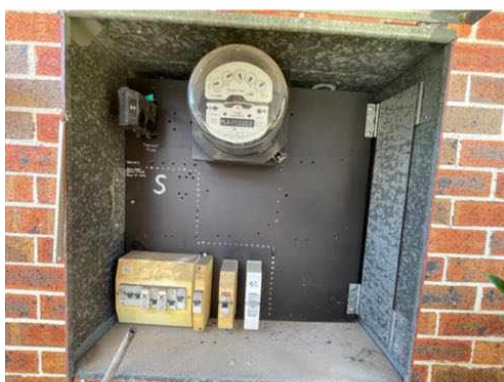
Building: Building 1
 Location: Yard - Side
 Finding: Termite Management System - no evidence of installation
 Information: The application of a post-construction chemical termite barrier is highly recommended for all properties, particularly if live termite activity has been found on the site previously. Such barriers are highly effective in preventing termite attack on any timber building elements throughout the property.

A durable notice should be placed in the switchboard unit to indicate current termite barriers. At the time of inspection, it appeared as though no termite management system has been installed, with no evidence to suggest preventative works taking place.

The client may consider gaining further advice from a pest controller as to the costs and procedures involved with this application. It is recommended that obtaining such advice be a short-term priority.

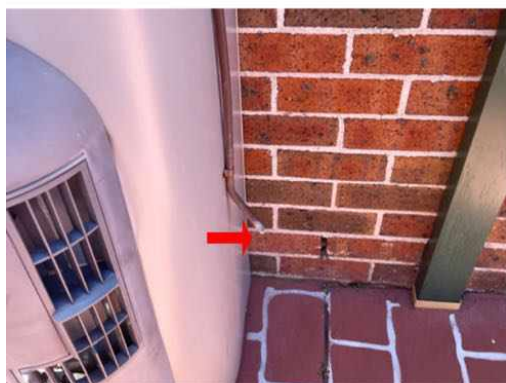
Finding: HWS Overflow - Not Connected
 Information: The Hot Water System (HWS) overflow was found to be disconnected from storm water drainage and is creating excessive moisture in the surrounding area.

These damp conditions can lead to secondary defects such as rot, rust or corrosion of associated building elements, the formation of fungal decay, or even the creation of potential slip hazards. When coupled with poor site drainage, pooling of water may also attract termite activity to this area.

It is highly recommended that a licensed plumber be appointed to connect the HWS overflow in order to prevent such an environment from being created. These minor works should be carried out as soon as possible.

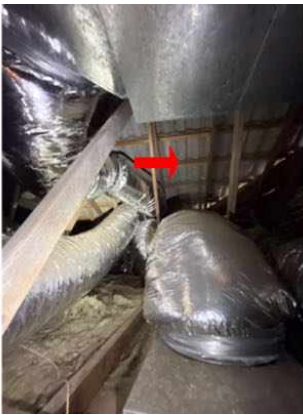
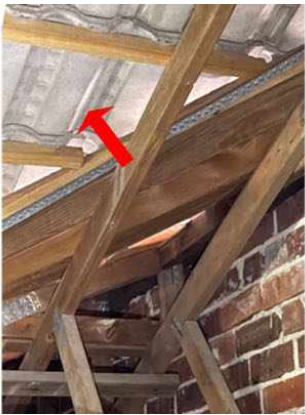
Building: Building 1
 Location: Roof Void
 Finding: Sarking - Missing
 Information: Sarking is missing under the roof sheeting. Sarking acts as an insulator that helps with noise reduction and protects against water penetration. Sarking plays a key role in the operation and function of the overall roofing structure and its performance.

Although not a requirement at the time of construction, replacement of any missing building element is advisable (although this can be quite expensive to do after the time of construction). Where sarking is missing, regular inspections of the roof tiles for cracking and potential moisture penetration is required.

Sarking may be retrospectively fitted by a registered builder at the discretion of the client.

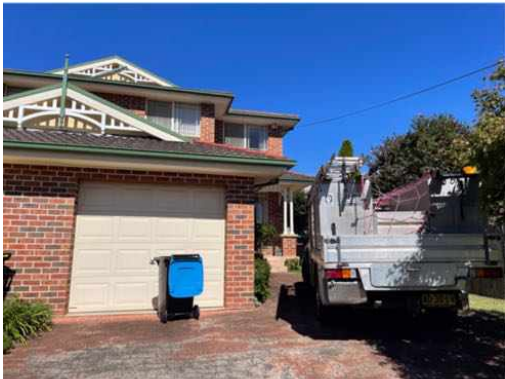
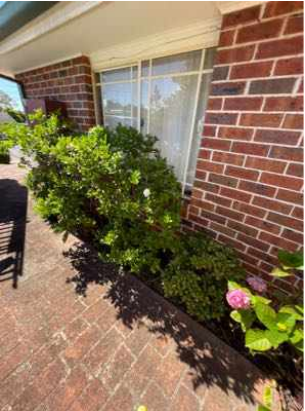
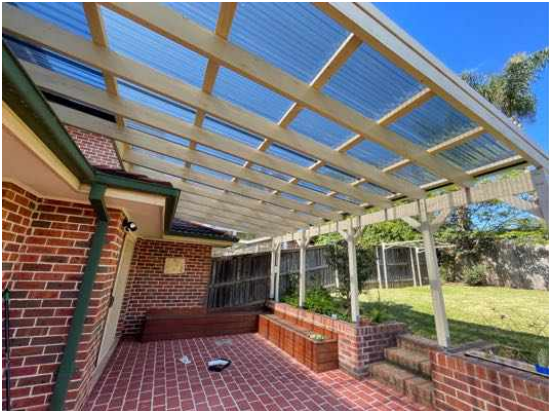
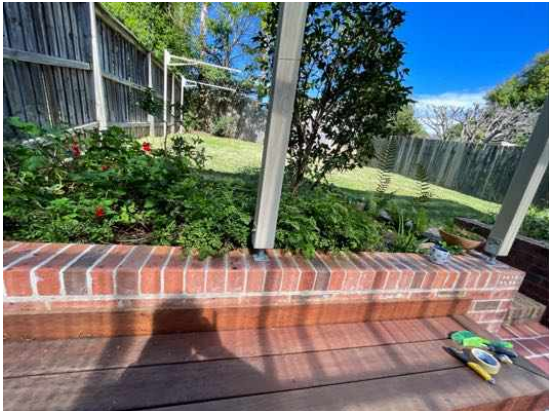
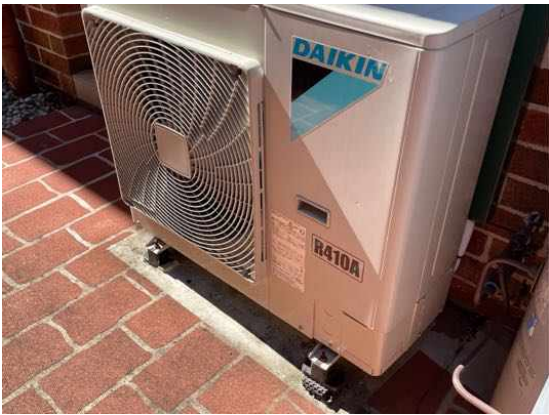
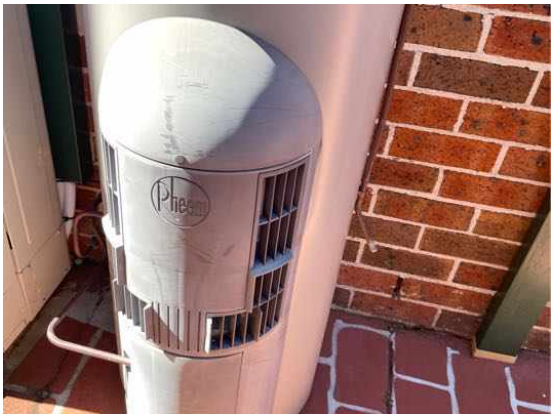
Building: Building 1
Location: All Areas
Finding: Additional Photos - Obstructions and Limitations
Information: These photographs are an indication of the obstructions and limitations which impeded full inspection of the property at the time of inspection. These obstructions can hide an array of defects and should be removed to allow full inspection to be carried out. A re-inspection is recommended once the areas are made accessible.
