## Section D Significant Items

### Defects 3.1

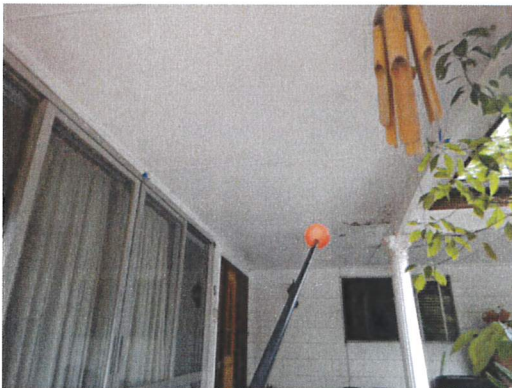
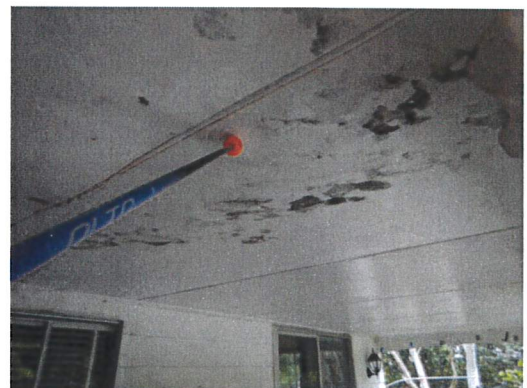
### Defects 3.13

Building: Main Building  
Location: All Areas  
Finding: Painted surface - Bubbling  
Information: Sections of paint in this area was found to have bubbled and deteriorated. Paint bubbling is generally an indication of excessive moisture in the area, that is currently hidden by the painted surface.

The presence of excessive moisture can have major implications on associated building elements if left unattended. While only seemingly minor at this stage, the damage cannot be determined due to the paint obstructing any further inspection of the damage.

It is highly advised that the affected paint be cleaned to allow a further, more invasive inspection by a licensed plumber. Failure to act on this defect may necessitate major works in the future.

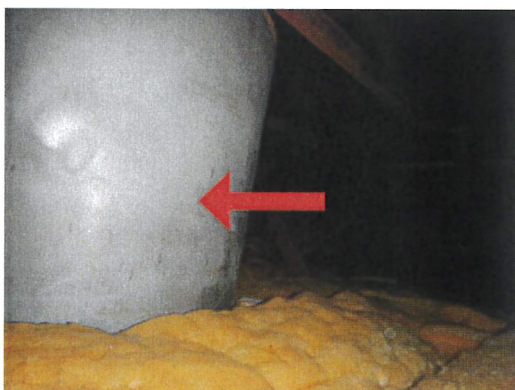
### Noted Item

Building: Main Building  
Location: Roof Void  
Finding: Gravity-Fed HWS - Disconnected  
Information: It was noted at the time of inspection that a disconnected gravity-fed hot water system (HWS) remains in this area.

Despite this plumbing structure being unused, it is likely to be storing residual water, and is therefore susceptible to rust and corrosion. If allowed to continue, rust and corrosion is likely to lead to damage to adjoining building elements, and may also make the area susceptible to termite or timber pest activity.

While it is a costly exercise to remove the disused gravity-fed HWS, it is advisable in the short-term future to prevent any further damage to the area. Further consultation with a licensed plumber is required to gain further advice on removal of the structure.

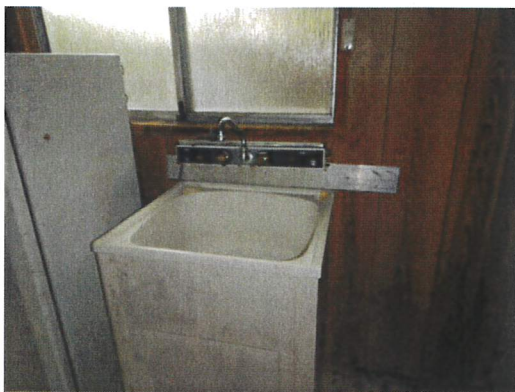
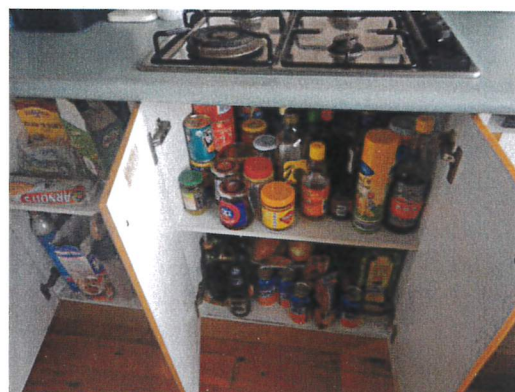
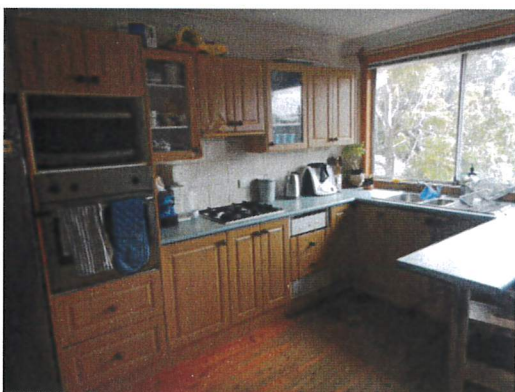
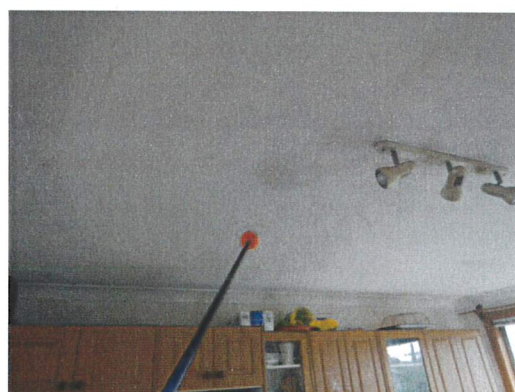
### Noted Item

Finding: Additional Photos - Obstructions and Limitations

Information: These photographs are an indication of the obstructions and limitations which impeded full inspection of the property at the time of inspection.
