BUILDING & TIMBER PEST INSPECTION REPORT

11565

81 Wesley Street, Elanora Heights NSW 2101

03 April 2023

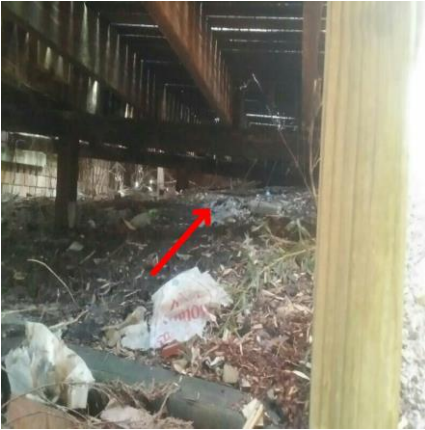
Visual inspection limited to some sections of the rear deck subfloor area due to low vertical clearances.

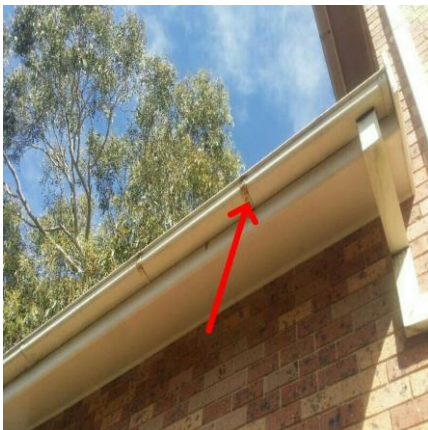
Corrosion to various gutter brackets. Rust treatment is recommended to help prevent further deterioration.

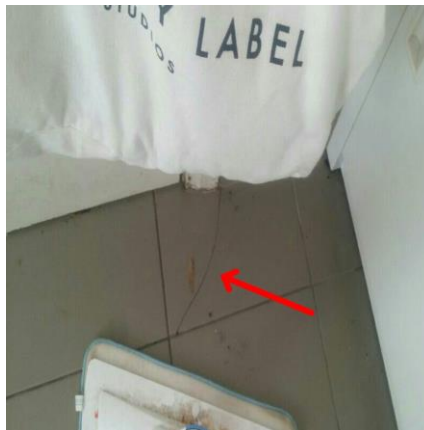
Cracked floor tile adjacent laundry external access door. Repairs aren't considered essential but would improve appearances.

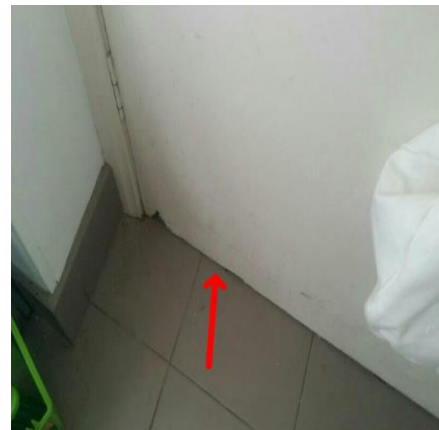
Moisture damage to laundry external access door. Repairs recommended to help prevent further deterioration.

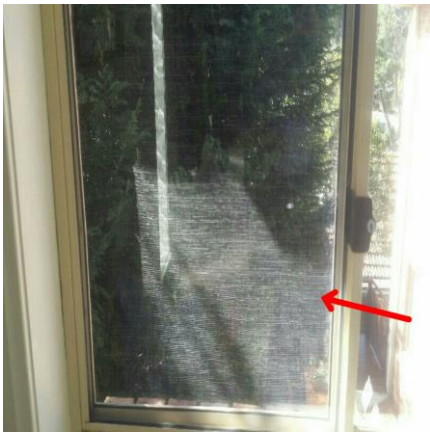
Some general repairs to window screens are required.

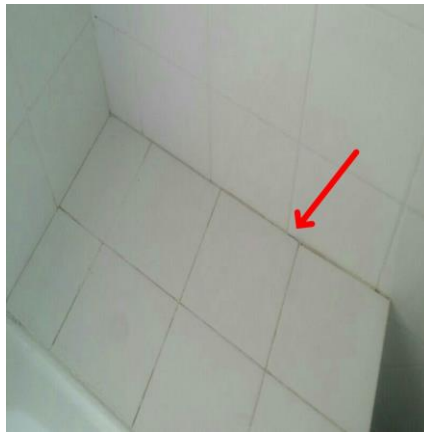
Recommend resealing bath hob at hob/ wall junction. A flexible sealant is recommended where differential movement takes place.

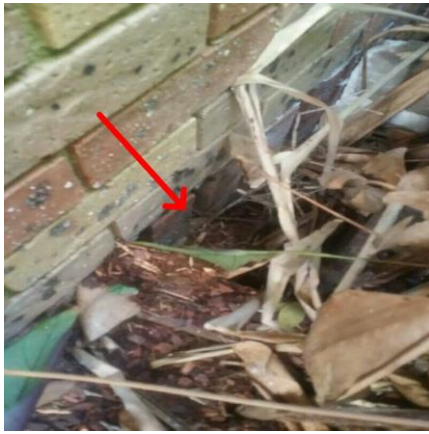
A 75mm ground clearance is required below subfloor vents to help prevent undetected termite entry.

Gardens abutting dwelling are areas where termites may colonise and enter dwelling via covered subfloor vents . Recommend removal to 75mm clearance below subfloor vents

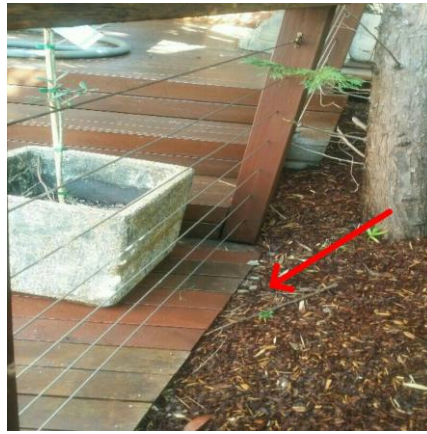
Recommend clearing mulch / leaf litter from rear deck joists and decking boards to help prevent undetected termite entry and possible wood decay.

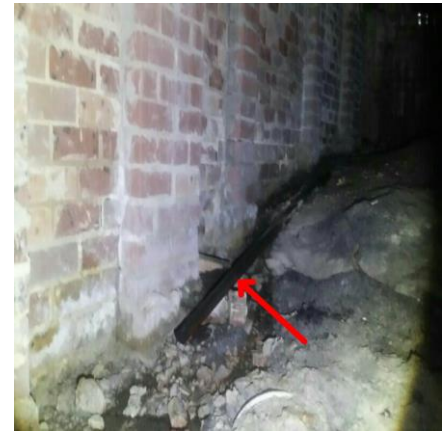
Timber debris in the subfloor area should be permanently removed to help prevent undetected termite activity.

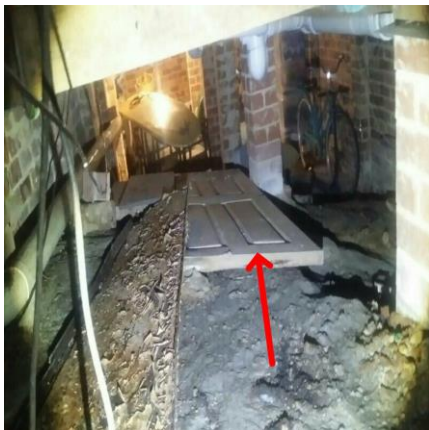
Stored goods should be permanently removed from the subfloor area to help prevent undetected termite activity.

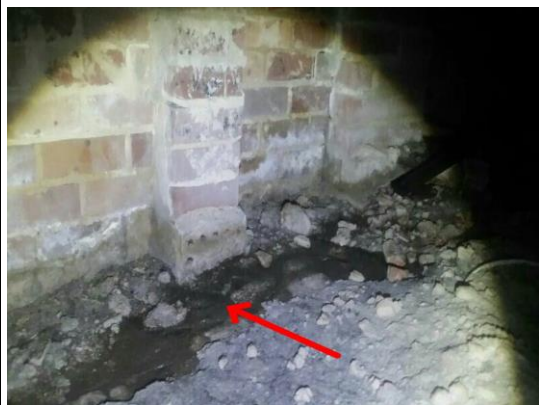
Stormwater runoff was detected in the subfloor area due to dwelling being built on exposed bedrock. The installation of a mechanical ventilation system is recommended to help keep the subfloor area dry. Recommend seeking further advice from a ventilation specialist.

Stormwater runoff was detected in the subfloor area. This is a common issue to dwellings that have exposed bedrock foundations. Monitor this area in future rain events. If excessive runoff is detected then further improvements to drainage may be necessary. Installing a mechanical ventilation system is recommended to help keep subfloor area dry.

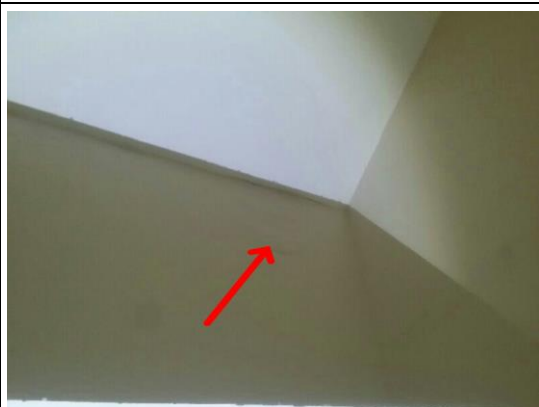
Moisture staining / blistered paint to top level, middle bedroom wall above the built in robe. Suggests previous leaks. Recommend to monitor for any further changes/staining, if so, further investigation into the cause of the leaking may be required.

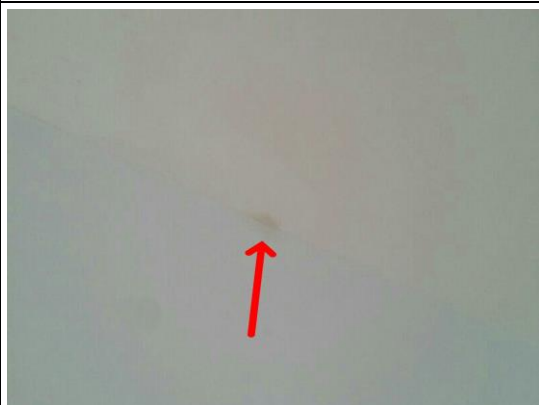
Moisture staining to top level hallway ceiling / wall junction. Suggests previous leaks. Recommend to monitor for any further changes/staining, if so, further investigation into the cause of the leaking may be required. This area is on the same line as the blistered wall paint in the middle bedroom.
