## Building Inspection Report

Inspection Date: Tue, 15 Nov 2022

Property Address: 7 Romford Rd, Frenchs Forest NSW 2086,  
Australia

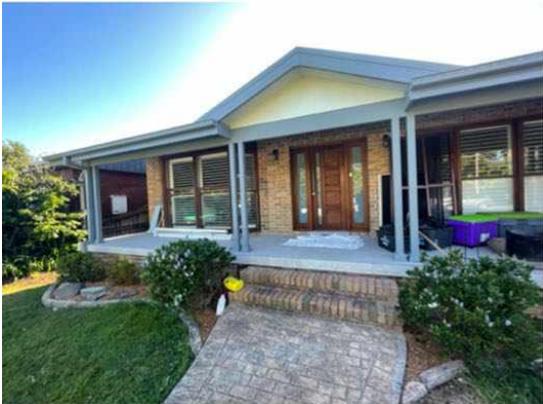
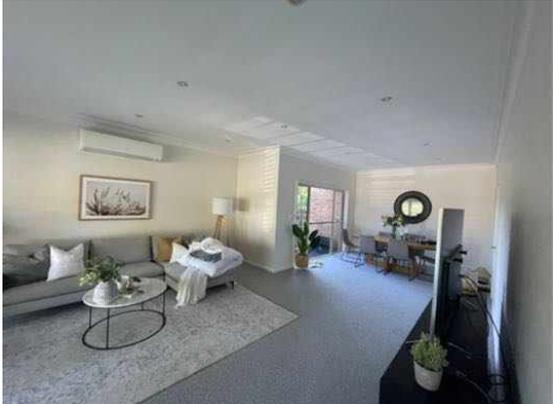
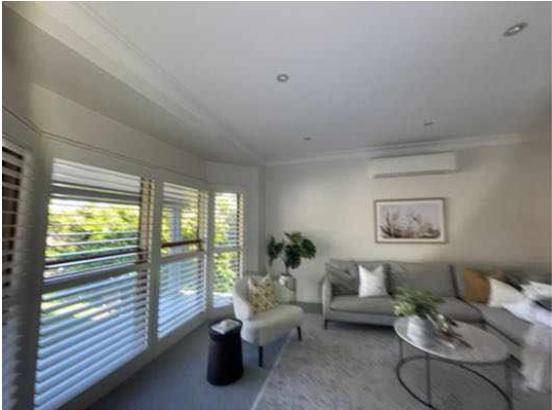
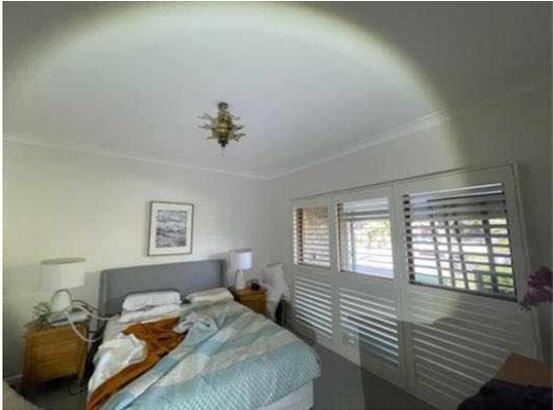
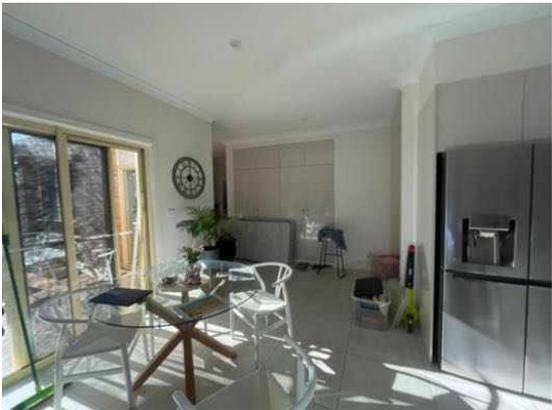
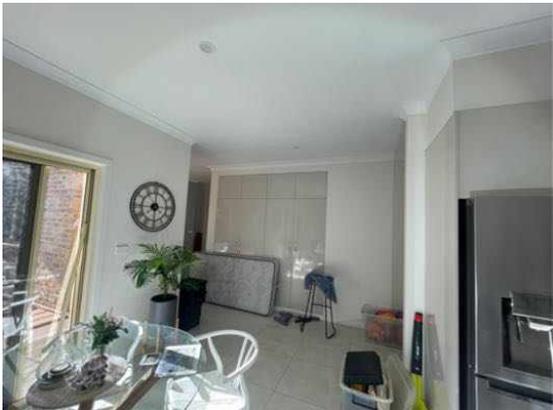
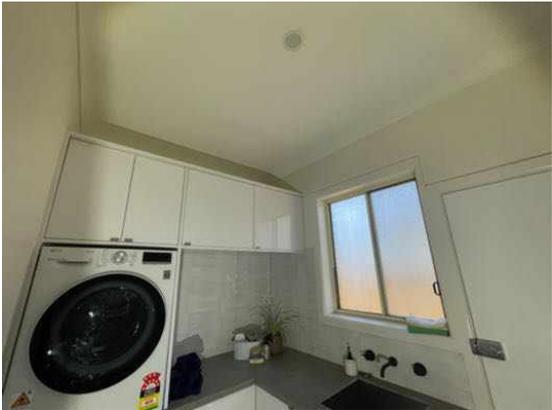
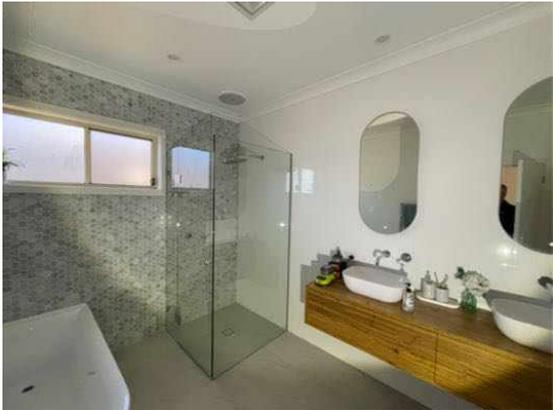
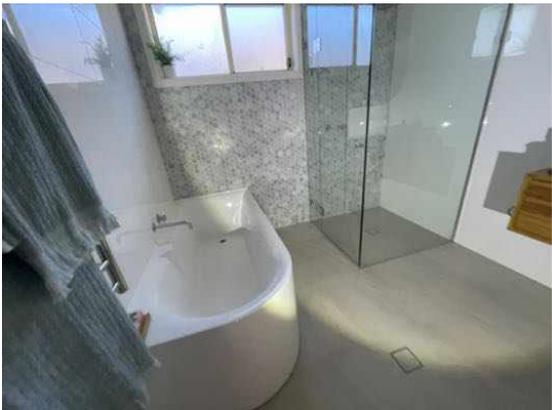
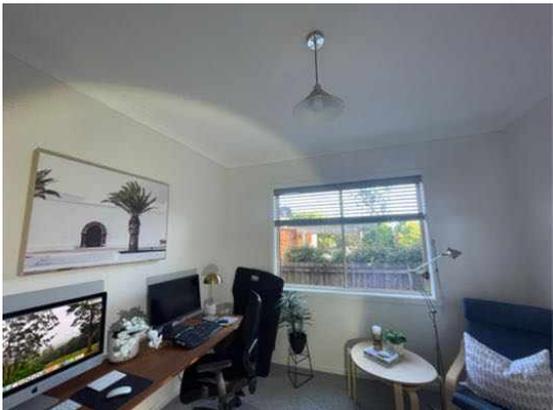
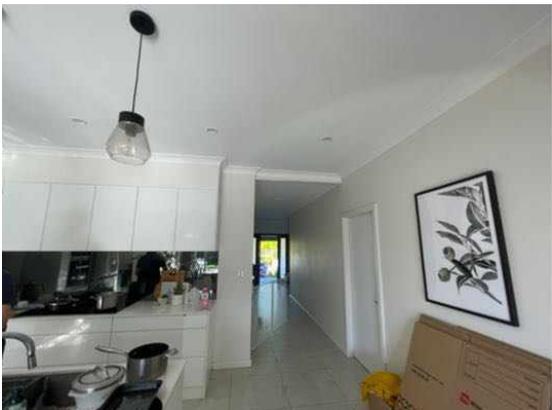
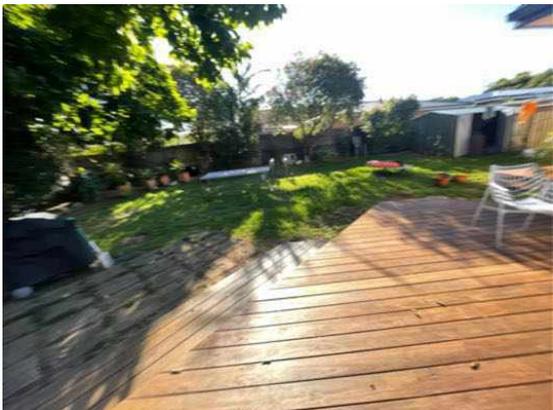
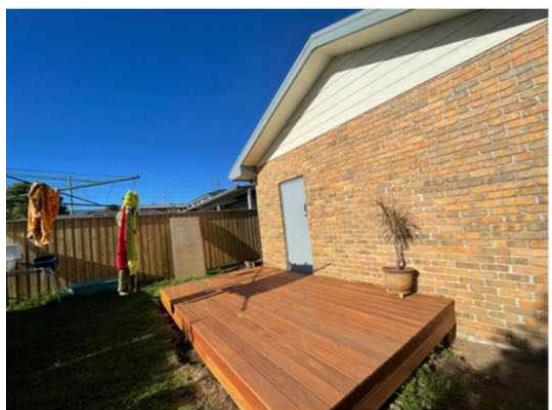
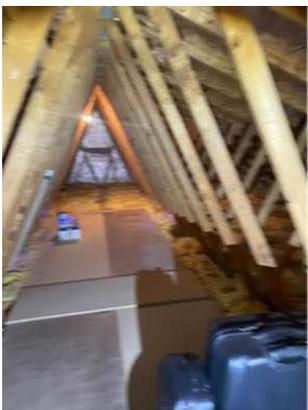
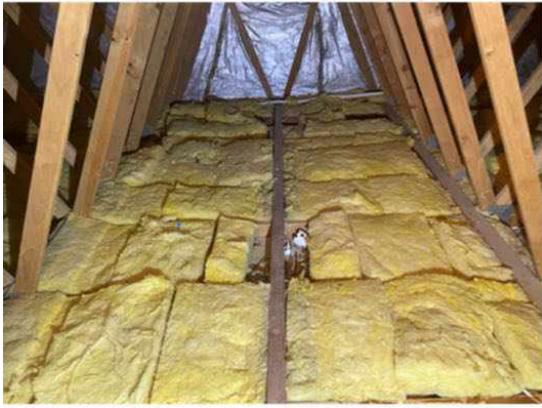
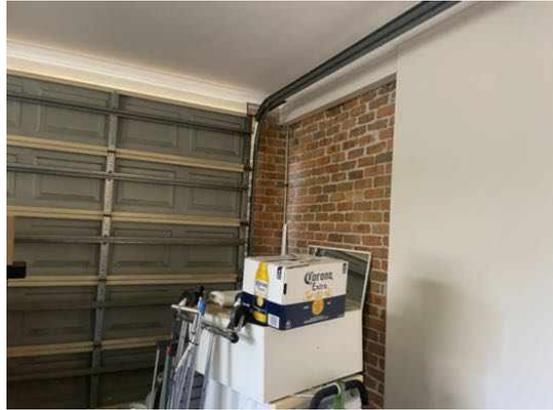
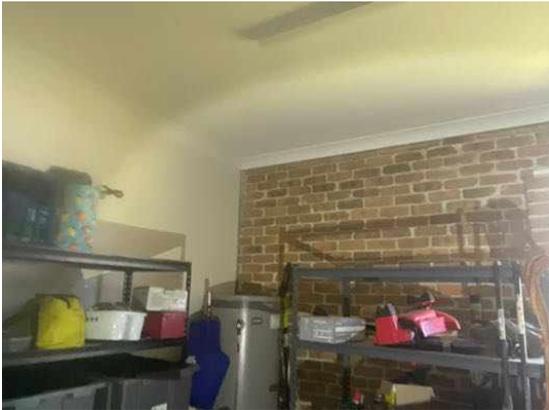
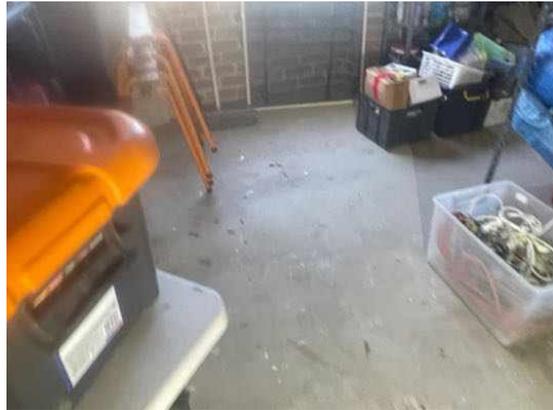
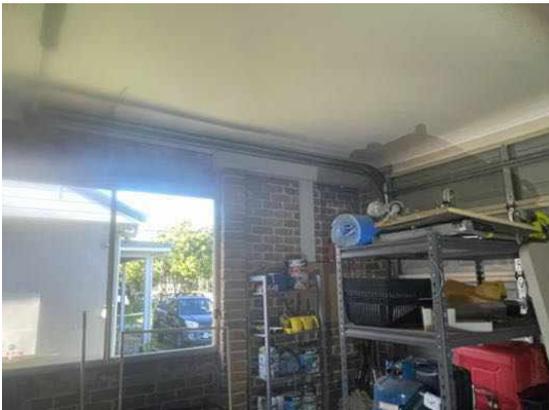
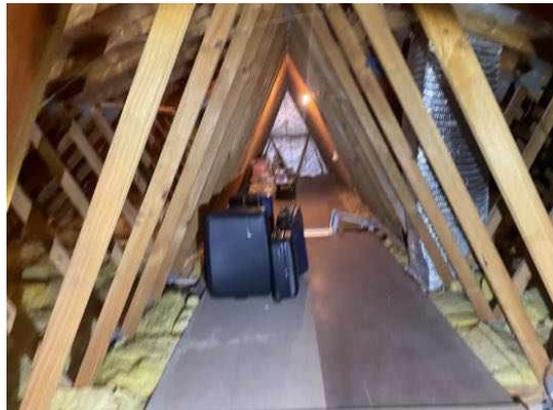
Building: Building 1  
Location: All Areas  
Finding: Additional Photos - Obstructions and Limitations  
Information: These photographs are an indication of the obstructions and limitations which impeded full inspection of the property at the time of inspection.

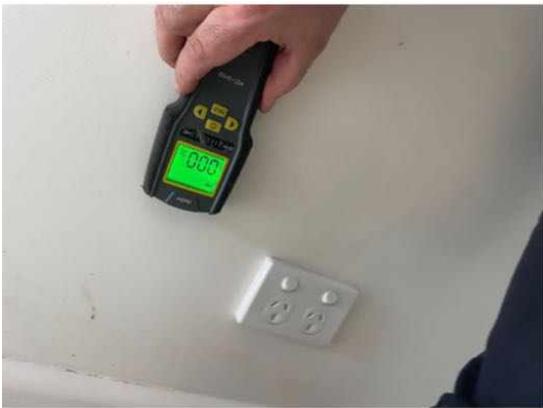
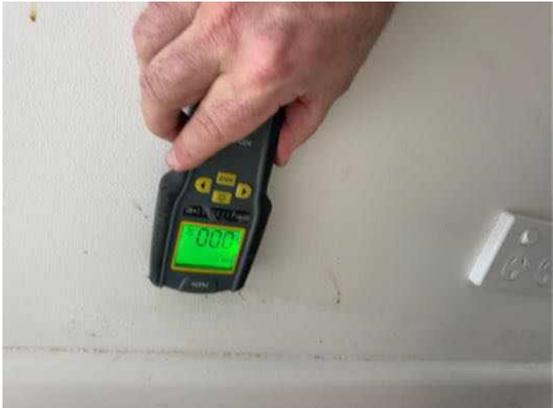
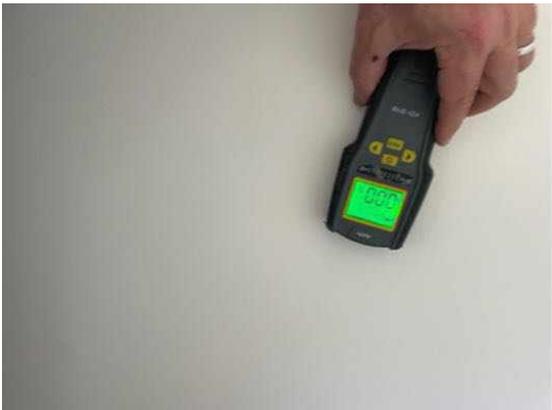
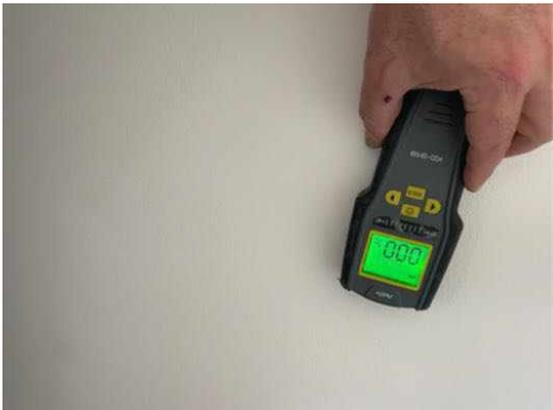
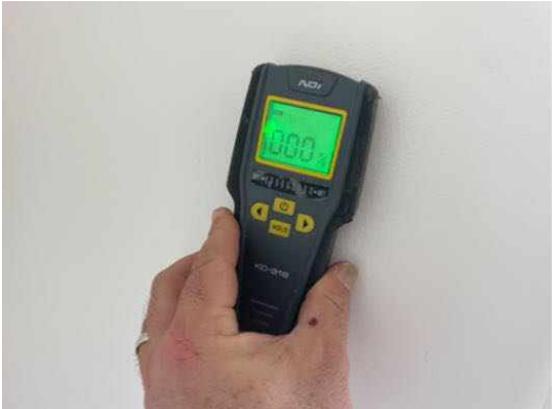
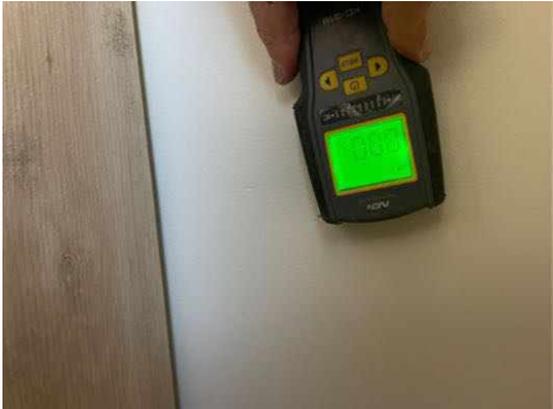
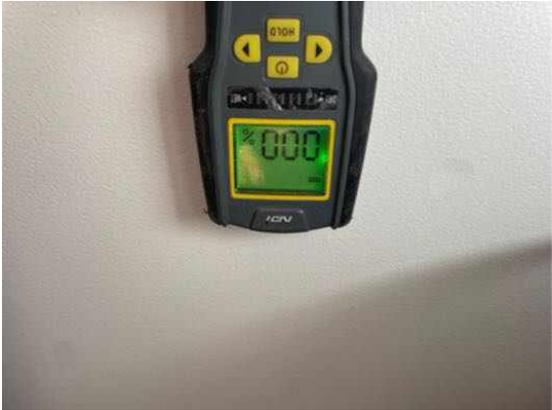
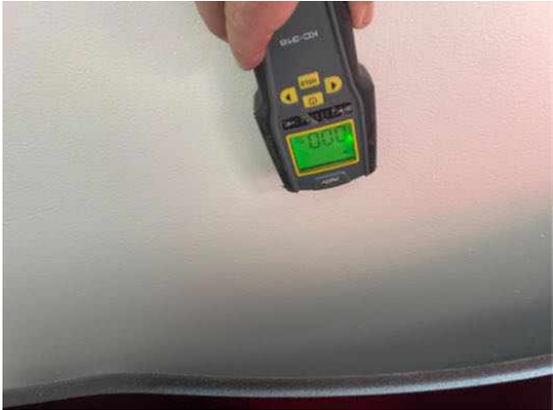
Building: Building 1  
 Location: All Areas  
 Finding: Moisture meter readings - low  
 Information: The moisture meter result for the areas inspected.

The moisture reading of 0-15% is quite normal and gives no cause for concern. However, moisture readings in excess of 15% indicate the need for further inspection.

Levels between 25-30% indicate that there may be water ingress, meaning that remedial work could be required.

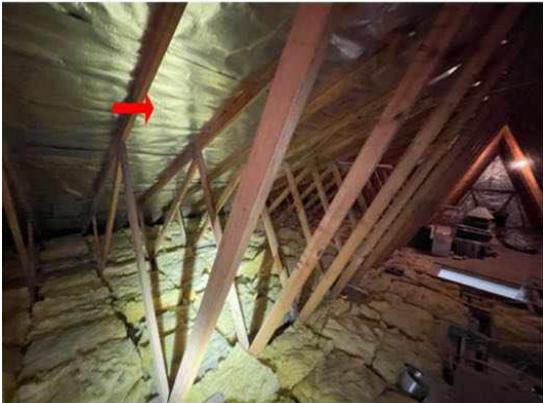
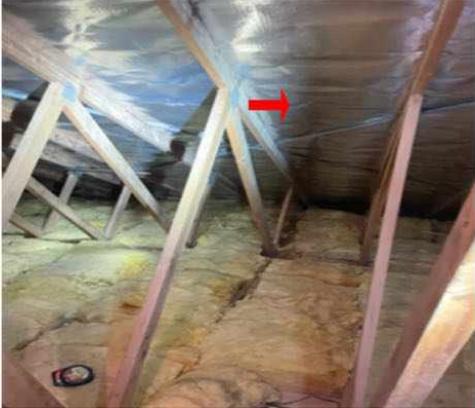
Building: Building 1  
Location: Roof Void  
Finding: Sarking - installed  
Information: Sarking is under the roof sheeting. Sarking acts as an insulator that helps with noise reduction and protects against water penetration. Sarking plays a key role in the operation and function of the overall roofing structure and its performance.

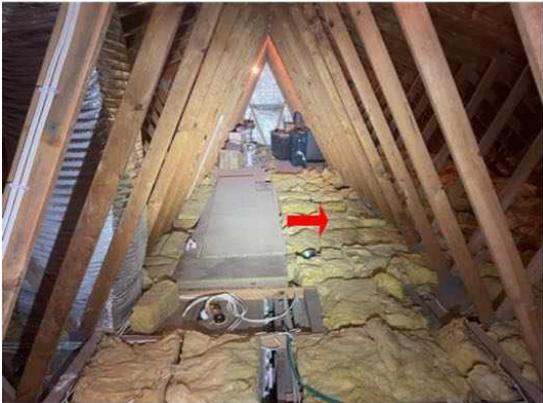
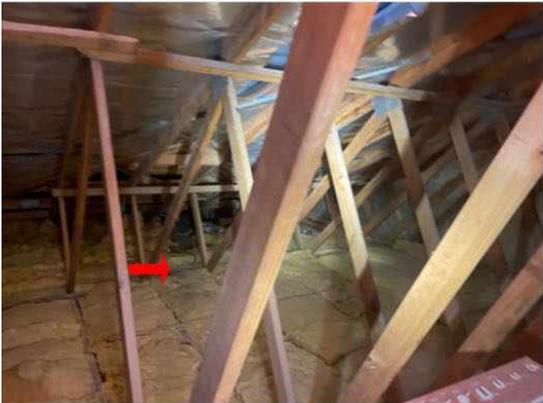
Building: Building 1  
Location: Roof Void  
Finding: Insulation- installed  
Information: Insulation is under the roof sheeting. Insulation acts as an insulator that helps with heat reduction.
