## **VISUAL VENDOR MAINTENANCE PEST INSPECTION REPORT** **25206-2017**

Date Inspection carried out: Thursday, 15th JUNE 2017

**22 Inverness Avenue, FRENCHS FOREST.**

# VISUAL TIMBER PEST INSPECTION REPORT

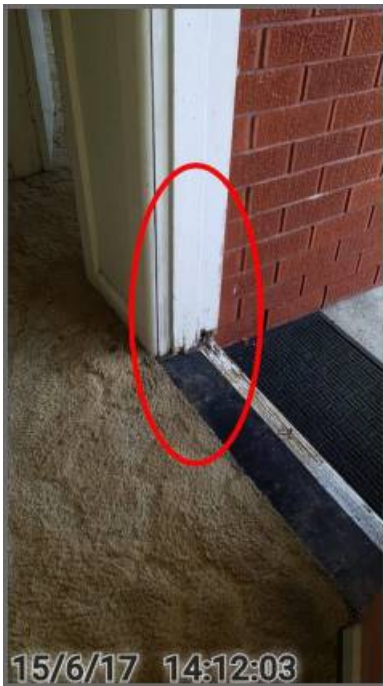
Yes - Wood decay damage was noted to the following timbers/areas.

#### **Affected interior timbers**

Door frame/jamb timbers:

Visible timber damage appears moderate however, we are not builders and this is not to be considered a builder's opinion.

Recommend consult and licensed building contractor to advise further as to costs and scope of works. Refer to the definitions section of this report - Section 1.6 - Timber Damage.

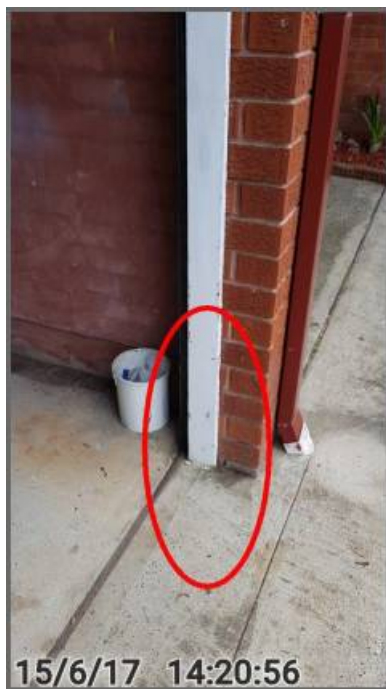
The following timbers are in contact with concrete / soil. Direct timber to concrete / soil contact can allow concealed termite entry and we recommend timbers be trimmed at least 75mm above finished floor level. Recommend consult licensed builder to advise further.

#### **Affected garaging timbers**

Door frame timbers:
