Timber Pest Inspection Report

Inspection Date: Sat, 1 Oct 2022

Property Address: 16 Prahran Ave, Frenchs Forest NSW 2086,
Australia

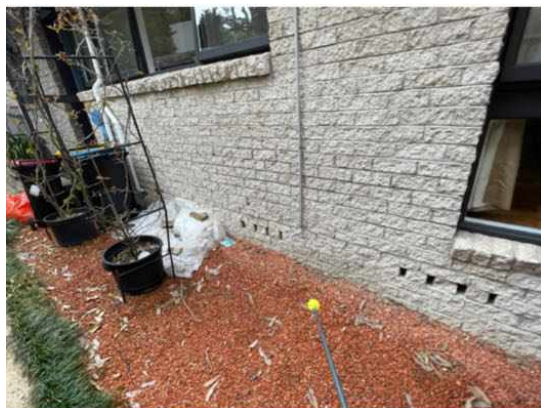
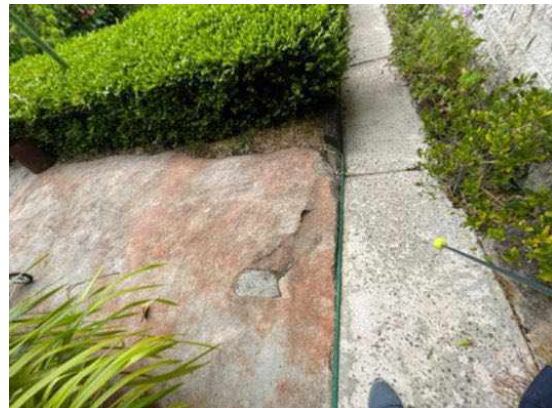
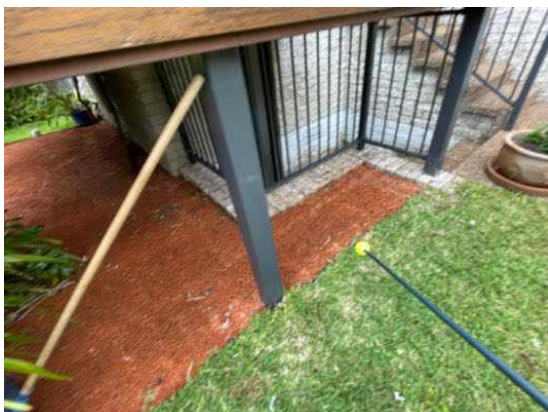
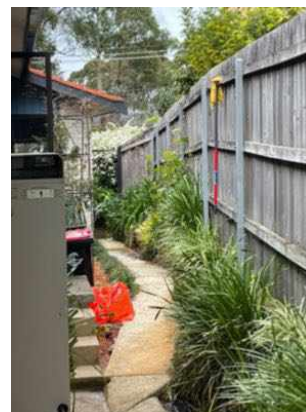
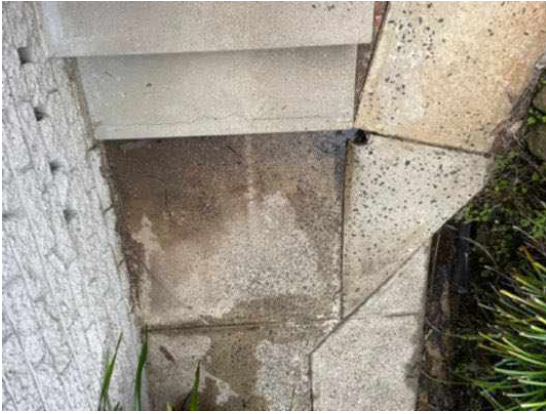
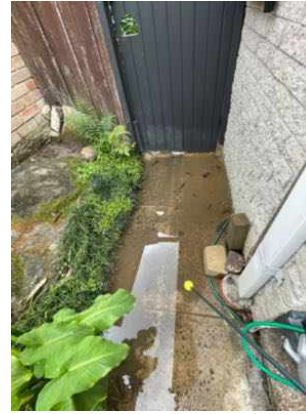
Termite and Timber Pest 1.01

Building: Building 1
Location: All External Areas
Finding: Evidence of excessive moisture was present at the time of inspection
Information: Excessive moisture can attract termites and produce conditions that promote termite attack fungal growth and wood decay.

Excessive moisture is generally caused by deteriorated inadequate or missing roof drainage leaking plumbing pipes or fixtures poorly plumbed HWS overflows or condenser units and poor site drainage.

It is highly recommended that all plumbing and drainage fixtures and fittings be maintained regularly in order to prevent excessive moisture being present in the external / internal property.

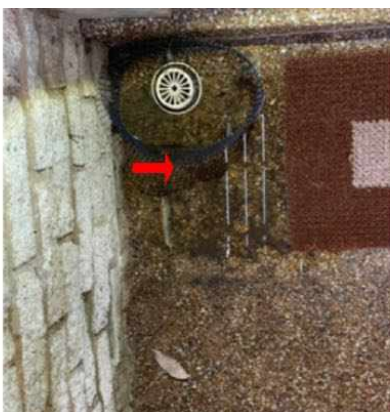
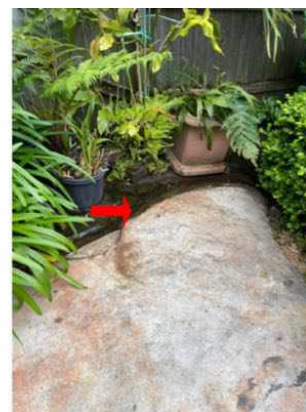
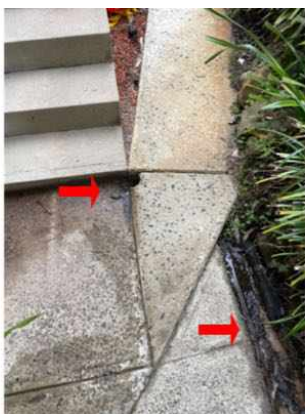
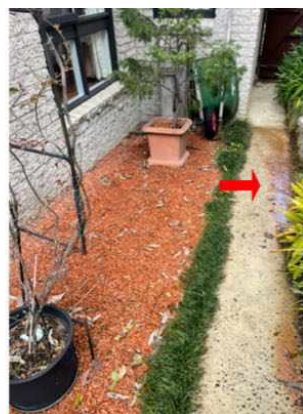
Termite and Timber Pest 1.02

Building:	Building 1
Location:	All External Areas
Finding:	Site drainage - suspected Inadequate
Information:	The site drainage in this area was found to be suspected inadequate at the time of inspection, creating potential for subsequent water damage to associated building elements.

It is important that water does not lie against the base of walls; surrounding paths and ground levels should be sloped to drain water away from walls. Downpipes should not discharge stormwater onto lower walls or plinths. Stormwater should be carried away by large, regularly cleaned drains. Ground levels may need to be lowered to expose a buried DPC.

Where site drainage is inadequate, installation of an Agricultural (Aggie) Drain may be required. A qualified plumber should be appointed to further inspect the property and perform any remedial works as necessary. Water damage and secondary defects are likely to occur if left unmanaged.

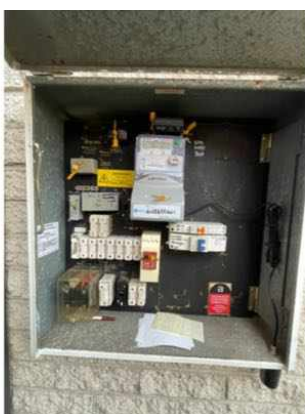
Termite and Timber Pest 1.03

Building:	Building 1
Location:	Yard - Side
Finding:	Termite durable notice not present
Information:	The application of a post-construction chemical termite barrier is highly recommended for all properties. Such barriers are highly effective in preventing termite attack on any timber building elements throughout the property.

A durable notice has been placed in the switchboard unit to indicate current termite barriers. At the time of inspection, it appeared as though there is only a physical termite management system has been installed.

The client may consider gaining further advice from a pest controller as to the costs and procedures involved with this application. It is recommended that obtaining such advice be a short-term priority.

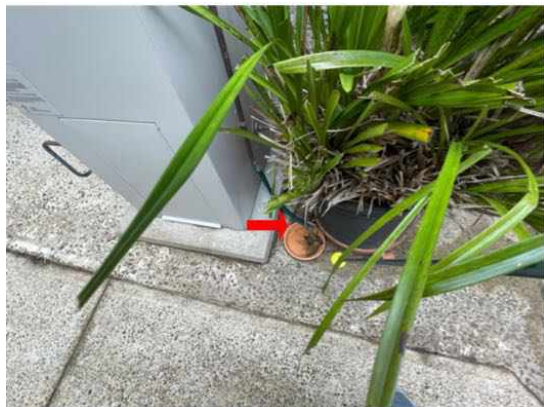
Termite and Timber Pest 1.04

Building:	Building 1
Location:	All External Areas
Finding:	HWS Overflow - Not Connected
Information:	The Hot Water System (HWS) overflow was found to be disconnected from storm

water draining and is creating excessive moisture in the surrounding area.

These damp conditions can lead to secondary defects such as rot, rust or corrosion of associated building elements, the formation of fungal decay, or even the creation of potential slip hazards. When coupled with poor site drainage, pooling of water may also attract termite activity to this area.

It is highly recommended that a licensed plumber be appointed to connect the HWS overflow in order to prevent such an environment from being created. These minor works should be carried out as soon as possible.

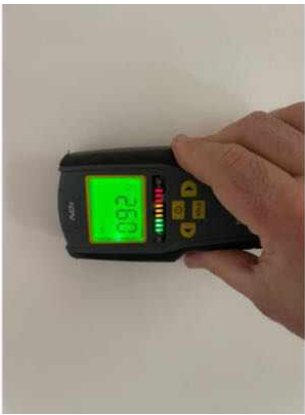
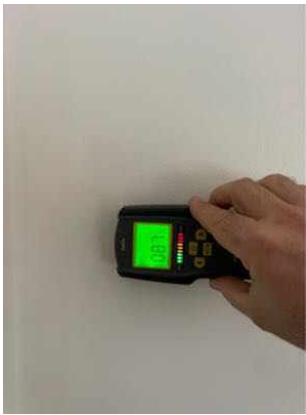
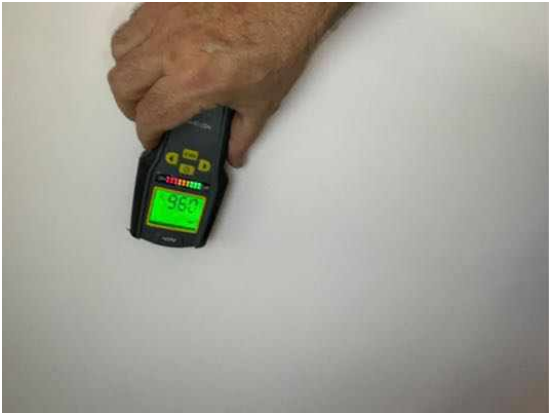
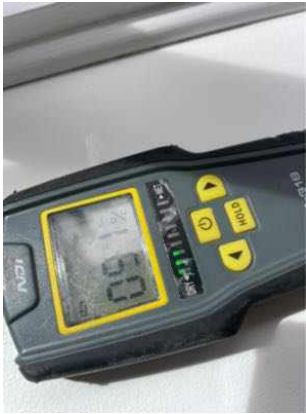
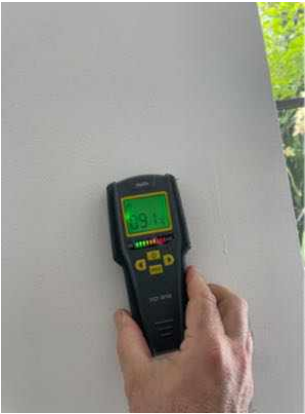
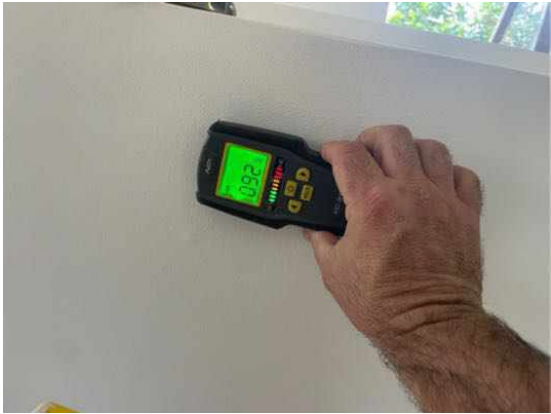
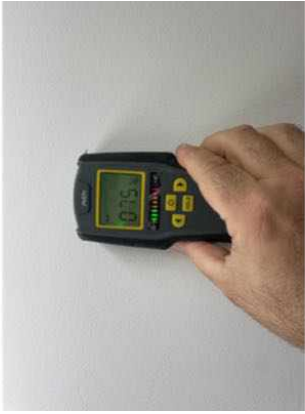
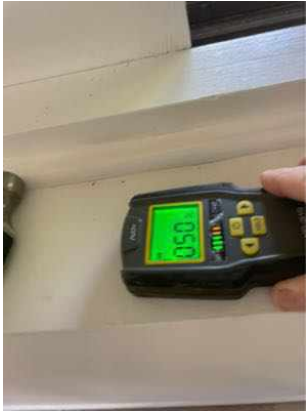
Termite and Timber Pest 1.05

Building:	Building 1
Location:	All Areas > Ground Level
Finding:	Evidence of excessive moisture was present at the time of inspection
Information:	Excessive moisture can attract termites and produce conditions that promote termite attack fungal growth and wood decay.

Excessive moisture is generally caused by deteriorated inadequate or missing roof drainage leaking plumbing pipes or fixtures poorly plumbed HWS overflows or condenser units and poor site drainage.

It is highly recommended that all plumbing and drainage fixtures and fittings be maintained regularly in order to prevent excessive moisture being present in the external / internal property.

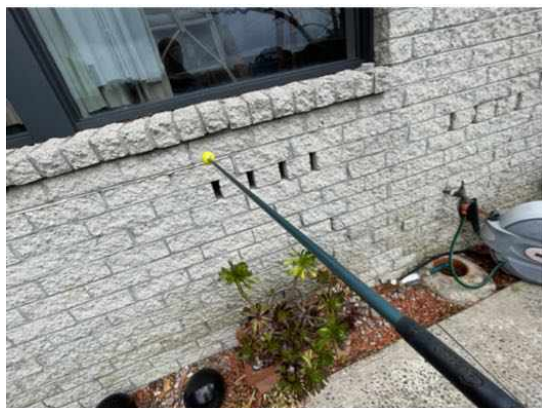
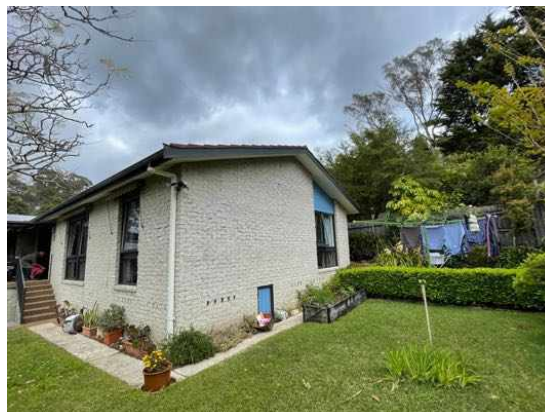
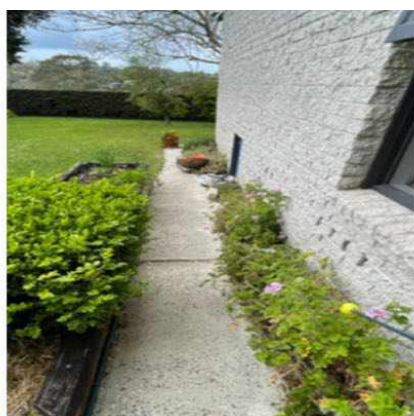
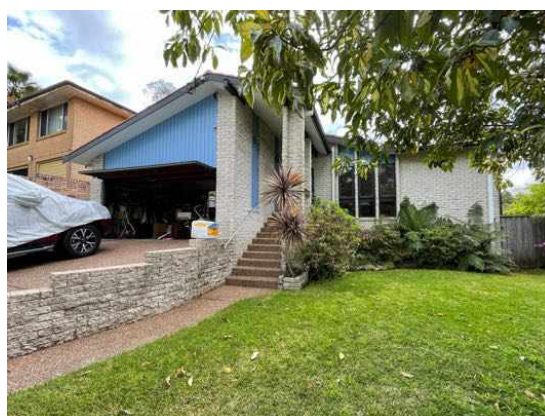
Termite and Timber Pest 1.06

Building:	Building 1
Location:	All External Areas
Finding:	Garden Beds - Conditions Conducive to Termites
Information:	Garden beds were found to be evident in the garden area. These garden beds can include untreated timber, and with a combination of moisture from watering hosing can make conditions conducive to termite activity and termite ingress.

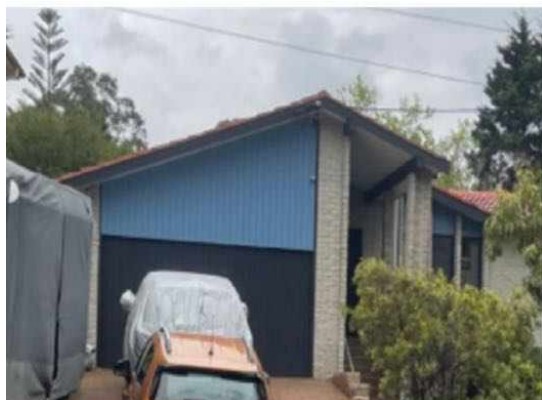
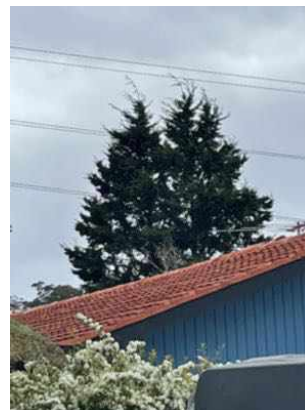
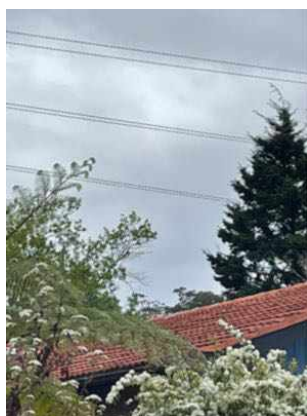
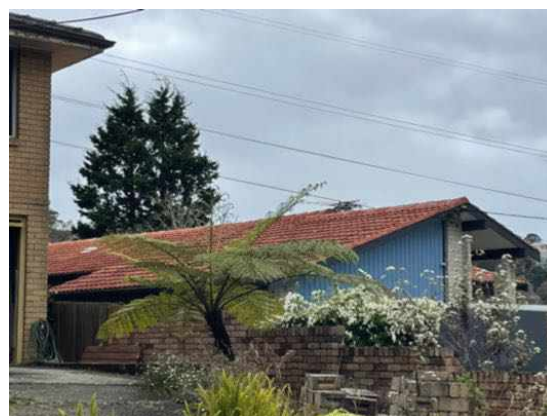
Termite and Timber Pest 1.07

Building:	Building 1
Location:	All Areas
Finding:	Trees - Overhanging and filling gutters
Information:	Overhanging trees often result in excessive amounts of leaf debris accumulating in gutters.

Gutters are a critical part of the building's management of storm water and rain. It is therefore important that they be kept clear to prevent secondary damage to associated building elements, including exterior and interior walls, ceiling linings and any adjoining building elements. Where gutters are blocked, pooling of rainwater is likely to occur, fast-tracking rust and corrosion of the roof plumbing elements.

It is highly advised that all overhanging tree branches be removed as soon as possible to prevent any further damage. Repair and/or replacement of sections of damaged

guttering may also be required where the extent of the damage necessitates.

Such works should be performed by the homeowner; however, appointment of a landscape contractor or an arborist may be required. Consultation with a licensed roof plumber is required where guttering has been damaged.

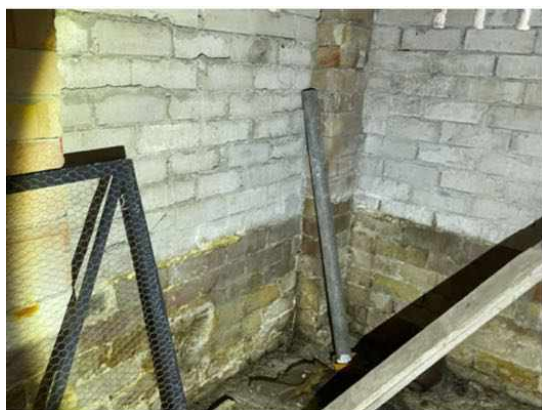
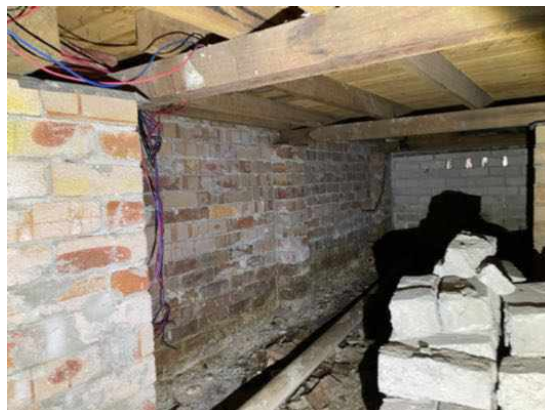
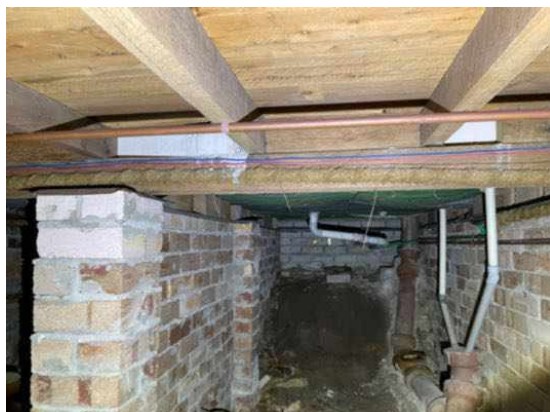
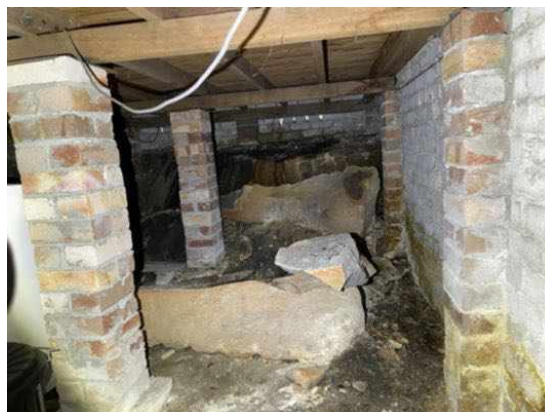
Termite and Timber Pest 1.08

Building:	Building 1
Location:	Subfloor
Finding:	Evidence of excessive moisture was present at the time of inspection
Information:	Excessive moisture can attract termites and produce conditions that promote termite attack fungal growth and wood decay.

Excessive moisture is generally caused by deteriorated inadequate or missing roof drainage leaking plumbing pipes or fixtures poorly plumbed HWS overflows or condenser units and poor site drainage.

It is highly recommended that all plumbing and drainage fixtures and fittings be maintained regularly in order to prevent excessive moisture being present in the external / internal property.

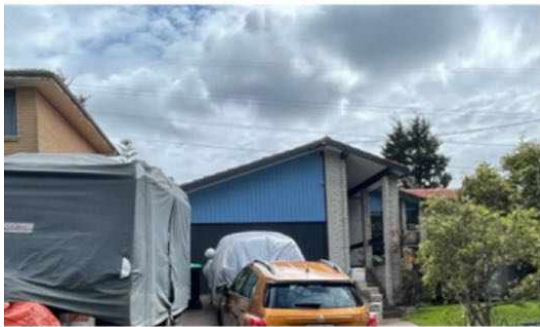
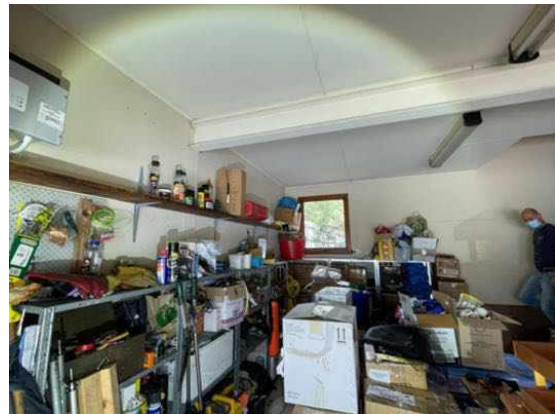
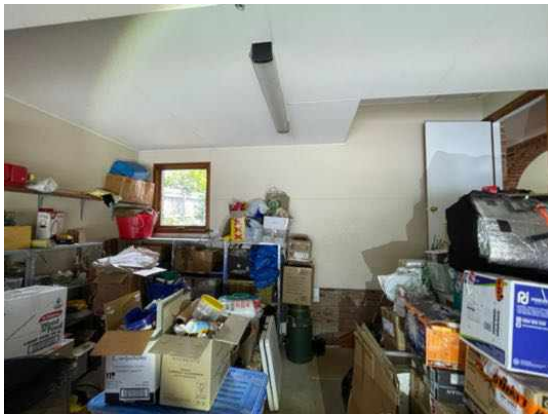
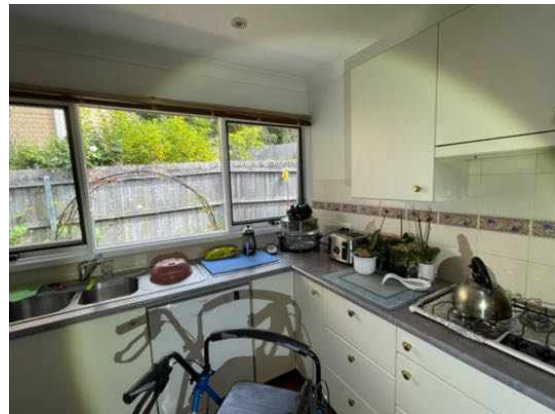
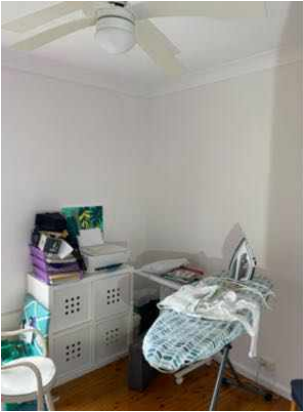
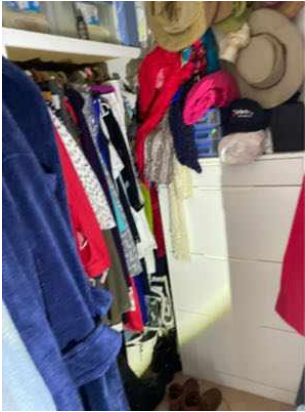
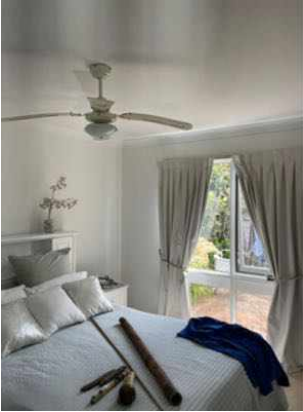
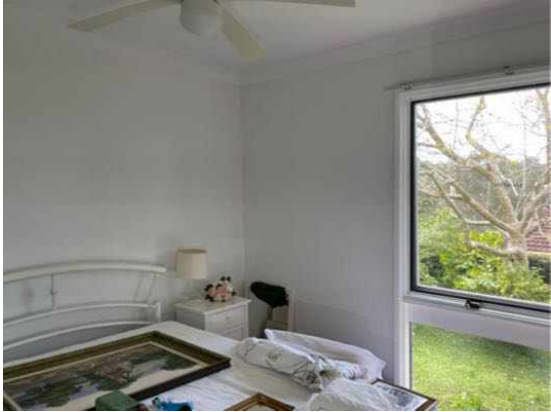
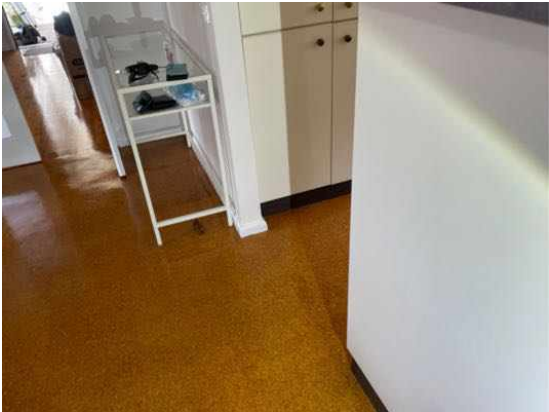
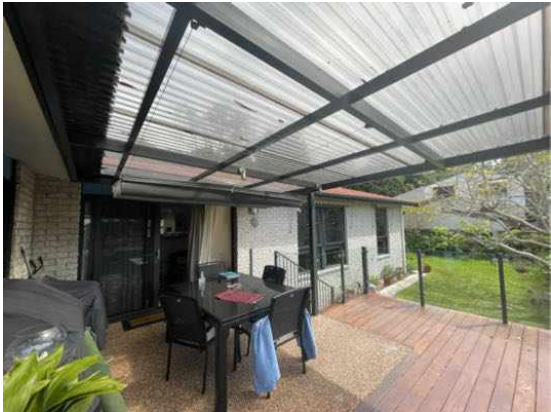
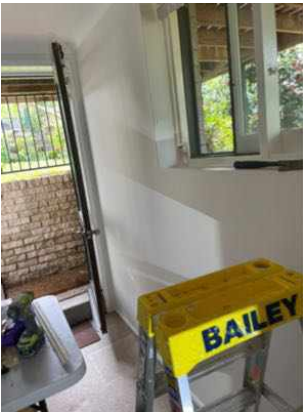
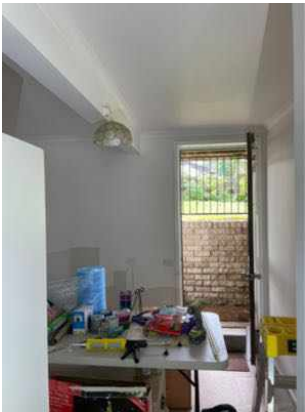
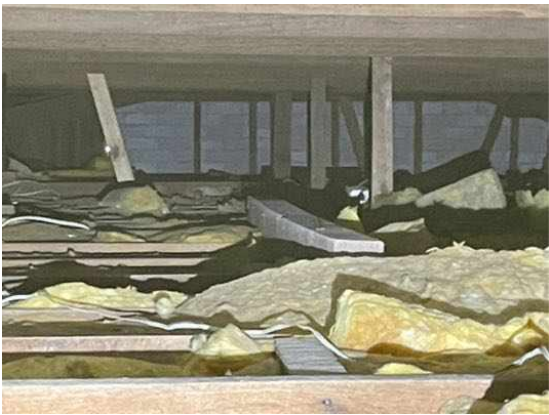
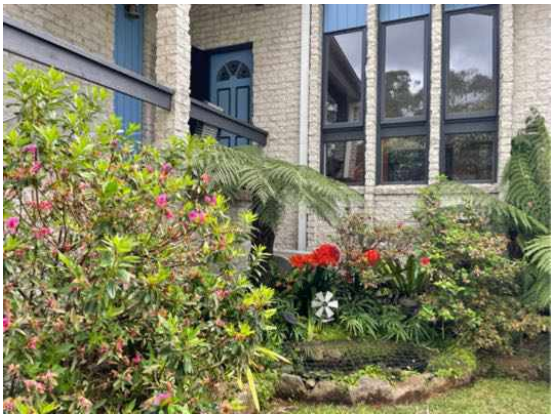
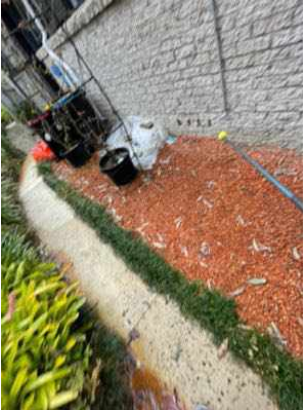
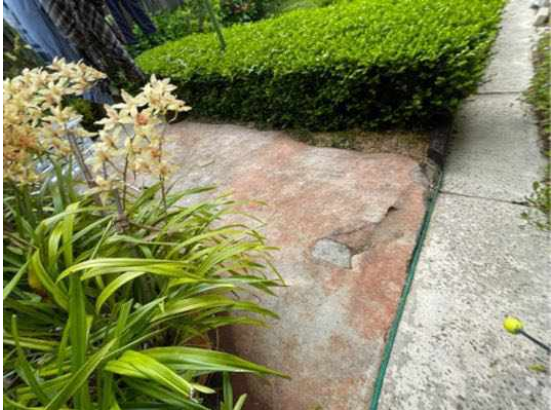
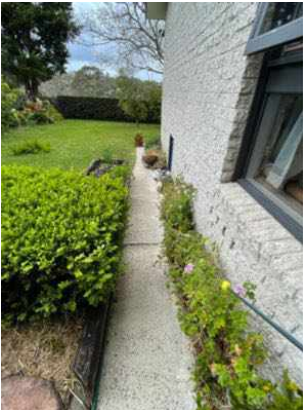
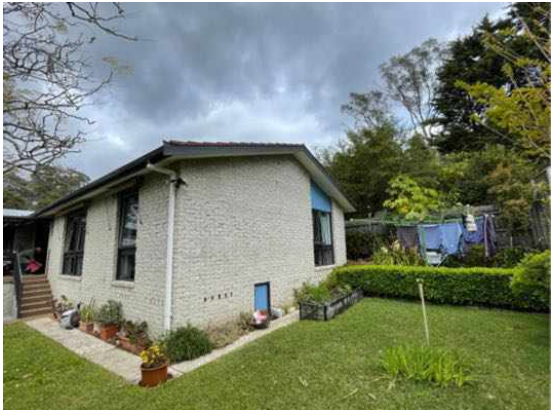
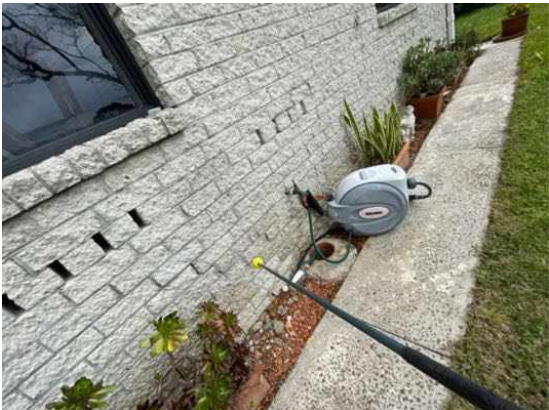
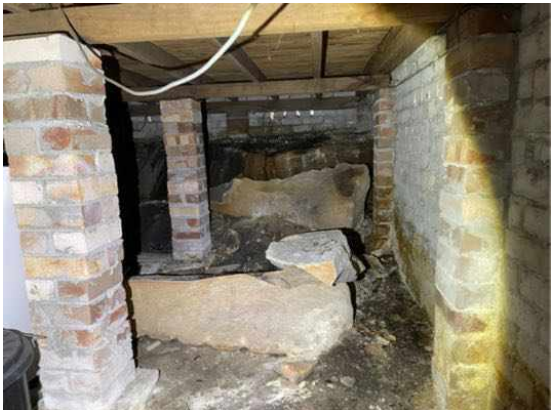
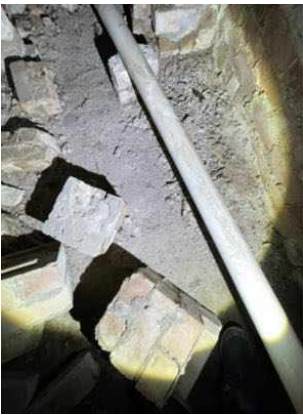
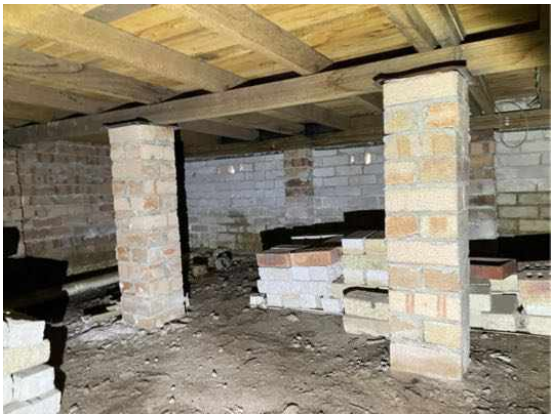
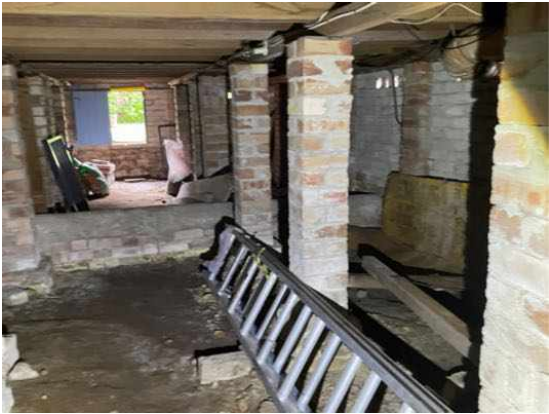
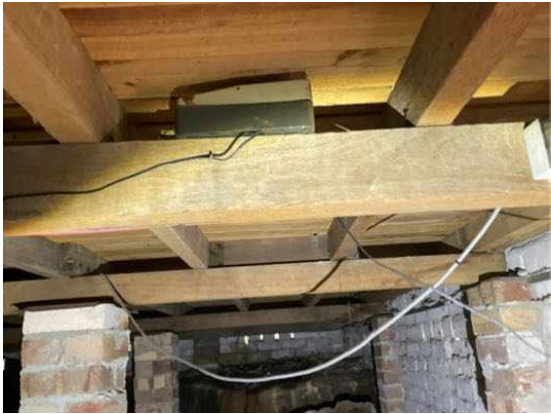
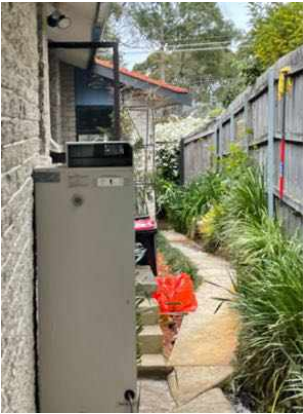
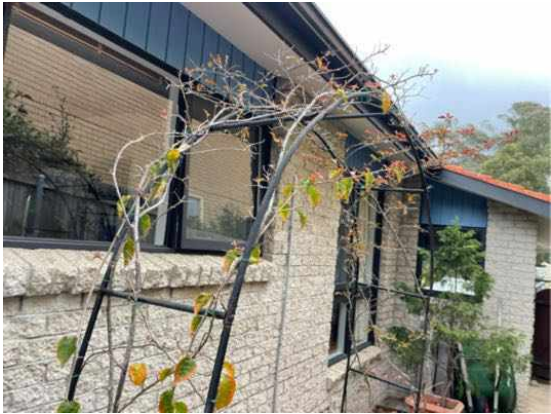
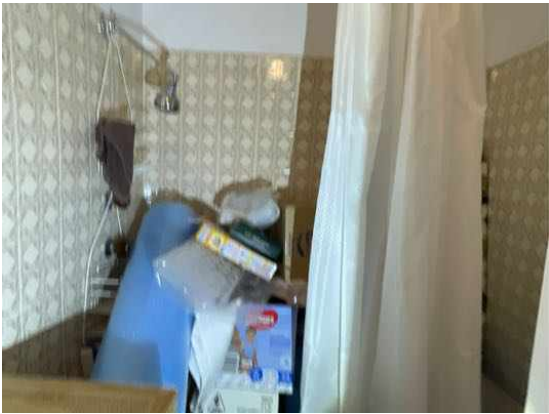
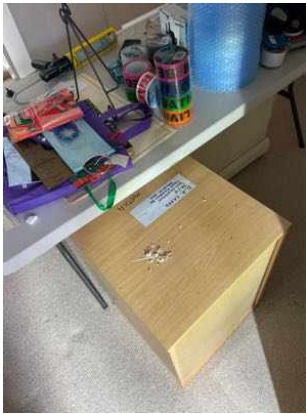
Noted Item

Building: Building 1
Location: All Areas
Finding: Additional Photos - Obstructions and Limitations
Information: These photographs are an indication of the obstructions and limitations which impeded full inspection of the property at the time of inspection. These obstructions can hide an array of defects and should be removed to allow full inspection to be carried out. A re-inspection is recommended once the areas are made accessible.
