## Building Inspection Report

Inspection Date: Tue, 23 Jul 2024

Property Address: 19 Elliot St, Beacon Hill NSW 2100,  
Australia

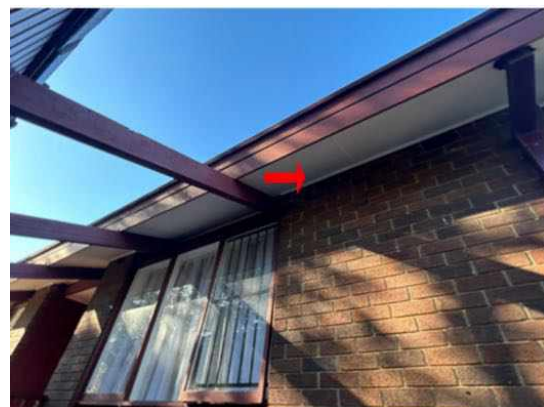
#### Defects 1.01

Building:	Building 1
Location:	All Areas
Finding:	Asbestos - Suspected ACM Identified on Site
Information:	Reporting on Asbestos is outside the Scope of this Report. This suspected defect is highlighted as a caution only. We suspect, based on our experience in the building industry, that there is a higher risk of the identified building element containing asbestos.

As Asbestos Reporting is outside the scope of this report, we advise that you consider a separate Asbestos Inspection and Condition Audit, which can include the taking of samples for definitive confirmation of the presence of Asbestos.

In the interim, the client is advised to act with caution, especially when considering any damage to building materials general wear and tear renovations extensions demolition and general maintenance activities due to the suspected presence of Asbestos.

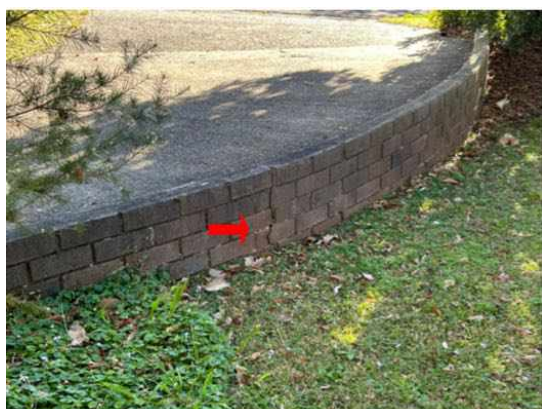
### Defects 3.01

Building:	Building 1
Location:	Yard - Back
Finding:	Retaining wall - Defective
Information:	The retaining wall in this area was found to be defective at the time of inspection. Generally, defective retaining walls are caused by poor original design or material use. However, deteriorated retaining walls may also be a result of substandard construction, poor site drainage or unmanaged stormwater flows.

If left unmanaged, the retaining wall may become a safety hazard if it continues to

destabilise.

Where retaining walls are considered structural walls, a structural engineer / surveyor should be consulted regarding required remedial works. Otherwise, a landscaper or retaining wall installer may be appointed to repair or replace the wall, at the discretion of the client.

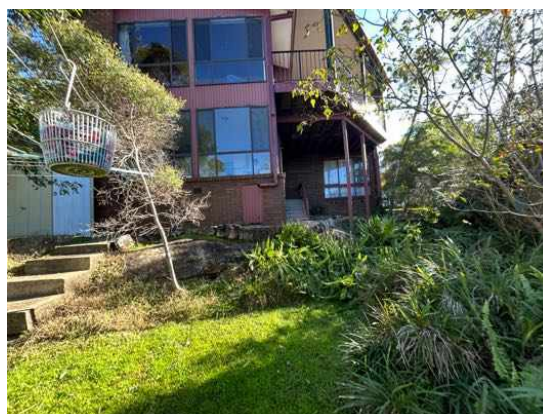
### Defects 3.02

Building:	Building 1
Location:	All Areas
Finding:	Evidence of excessive moisture was present at the time of inspection
Information:	Excessive moisture is generally caused by deteriorated inadequate or missing roof drainage leaking plumbing pipes or fixtures poorly plumbed HWS overflows or condenser units and poor site drainage.

Excessive moisture can attract termites and produce conditions that promote termite attack fungal growth and wood decay.

It is recommended that all plumbing and drainage fixtures and fittings be maintained regularly in order to prevent excessive moisture being present in the external / internal property.

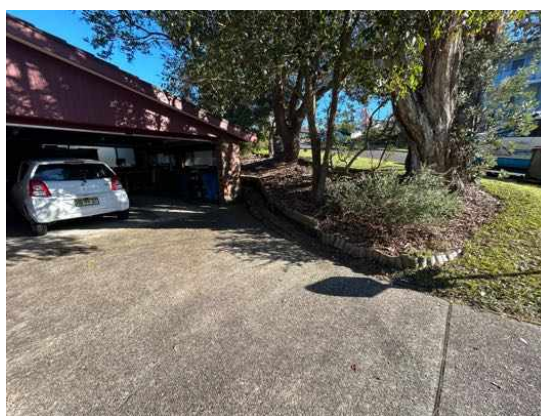
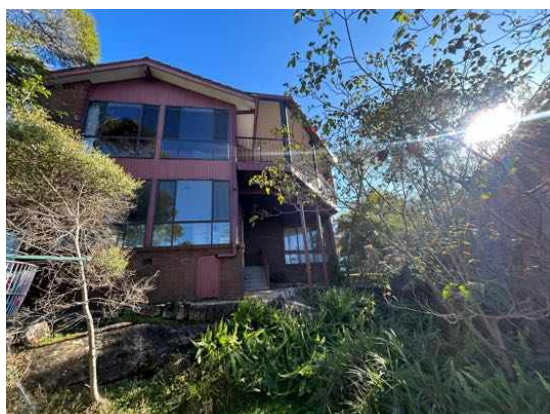
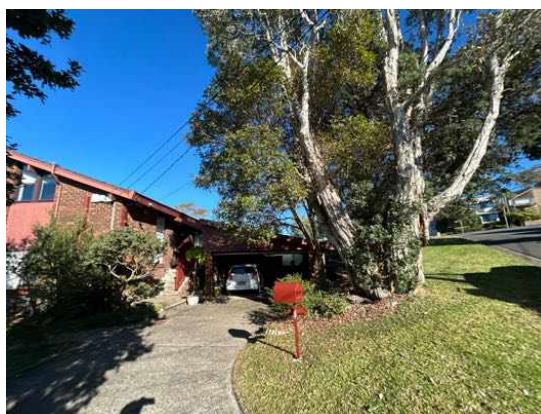
### Defects 3.03

Building: Building 1  
 Location: Yard - Back  
 Finding: Trees - Overhanging and filling gutters  
 Information: Overhanging trees often result in excessive amounts of leaf debris accumulating in gutters.

Gutters are a critical part of the building's management of storm water and rain. It is therefore important that they be kept clear to prevent secondary damage to associated building elements, including exterior and interior walls, ceiling linings and any adjoining building elements. Where gutters are blocked, pooling of rainwater is likely to occur, fast-tracking rust and corrosion of the roof plumbing elements.

It is highly advised that all overhanging tree branches be removed as soon as possible to prevent any further damage. Repair and/or replacement of sections of damaged guttering may also be required where the extent of the damage necessitates.

Such works should be performed by the homeowner; however, appointment of a landscape contractor or an arborist may be required. Consultation with a licensed roof plumber is required where guttering has been damaged.

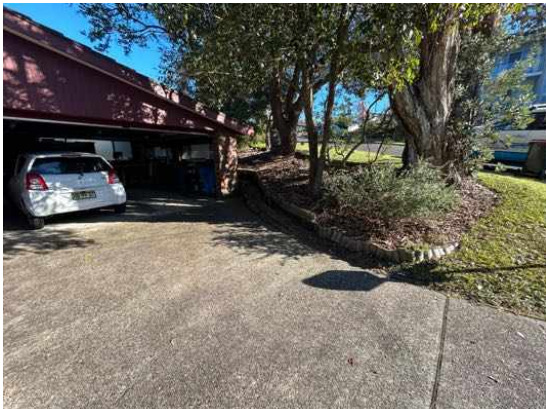
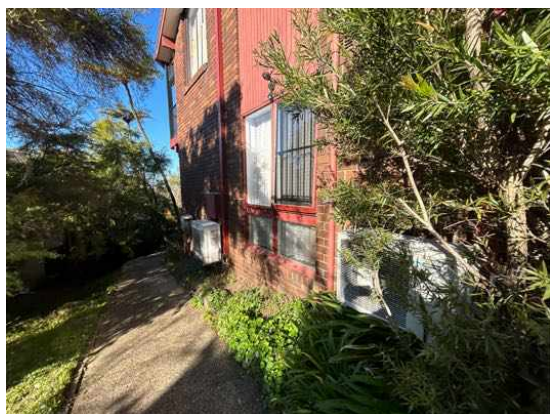
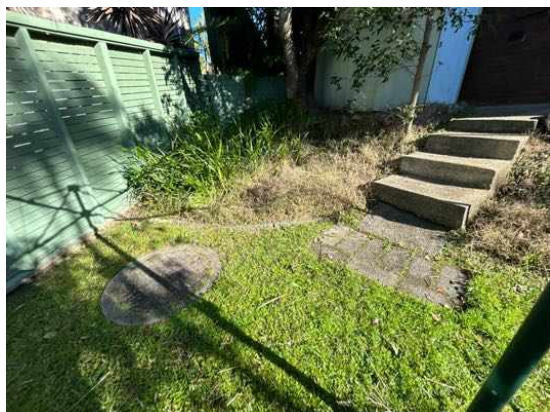
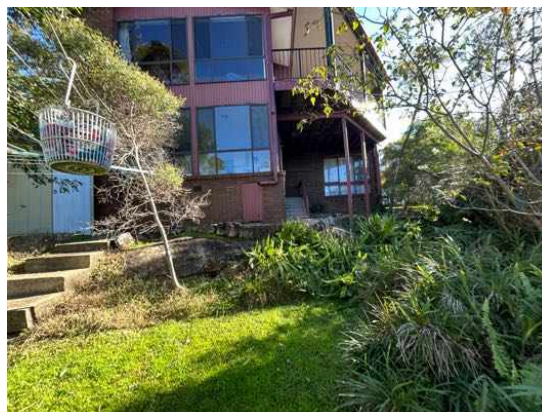
### Defects 3.04

Building:	Building 1
Location:	All Areas
Finding:	Site drainage - suspected Inadequate
Information:	The site drainage in this area was found to be inadequate at the time of inspection, creating potential for subsequent water damage to associated building elements.

Where site drainage is inadequate, installation of an Agricultural (Aggie) Drain may be

required. A qualified plumber should be appointed to further inspect the property and perform any remedial works as necessary. Water damage and secondary defects are likely to occur if left unmanaged.

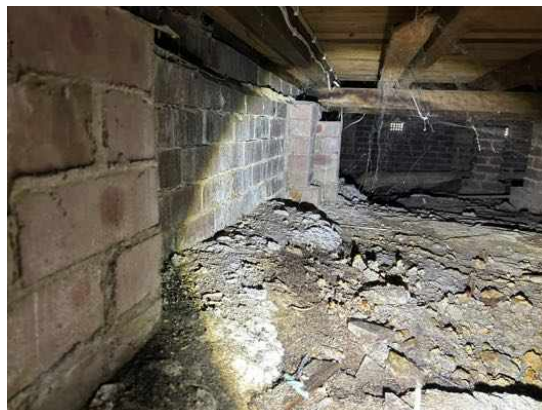
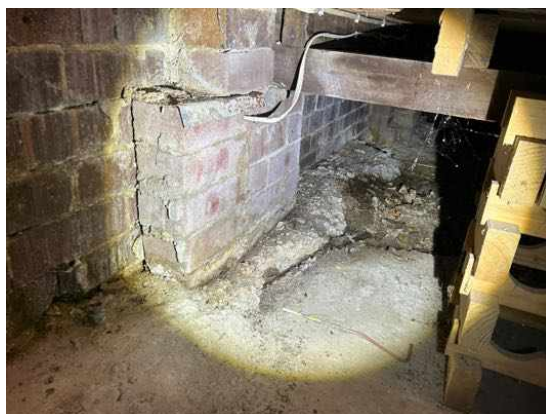
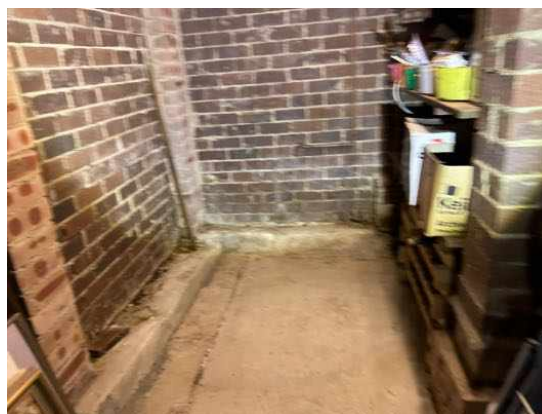
### Defects 3.08

Building:	Building 1
Location:	Subfloor
Finding:	Evidence of excessive moisture was present at the time of inspection
Information:	Excessive moisture can attract termites and produce conditions that promote termite attack, fungal growth and wood decay. Excessive moisture is generally caused by deteriorated, inadequate or missing roof drainage, leaking plumbing pipes or fixtures, poorly plumbed HWS overflows or condenser units and poor site drainage.
	It is recommended that all plumbing and drainage fixtures and fittings be maintained regularly to prevent excessive moisture from being present in the external / internal property.

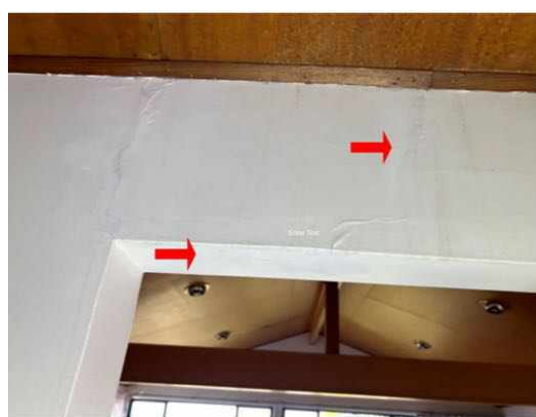
### Defects 3.10

Building:	Building 1
Location:	All Areas
Finding:	Ceiling - Water stained
Information:	Water staining to ceiling linings in this area was evident at the time of inspection. Water staining indicates that surfaces have been exposed to excessive moisture over time. The minerals and other elements in the water lead to staining, which may graduate to corrosion and deterioration if left unmanaged.

While mostly an appearance defect, water staining can be indicative of more serious defects, which may be currently concealed by interior ceilings.

Where water staining is active, a licensed plumber must be consulted to identify the cause of the staining and to provide advice on any reparation works that may be required. Replacement or repair of any damaged structures is advised.

Conversely, where water staining is old and inactive, affected building materials may be repaired or replaced at client discretion.

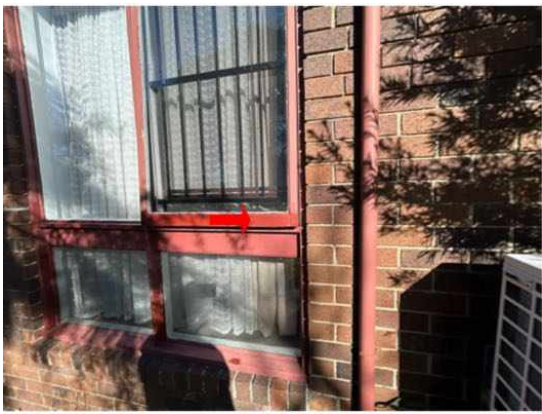
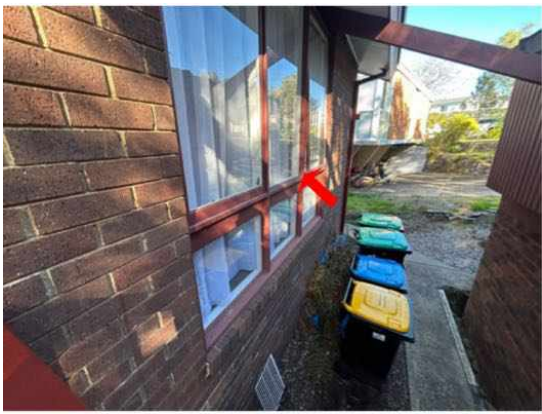
**Defects 3.11**

Building: Building 1  
Location: All Areas  
Finding: Window Evidence of deterioration  
Information: Rectification works may include repair or replacement depending on the extent of damage.

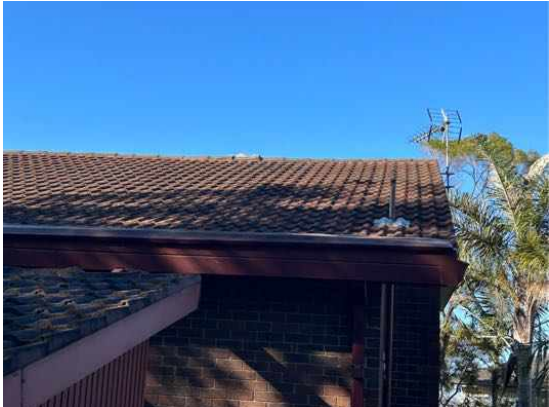
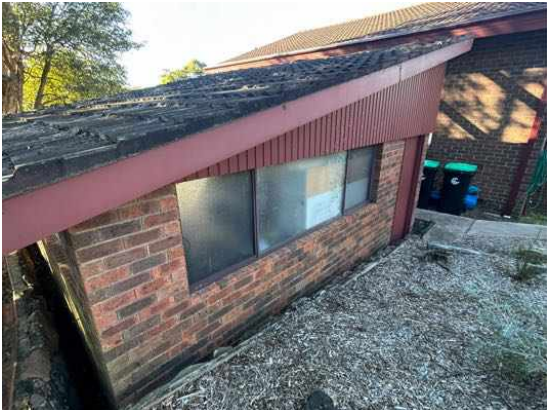
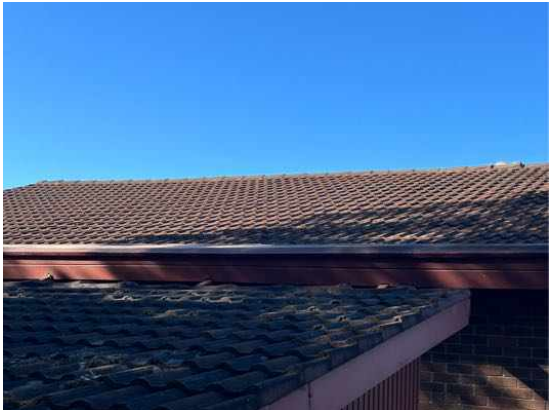
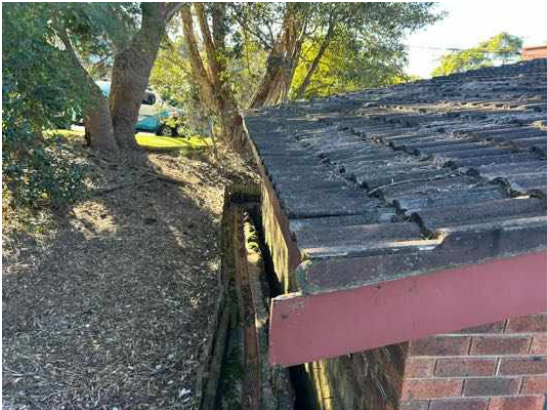
**Defects 3.12**

Building: Building 1  
Location: Roof Exterior

Information: Upon the inspection of the exterior roofing, the majority of roof tiles were considered to be in a fair condition. While the weathering of the tiles is consistent with the age of the property, maintenance works are required.

Where left unmanaged, deteriorating roof tiles are likely to lead to a number of secondary defects, including minor water leaks and weather exposure to internal roofing structures.

Consultation with a roofing contractor is highly advised to gain advice on cost of remedial works that may be required in the short to medium term. Remedial works are likely to increase the longevity of the exterior roofing structure.

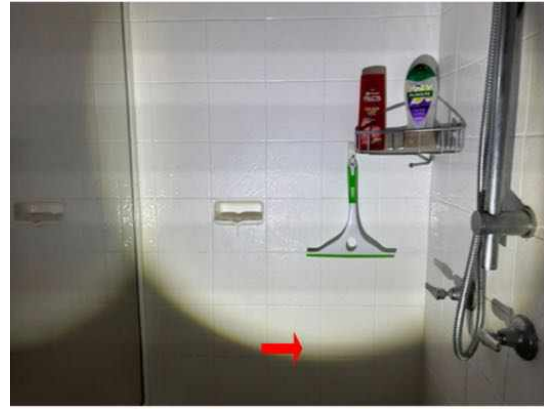
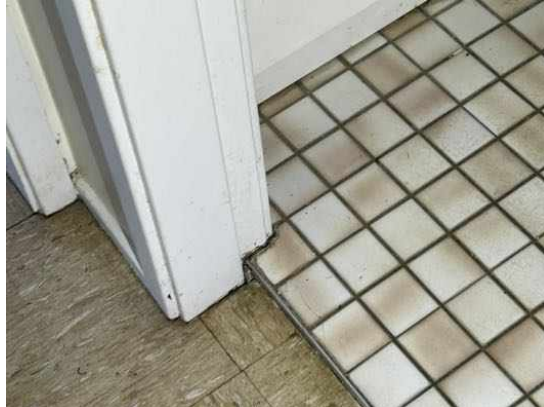
**Defects 3.14**

Building: Building 1  
Location: Bathrooms/ showers  
Finding: Sealant - Deterioration in areas/Missing in areas  
Information: It was noted on inspection that sealant is missing in areas & deteriorated in areas to the tiled wet areas. Grouting was identified in areas however grout can crack and allow water entry. A flexible sealant should be applied to affected areas to prevent any subsequent water damage that is likely to occur.

Regular maintenance and replacement of damage or missing sealant & grout is highly recommended for the wet areas as this is a regular wear and tear defect. Sealant and grouting in areas that come into regular contact with water should be maintained for the long term care of

A licensed sealant specialist can be appointed to complete these works.

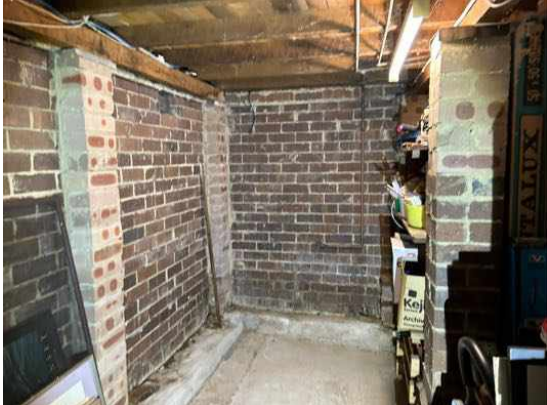
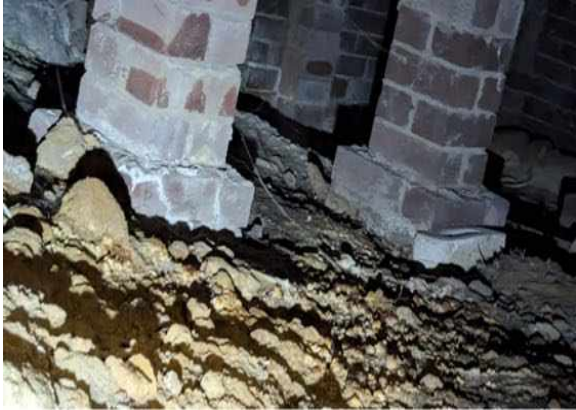
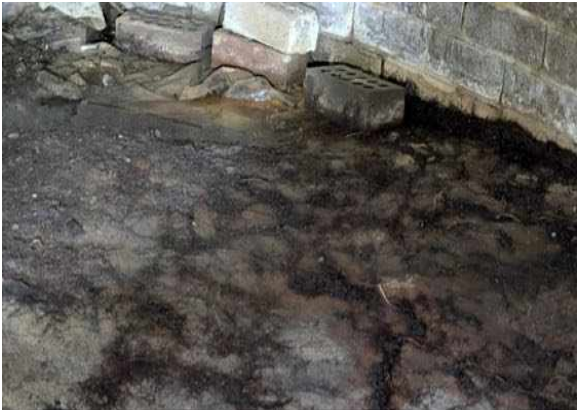
### Defects 3.15

Building:	Building 1
Location:	Subfloor
Finding:	Evidence of excessive moisture was present at the time of inspection
Information:	Excessive moisture can attract termites and produce conditions that promote termite attack, fungal growth and wood decay. Excessive moisture is generally caused by deteriorated, inadequate or missing roof drainage, leaking plumbing pipes or fixtures, poorly plumbed HWS overflows or condenser units and poor site drainage.

It is recommended that all plumbing and drainage fixtures and fittings be maintained regularly to prevent excessive moisture from being present in the external / internal property.

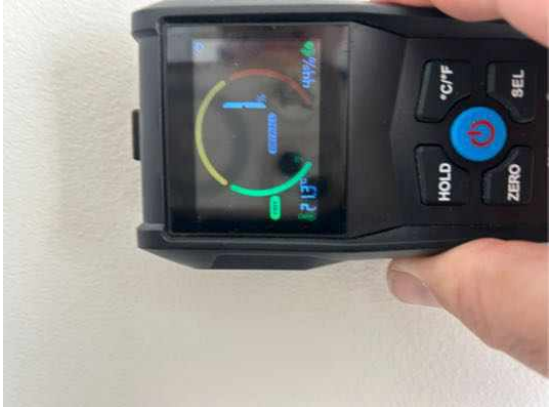
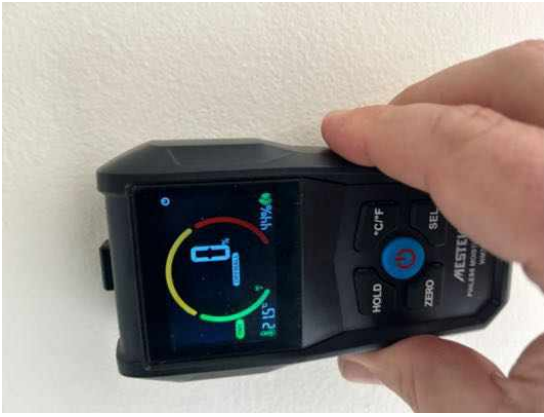
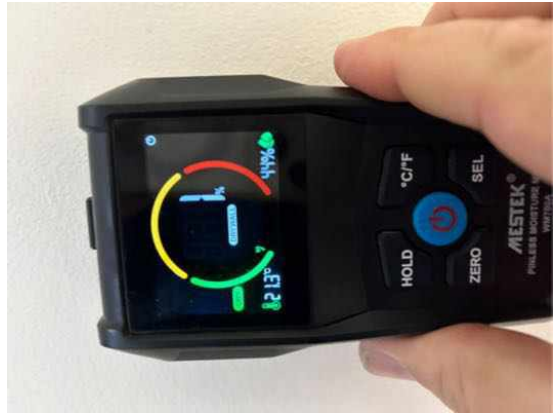
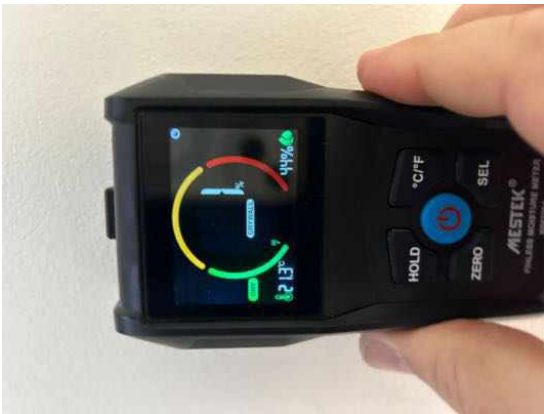
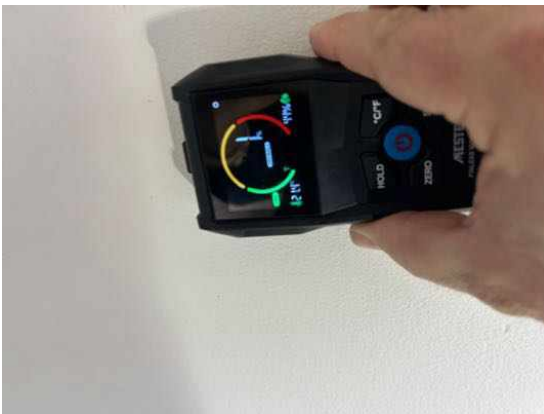
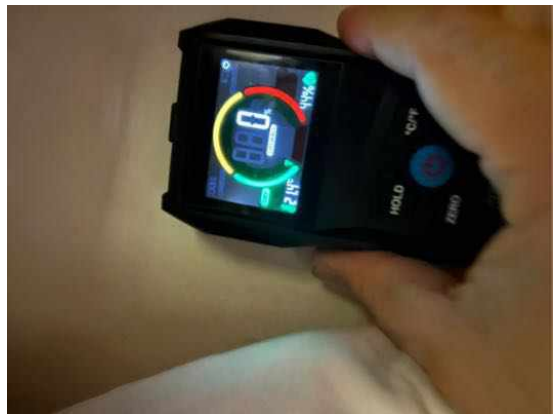
**Noted Item**

Building: Building 1  
 Location: All Areas  
 Finding: Moisture meter readings - low  
 Information: The moisture meter result for the areas inspected.

The moisture reading of 0-15% is quite normal and gives no cause for concern. However, moisture readings in excess of 15% indicate the need for further inspection.

Levels between 25-30% indicate that there may be water ingress, meaning that remedial work could be required.

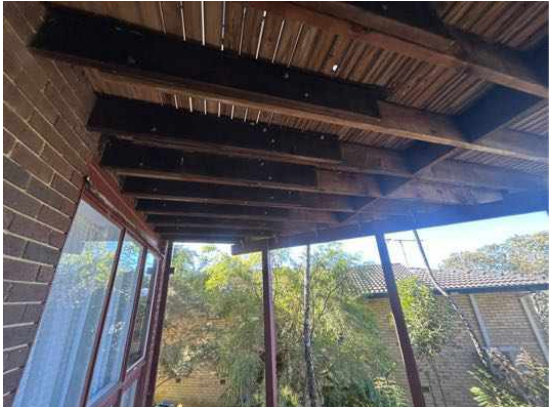
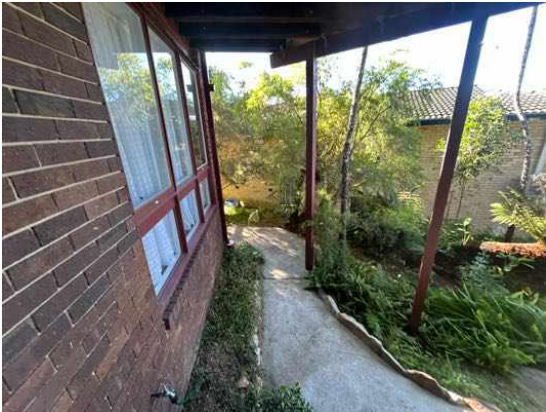
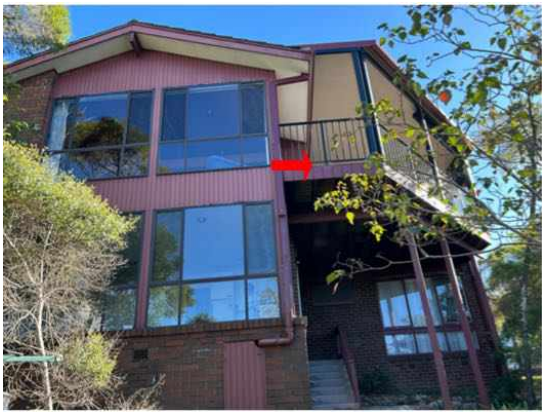
### Noted Item

Building: Building 1  
 Location: All External Areas  
 Finding: External Timber Balcony or Deck - Structural Stability  
 Information: The load capacity of the external balcony or deck could not be verified during the inspection.

External timber structures are also constantly exposed to weather elements and can deteriorate in an accelerated manner, ongoing assessments are required.

It is highly recommended that a Structural Engineer further assess the external timber balcony or deck to inform the client of its load capacity. Regular maintenance inspections by competent practitioners is needed.
