# Building Inspection Report

Inspection Date: Thu, 06 Feb 2020

Property Address: 1A Wirrilda Way, Forestville NSW 2087, Australia

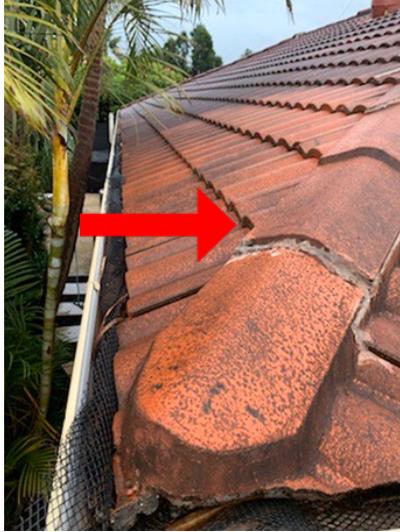
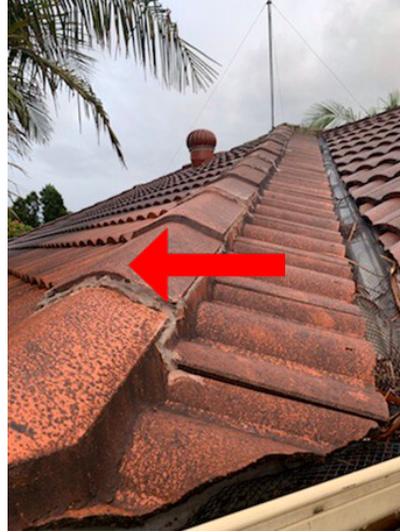
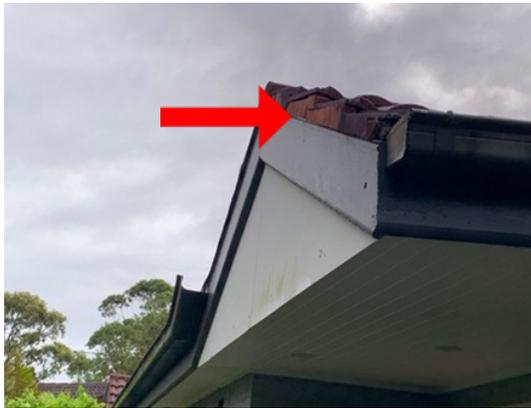
#### Defects 3.01

Building: Main Building

Location: Roof Exterior

Finding: Mortar - Deterioration

Information: Mortar, or `bedding`, is the material which fills joins and intersections between tiles and other building elements on the exterior roof covering, such as gable ends, hip capping and valleys. Upon inspection of the exterior roof, it was noted that sections of the mortar show varying levels of deterioration.

Mortar generally deteriorates as a result of frequent exposure to weather conditions over a prolonged period of time. Mortar that is deteriorating may allow water ingress into the roof void, putting associated building elements and roofing structures at risk of water damage. Deteriorated mortar also detracts from the functionality of roof tiles and other roofing elements, potentially decreasing weather tightness and roof drainage.

Mortar deterioration can be attended to by a handyperson where areas of deterioration are localised and easily accessible. Otherwise, consultation with a roofing contractor is advised where greater works are required.

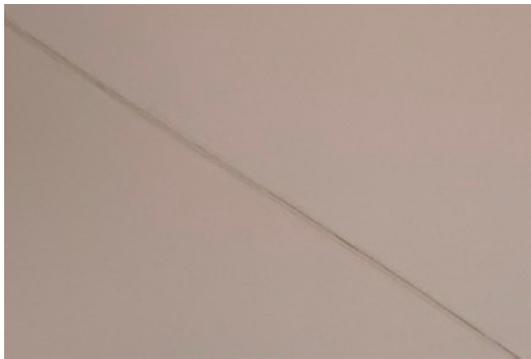
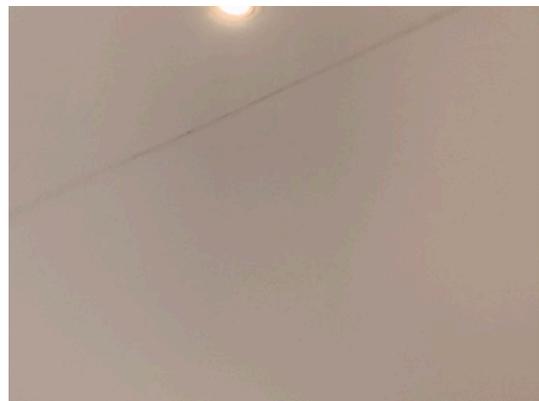
## Defects 3.02

Building:	Main Building
Location:	Lounge Room
Finding:	Cracking - Damage Category 1 - Fine (up to 1mm)
Information:	Although fine cracks are quite noticeable, they are often only considered to be an appearance defect, and usually do not indicate any structural damage. Generally, the cause of a fine crack is indicative of a separation between building materials and finishes (e.g. paint, plaster, etc.) along joins.

Cracking of this nature can generally be repaired with minor sanding, filling and/or repainting. Such works should be performed by a qualified painter or a general handyman.

Monitoring of all cracking should be conducted frequently. Always contact a building inspector should cracks widen, lengthen, or become more numerous.

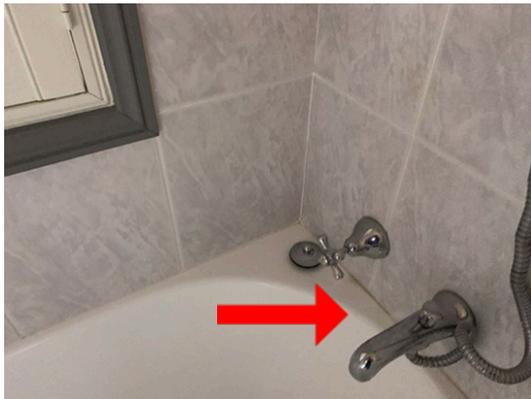
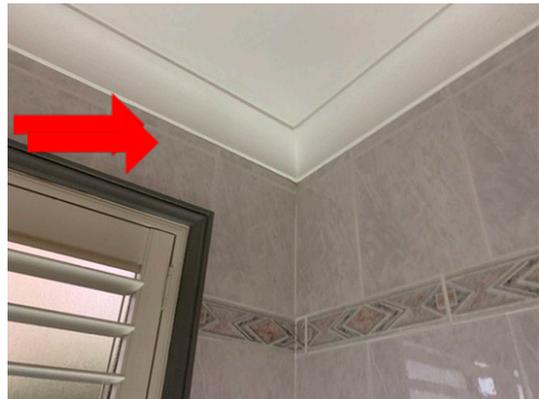
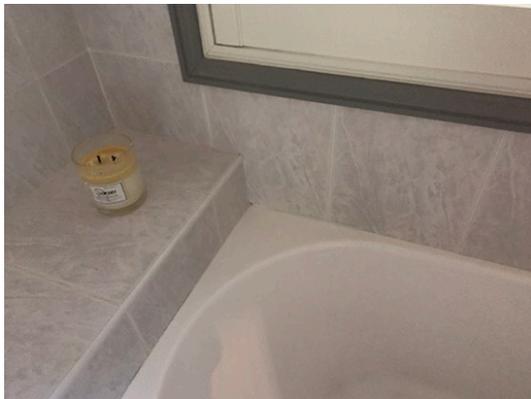
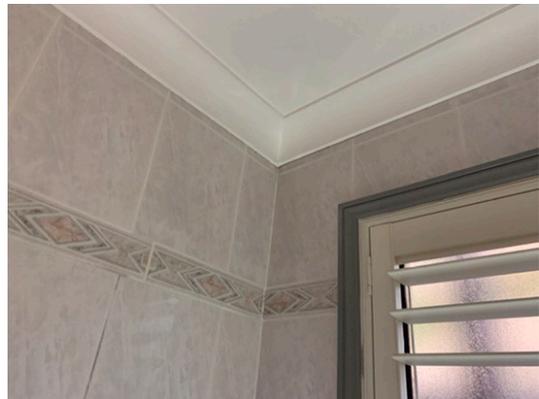
### Defects 3.03

Building: Main Building

Location: Bathroom

Finding: Sealant and grouting - Missing or damaged

Information: Flexible and mould resistant materials should be applied to affected areas to prevent any subsequent water damage that is likely to occur. Regular maintenance and replacement of damage or missing or damaged sealant and grout is highly recommended to the wet areas, as this is a regular wear and tear defect. Sealant and grouting in areas that come into regular contact with water should be maintained for the long term care of your property.

A sealant specialist or tiling contractor should be appointed to complete these works as soon as possible

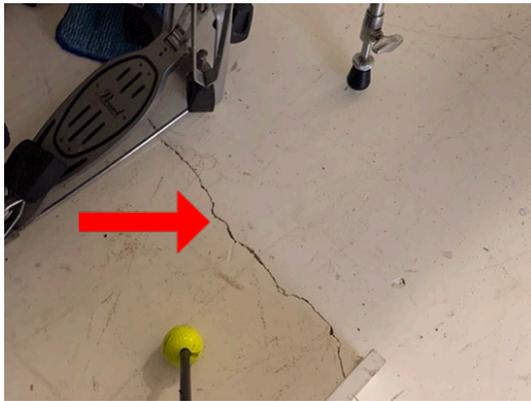
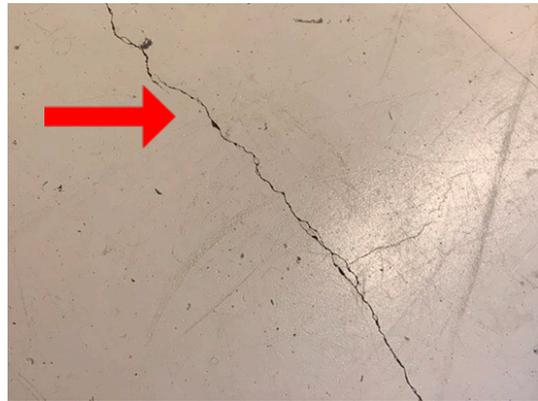
### Defects 3.04

Building: Main Building

Location: Garage

Finding: Crack in concrete slab - Category 2

Information: A crack coded as Category 2 was identified in the slab. A Category 2 crack is described as a distinct crack, with the slab being noticeably curved or changed in level.

To be considered Category 2, the approximate width of the crack is  $<1.0\text{mm}$ , or a change in offset of  $<10\text{mm}$  when a 3m straight edge is placed over the defect.

Category 2 cracks to slabs should be monitored for a period of 12 months. At the end of the monitoring period, cracks rated greater than Category 2 are considered defects that require rectification.

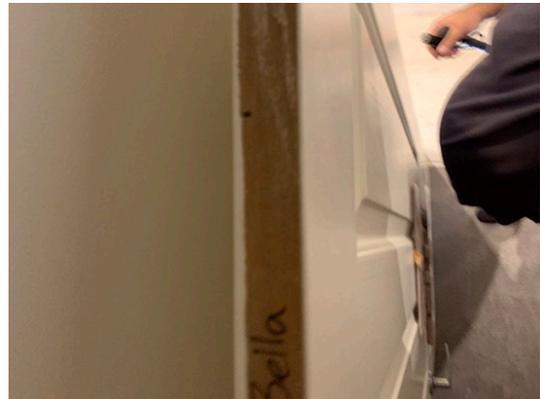
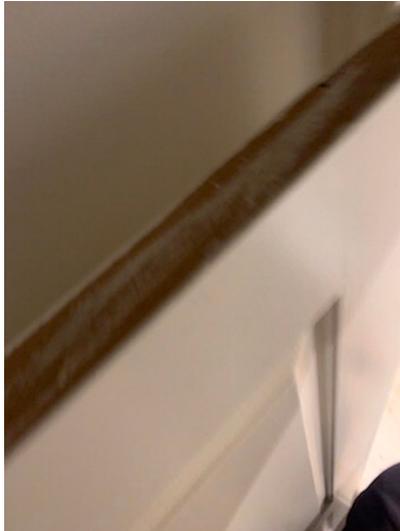
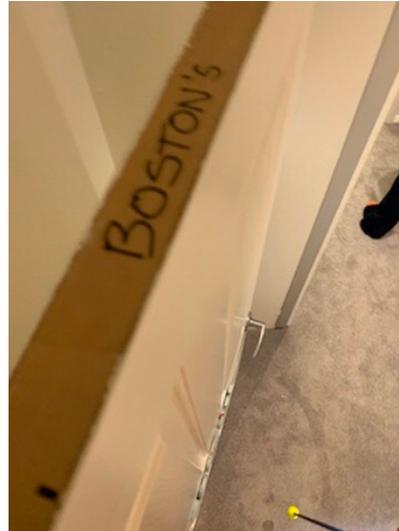
## Defects 3.05

Building:	Main Building
Location:	All Areas
Finding:	Door finish - incomplete on top and bottom of door
Information:	The paint finish in this area was identified as being incomplete at the time of inspection.

Whilst incomplete or missing paint finish is generally an appearance defect, it can also lead to the development of secondary building defects over time. Incomplete areas of paint finish exposes the area to moisture, potentially accelerating the deterioration of underlying building materials.

A painting contractor should be appointed to perform necessary works to aid the appearance of the affected area and to ensure the area is protected against further deterioration. Alternatively, the homeowner following manufacturer instructions may perform these works.

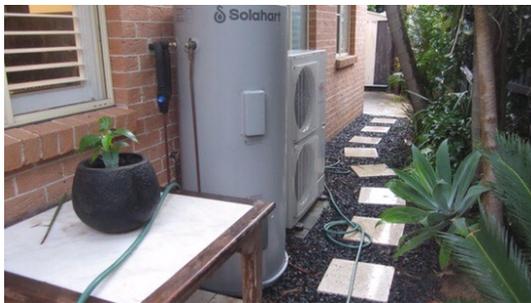
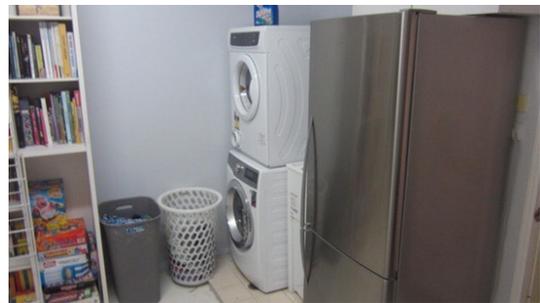
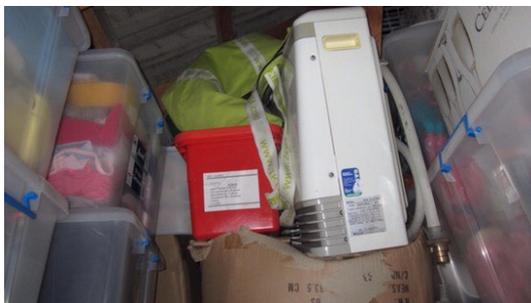
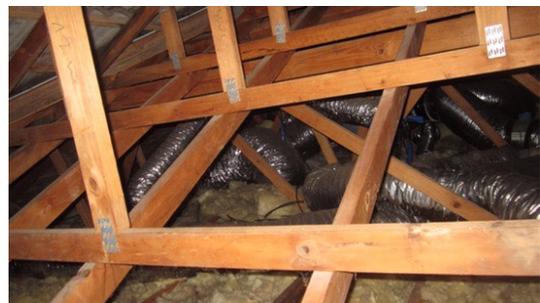
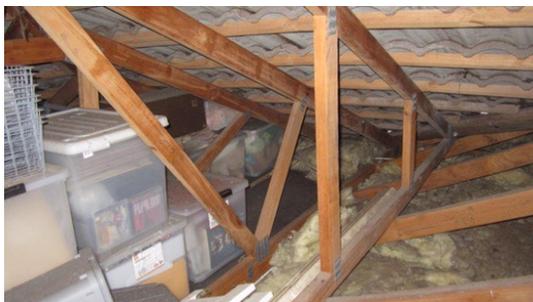
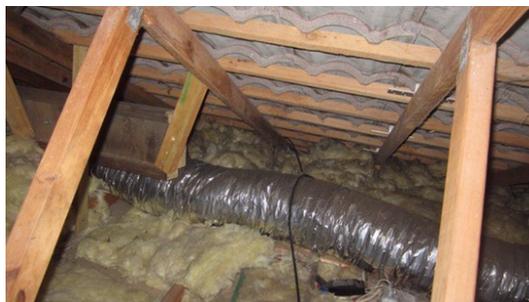
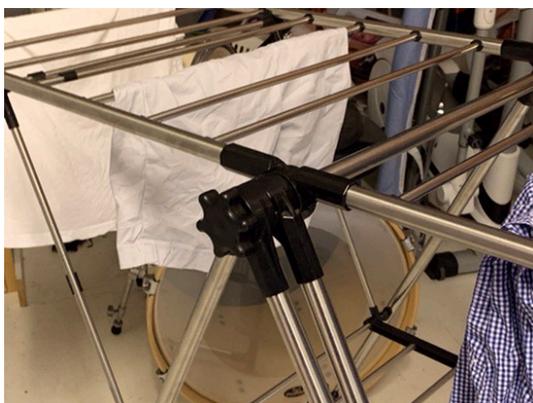
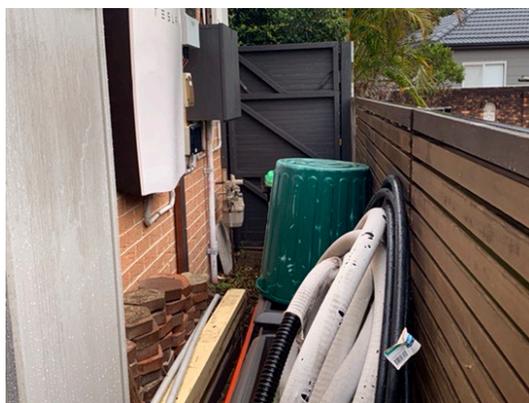
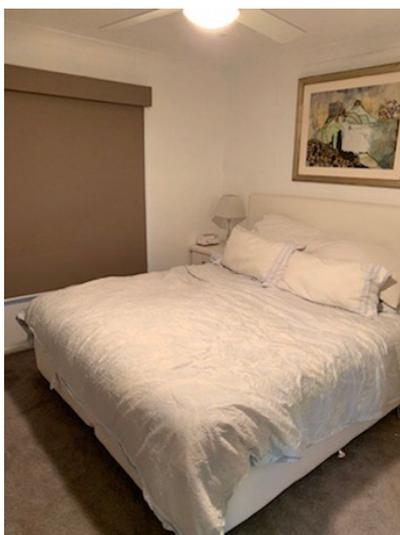
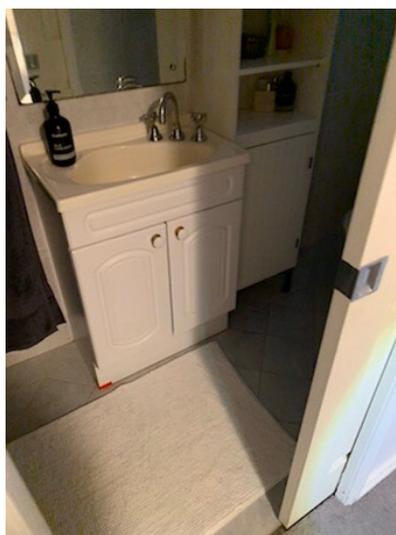
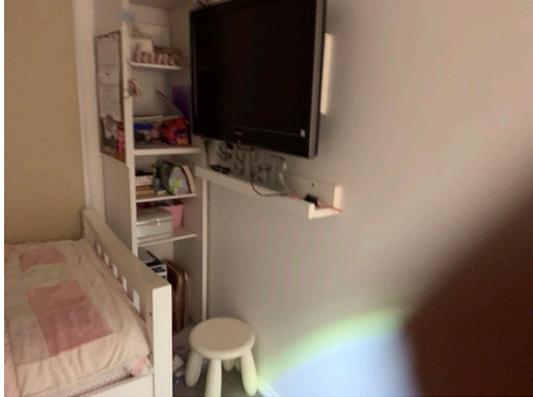
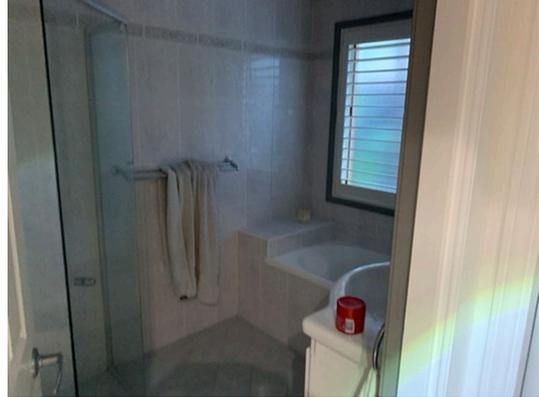
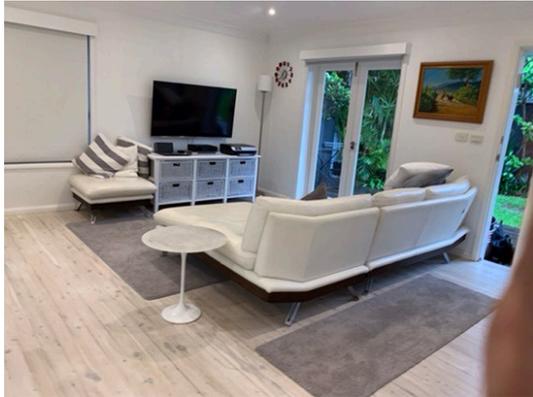
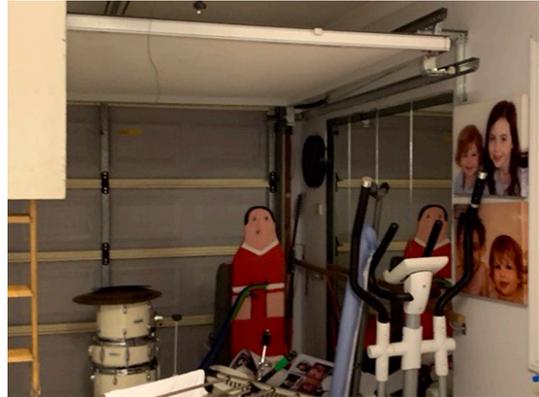
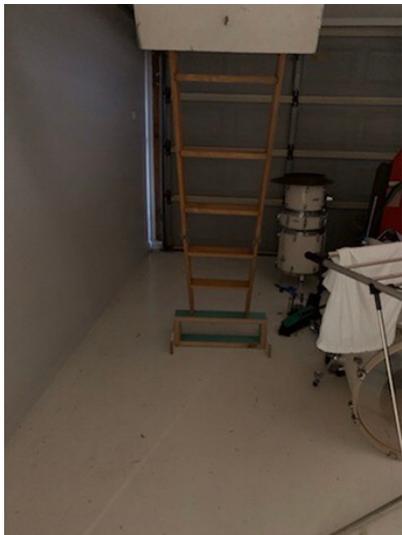
Building: Building 1  
Location:  
Finding: Additional Photos - Obstructions and Limitations  
Information: These photographs are an indication of the obstructions and limitations which impeded full inspection of the property at the time of inspection.

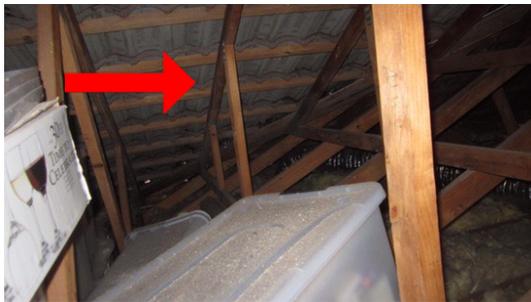
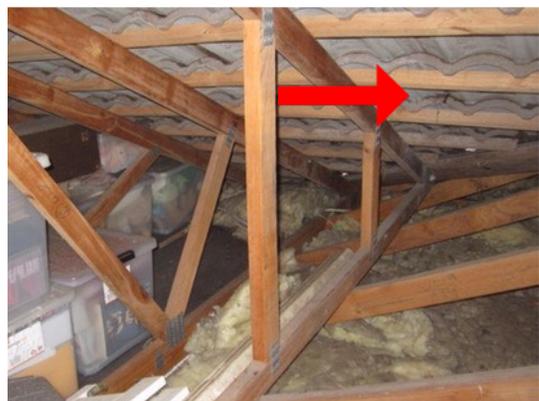
Building:	Main Building
Location:	Roof Void
Finding:	Sarking - Missing
Information:	Sarking is missing under the roof sheeting. Sarking acts as an insulator that helps with noise reduction and protects against water penetration. Sarking plays a key role in the operation and function of the overall roofing structure and its performance.

Although not a requirement at the time of construction, replacement of any missing building element is advisable (although this can be quite expensive to do after the time of construction). Where sarking is missing, regular inspections of the roof tiles for cracking and potential moisture penetration is required.

Sarking may be retrospectively fitted by a registered builder at the discretion of the client.
