Building and Timber Pest Inspection Report

Inspection Date: Sun, 12 Sep 2021

Property Address: 2-10 Lochview Ct, Tamborine QLD 4270,
Australia

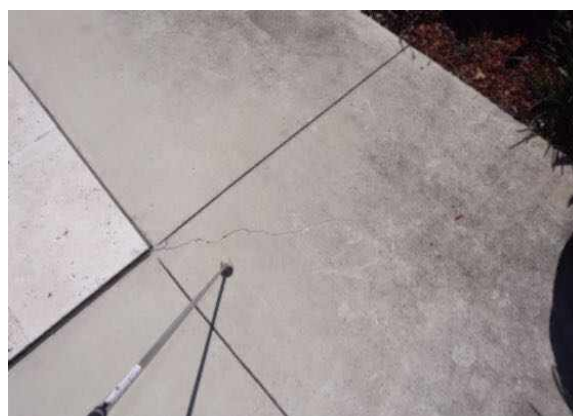
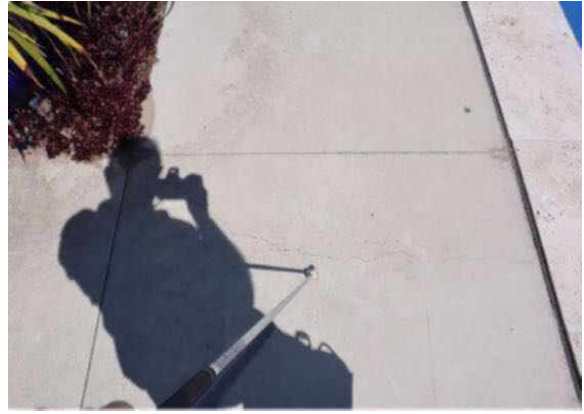
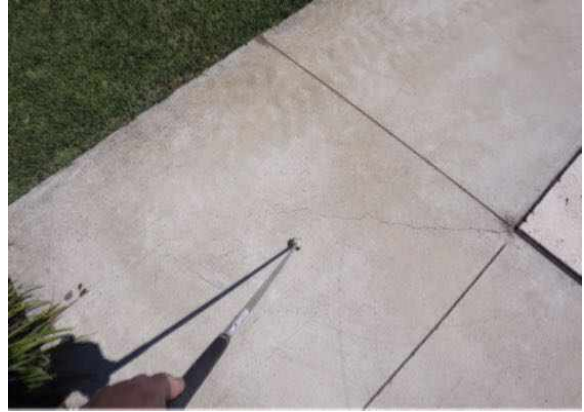
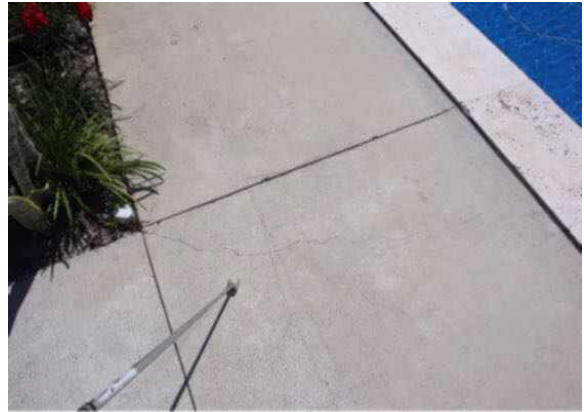
Building: Yard
 Location: Pool Area > Existing
 Finding: Crack in concrete slab - Category 0
 Information: A crack coded as Category 0 was identified in the slab. A Category 0 crack is described as a hairline crack, representing insignificant movement of slab from level.

The approximate width of the crack to be considered Category 0 is 0.3mm, or change in offset of less than 8mm when a 3m straight edge is placed over the defect.

No rectification is required at this time. However, all cracking should be monitored over a 12 month period to identify any further damage in the area.

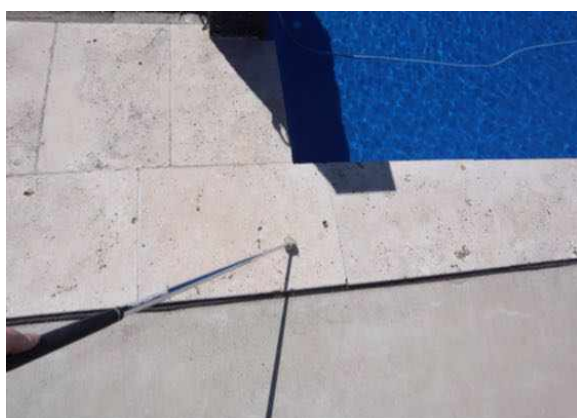
Finding 3.05

Building:	Yard
Location:	Pool Area > Existing
Finding:	Tiles - Drummy
Information:	Drummy tiled areas were identified at the time of inspection. The term 'drummy' refers to tiles that have become detached from their fixing, despite otherwise being in relatively good condition. Such defects are generally caused by physical or moisture damage to the area. Drummy tiled areas may also be a direct result of poor workmanship during the construction process.

Tiled areas may swell and shrink with changes in air humidity if the area has sustained moisture damage. Any exposure to moisture is capable of causing tiled areas to become drummy and/or cracked over a prolonged period of time. Drummy tiled areas generally require removal and replacement of affected tiles, with adequate sealant and grouting.

Specialist trades are available for these types of services. A registered builder may be required to undertake works if damage is extensive or if secondary building defects have resulted. Otherwise, it is advised that a tiling contractor be appointed to perform works as necessary. Immediate action is recommended to ensure that no further damage is sustained in the affected area.

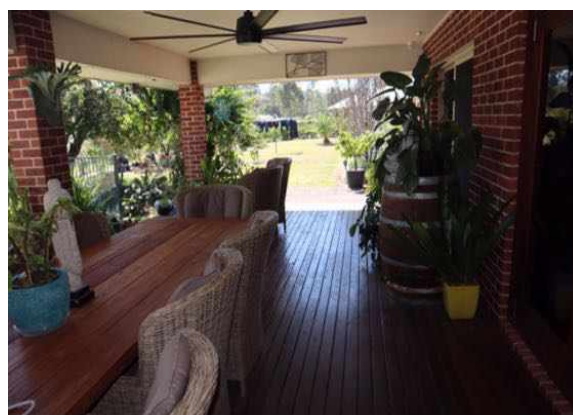
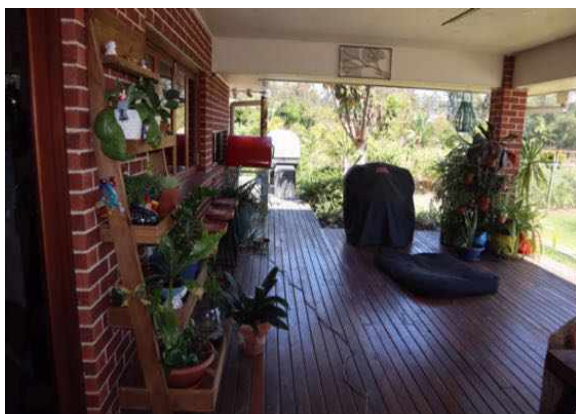
Finding 3.06

Building: Main Building
Location: Deck > Rear
Finding: Evidence of termite damage - minor
Information: Despite no live termite or timber pest activity being indicated, previous termite damage was found to have affected this timber deck members. This damage is considered to be inactive and is minor in nature.

It is advised that the area be visually inspected frequently to ensure that the condition of affected building materials does not worsen. At the time of inspection, damage is not structural and is only considered to be superficial.

A building contractor may be appointed to provide a further invasive inspection if further damage is evident.

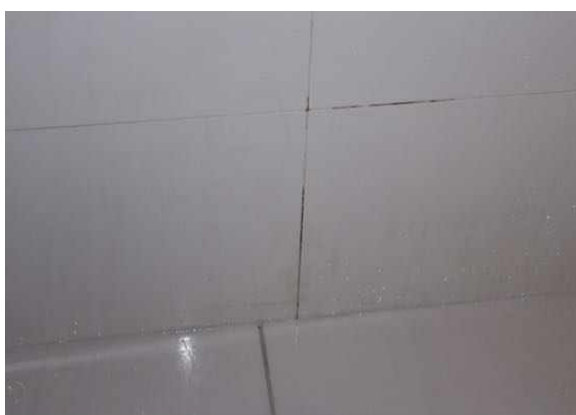
Building:	Main Building
Location:	Ensuite 2 > Centre
Finding:	Mould - Present minor
Information:	Where evidence of mould growth was noted, there may be environmental, biological or health issues associated with the report. A specialist inspection by a suitably qualified environmental health inspector is warranted, where mould is extensive or where any queries regarding air quality spores or other related issues apply.

Generally, the client is advised to ensure that the general environment is free of moisture and humidity to aid in the prevention of mould formation and development. Any mould found during the inspection should be cleaned immediately by a cleaning

contractor or the homeowner as applicable.

Please note that severely affected building elements may require replacement by a registered builder or qualified carpenter.

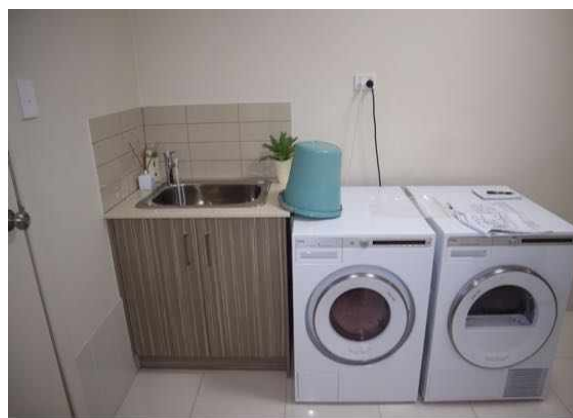
Building: Main Building
 Location: Laundry > Centre Left
 Finding: Gaps in architrave joints
 Information: At the time of inspection it was noted that there were gaps in the joints in the architrave.

Although this has no structural integrity this may take away the aesthetic look of the overall appearance.

A handyman or painter maybe required to rectify this issue.

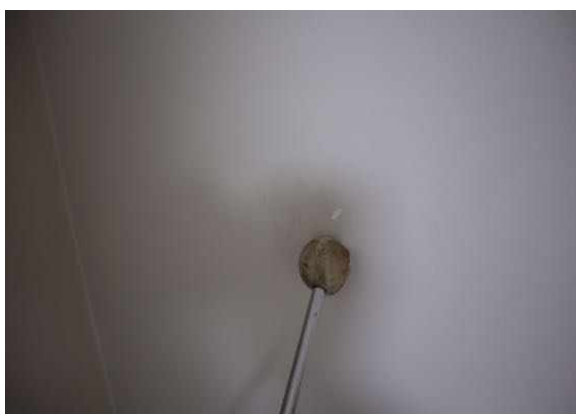
Finding 3.13

Building:	Main Building
Location:	Laundry > Centre Right
Finding:	Walls - Scuffed
Information:	Superficial scuff marks were noted to the internal walls in this area at the time of inspection. Marked and scuffed surfaces, while detracting from the overall appearance of the affected building element, do not indicate any operational or structural damage. This degree of surface damage is consistent with general wear and tear.

Marked surfaces may be left at client discretion, as no repair/replacement is necessarily required. Marked surfaces are unlikely to result in the development of secondary damage; however, the client may wish to seek quotations for the cost to refurbish or replace the affected wall linings.

A general handyperson or cleaning contractor may be appointed to rectify marked or scuffed surfaces at the client's discretion.

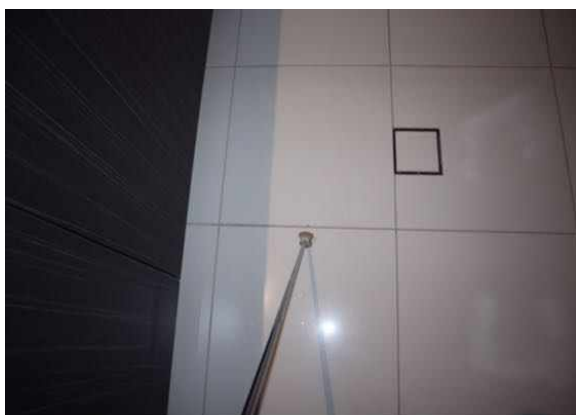
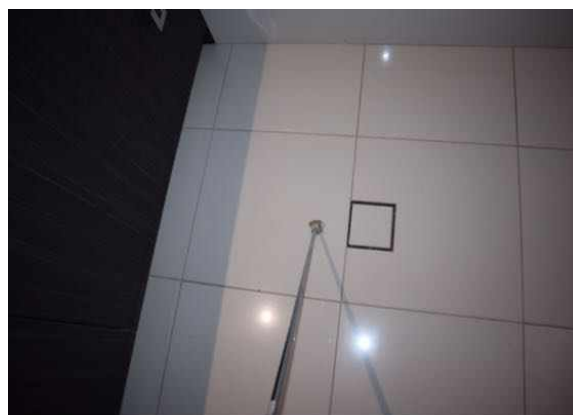
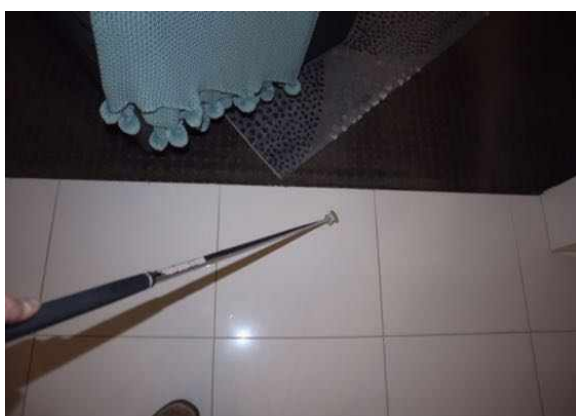
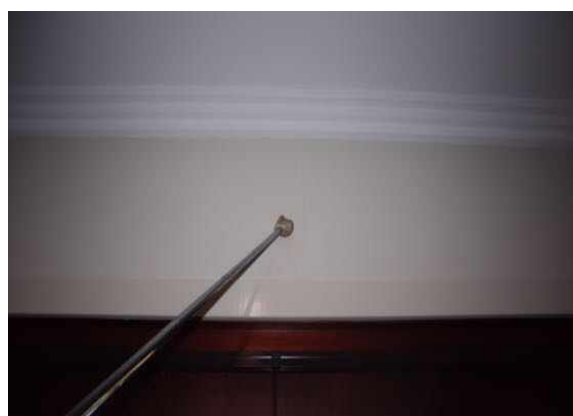
Building:	Main Building
Location:	Ensuite - Master > Existing
Finding:	Tiles - Drummy
Information:	<p>Drummy tiled areas were identified at the time of inspection. The term 'drummy' refers to tiles that have become detached from their fixing, despite otherwise being in relatively good condition. Such defects are generally caused by physical or moisture damage to the area. Drummy tiled areas may also be a direct result of poor workmanship during the construction process.</p>

Tiled areas may swell and shrink with changes in air humidity if the area has sustained moisture damage. Any exposure to moisture is capable of causing tiled areas to

become drummy and/or cracked over a prolonged period of time. Drummy tiled areas generally require removal and replacement of affected tiles, with adequate sealant and grouting.

Specialist trades are available for these types of services. A registered builder may be required to undertake works if damage is extensive or if secondary building defects have resulted. Otherwise, it is advised that a tiling contractor be appointed to perform works as necessary. Immediate action is recommended to ensure that no further damage is sustained in the affected area.

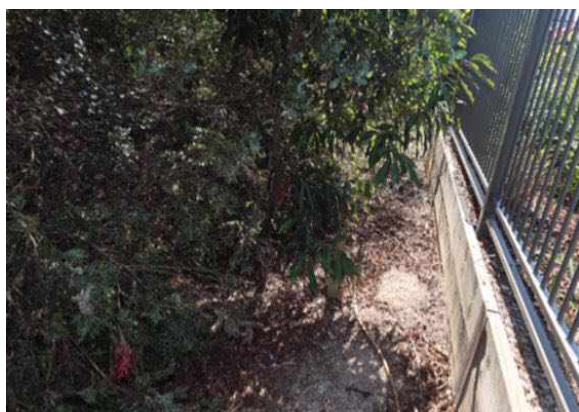
Finding 6.01

Building:	Yard
Location:	Yard - Back > Existing
Finding:	Garden Beds - Conditions Conducive to Termites
Information:	Garden beds were found to be evident in the garden area. These garden beds can include untreated timber, and with a combination of moisutre from watering hosing can make conditions conducive to termite activity and termite ingress.

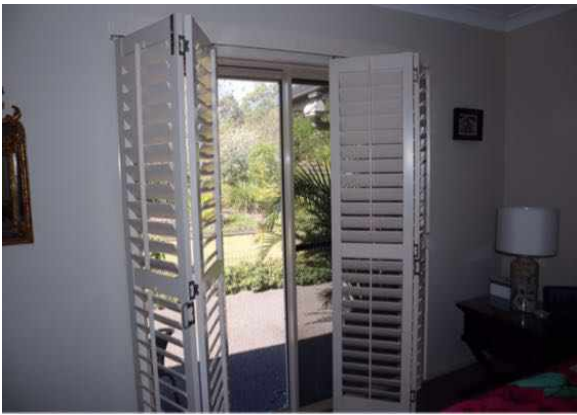
Building: Main Building
Location: Bedroom 2 > Existing
Finding: Gaps on window architrave minor
Information: At the time of inspection it was noted that there was minor cracks in window architraves.

A handyman maybe required to rectify this issue.

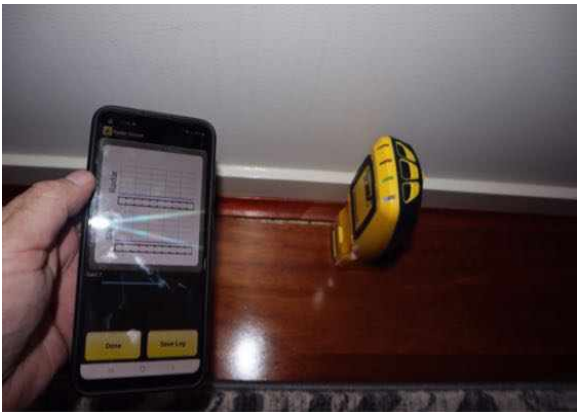
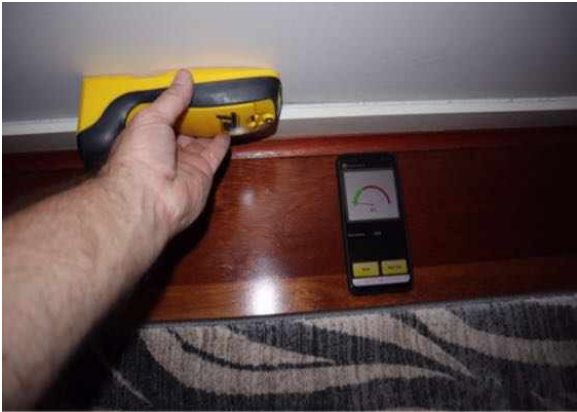
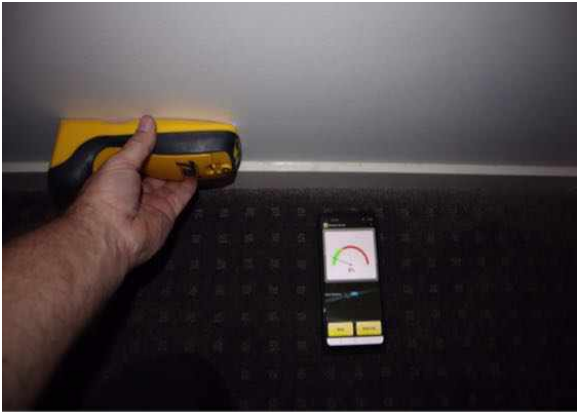
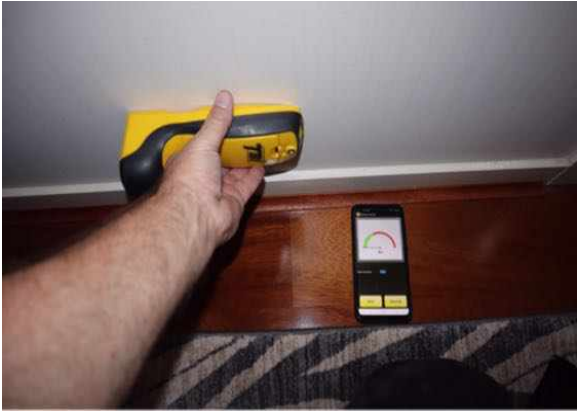
No evidence of termite activity was found inside the house at the time of the inspection.

High readings for moisture was found in the lower walls of the wet areas which warrants further invasive investigation.
