Timber Pest Inspection Report

Inspection Date: Tue, 26 Nov 2019

Property Address: 7 Stirling Pl, Belrose NSW 2085, Australia

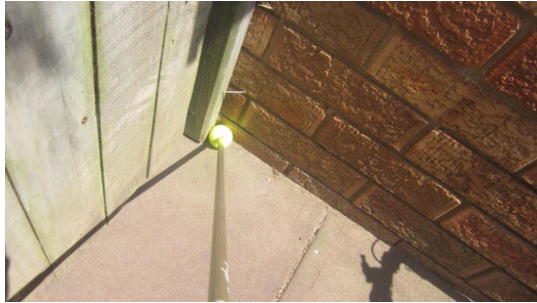
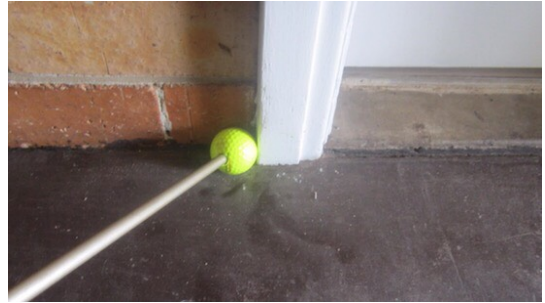
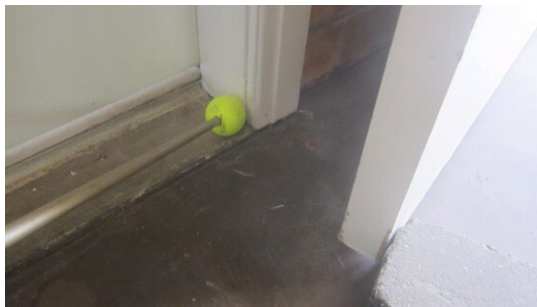
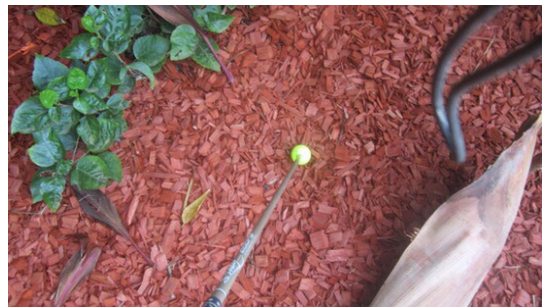
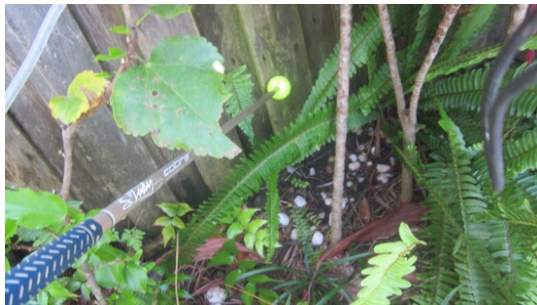
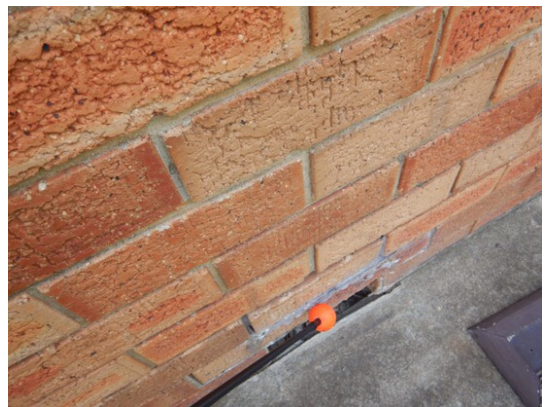
Building:	Main Building
Location:	All External Areas
Finding:	In ground contact
Information:	Any timbers in direct ground contact provide opportunity for concealed termite entry and are likely to be subject to premature rot and decay as the soil retains moisture or damp conditions against the timbers.

Remove untreated timber that is in direct contact with external grounds. Consider replacement with more durable materials i.e. treated timber or non timber elements. Frequent pest inspections are advised to readily identify any termite activity in these areas.

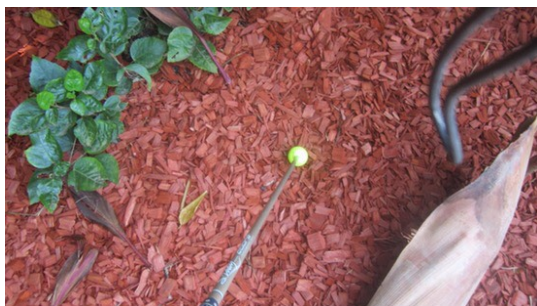
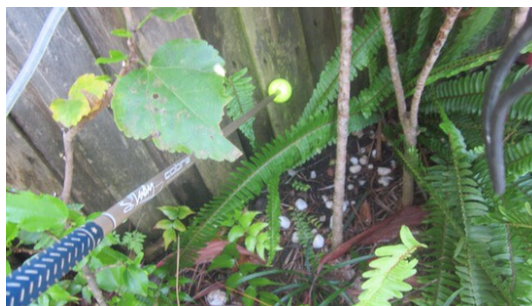
Building:	Main Building
Location:	Subfloor
Finding:	Garden Beds - Conditions Conducive to Termites
Information:	Garden beds were found to be evident in the garden area. These garden beds can include untreated timber, and with a combination of moisture from watering hosing can make conditions conducive to termite activity and termite ingress.

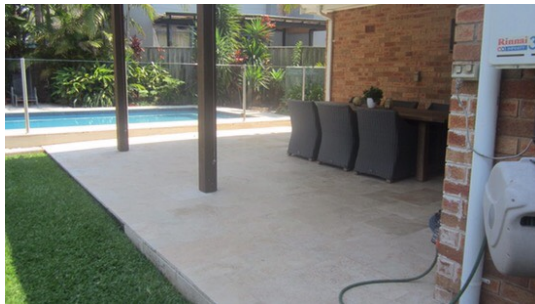
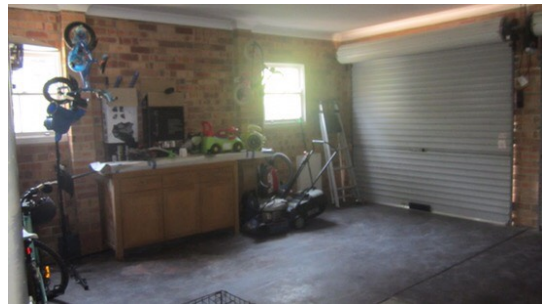
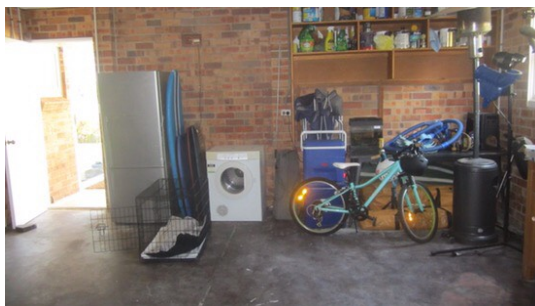
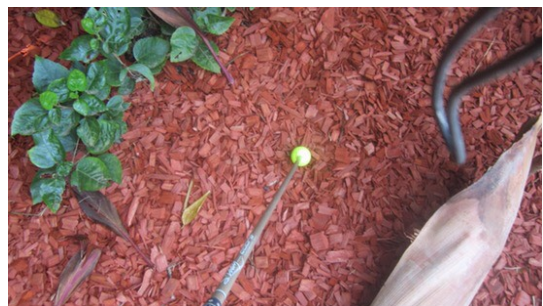
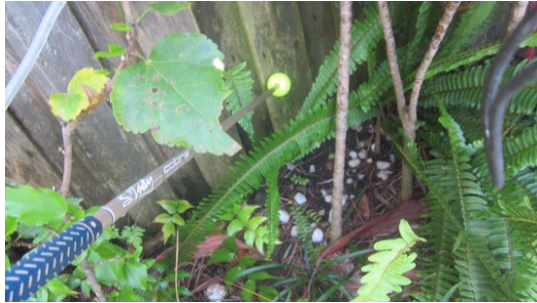
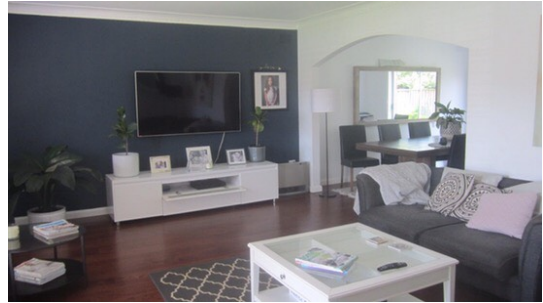
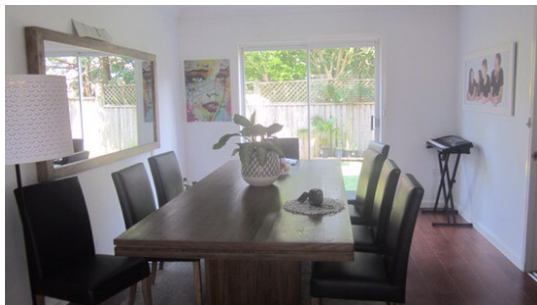
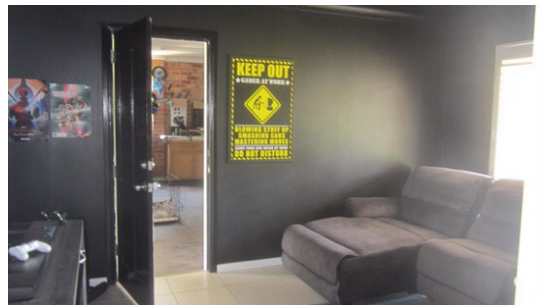
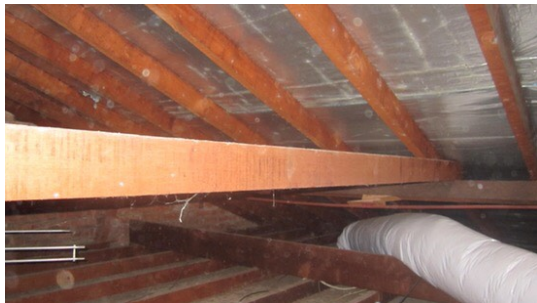
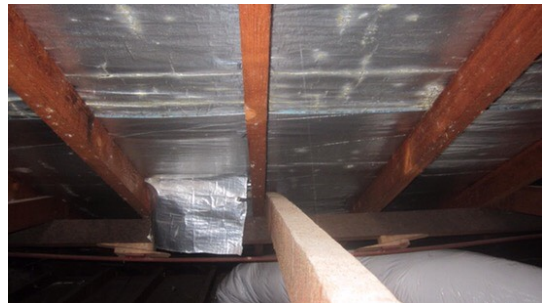
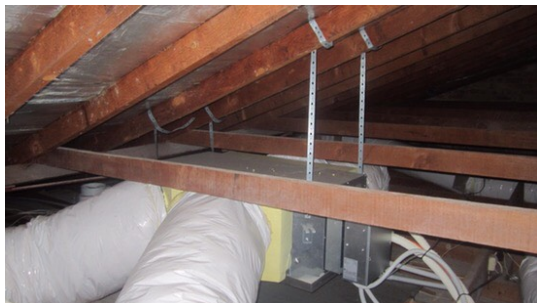
Finding: Additional Photos - Obstructions and Limitations

Information: These photographs are an indication of the obstructions and limitations which impeded full inspection of the property at the time of inspection. These obstructions can hide an array of defects and should be removed to allow full inspection to be carried out. A re-inspection is recommended once the areas are made accessible.

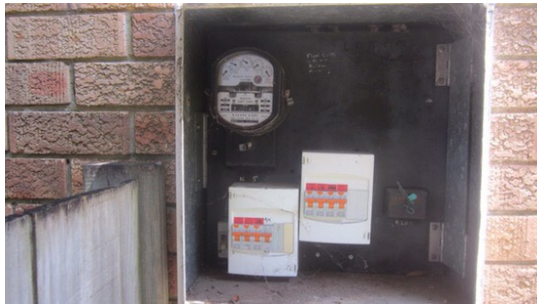
Building:	Main Building
Location:	All Areas
Finding:	Termite Management System - no evidence of installation
Information:	The application of a post-construction chemical termite barrier is highly recommended for all properties, particularly if live termite activity has been found on the site previously. Such barriers are highly effective in preventing termite attack on any timber building elements throughout the property.

A durable notice should be placed in the switchboard unit to indicate current termite barriers. At the time of inspection, it appeared as though no termite management system has been installed, with no evidence to suggest preventative works taking place.

The client may consider gaining further advice from a pest controller as to the costs and procedures involved with this application. It is recommended that obtaining such advice be a short-term priority.
