## Building and Timber Pest Inspection Report

Inspection Date: Thu, 16 Dec 2021

Property Address: 62 The Esplanade, Frenchs Forest NSW  
2086, Australia

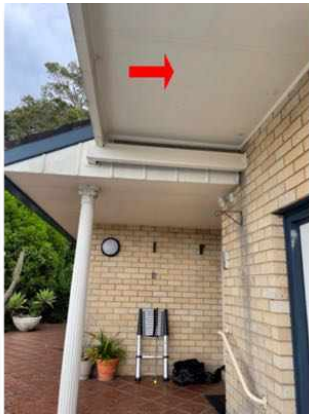
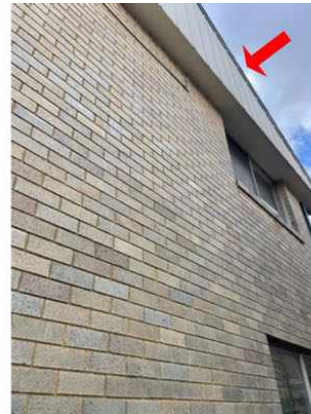
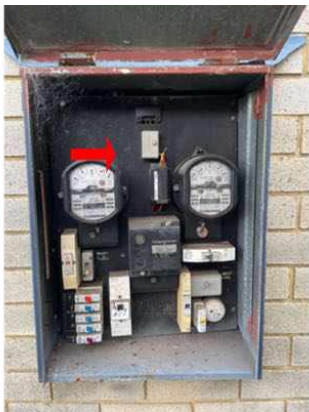
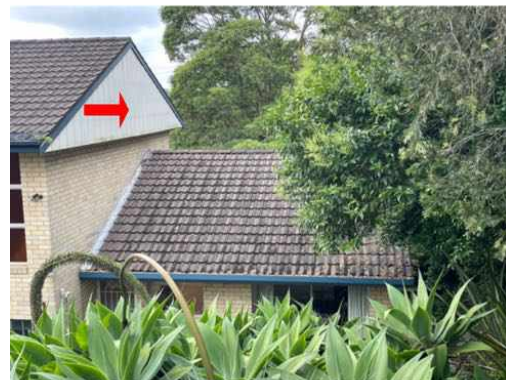
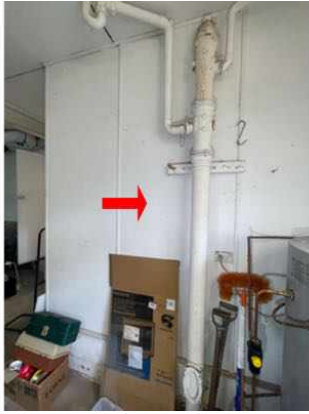
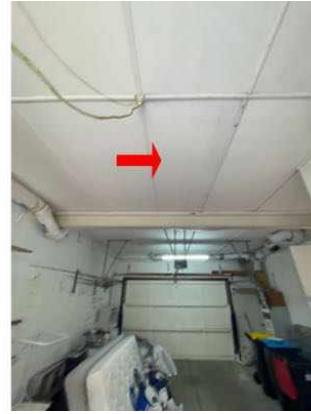
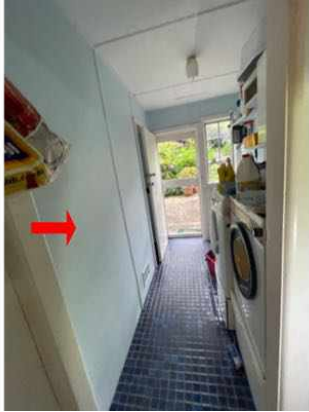
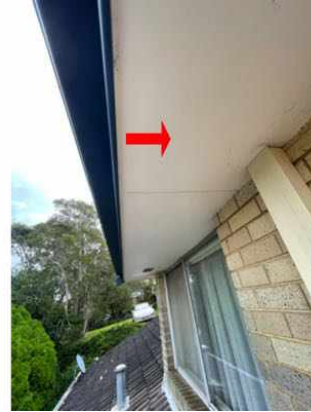
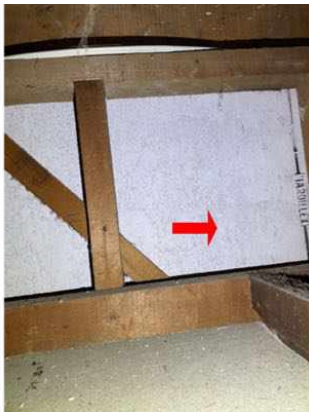
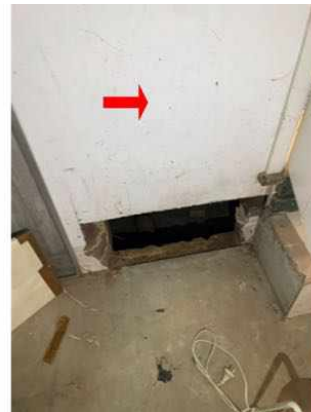
#### Defects 1.01

Building: Building 1  
Location: All Areas  
Finding: Asbestos - Suspected ACM Identified on Site  
Information: As Asbestos Reporting is outside the scope of this report, we advise that you consider a separate Asbestos Inspection and Condition Audit, which can include the taking of samples for definitive confirmation of the presence of Asbestos.

In the interim, the client is advised to act with caution, especially when considering any damage to building materials general wear and tear renovations extensions demolition and general maintenance activities due to the suspected presence of Asbestos.

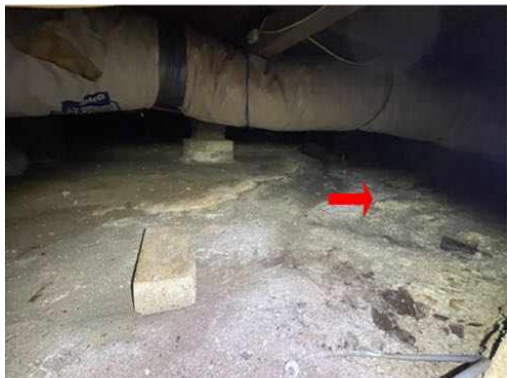
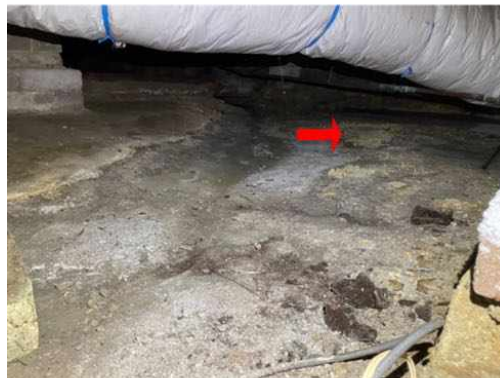
## Defects 1.02

Building: Building 1  
 Location: Subfloor  
 Finding: Mould - Present  
 Information:

Where evidence of mould growth was noted, there may be environmental, biological or health issues associated with the report. A specialist inspection by a suitably qualified environmental health inspector is warranted, where mould is extensive or where any queries regarding air quality spores or other related issues apply.

Generally, the client is advised to ensure that the general environment is free of moisture and humidity to aid in the prevention of mould formation and development. Any mould found during the inspection should be cleaned immediately by a cleaning

contractor or the homeowner as applicable.

Please note that severely affected building elements may require replacement by a registered builder or qualified carpenter.

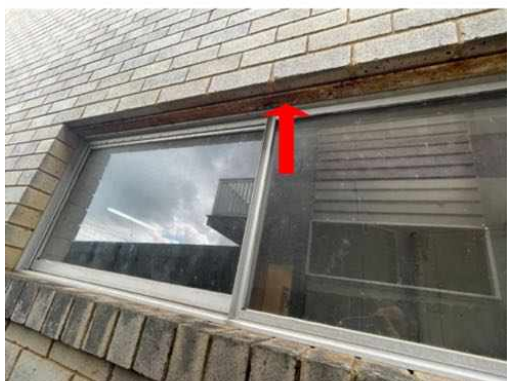
### Defects 3.01

Building:	Building 1
Location:	All Areas
Finding:	Building element - Rusted or corroded
Information:	This building element shows evidence of rusting and corrosion, which is likely to have developed as a result of excessive exposure to moisture and or inadequate coatings.

Rusting and corrosion should be managed by ideally removing or limiting the affected surface from exposure to moisture.

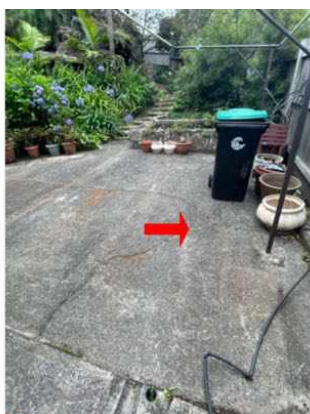
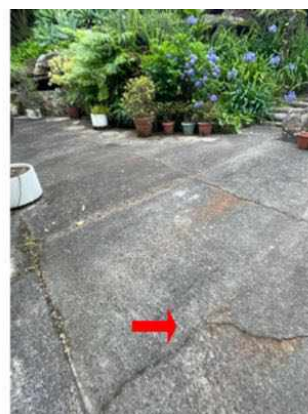
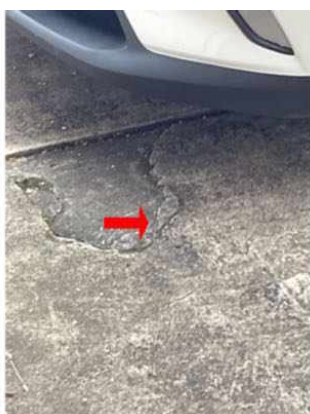
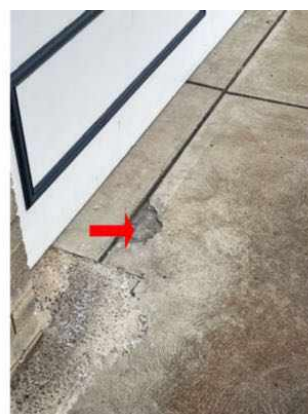
## Defects 3.02

Building: Building 1  
 Location: All Areas  
 Finding: Crack in concrete slab - Category 1  
 Information: A crack coded as Category 1 was identified in the slab. A Category 1 crack is described as a fine but noticeable crack, with the slab at an otherwise reasonable level.

To be considered Category 1, the approximate width of the crack is less than 1.0mm, or a less than 10mm change in offset when a 3m straight edge is placed over the defect.

Category 1 cracks should be monitored for a period of 12 months. At the end of the monitoring period, identified cracks that are rated greater than Category 2 are considered defects, and require rectification.

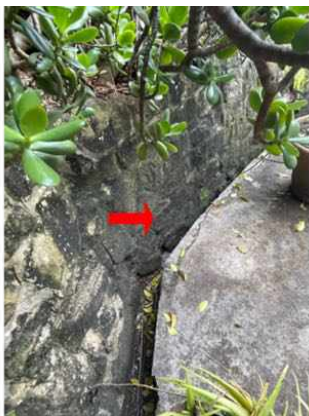
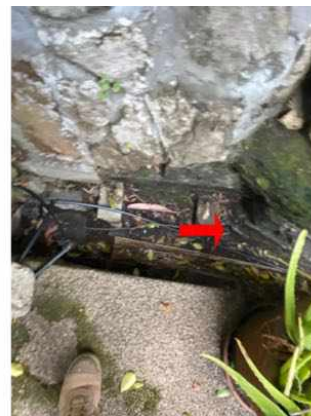
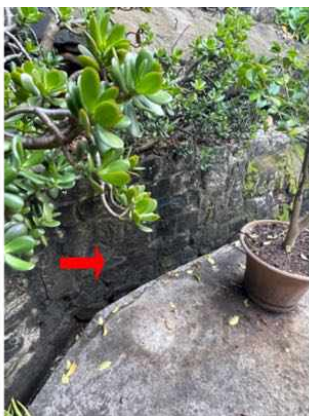
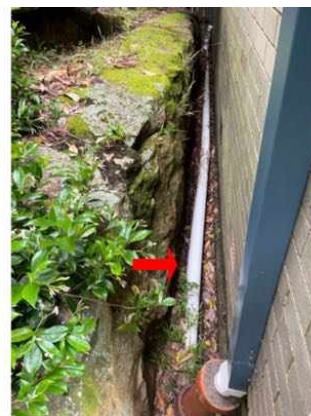
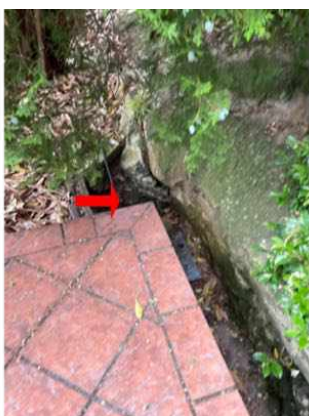
## Defects 3.03

Building: Building 1  
 Location: All Areas  
 Finding: Site drainage - suspected inadequate  
 Information: The site drainage in this area was found to be inadequate at the time of inspection,

creating potential for subsequent water damage to associated building elements.

It is important that water does not lie against the base of walls; surrounding paths and ground levels should be sloped to drain water away from walls. Downpipes should not discharge stormwater onto lower walls or plinths. Stormwater should be carried away by large, regularly cleaned drains. Ground levels may need to be lowered to expose a buried DPC.

Where site drainage is inadequate, installation of an Agricultural (Aggie) Drain may be required. A qualified plumber should be appointed to further inspect the property and perform any remedial works as necessary. Water damage and secondary defects are likely to occur if left unmanaged.

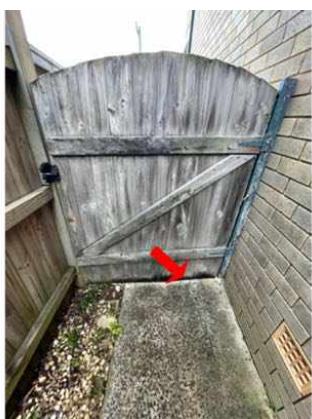
## Defects 3.04

Building:	Building 1
Location:	All Areas
Finding:	Wood rot
Information:	This building element shows evidence of wood rot. Wood rot, also known as Fungal Decay, occurs when timbers and other cellulose building materials are exposed to damp conditions on an ongoing basis. This could be the result of exposure to weathering over a prolonged period of time, or the attraction of excessive moisture from other abutting building materials. Contributing factors also include poor air ventilation in the area.

Wood rot is often associated with general damp problems and is evidenced by a 'musty' smell or mould and mildew occurring on surfaces. If left unmanaged, damp conditions can lead to further health problems and the decay of timbers will continue.

Early intervention and regular maintenance, particularly of exterior timbers, will prolong the useful life of these building elements. Prior to any works being performed, the cause of the moisture that has created the visible wood rot should be identified and addressed in a suitable manner. Replacement of affected timbers may then be a necessary step in protecting surrounding building elements from such deterioration.

A qualified plumber may be appointed to assess the cause of excessive moisture and to provide advice on any remedial works as required. A qualified carpenter or registered builder may also be required to replace affected building materials.

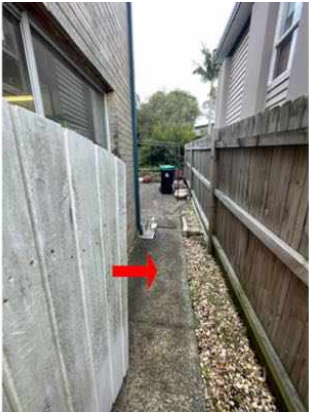
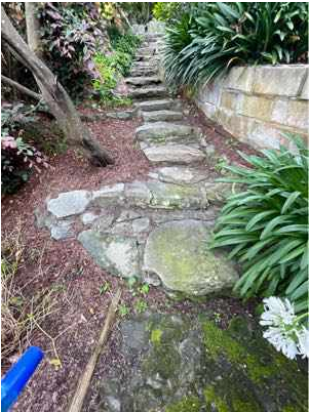
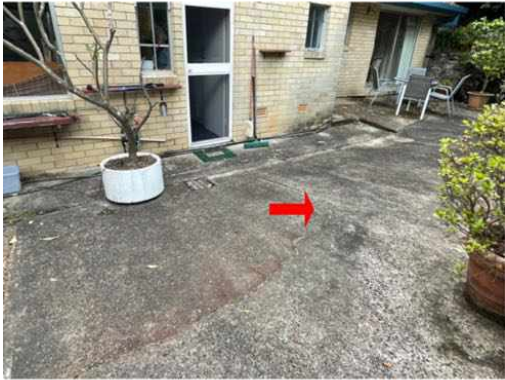
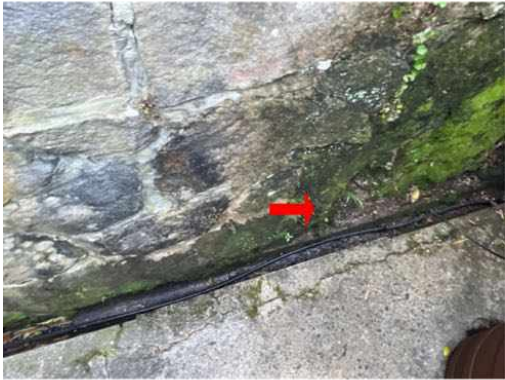
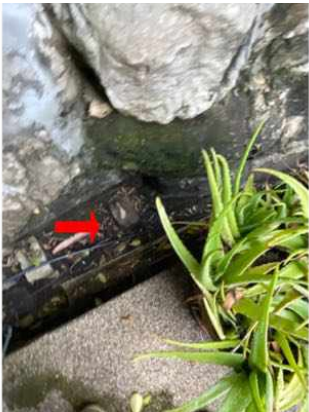
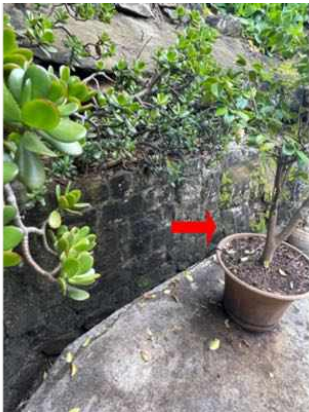
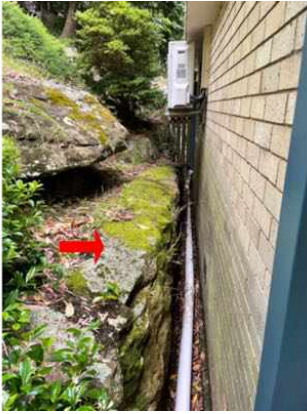
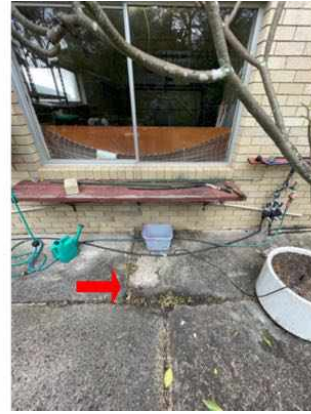
## Defects 3.05

Building:	Building 1
Location:	All Internal Areas
Finding:	Evidence of excessive moisture was present at the time of inspection
Information:	Excessive moisture can attract termites and produce conditions that promote termite attack fungal growth and wood decay.

Excessive moisture is generally caused by deteriorated inadequate or missing roof drainage leaking plumbing pipes or fixtures poorly plumbed HWS overflows or condenser units and poor site drainage.

It is highly recommended that all plumbing and drainage fixtures and fittings be maintained regularly in order to prevent excessive moisture being present in the external / internal property.

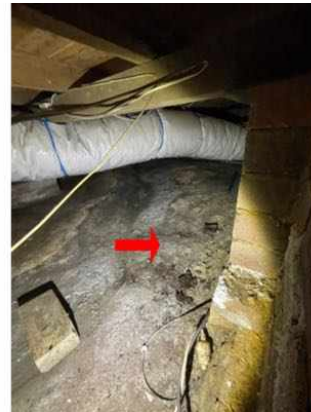
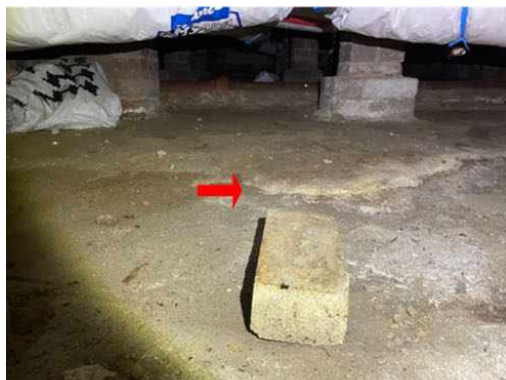
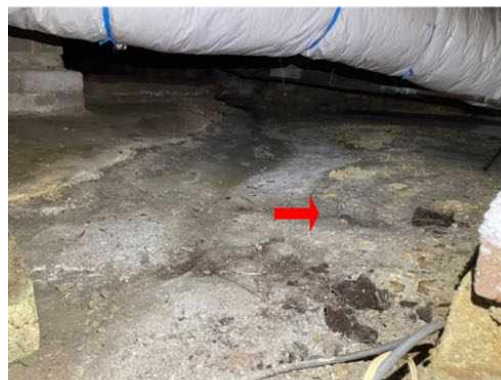
### Defects 3.06

Building:	Building 1
Location:	Subfloor
Finding:	Evidence of excessive moisture was present at the time of inspection
Information:	Excessive moisture can attract termites and produce conditions that promote termite attack fungal growth and wood decay.

Excessive moisture is generally caused by deteriorated inadequate or missing roof drainage leaking plumbing pipes or fixtures poorly plumbed HWS overflows or condenser units and poor site drainage.

It is highly recommended that all plumbing and drainage fixtures and fittings be maintained regularly in order to prevent excessive moisture being present in the external / internal property.

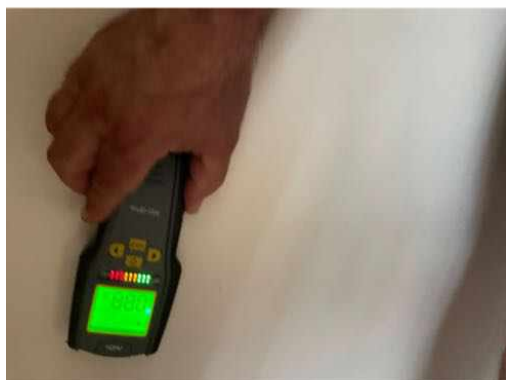
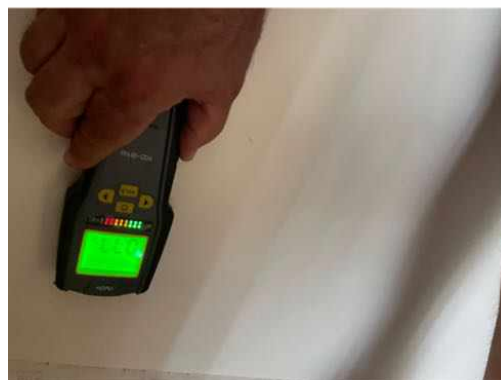
### Defects 3.07

Building:	Building 1
Location:	Lounge Room
Finding:	Evidence of excessive moisture was present at the time of inspection
Information:	Excessive moisture can attract termites and produce conditions that promote termite attack fungal growth and wood decay.

Excessive moisture is generally caused by deteriorated inadequate or missing roof drainage leaking plumbing pipes or fixtures poorly plumbed HWS overflows or condenser units and poor site drainage.

It is highly recommended that all plumbing and drainage fixtures and fittings be maintained regularly in order to prevent excessive moisture being present in the external / internal property.

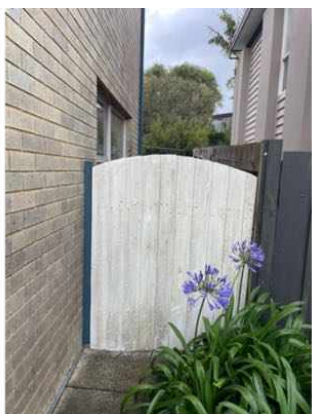
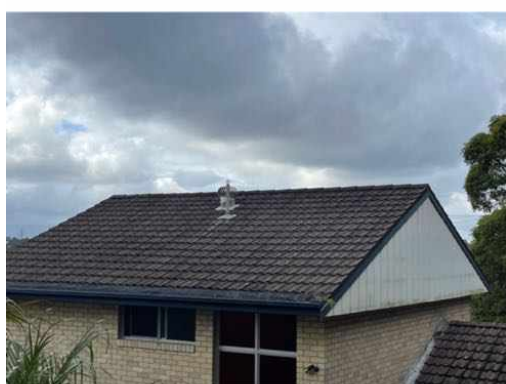
### Defects 3.08

Building:	Building 1
Location:	All Areas
Finding:	painting deteriorated
Information:	Whilst incomplete or missing paint finish is generally an appearance defect, it can also lead to the development of secondary building defects over time. Incomplete areas of

paint finish exposes the area to moisture, potentially accelerating the deterioration of underlying building materials.

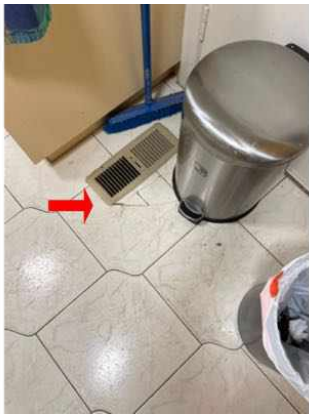
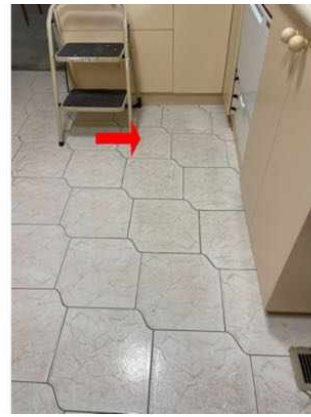
### Defects 3.09

Building:	Building 1
Location:	All Areas
Finding:	Tiles - Cracked or damaged
Information:	Cracking was evident to the tiling in this area at the time of inspection. While the cracking appears to be minor, this area is frequently exposed to water, allowing potential for water penetration into adjoining sections of walls or flooring.

If left unmanaged, water penetration to these areas may lead to subsequent water damage, which is likely necessitate repair work to affected building elements.

A tiling contractor should be appointed to ensure that no further water damage occurs. The re-application of silicone and grouting throughout remaining tile work is also advised, to further protect the area against water penetration.

Where water penetration has led to water damage, appointment of a relevant tradesperson may be required to repair damaged building elements.

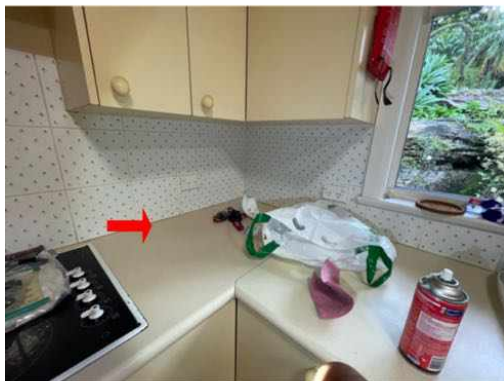
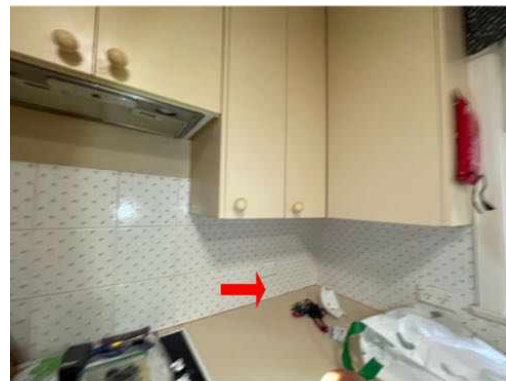
### Defects 3.10

Building:	Building 1
Location:	All Areas
Finding:	Sealant - missing/ deteriorated
Information:	Flexible and mould resistant materials should be applied to affected areas to prevent any subsequent water damage that is likely to occur. Regular maintenance and replacement of damage or missing or damaged sealant and grout is highly recommended to the wet areas, as this is a regular wear and tear defect.

Sealant and grouting in areas that come into regular contact with water should be maintained for the long term care of your property. A sealant specialist or tiling contractor should be appointed to complete these works as soon as possible

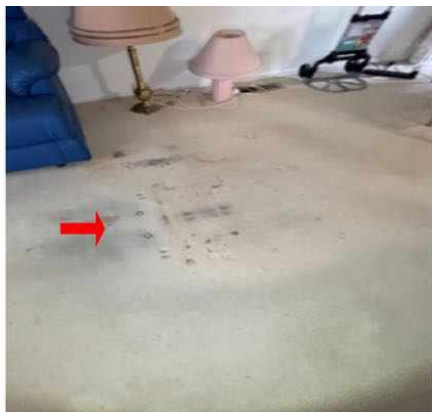
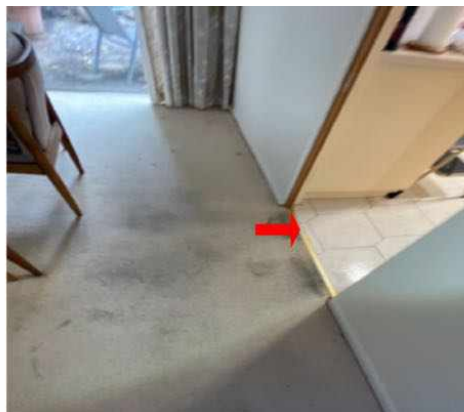
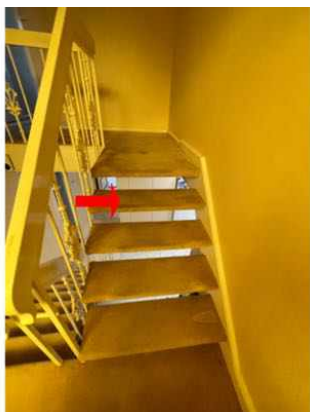
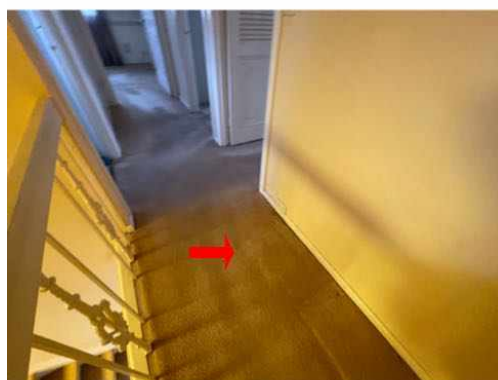
### Defects 3.11

Building:	Building 1
Location:	All Areas
Finding:	Carpet - Deteriorated
Information:	Sections of the carpet floor covering in this area appeared to be deteriorated.

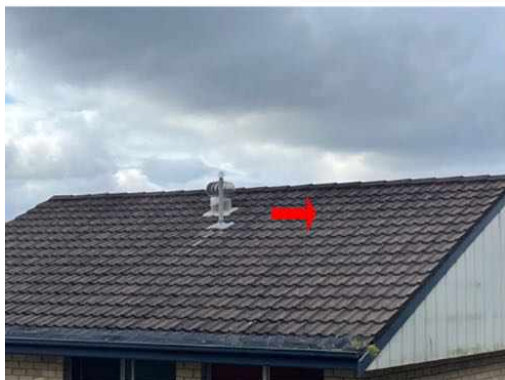
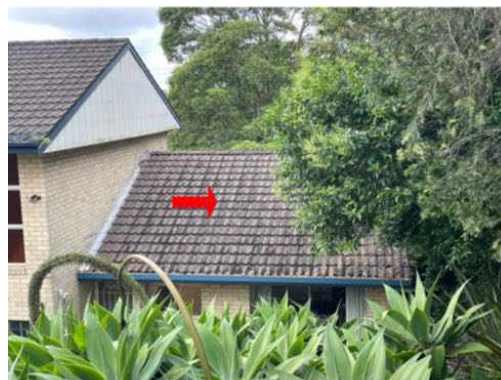
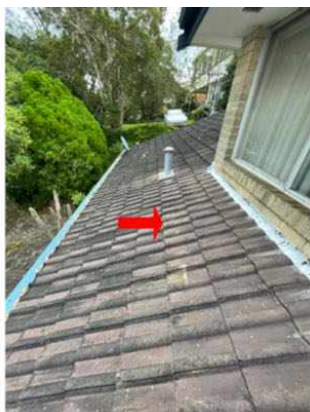
### Defects 3.12

Building:	Building 1
Location:	All Areas
Finding:	Roof tiles - Weathered
Information:	Upon inspection of the exterior roofing, the majority of roof tiles were considered to be in a fair condition. While weathering of the tiles is consistent with the age of the property, maintenance works are required.

Where left unmanaged, deteriorating roof tiles are likely to lead to a number of secondary defects, including minor water leaks and weather exposure to internal roofing structures.

Consultation with a roofing contractor is highly advised to gain advice on cost of remedial works that may be required in the short to medium term. Remedial works are likely to increase the longevity of the exterior roofing structure.

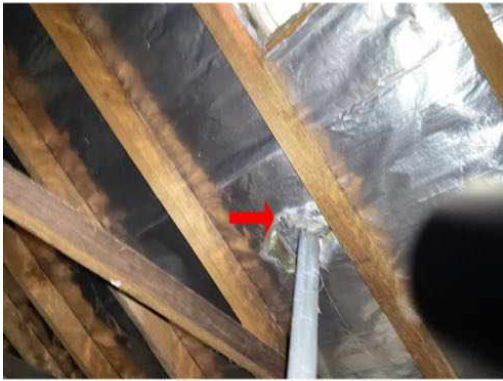
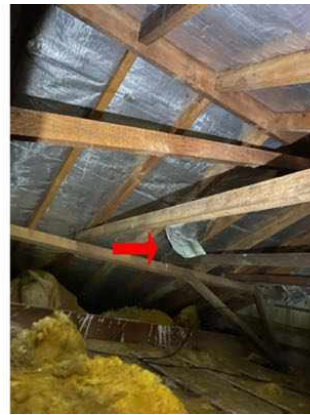
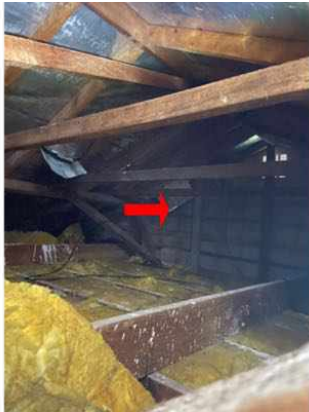
### Defects 3.13

Building:	Building 1
Location:	All Areas
Finding:	Sarking - Damaged
Information:	Sarking, a laminated aluminium foil applied to the interior of the roof covering, assists in insulating the property and acting as a vapour-barrier to the roof void and, subsequently, to the household.

Where sarking is damaged, both insulation and moisture protection of the property are inhibited. This creates a loss of energy and thus negatively impacts the energy efficiency of the property, allowing potential for moisture ingress from condensation or leaking roof tiles.

It is important to repair any holes or damaged sections of sarking to ensure that the building material is fully functional. A registered builder or qualified carpenter should be consulted to provide further advice on this defect and to perform rectification works at client discretion.

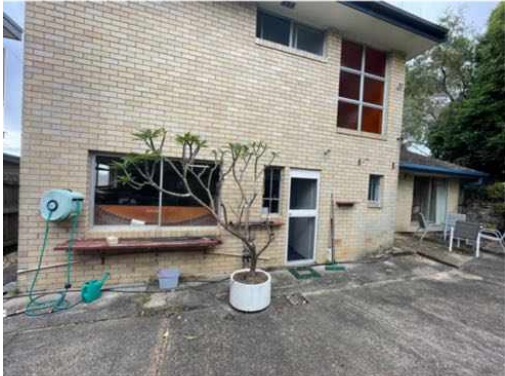
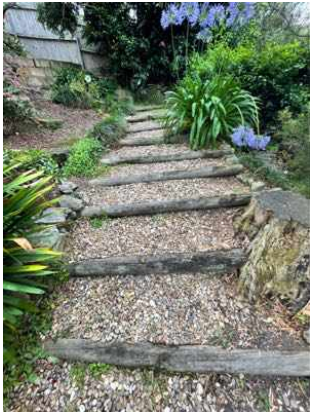
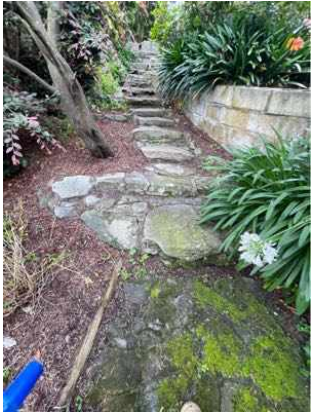
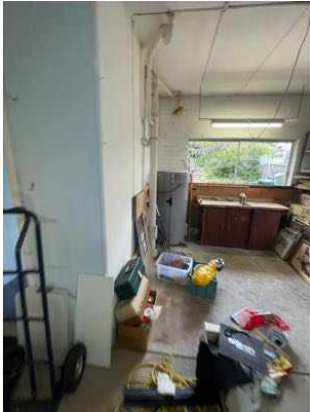
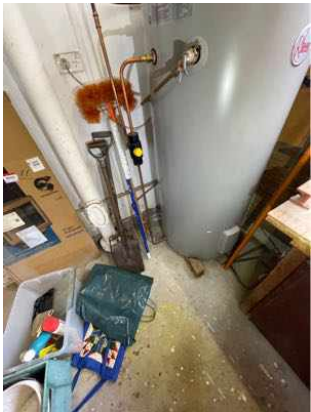
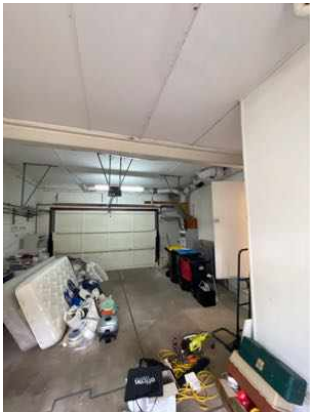
Building: Building 1  
Location: All Areas  
Finding: Additional Photos - Obstructions and Limitations  
Information: These photographs are an indication of the obstructions and limitations which impeded full inspection of the property at the time of inspection.

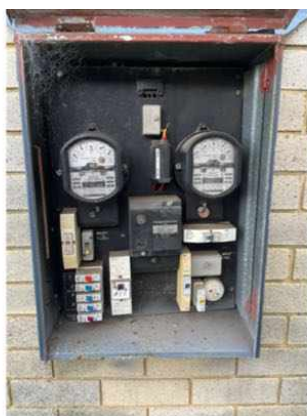
Building: Building 1  
 Location: Yard - Side  
 Finding: Termite Management System - no evidence of a chemical installation  
 Information: The application of a post-construction chemical termite barrier is highly recommended for all properties, particularly if live termite activity has been found on the site previously. Such barriers are highly effective in preventing termite attack on any timber building elements throughout the property.

A durable notice should be placed in the switchboard unit to indicate current termite barriers. At the time of inspection, it appeared as though no termite management system has been installed, with no evidence to suggest preventative works taking place.

The client may consider gaining further advice from a pest controller as to the costs and procedures involved with this application. It is recommended that obtaining such advice be a short-term priority.

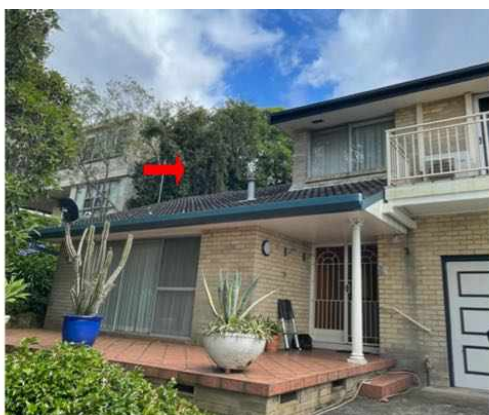
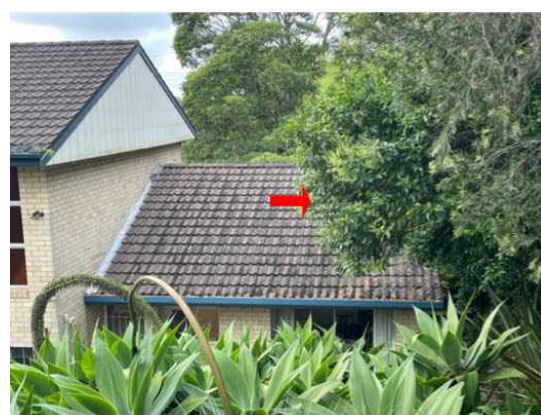
Gutters are a critical part of the building's management of storm water and rain. It is therefore important that they be kept clear to prevent secondary damage to associated building elements, including exterior and interior walls, ceiling linings and any adjoining building elements. Where gutters are blocked, pooling of rainwater is likely to occur, fast-tracking rust and corrosion of the roof plumbing elements.

It is highly advised that all overhanging tree branches be removed as soon as possible to prevent any further damage. Repair and/or replacement of sections of damaged guttering may also be required where the extent of the damage necessitates.

Such works should be performed by the homeowner; however, appointment of a landscape contractor or an arborist may be required. Consultation with a licensed roof plumber is required where guttering has been damaged.
