10 Rounce Ave, Forestville

Standard Termite Detection Report

18th Apr, 2021

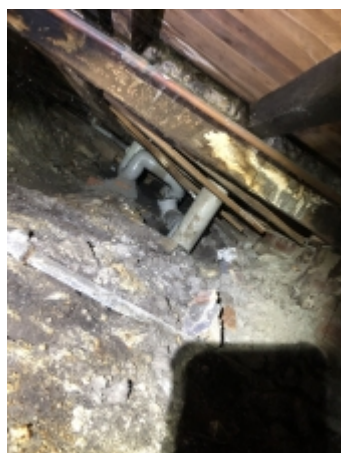
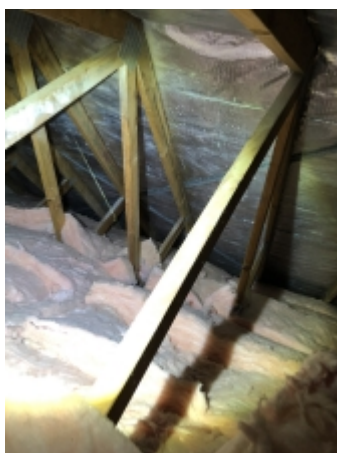
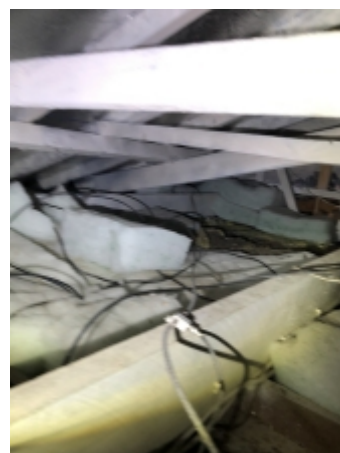
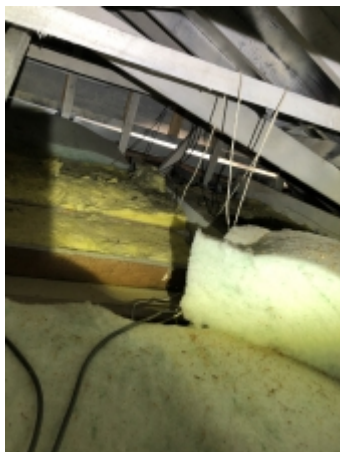
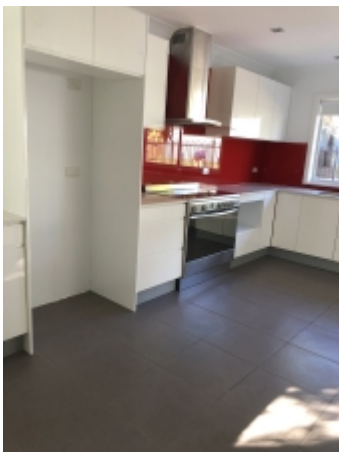
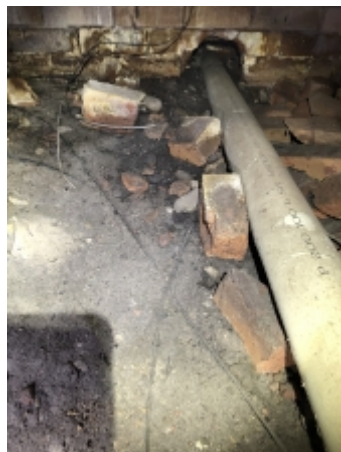
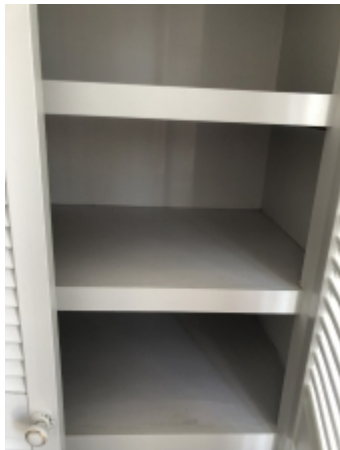
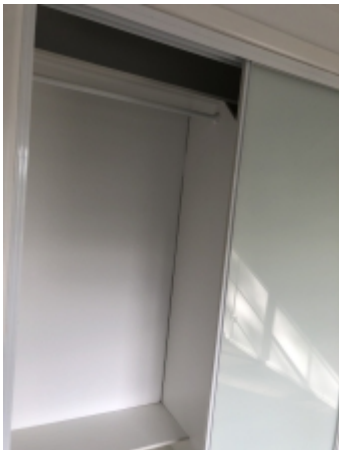
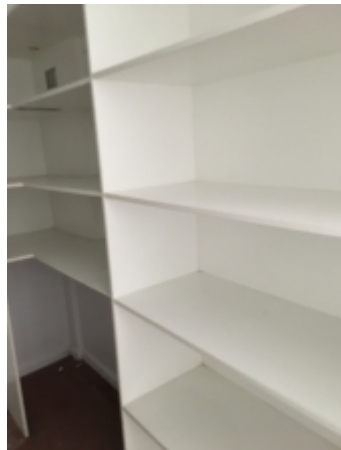
Obstruction Photos

>Interior Obstructions	Behind Fixtures and fittings, Behind wall linings, Under floor coverings
Comments	Almost every building has obstructions. Whether they are removable furniture such as bookcase or fixtures such as kitchen cabinets or wall linings, they can all limit the visual inspection and the moisture testing. The obstructions can also conceal termite activity. Comments in this report are based on the areas which could be visually inspected and physically tested.

Roof Space Obstructions	Low clearance, Thermal Insulation, Sarking, Low clearance edges to roof void
Comments	Thermal insulation materials, stored goods or fixed equipments can conceal termite activity by preventing visual inspection. Low clearance edges of the roof void causes the same problem. More frequent inspection and installation of termite management system can help detect/ prevent termite activity before they cause substantial damages

Subfloor Obstructions	Low Clearance, No access
Comments	Some parts of the subfloor could not be accessed due to the low clearance. The comments on this section are based on the areas which could be visually inspected.

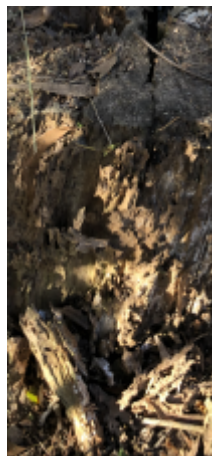
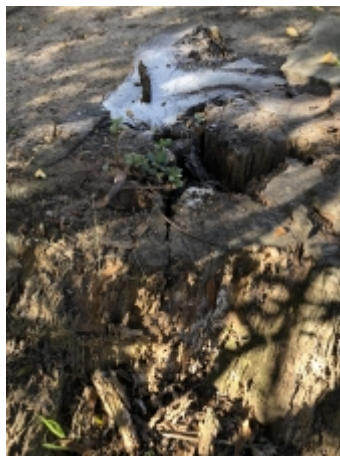
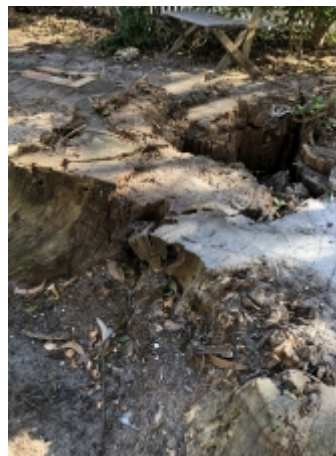
Working Or Damage Photos

Was evidence of termite workings or damage found?	Yes - see clauses A.4 and A.5
The extent of any visible damage appears:	Localised

Details - indicate the location of all accessible timbers and other materials showing signs of attack, and a description of any termite workings found:	Previous termite activity was found in a tree stump in front yard next to the carport. No live activity was found.
---	--

RECOMMENDATION: Where evidence of damage to building timbers exists, competent advice (e.g. from a licensed and practicing building contractor) should be obtained to determine the extent of any structural damage and as to the need or otherwise for rectification or repair work. See also Item 3.5 'Frequency of Future Inspections' recommendation.

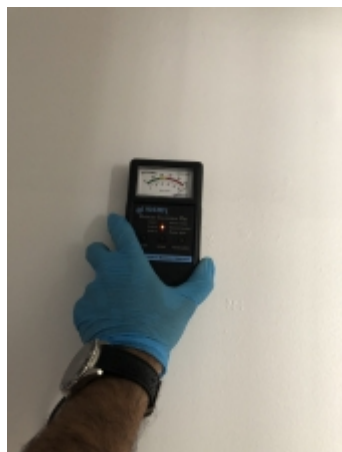
Details (include the location and any recommendation for further expert advice e.g. from a licensed a plumbing contractor):	Excessive moisture reading was obtained by professional moisture meter from a wall in ground floor shower and the wall behind it. The cause of moisture can be a leaking plumbing, termite activity or both. We strongly recommend a licensed plumber to conduct a controlled invasive inspection to find the exact cause of moisture. Excessive moisture reading also obtained from a wall of the sunken room in ground floor. This also needs to be inspected by a licensed plumber or a builder.
---	---

Excessive moisture reading

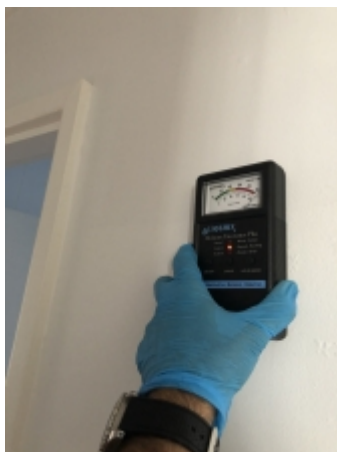
Excessive moisture reading

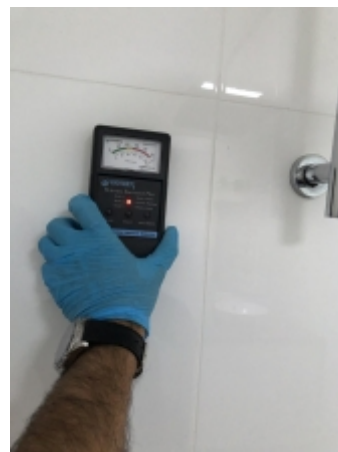
Excessive moisture reading

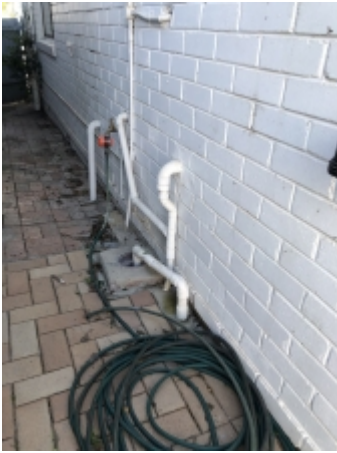
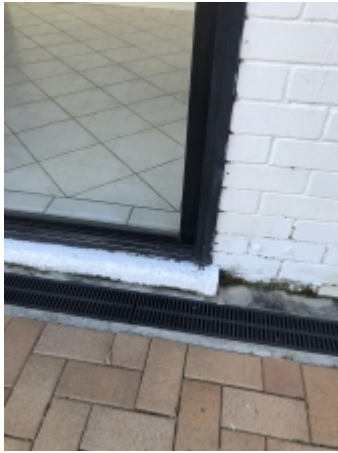
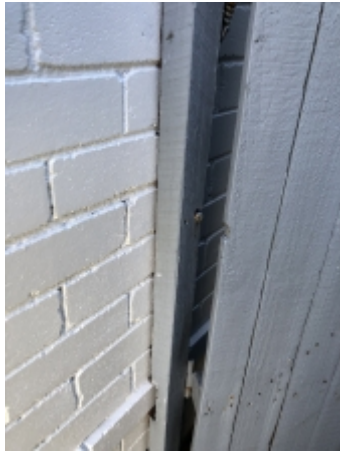
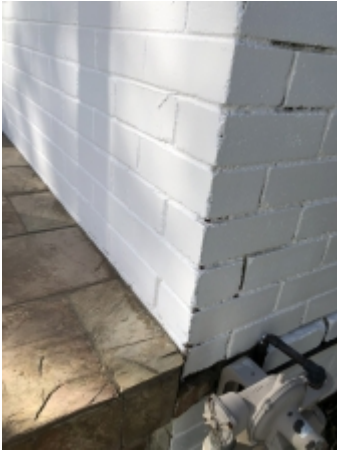
Bridging Breaching Photos

Was the finished ground or paving level above the adjacent internal floor level or damp-proof-course or obstructing any weephole or vent face on external walls?	Yes
Was evidence of bridging or breaching including the condition insufficient slab edge exposure found?	Yes - see clauses A.4 and A.5
Include any visible evidence of bridging or breaching or slab edges obstructed by:	Steps/Ramps, Pipework
Details (include the location and any recommendation for further expert advice e.g. from a licensed a building contractor):	Termites can bridge or breach into the buildings undetected where there are building elements that cover damp proof course or being installed above internal floor. In many cases, such as this house, steps, front deck or pipes create such condition. If rectifying these conditions are not possible at all, more frequent inspections and installation of termite management system is highly recommended.

Bridging and breaching photos

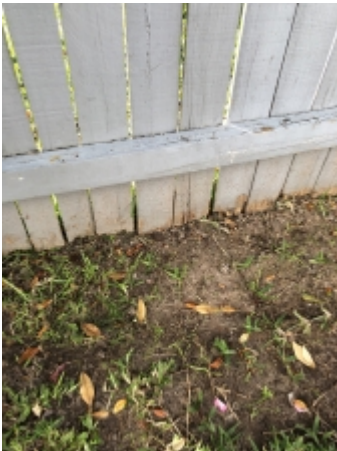
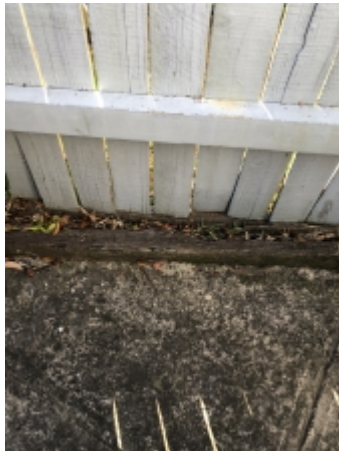
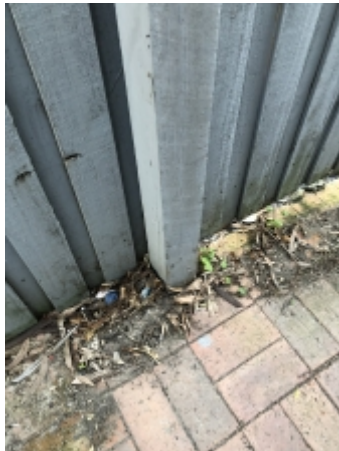
Earth- Wood / Damp Masonary Photos

Was evidence of earth-wood or damp masonry-wood contact found?	Yes
Details (include the location and any recommendation for further expert advice e.g. from a licensed a building contractor):	Any direct wood-to-soil contact within or around a building's foundation increases the risk of termite invasion. This is true even for "treated" wood. It is therefore very important to maintain a separation of 15cm or more between all wood and any soil or gardening material

Timber in contact with damp soil

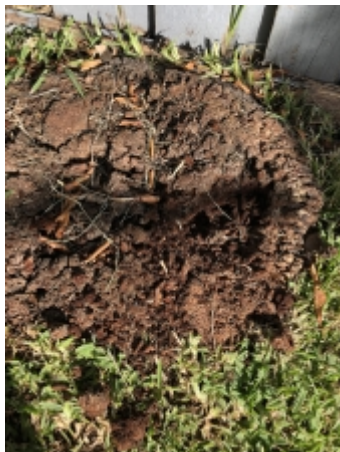
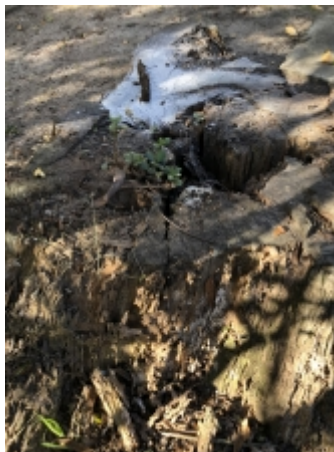
Conductive Conditions Photos

Was evidence of any other condition conducive to termite attack found?	Yes
Details (include the location and any recommendation for further expert advice e.g. from a licensed a building contractor):	Tree stumps or logs eventually become an ideal place for termites to establish their nest. Once a stump "ages" the timbers become susceptible and desirable to foraging termites. For a termite colony, stumps provide an ample source of food and a safe haven. Removing the stumps from the yard or injecting termiticide in and around the them, can greatly reduce the risk of termites nesting in the property.

Tree stumps
