VISUAL BUILDING AND PEST INSPECTION REPORT

Complies with Australian Standard 4349.1 & 4349.3

7 Rangers Retreat Road, Frenchs Forest

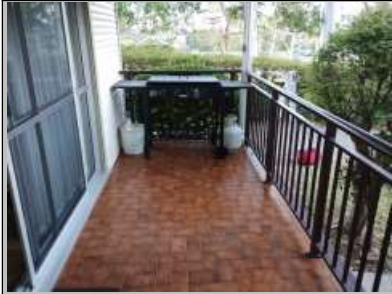
Front elevation.

Constructed from concrete or masonry. The condition of the structure is generally acceptable.

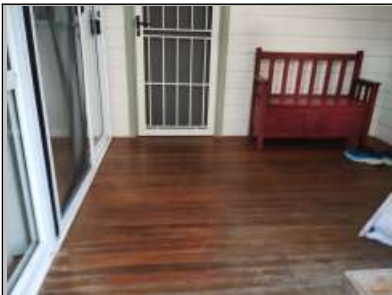
Rear elevation.

The general condition of this structure is fair.

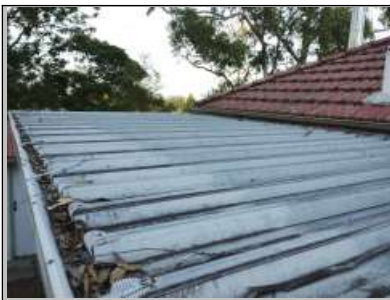
Rear elevation.

The overall condition of the roof coverings is fair.

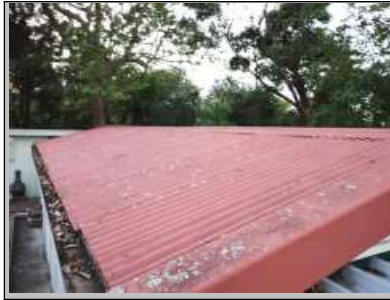
The corrugated fiber cement roof sheets are deteriorating/cracked and damaged areas will require replacement.

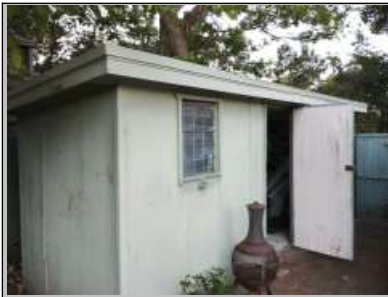
Southeastern elevation.

Recommend that an upgrade of this structure be considered.

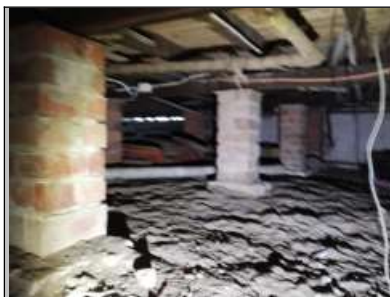
The building is constructed on a combination of strip footings and piers. The footings appear to be generally sound.

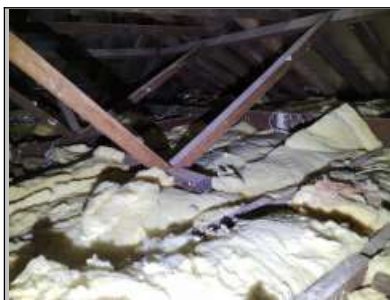
Insulation is present in the roof cavity. This restricted inspection to some roofing timbers. Removal of insulation is not within the scope of a standard visual inspection report, however as in accordance with "industry best standard" the inspector will lift insulation in 3 areas in roof void. Sarking membrane covered tile battens restricting inspection.

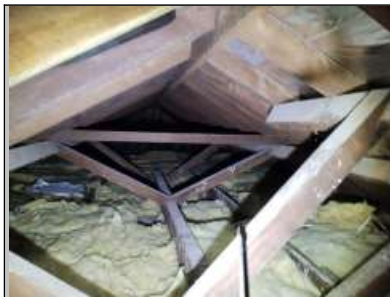
The cut and pitched roof timbers appear to provide adequate support.

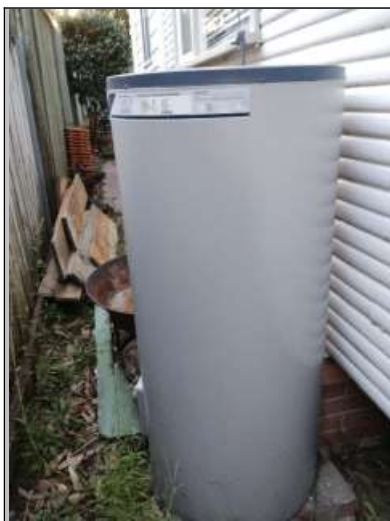
Mains electric hot water system: Mains pressure: Located externally: The hot water system appears to be in working condition. No specific tests other than running the hot water tap were carried out. No determination has been made as to the suitability or adequacy of the hot water system in relation to capacity or otherwise.

The unit was manufactured in 2013.

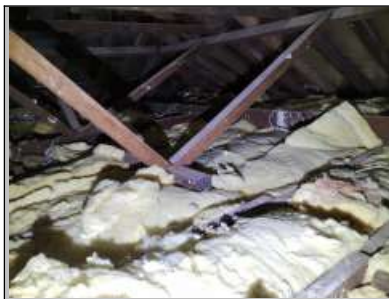
Insulation is present in the roof cavity. This restricted inspection to some roofing timbers. Removal of insulation is not within the scope of a standard visual inspection report, however as in accordance with "industry best standard" the inspector will lift insulation in 3 areas in roof void. Sarking membrane covered tile battens restricting inspection.
