## **VISUAL BUILDING AND PEST INSPECTION REPORT**

Vendor Report

30 Frenchs Forest Road East Frenchs Forest

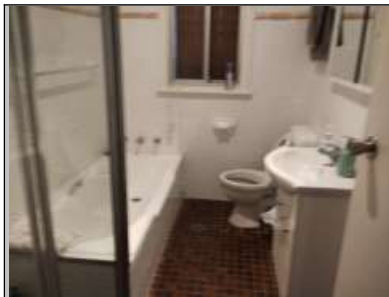
Rear.

The shower recess was tested and found to be leaking. Continued leaking may allow damage and decay to surrounding components. Rectification will be required and evaluation of extent of works should be requested from a Licensed Builder.

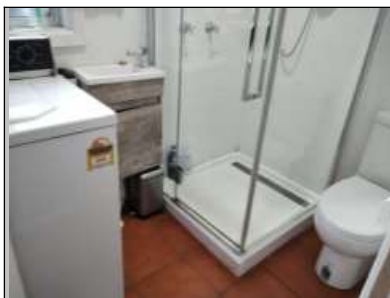
Rear.

The shower recess was tested and there was no visible water penetration to surrounding areas. IMPORTANT NOTE: This test may not reveal water leaks until the shower is put into constant use and surrounding areas monitored over a period of time.

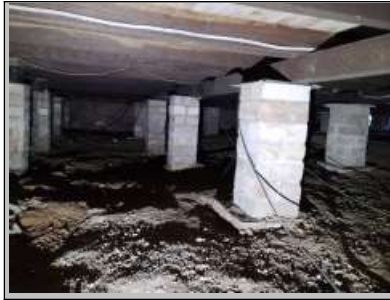
The building is constructed on a combination of strip footings and piers. The footings appear to be generally sound.

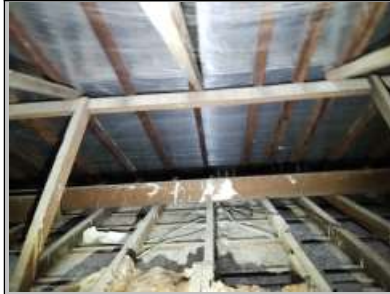
Sarking membrane covered tile battens restricting inspection.

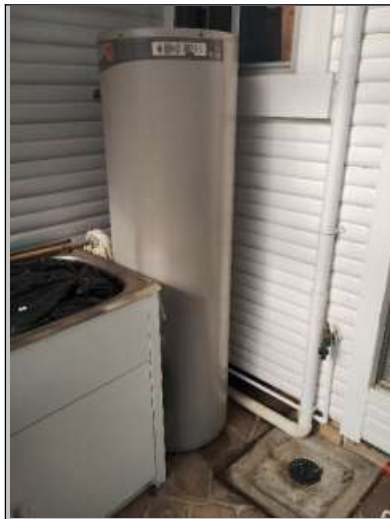
Mains electric hot water system: Mains pressure: Located externally: The hot water system appears to be in working condition. No specific tests other than running the hot water tap were carried out. No determination has been made as to the suitability or adequacy of the hot water system in relation to capacity or otherwise.

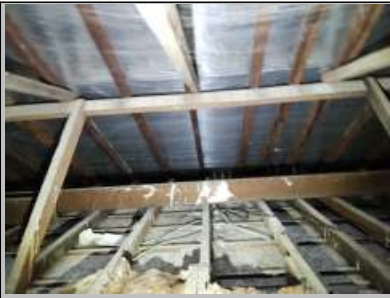
Sarking membrane covered tile battens restricting inspection.
