Building Inspection Report

Inspection Date: Tue, 01 Oct 2019

Property Address: 94 Bantry Bay Road, Frenchs Forest NSW, Australia

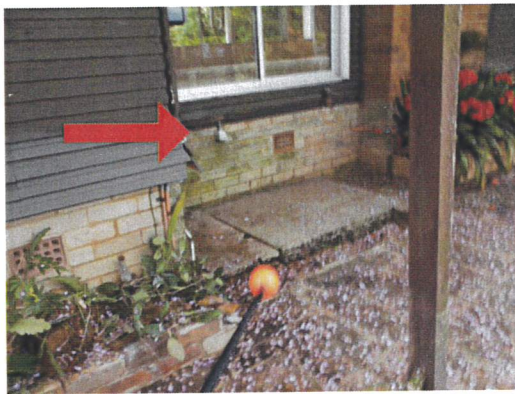
Defects 1.01

Building: Main Building
Location: Yard - Back
Finding: Stairs - not installed
Information: No stairs have been installed to the external of the building.t.

The absence stair are a hazard and may cause personal injury.The installation external stairs is recommended as soon as possible. Works should be completed by a general handyman at the discretion of the client.

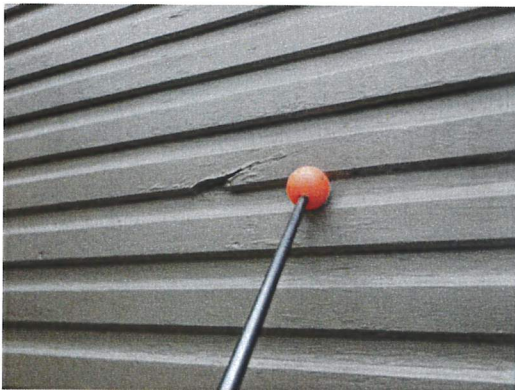
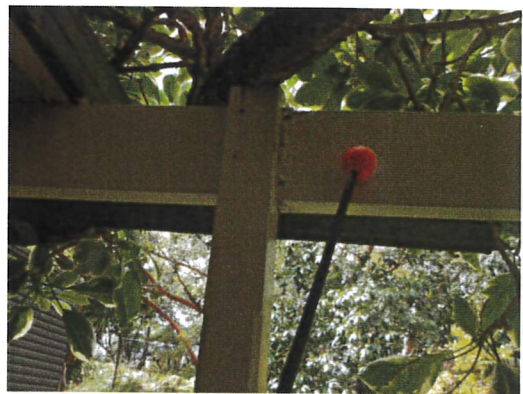
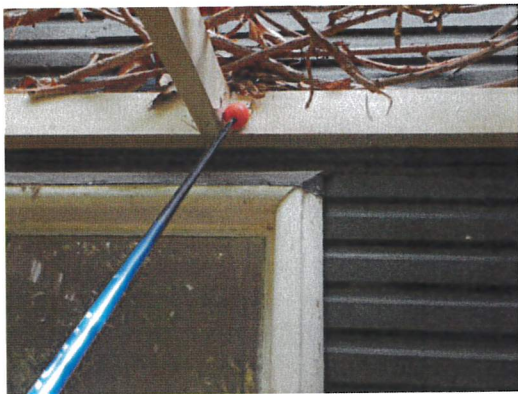
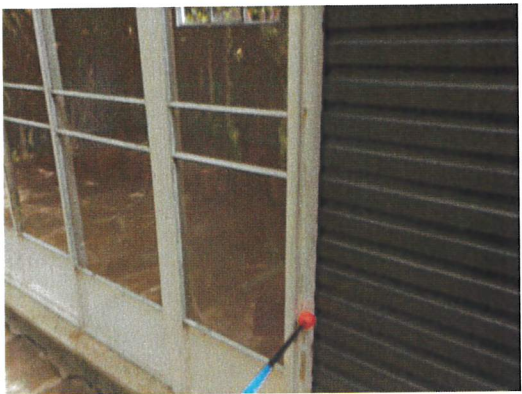
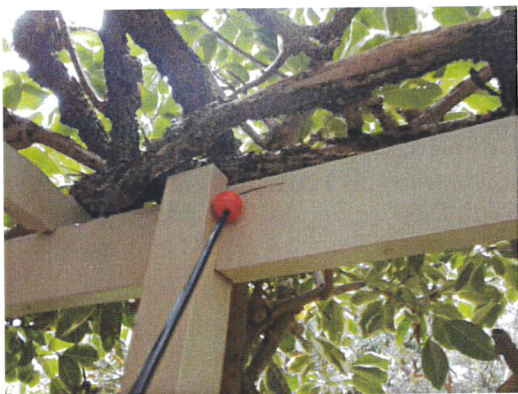
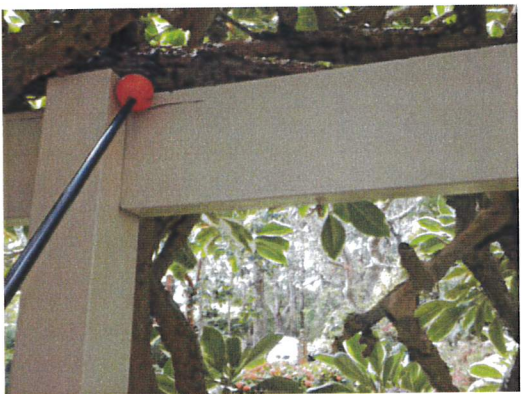
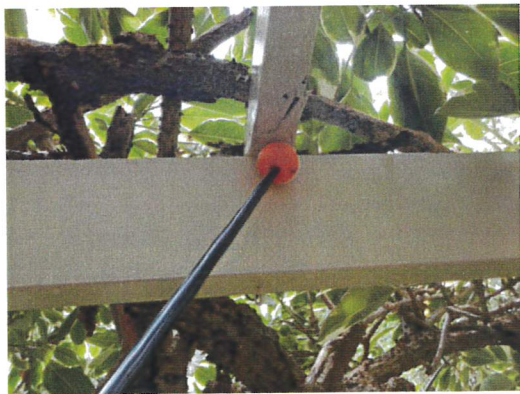
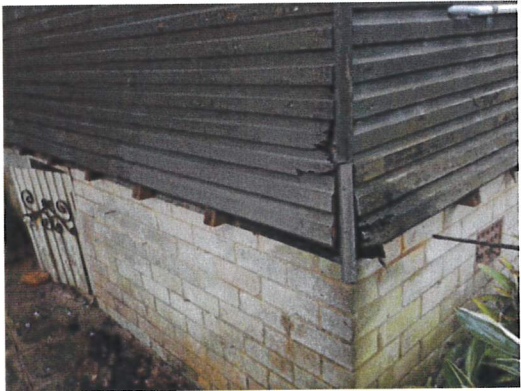
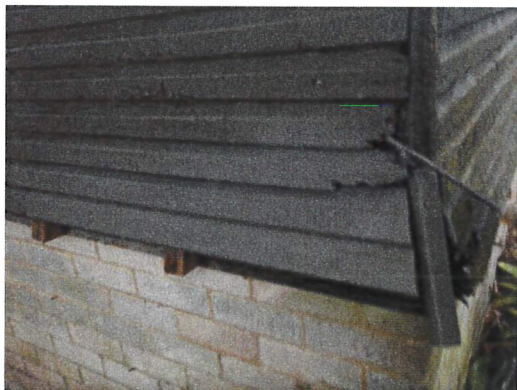
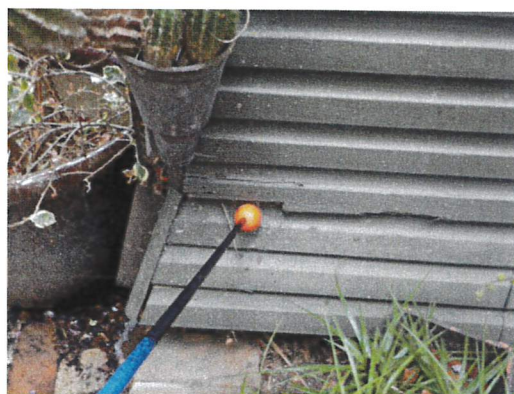
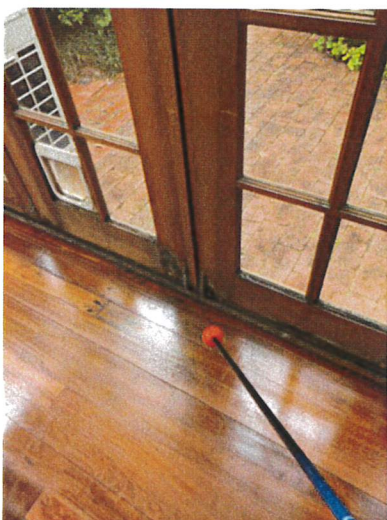
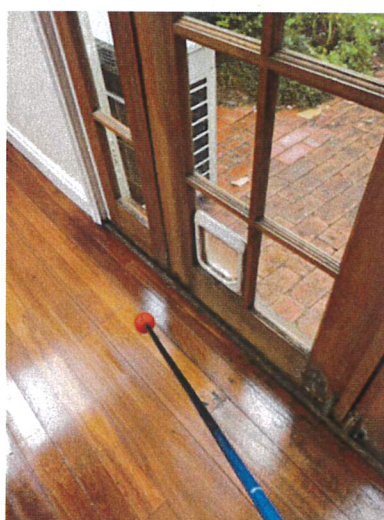
Defects 2.01

Building: Main Building

Location: All Areas

Finding: Wood rot

Information: This building element shows evidence of wood rot. Wood rot, also known as Fungal Decay, occurs when timbers and other cellulose building materials are exposed to damp conditions on an ongoing basis. This could be the result of exposure to weathering over a prolonged period of time, or the attraction of excessive moisture from other abutting building materials. Contributing factors also include poor air ventilation in the area.

Wood rot is often associated with general damp problems and is evidenced by a 'musty' smell or mould and mildew occurring on surfaces. If left unmanaged, damp conditions can lead to further health problems and the decay of timbers will continue.

Early intervention and regular maintenance, particularly of exterior timbers, will prolong the useful life of these building elements. Prior to any works being performed, the cause of the moisture that has created the visible wood rot should be identified and addressed in a suitable manner. Replacement of affected timbers may then be a necessary step in protecting surrounding building elements from such deterioration.

A qualified plumber may be appointed to assess the cause of excessive moisture and to provide advice on any remedial works as required. A qualified carpenter or registered builder may also be required to replace affected building materials.

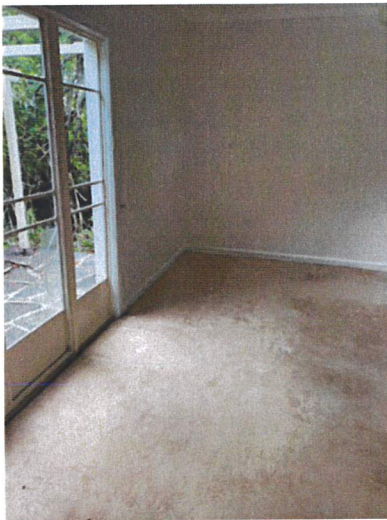
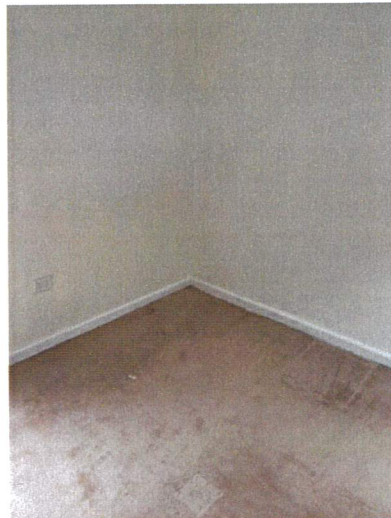
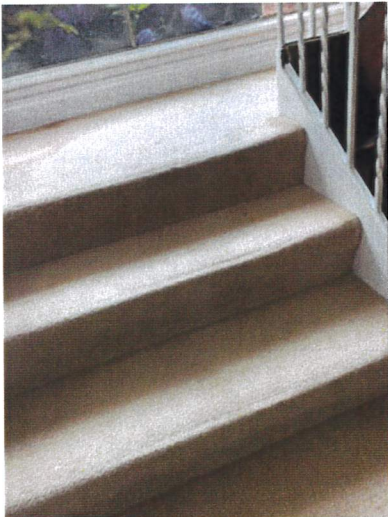
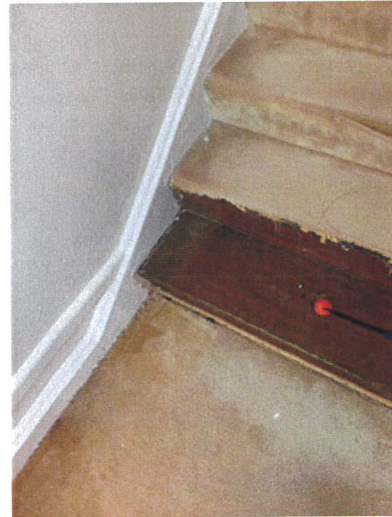
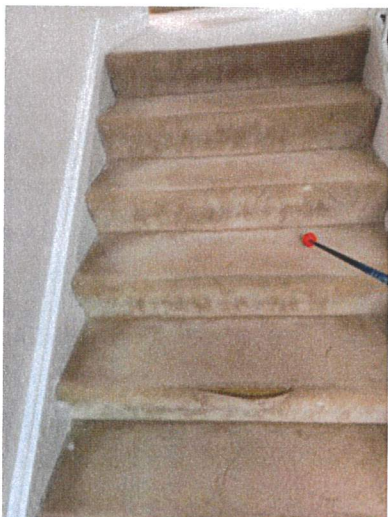
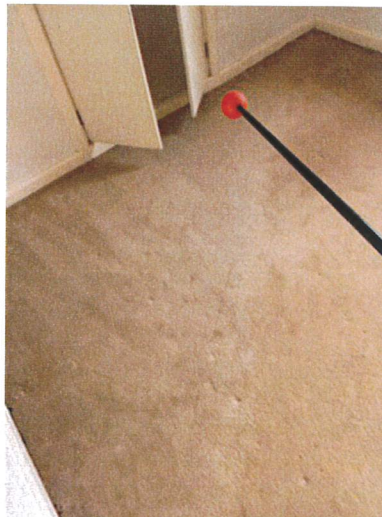
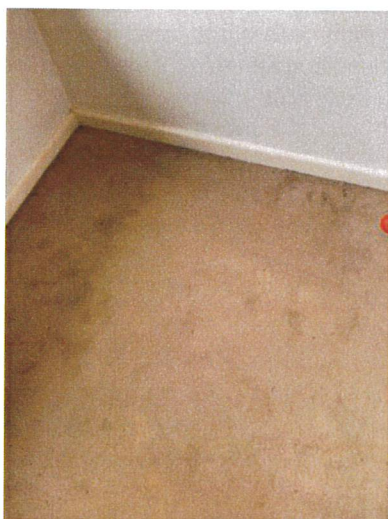
Defects 2.02

Building: Main Building
Location: All Areas
Finding: Carpet - Deteriorated
Information: Sections of the carpet floor covering appeared to be damaged. Replacement will be required in the near future.

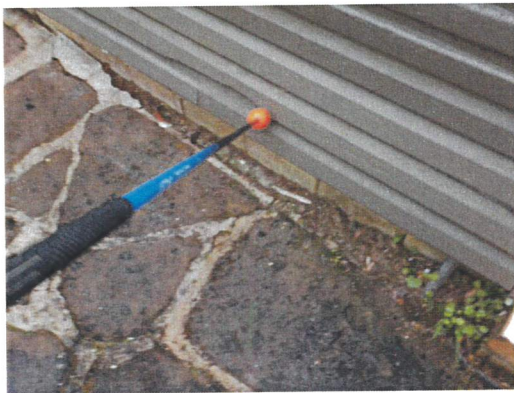
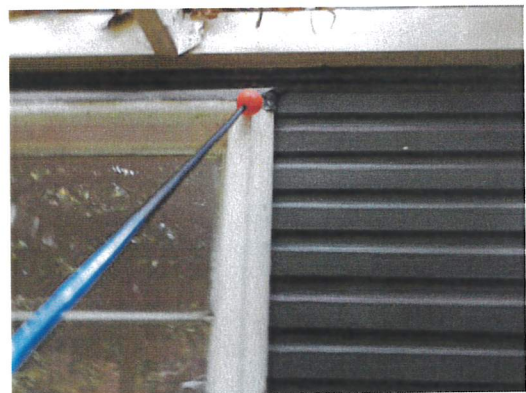
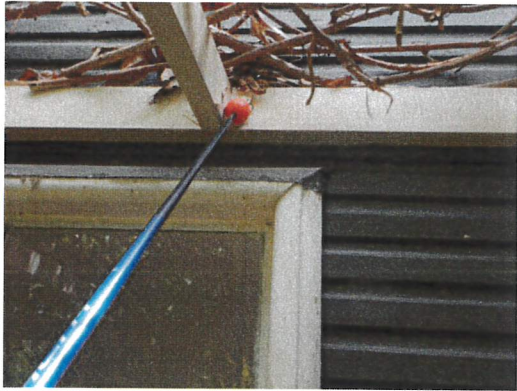
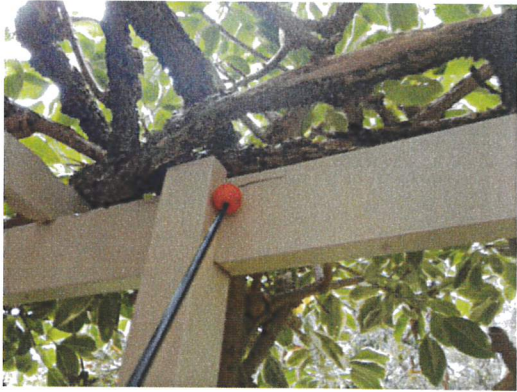
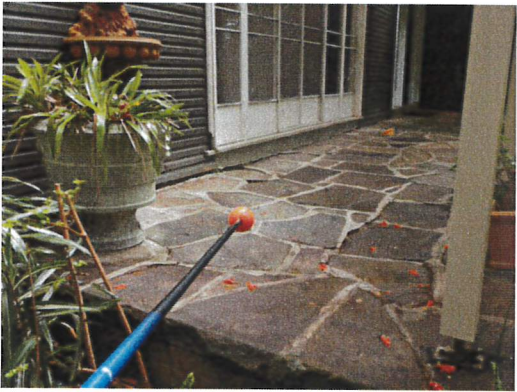
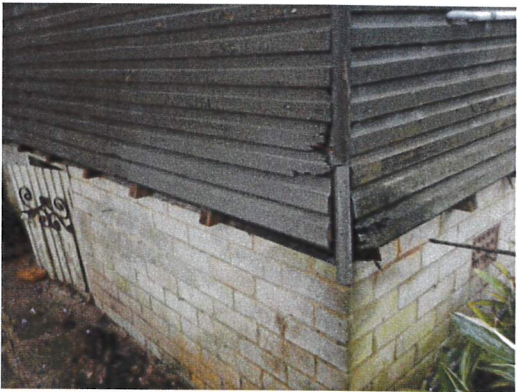
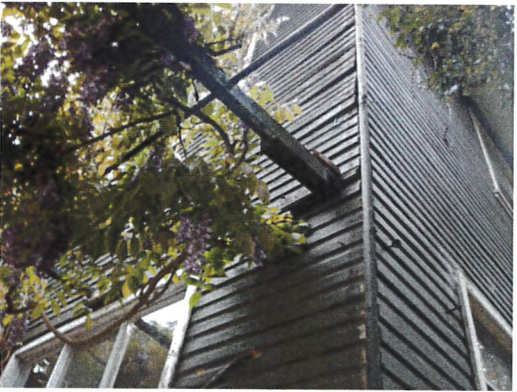
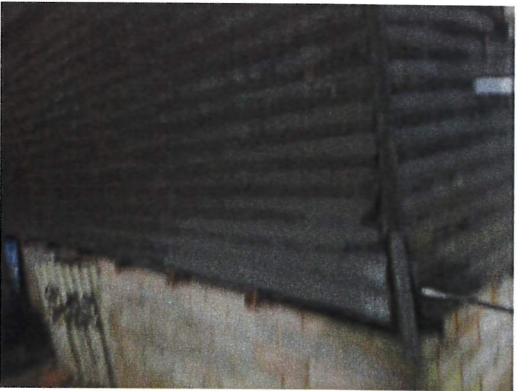
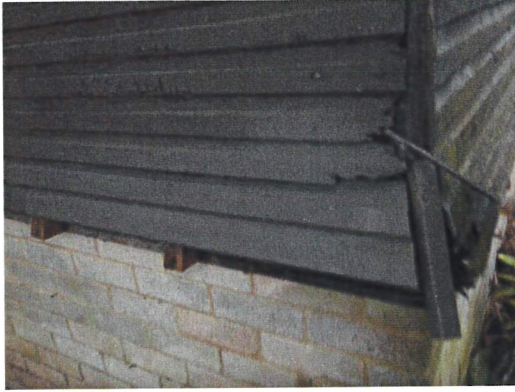
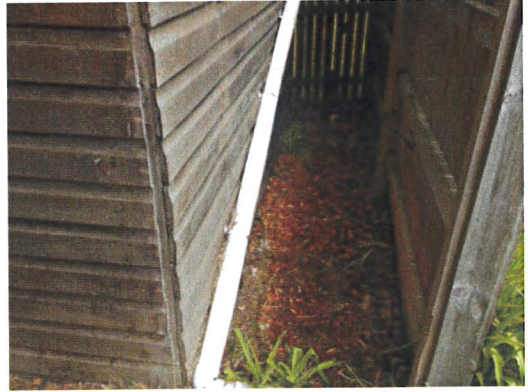
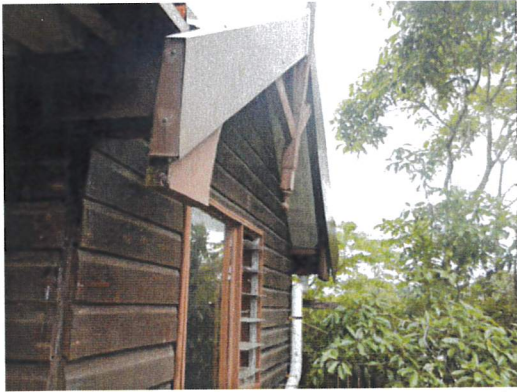
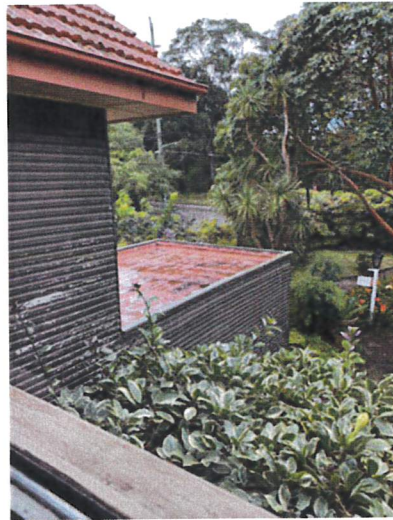
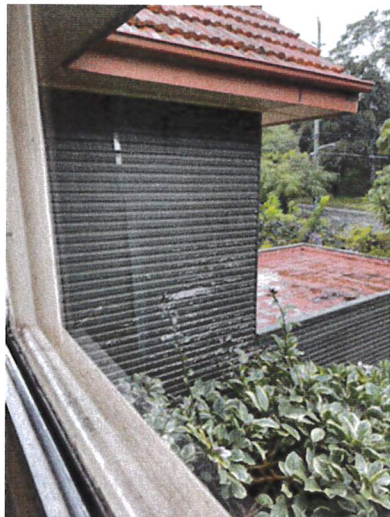
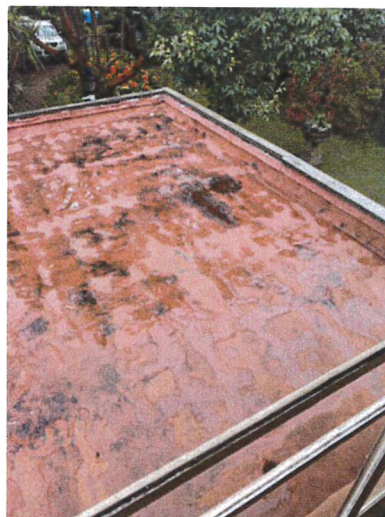
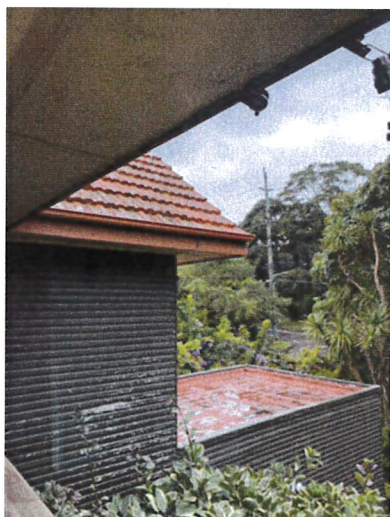
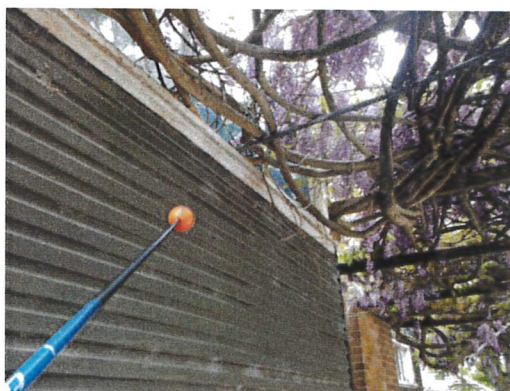
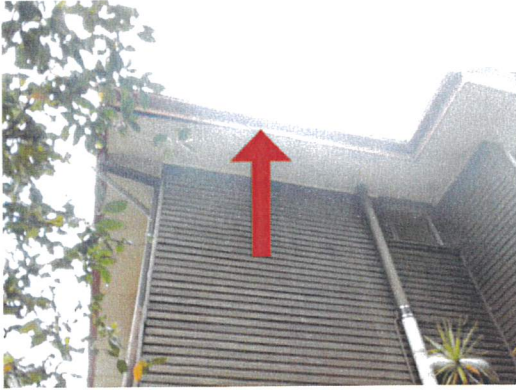
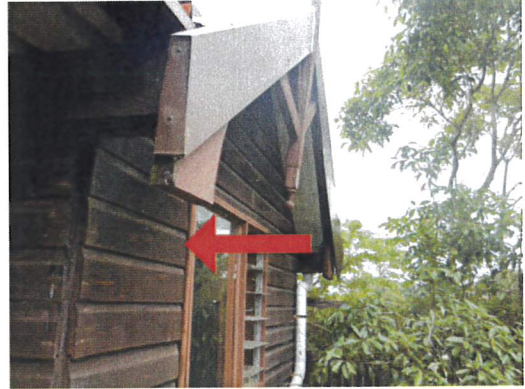
Defects 2.03

Building:	Main Building
Location:	All Areas
Finding:	External painting deteriorated
Information:	Much of the external paint work including but not limited to windows, fascias, guttering, veranda and other external fitments have been neglected and require attention to prepare and re paint.

Whilst incomplete or missing paint finish is generally an appearance defect, it can also lead to the development of secondary building defects over time. Incomplete areas of paint finish exposes the area to moisture, potentially accelerating the deterioration of underlying building materials.

Degraded paint finishes should be sanded back, filled, leveled and painted, as applicable. Where inadequate or missing paint protection has led to the deterioration of the associated building element, repair and/or replacement of this building element may be required.

A painting contractor should be appointed as soon as possible to perform necessary works to aid the appearance of the affected area and to ensure the area is protected against further deterioration. Alternatively, the homeowner following manufacturer instructions may perform these works.

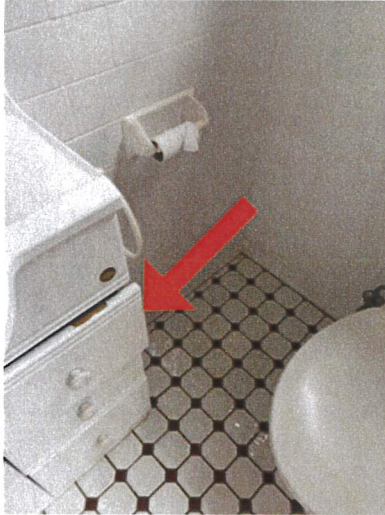
Defects 3.01

Building: Main Building

Location: Bathroom

Finding: Building element - Broken

Information: Breakage occurs generally when the building materials have either aged and decayed, or as a result of damage (accidental or deliberate).

Repair and/or replacement of broken elements is advised to ensure that additional secondary defects do not arise as a consequence. Such works are necessary, as all building elements play a key role in the operation and function of the overall structure and its performance.

A relevant tradesperson should be appointed to repair or replace the affected building element prior to any subsequent damage being caused.

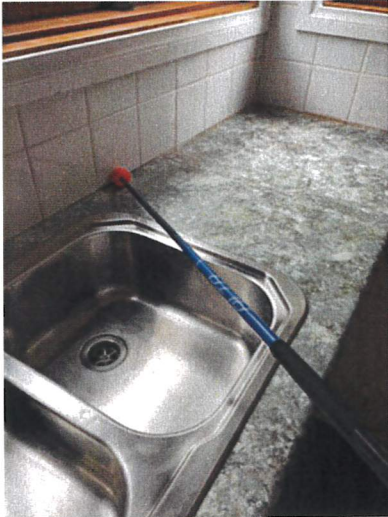
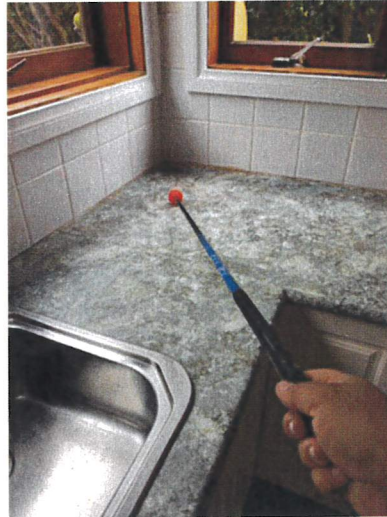
Defects 3.02

Building: Main Building

Location: Kitchen

Finding: Sealant

Information: Flexible and mould resistant materials should be applied to affected areas to prevent any subsequent water damage that is likely to occur. Regular maintenance and replacement of damage or missing or damaged sealant and grout is recommended to the wet areas, as this is a regular wear and tear defect.

Sealant and grouting in areas that come into regular contact with water should be maintained for the long term care of your property.

A sealant specialist or tiling contractor should be appointed to complete these works.
