## Building Inspection Report

Inspection Date: Fri, 7 Jul 2023

Property Address: 81 Dareen St, Frenchs Forest NSW 2086,  
Australia

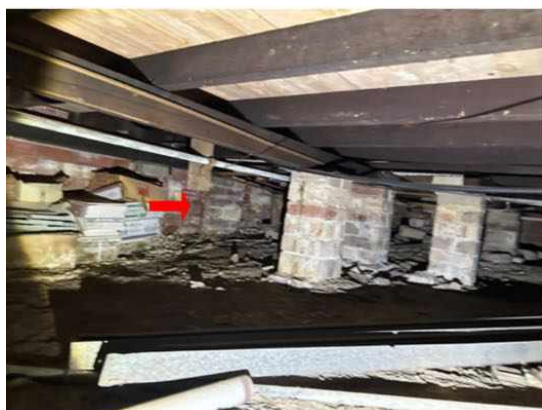
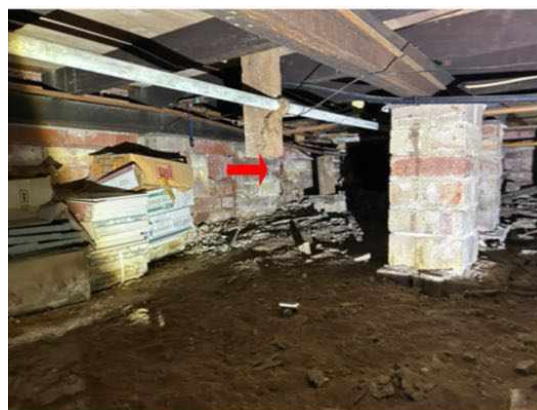
#### Defects 1.01

Building:	Building 1
Location:	Subfloor
Finding:	Mould - Present
Information:	Generally, the client is advised to ensure that the general environment is free of moisture and humidity to aid in the prevention of mould formation and development. Any mould found during the inspection should be cleaned immediately by a cleaning contractor or the homeowner as applicable.

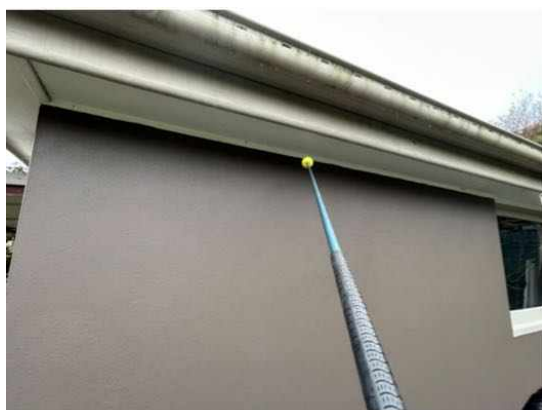
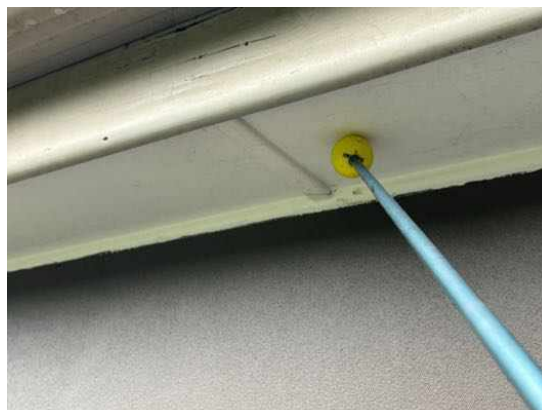
#### Defects 1.02

Building:	Building 1
Location:	All Areas
Finding:	ACM visual suspected in Eave Sheet
Information:	The area inspected is suspected asbestos-containing materials identified.

Various factors were assessed including the visual presentation of building materials, construction method and the age of the building to determine this finding.

The material appears to have no obvious signs of damage or deterioration, indicating that the asbestos is currently encapsulated and contained.

The Asbestos visually identified would be considered low risk.

No works should be carried out to the ACM or associated building elements without further specialist advice. Furthermore, areas with suspected ACMs should be avoided by all persons to minimise potential for health safety risk.

A sample for lab analysis to confirm the presence of asbestos should be taken.

Removal by a Licensed Asbestos Removal firm would be recommended.

Asbestos was suspected to be present at the time of inspection. As Asbestos Reporting is outside the scope of this report, we advise that you consider a separate Asbestos Inspection and Condition Audit, which can include the taking of samples for defin

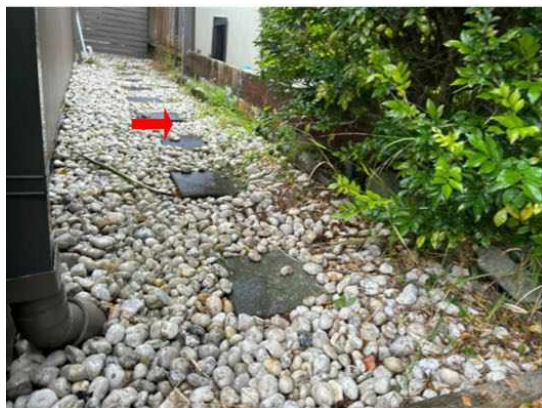
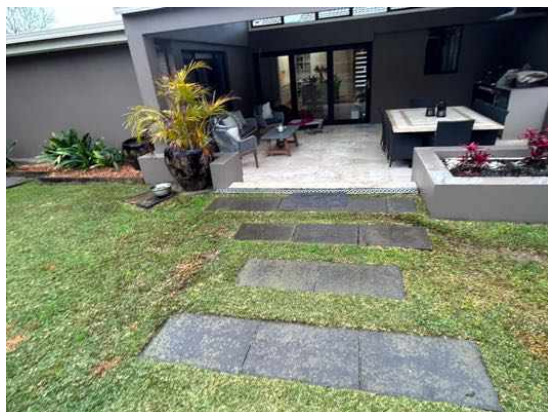
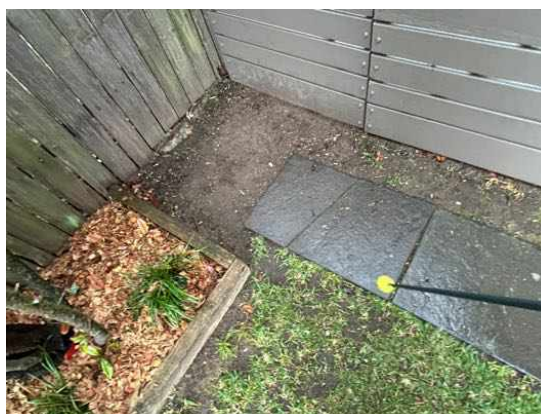
### Defects 3.01

Building:	Building 1
Location:	All External Areas
Finding:	Site drainage - suspected inadequate
Information:	The site drainage in this area was found to be inadequate at the time of inspection, creating potential for subsequent water damage to associated building elements.

It is important that water does not lie against the base of walls; surrounding paths and ground levels should be sloped to drain water away from walls. Downpipes should not disgorge stormwater onto lower walls or plinths. Stormwater should be carried away by large, regularly cleaned drains. Ground levels may need to be lowered to expose a buried DPC.

Where site drainage is inadequate, installation of an Agricultural (Aggie) Drain may be required. A qualified plumber should be appointed to further inspect the property and perform any remedial works as necessary. Water damage and secondary defects are likely to occur if left unmanaged.

The current site drainage should be assessed by a qualified plumber.

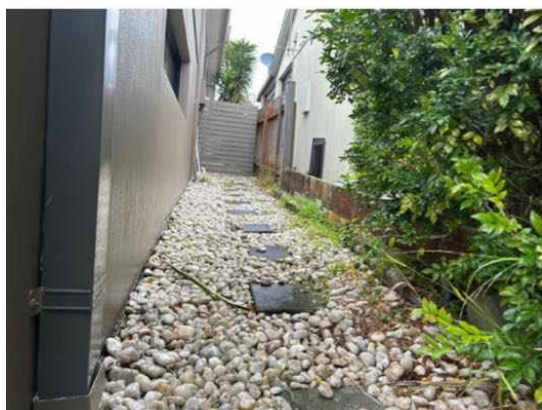
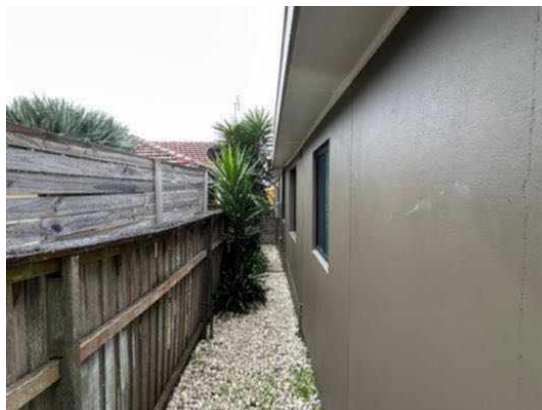
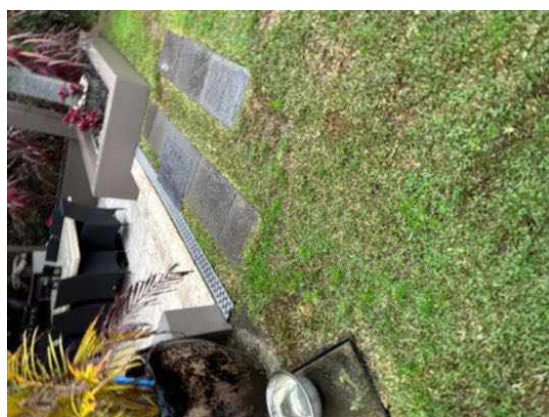
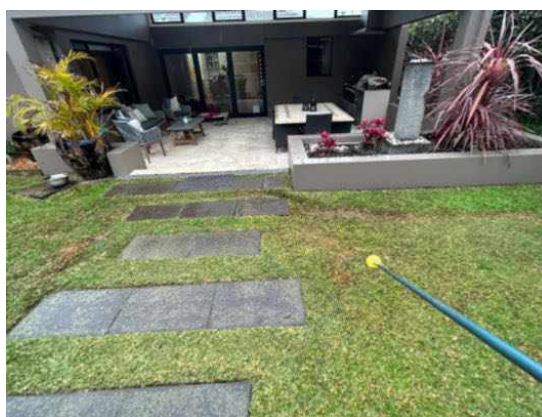
### Defects 3.02

Building:	Building 1
Location:	All Areas
Finding:	Evidence of excessive moisture was present at the time of inspection
Information:	Excessive moisture can attract termites and produce conditions that promote termite attack fungal growth and wood decay.

Excessive moisture is generally caused by deteriorated inadequate or missing roof drainage leaking plumbing pipes or fixtures poorly plumbed HWS overflows or condenser units and poor site drainage.

It is highly recommended that all plumbing and drainage fixtures and fittings be

maintained regularly in order to prevent excessive moisture being present in the external / internal property.

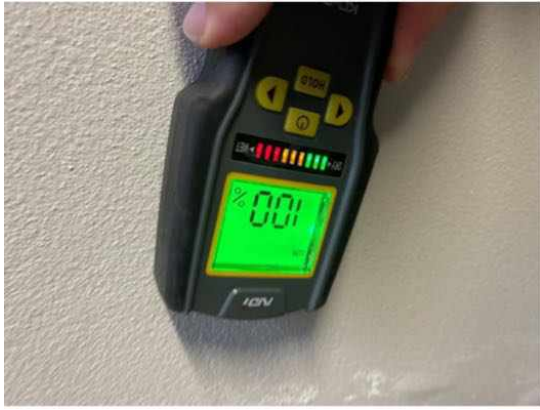
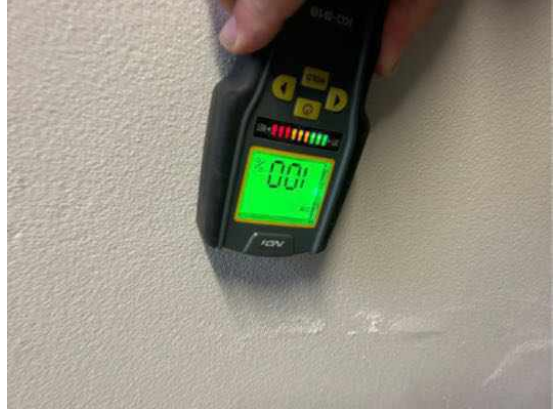
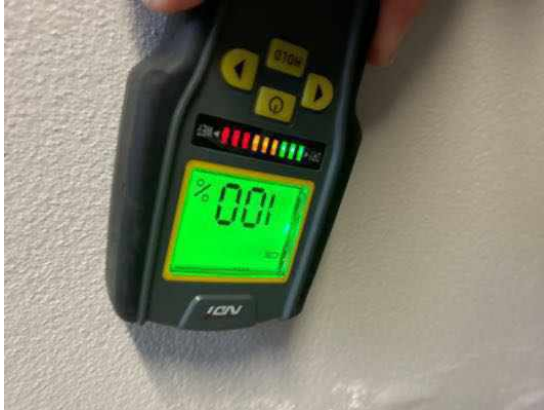
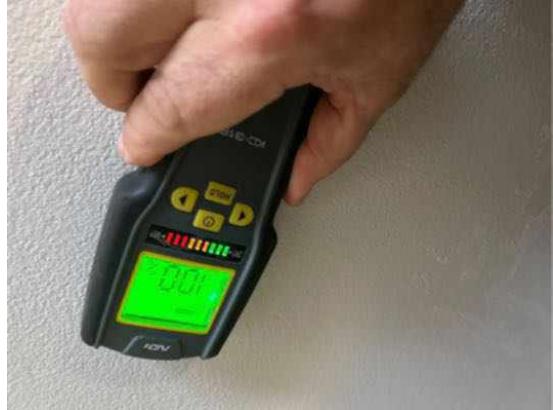
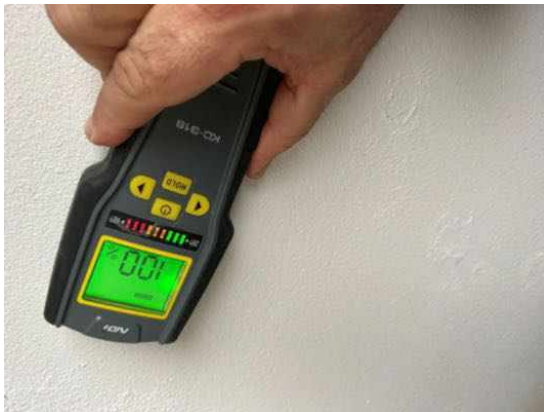
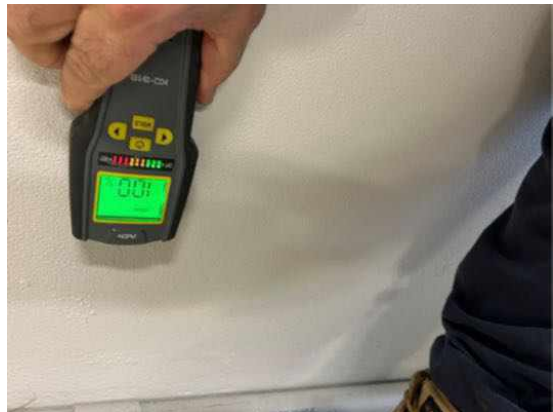
### Defects 3.03

Building:	Building 1
Location:	Garage
Finding:	Evidence of excessive moisture was present at the time of inspection
Information:	Excessive moisture can attract termites and produce conditions that promote termite attack fungal growth and wood decay.

Excessive moisture is generally caused by deteriorated inadequate or missing roof drainage leaking plumbing pipes or fixtures poorly plumbed HWS overflows or condenser units and poor site drainage.

It is highly recommended that all plumbing and drainage fixtures and fittings be maintained regularly in order to prevent excessive moisture being present in the external / internal property.

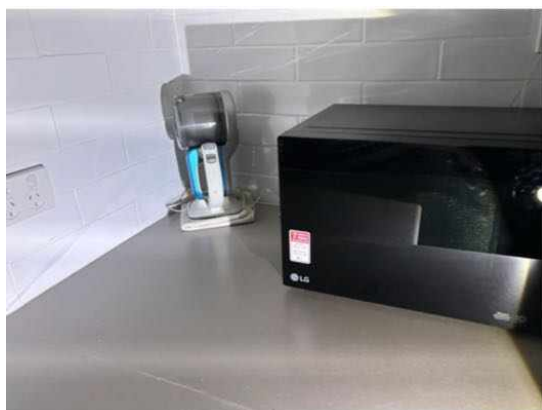
Defects 3.04

Building:	Building 1
Location:	Laundry
Finding:	Sealant - missing/ deteriorated
Information:	Flexible and mould resistant materials should be applied to affected areas to prevent any subsequent water damage that is likely to occur. Regular maintenance and replacement of damage or missing or damaged sealant and grout is highly recommended to the wet areas, as this is a regular wear and tear defect.

Sealant and grouting in areas that come into regular contact with water should be maintained for the long term care of your property. A sealant specialist or tiling contractor should be appointed to complete these works as soon as possible

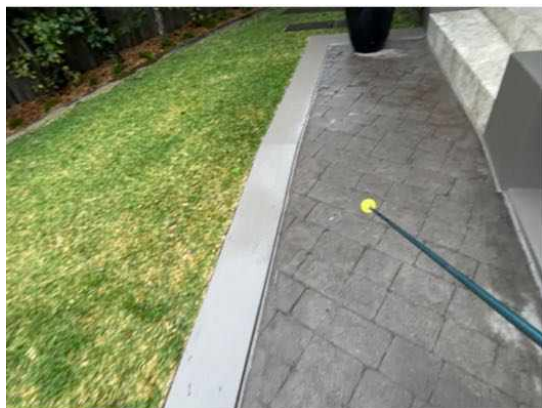
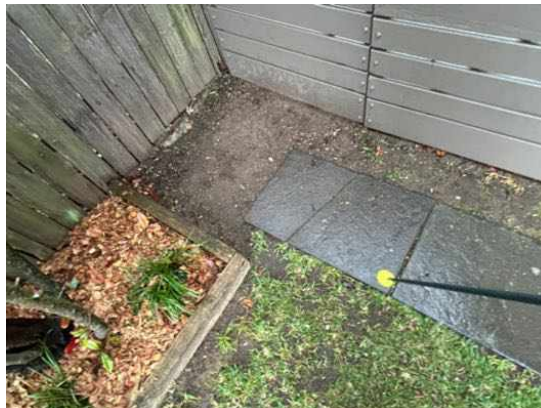
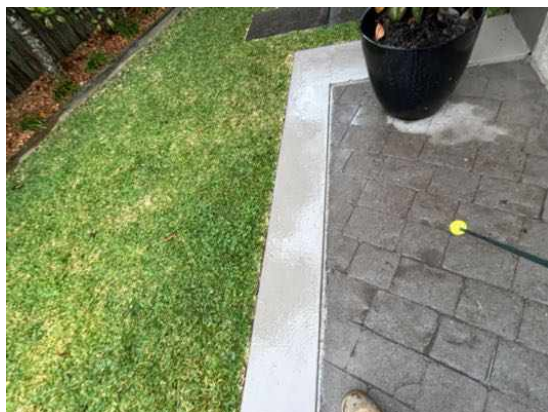
### Defects 3.05

Building:	Building 1
Location:	Driveway
Finding:	Cracking - External Concrete Paving Damage Category 1 - Fine (less than 2mm)
Information:	Fine cracks were identified in external concrete paving. Although fine cracks are quite noticeable, they are often only considered to be an appearance defect, and usually do not indicate any structural damage. To be considered a Category 1 or fine crack, the crack is found to be less than 2mm in width.

Generally the cause of a hairline crack in existing concrete paving such as driveways and pathways is indicative of the expansion and contraction of the concrete. Such causes are generally due to environmental factors, such as moisture levels, weather conditions, root systems of nearby trees or the soil types on which they are laid.

Fine cracks may also be due to poor original installation of the concrete. Factors such as poor compaction of the sub surface and/or inadequate reinforcing of the slab may create cracking and other secondary defects.

Monitoring of all cracking should be conducted frequently. Always contact a building inspector should cracks widen, lengthen, or become more numerous.

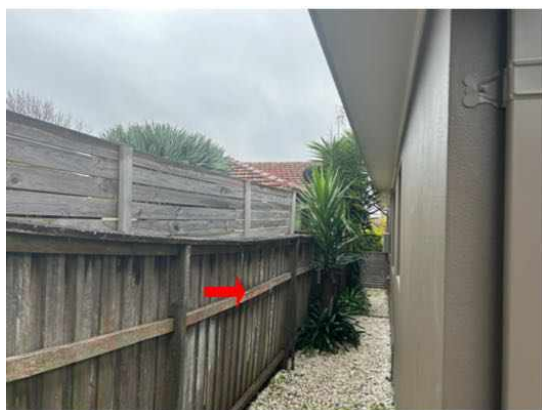
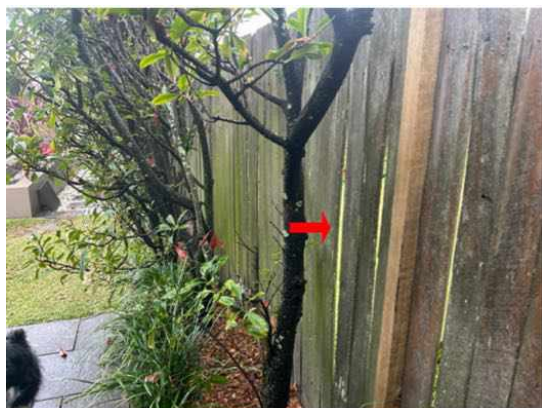
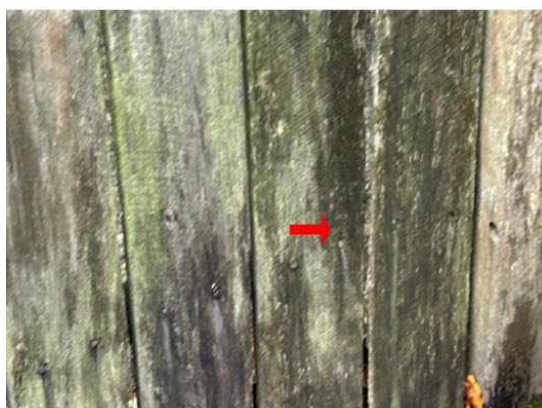
### Defects 3.06

Building:	Building 1
Location:	All External Areas
Finding:	Fencing - Deteriorated
Information:	It was noted at the time of inspection that sections of the fencing throughout the property have deteriorated. Typically fencing deteriorates due to age and or wear, rot and or rust which is generally expected for a structure of this age, due to prolonged exposure to weather conditions. Sometimes inadequate installation or maintenance can be to blame.

If left unattended, it is likely that further damage will occur. It is suspected that repair of several elements of the fencing may be required however replacement may be a consideration of the client also.

A licensed fencing contractor should be appointed to provide further advice and perform rectification works as necessary.

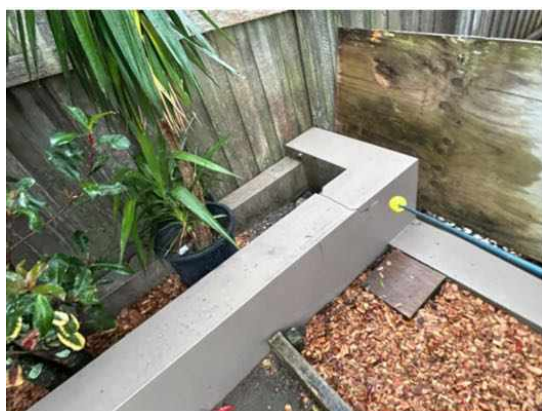
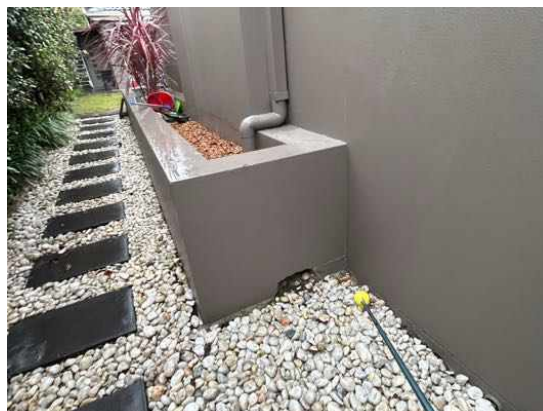
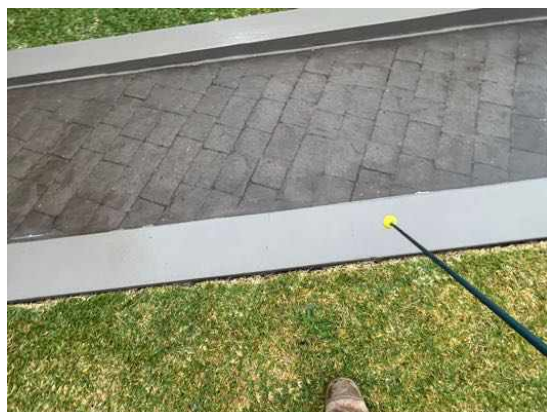
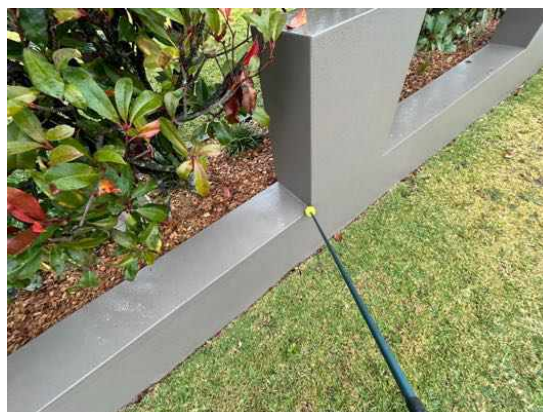
### Defects 3.08

Building: Building 1

Location: All Areas

Finding: Cracks to rendered surfaces - Category 1

Information: It has been observed that cracking to rendered surfaces has occurred in this area. The degree of damage falls within Category 1, described as fine cracks that do not need repair and which are less than 1.0mm in width limit.

Damage of this category is not considered a defect for rectification. Always contact your builder should cracks widen, lengthen, or become more numerous.

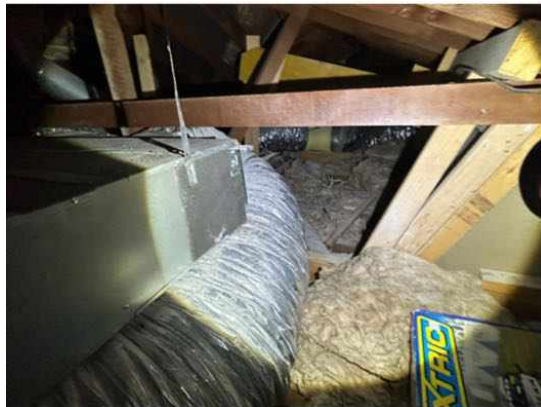
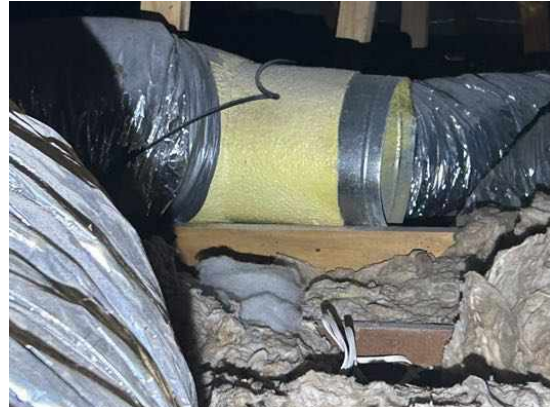
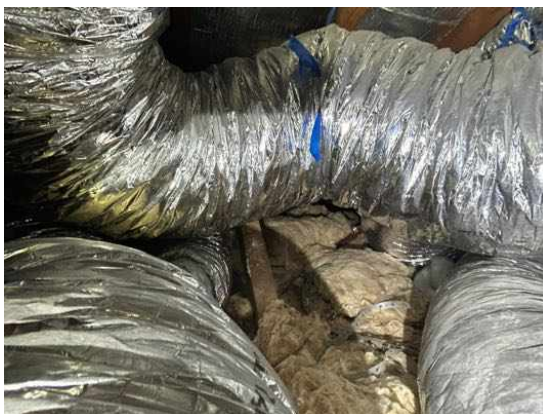
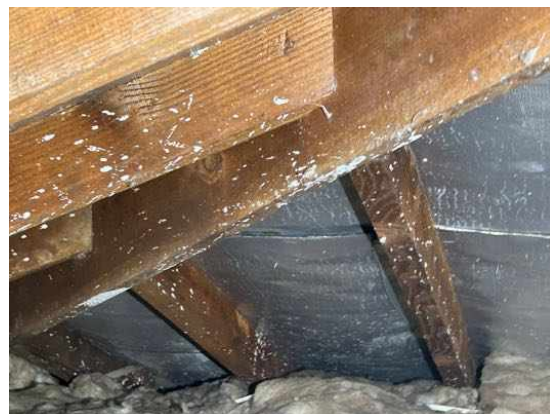
### Noted Item

Building: Building 1  
 Location: Roof Void  
 Finding: Insulation - present  
 Information: Upon inspection of the roof void it was noted that there is was insulation.

Caution should be exercised when accessing the roof void. Do not attempt to stand on the framework to the underside of the trusses and be aware there is a potential for electric shock if contact is made with exposed or faulty electrical wiring.

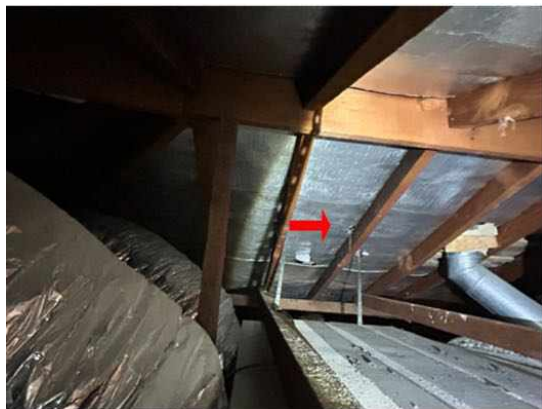
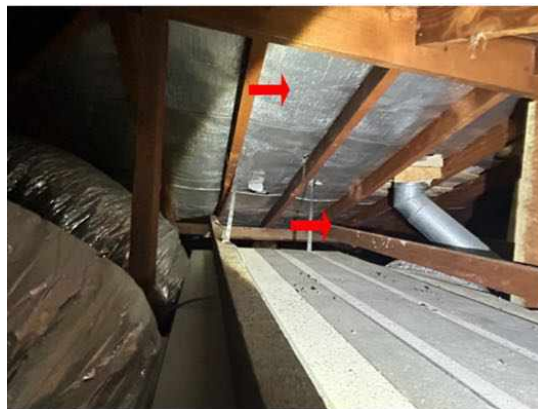
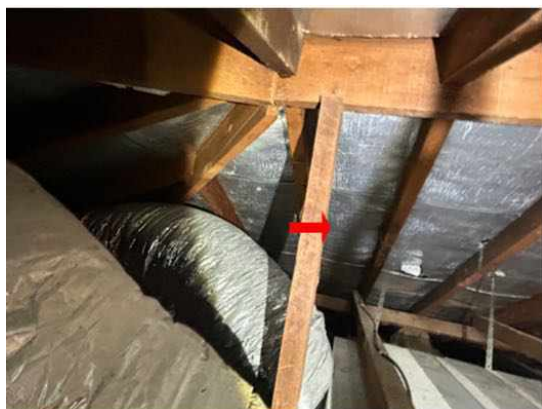
### Noted Item

Building:	Building 1
Location:	Roof Void
Finding:	Sarking - installed
Information:	Sarking is under the roof sheeting. Sarking acts as an insulator that helps with noise reduction and protects against water penetration. Sarking plays a key role in the operation and function of the overall roofing structure and its performance.

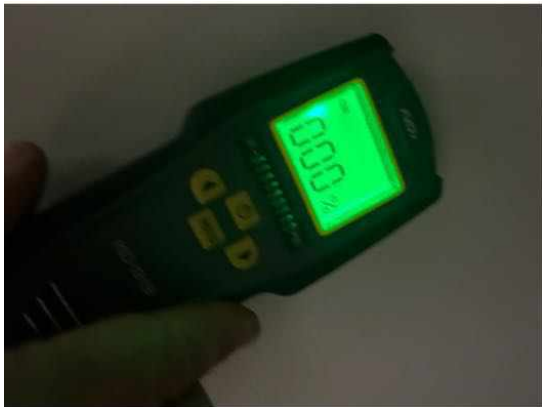
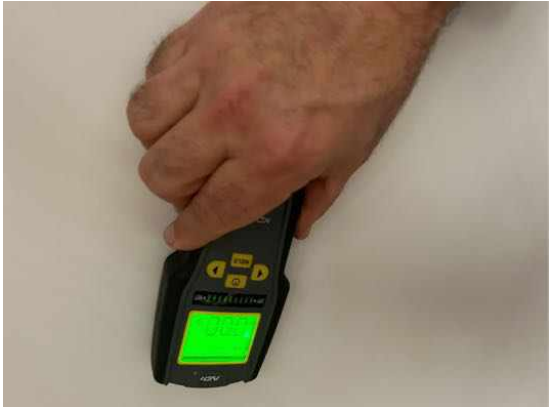
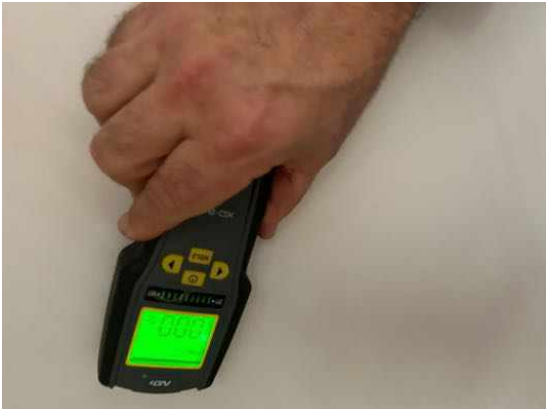
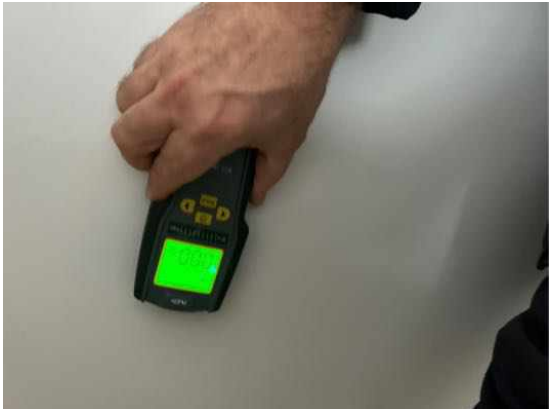
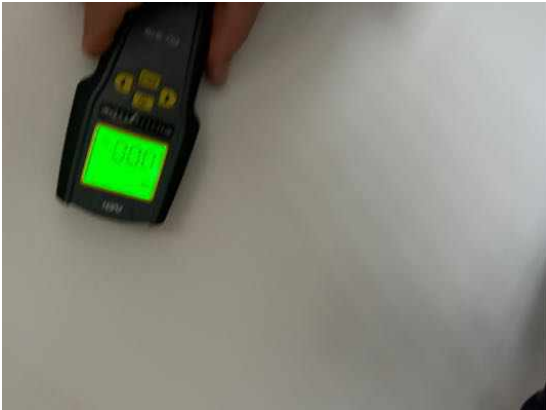
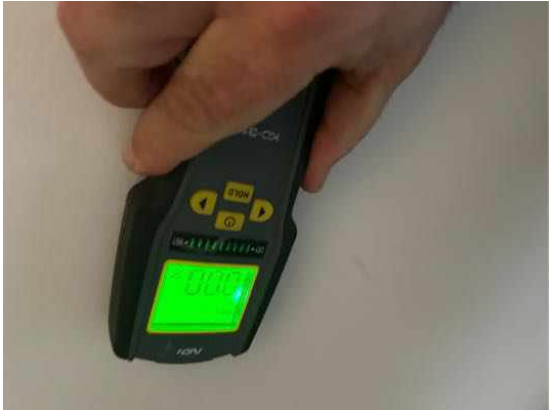
### Noted Item

Building:	Building 1
Location:	All Areas
Finding:	Moisture meter readings - low
Information:	The moisture meter result for the areas inspected.

The moisture reading of 0-15% is quite normal and gives no cause for concern. However, moisture readings in excess of 15% indicate the need for further inspection.

Levels between 25-30% indicate that there may be water ingress, meaning that remedial work could be required.

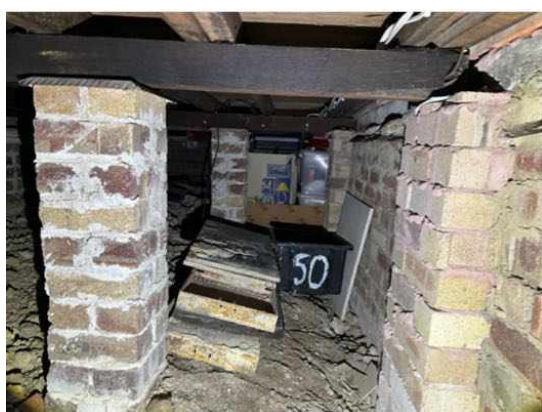
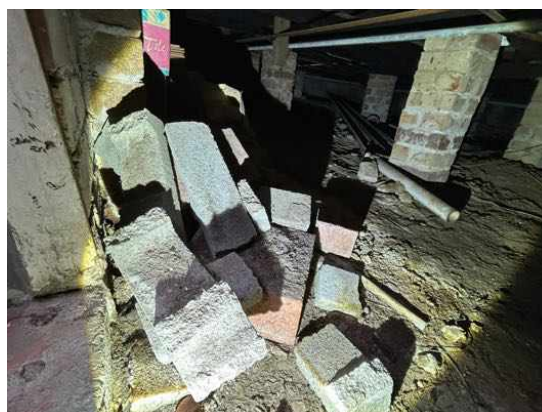
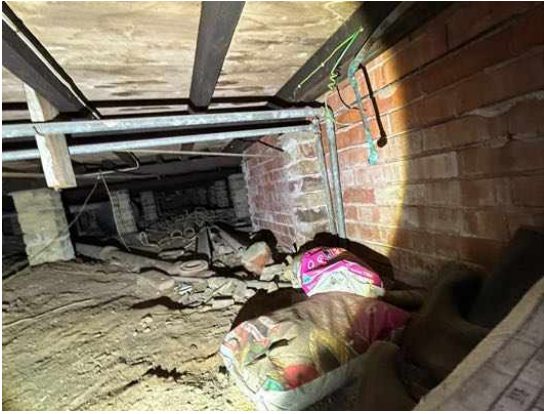
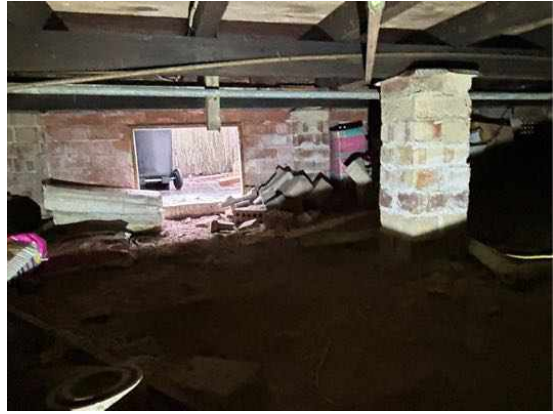
### Noted Item

Finding: Subfloor - Debris

Information: An array of debris was found in the subfloor area at the time of inspection. Debris in this area restricts subfloor ventilation and creates potential for concealed pest entry. Stored timbers and other materials may also make the area susceptible to termite activity and wood rot.

A clear and empty subfloor will be better ventilated and easier to maintain in a dry condition. The removal of any timber debris is vital in minimising the risk of termite or wood borer activity.

Debris in the subfloor should be removed as soon as possible. Depending on the location and amount of debris and stored items, the homeowner may elect to undertake this task. Alternatively there are a large number of rubbish removal subcontractors that could undertake these works.
