VISUAL BUILDING AND PEST INSPECTION REPORT

Complies with Australian Standard 4349.1 & 4349.3

Inspected Property:
25a Toronto Avenue, Cromer

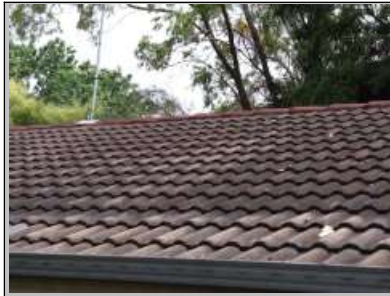
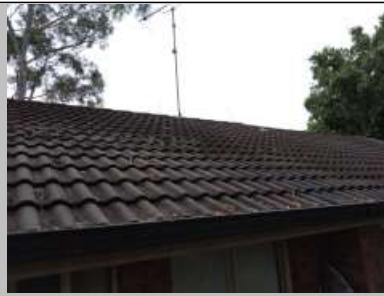
Roof Covering Condition

The overall condition of the roof coverings is fair.

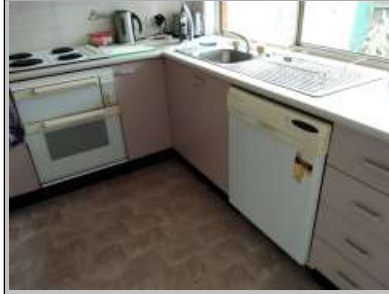
The condition of the tiles is generally fair.

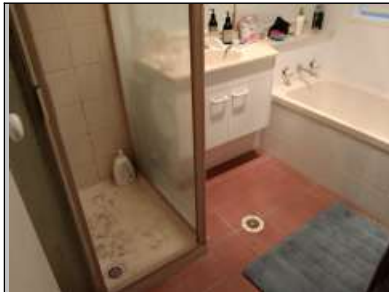
Rear.

The shower recess was tested and there was no visible water penetration to surrounding areas. **IMPORTANT NOTE:** This test may not reveal water leaks until the shower is put into constant use and surrounding areas monitored over a period of time.

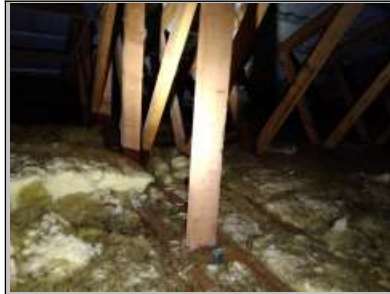
Insulation is present in the roof cavity. This restricted inspection to some roofing timbers. Removal of insulation is not within the scope of a standard visual inspection report, however as in accordance with "industry best standard" the inspector will lift insulation in 3 areas in roof void.

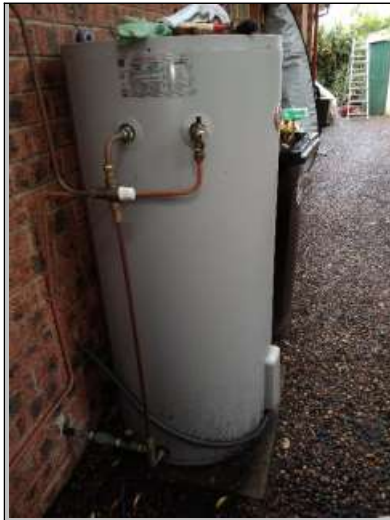
Mains electric hot water system: Mains pressure: Located externally: The hot water system appears to be in working condition. No specific tests other than running the hot water tap were carried out. No determination has been made as to the suitability or adequacy of the hot water system in relation to capacity or otherwise.

The unit was manufactured in 2020.

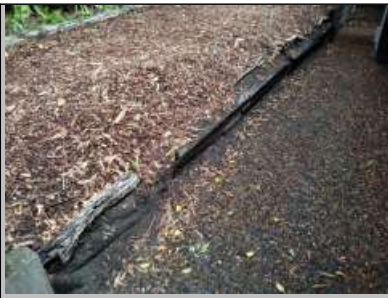
Sleepers or timber landscaping materials:

Yes - Wood decay damage was noted to the following timbers/areas.

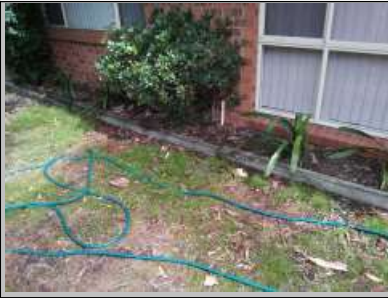
Garden beds have been built up against the external walls. These should be removed as they can allow concealed termite entry.

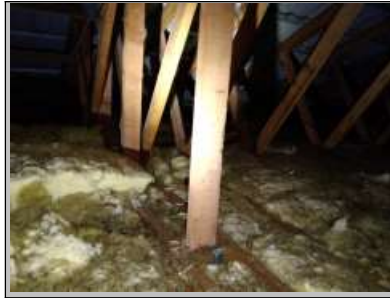
Insulation is present in the roof cavity. This restricted inspection to some roofing timbers. Removal of insulation is not within the scope of a standard visual inspection report, however as in accordance with "industry best standard" the inspector will lift insulation in 3 areas in roof void.
