Building and Timber Pest Inspection Report

Property Address: 14 Tyalla Ave, Frenchs Forest NSW 2086,
Australia

Original Inspection Date: Thu, 8 Apr 2021

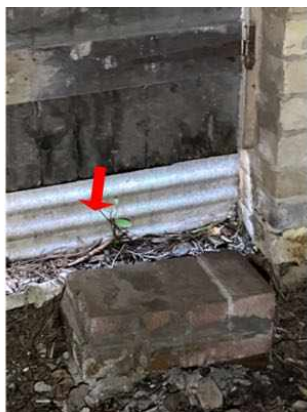
Building:	Building 1
Location:	All Areas
Finding:	Asbestos - Suspected ACM Identified on Site
Information:	Reporting on Asbestos is outside the Scope of this Report. This suspected defect is highlighted as a caution only. We suspect, based on our experience in the building industry, that there is a higher risk of the identified building element containing asbestos.

As Asbestos Reporting is outside the scope of this report, we advise that you consider a separate Asbestos Inspection and Condition Audit, which can include the taking of samples for definitive confirmation of the presence of Asbestos.

In the interim, the client is advised to act with caution, especially when considering any damage to building materials general wear and tear renovations extensions demolition and general maintenance activities due to the suspected presence of Asbestos.

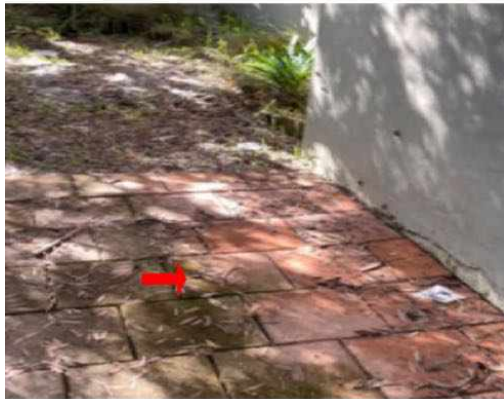
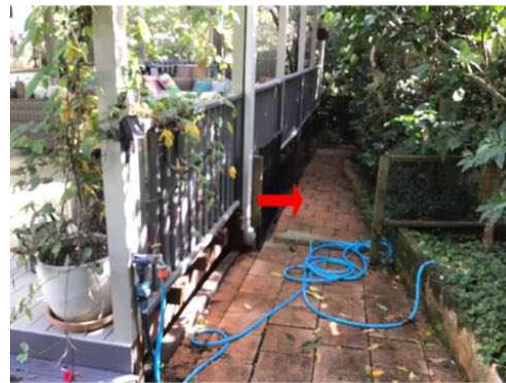
Defects 3.01

Information: Sections of the external paved area are uneven, creating a potential trip hazard. It appears as though the area has been subject to rough installation, or that paving sections have lifted due to movements in the foundation of the property.

Where paving creates a trip hazard, personal injury may ensue if due caution is not taken by all persons within this area.

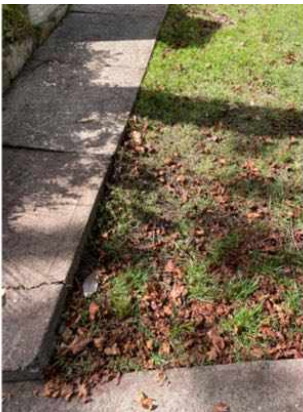
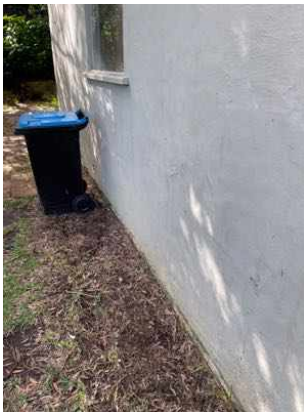
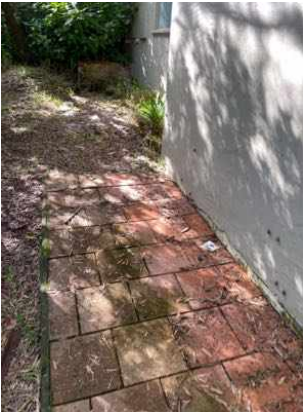
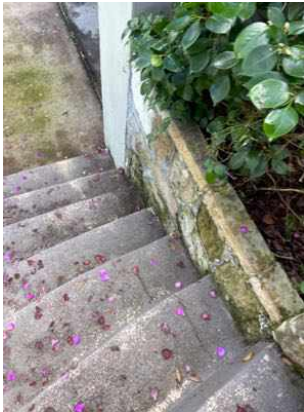
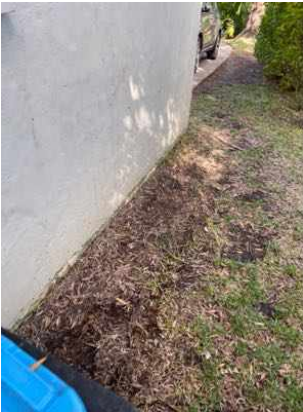
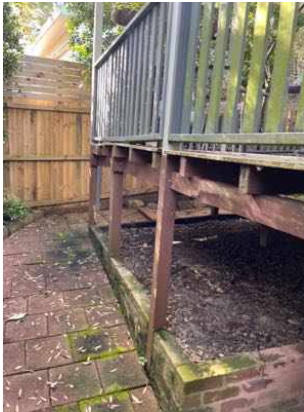
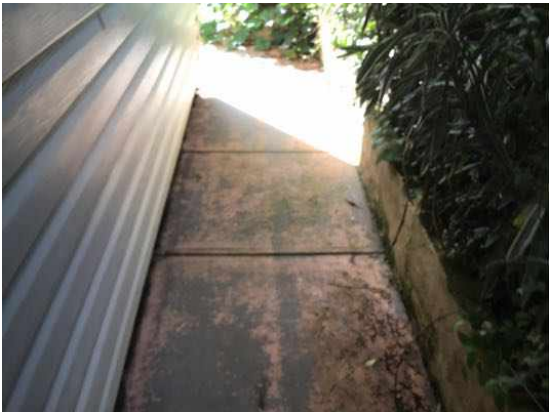
Defects 3.02

Building: Building 1
 Location: All Areas
 Finding: Evidence of excessive moisture was present at the time of inspection
 Information: Excessive moisture can attract termites and produce conditions that promote termite attack fungal growth and wood decay.

Excessive moisture is generally caused by deteriorated inadequate or missing roof drainage leaking plumbing pipes or fixtures poorly plumbed HWS overflows or condenser units and poor site drainage.

It is recommended that all plumbing and drainage fixtures and fittings be maintained regularly in order to prevent excessive moisture being present in the external / internal property.

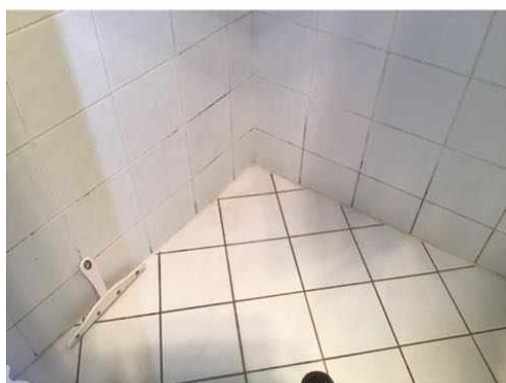
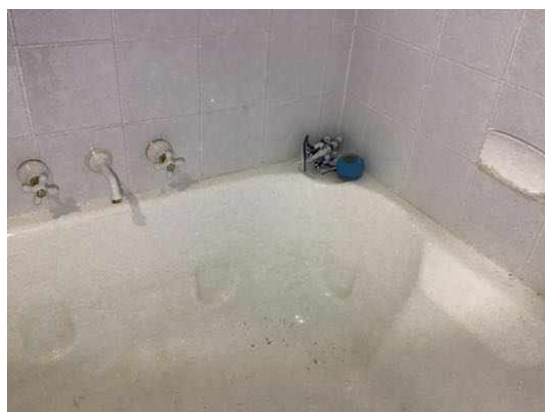
Defects 3.03

Building:	Building 1
Location:	Bathroom
Finding:	Sealant and grouting - Missing or damaged
Information:	It was noted on inspection that sealant or grout is degraded to the tiled shower alcove and or other areas of the bathroom.

Different materials and floor areas move at different rates, generally causing cracking to grout or sealant at this point. A flexible sealant is required to allow for expected expansion and contraction, while keeping the joint water tight and protective of all associated building materials.

Flexible and mould resistant materials should be applied to affected areas to prevent any subsequent water damage that is likely to occur. Regular maintenance and replacement of damage or missing or damaged sealant and grout is highly recommended to the wet areas, as this is a regular wear and tear defect. Sealant and grouting in areas that come into regular contact with water should be maintained for the long term care of your property.

A sealant specialist or tiling contractor should be appointed to complete these works.

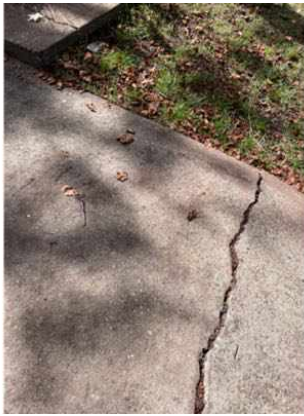
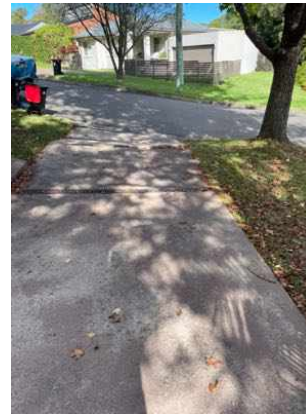
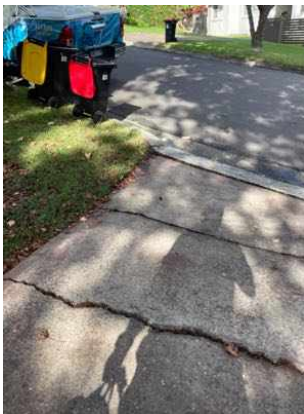
Defects 3.04

Building:	Building 1
Location:	Driveway
Finding:	Crack in concrete slab - Category 3
Information:	A crack coded as Category 3 was identified in the slab. A Category 3 crack is described as a wide crack with obvious curvature or change in level, affecting the slab.

The approximate width of the crack to be considered Category 3 is greater than 2.0mm, or a change in offset of 15-25mm when a 3m straight edge is placed over the defect.

Category 3 cracks to slabs exceed allowable Standards and Tolerances, and are considered defects requiring rectification.

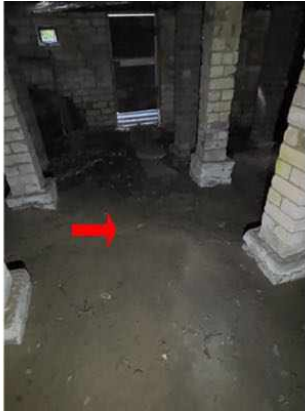
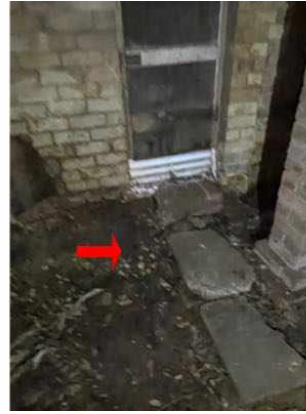
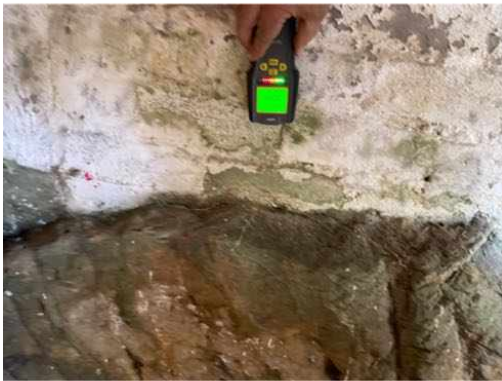
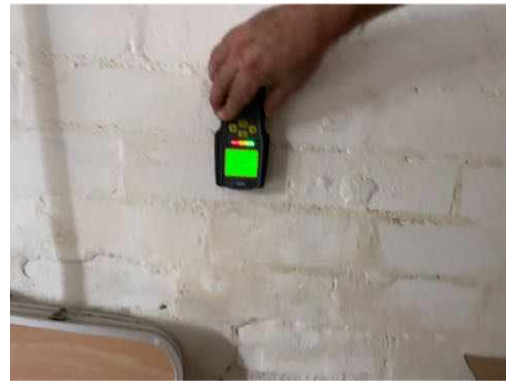
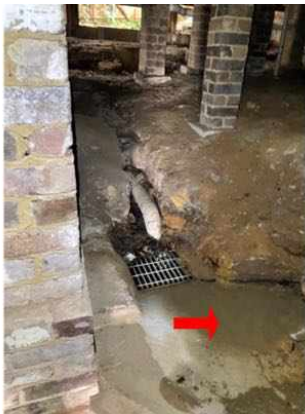
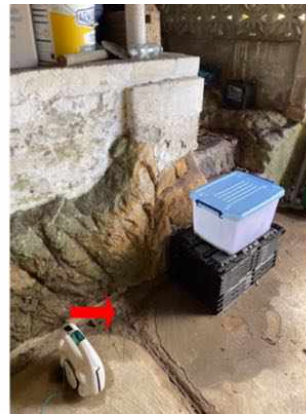
Defects 3.05

Building: Building 1
Location: Subfloor
Finding: Evidence of excessive moisture was present at the time of inspection
Information: Excessive moisture can attract termites and produce conditions that promote termite attack fungal growth and wood decay.

Excessive moisture is generally caused by deteriorated inadequate or missing roof drainage leaking plumbing pipes or fixtures poorly plumbed HWS overflows or condenser units and poor site drainage.

It is highly recommended that all plumbing and drainage fixtures and fittings be maintained regularly in order to prevent excessive moisture being present in the external / internal property.

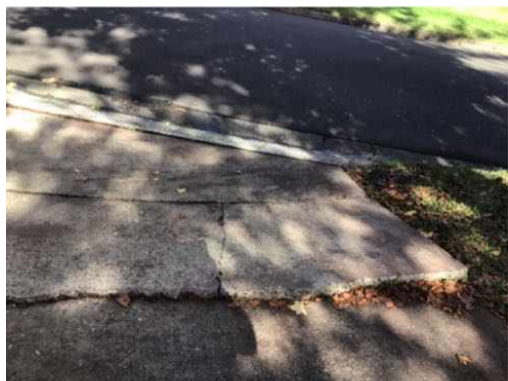
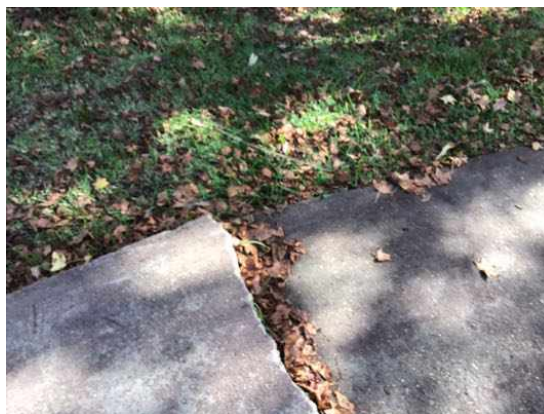
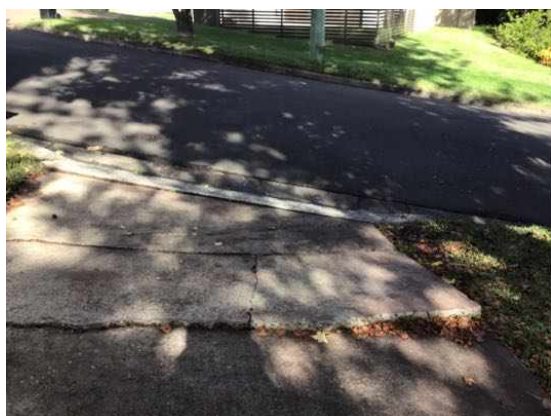
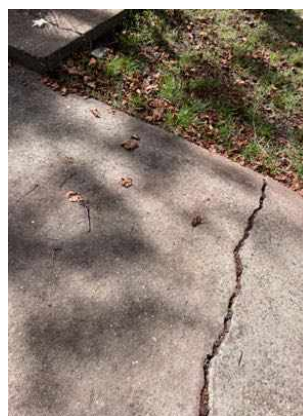
Defects 3.06

Building:	Building 1
Location:	Driveway
Finding:	Subsidence - Local trees and vegetation
Information:	Trees and other vegetation can have a significant local effect on drying of soils. Over a number of years, especially during drought conditions, adjacent trees and vegetation may draw excessive moisture from the soils. The opposite may also occur, where swelling of the soil results when the trees decline or are removed.

As the cumulative moisture deficient is reversed, the surface level around the tree (and adjoining subfloor) will rise and expand laterally. This is often damaging to buildings unless the foundations have been strengthened or designed to cope with the effect.

Subsidence can have complex and varying causes, which will influence the required remedial works. It is advised to begin by consulting a structural engineer to determine the required scope of works. This generally includes some form of underpinning, as well as addressing the underlying cause. Consultation with a geotechnical engineer may also be necessary.

A registered builder specialising in re-stumping would then generally carry out works as advised by an Engineer.

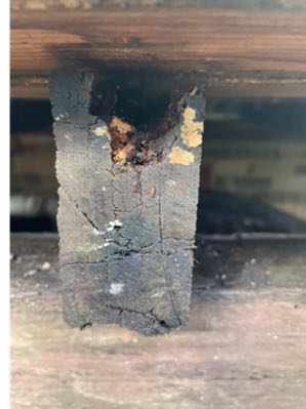
Defects 3.07

Building:	Building 1
Location:	Yard - Back
Finding:	Wood rot
Information:	This building element shows evidence of wood rot. Wood rot, also known as Fungal Decay, occurs when timbers and other cellulose building materials are exposed to damp conditions on an ongoing basis. This could be the result of exposure to weathering over a prolonged period of time, or the attraction of excessive moisture from other abutting building materials. Contributing factors also include poor air ventilation in the area.

the useful life of these building elements. Prior to any works being performed, the cause of the moisture that has created the visible wood rot should be identified and addressed in a suitable manner. Replacement of affected timbers may then be a necessary step in protecting surrounding building elements from such deterioration.

A qualified carpenter or registered builder may also be required to replace affected building materials.

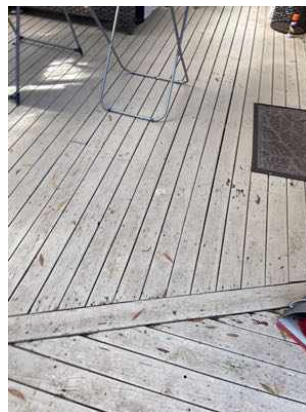
Defects 3.08

Building:	Building 1
Location:	All External Areas
Finding:	Timber - exposed to weather
Information:	External timbers that are frequently exposed to harsh weather conditions require adequate protection in order to maintain their condition. Where timbers have not been painted or treated adequately, general deterioration is likely to occur at an accelerated rate.

If left unattended, replacement of these timbers is likely to be necessary in the short-term future. Adequate treatment of these timbers is required as soon as possible by a painting contractor or general handyman.

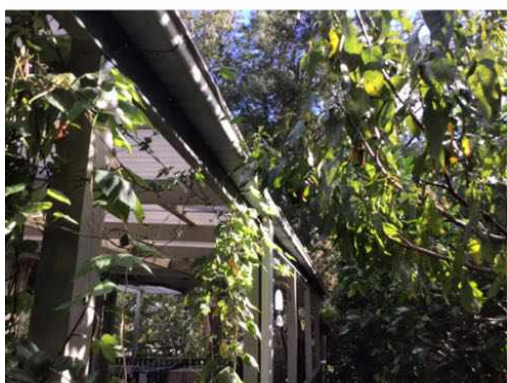
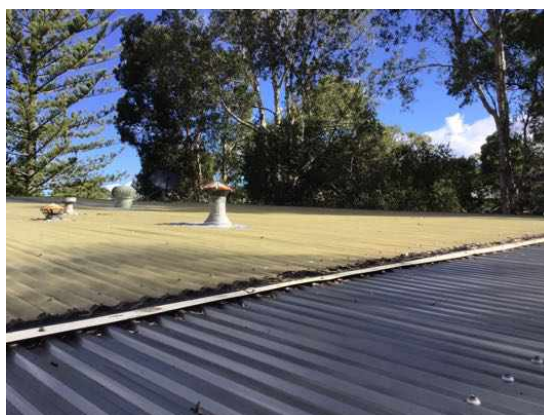
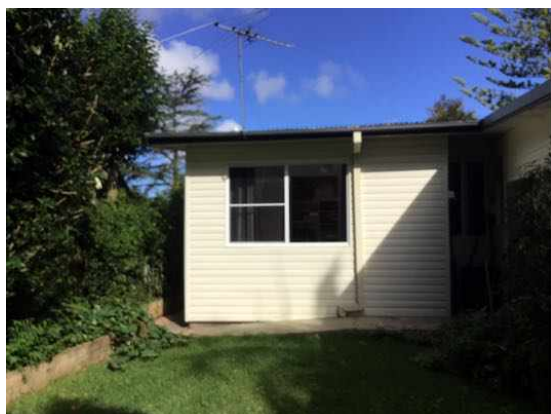
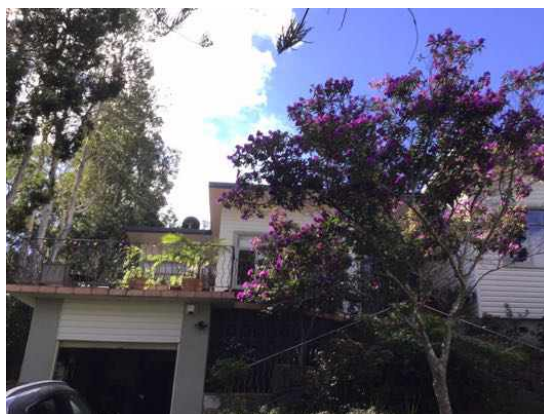
Defects 3.09

Building:	Building 1
Location:	All External Areas
Finding:	Trees - Overhanging and filling gutters
Information:	Overhanging trees often result in excessive amounts of leaf debris accumulating in gutters.

Gutters are a critical part of the building's management of storm water and rain. It is therefore important that they be kept clear to prevent secondary damage to associated building elements, including exterior and interior walls, ceiling linings and any adjoining building elements. Where gutters are blocked, pooling of rainwater is likely to occur, fast-tracking rust and corrosion of the roof plumbing elements.

It is advised that all overhanging tree branches be removed as soon as possible to prevent any further damage. Repair and/or replacement of sections of damaged guttering may also be required where the extent of the damage necessitates.

Such works should be performed by the homeowner; however, appointment of a landscape contractor or an arborist may be required. Consultation with a licensed roof plumber is required where guttering has been damaged.

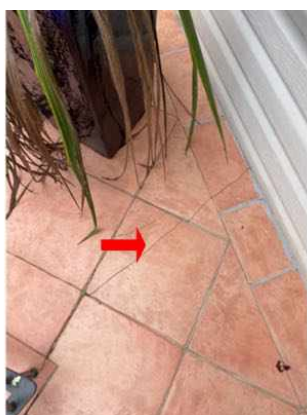
Defects 3.10

Location:	Entry
Finding:	Cracked floor tiles
Information:	Cracking in the floor tiles was evident in this area at the time of inspection. It is suspected that this cracking has occurred as a result of minor settlement or shrinkage of the slab.

Cracked tiles throughout the household detract from the overall appearance of the affected areas however it is unlikely to create or lead to any secondary defects.

While not considered a matter of urgency, replacement of cracked floor tiles is recommended at the clients discretion. A tiling contractor may be appointed to perform these works.

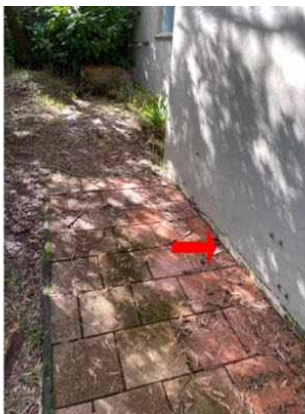
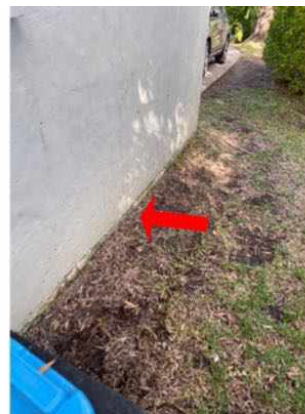
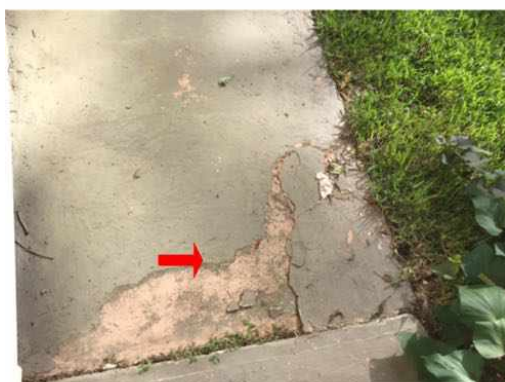
Defects 3.11

Building:	Building 1
Location:	Yard - Side
Finding:	External painting deteriorated
Information:	Some of the external paint work including but not limited to windows, fascias, guttering, veranda and other external fittings have been neglected and require attention to prepare and re paint.

Whilst incomplete or missing paint finish is generally an appearance defect, it can also lead to the development of secondary building defects over time. Incomplete areas of paint finish exposes the area to moisture, potentially accelerating the deterioration of underlying building materials.

A painting contractor should be appointed to perform necessary works to aid the appearance of the affected area and to ensure the area is protected against further deterioration. Alternatively, the homeowner following manufacturer instructions may perform these works.

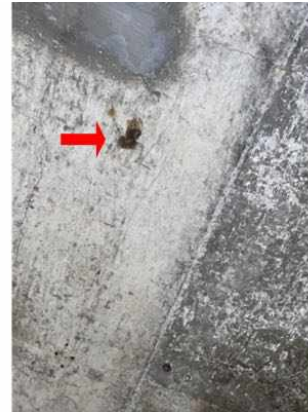
Defects 3.12

Information: Concrete cancer is the common term used to describe a number of factors which cause concrete construction to deteriorate. Generally, water penetration causes the concrete reinforcement to rust and expand, creating stresses on the surrounding concrete and in turn causing it to spall (or break away). Alternatively, if the cement component is too alkaline, reactions with the general atmosphere occurs and star-shaped cracks appear which allow rainwater to penetrate. Concrete cancer may also originate from poor original water proofing.

In some instances, repairs are possible; however, repair works will generally involve extensive works, including removal of affected concrete and the treatment or replacement of any exposed steel. Some injection of resins or special mortars may also be possible, however this depends on the size and extent of consequent damage.

Ultimately, the cause of the concrete cancer (e.g. poor water proofing) must also be addressed, otherwise the problem is likely to recur. Treatment of concrete cancer can be expensive and, left unmanaged, the problem is likely to worsen over time, potentially leading to the development of major structural defects or safety hazards.

The client is advised to exercise caution and to prepare for the potential cost of remedial and / or replacement works. A structural engineer should be appointed to provide estimates on the required works.

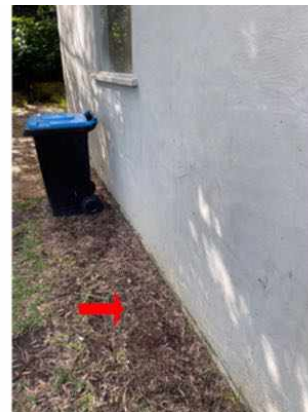
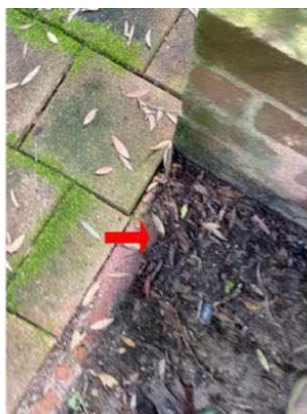
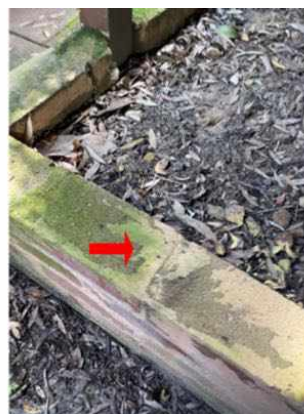
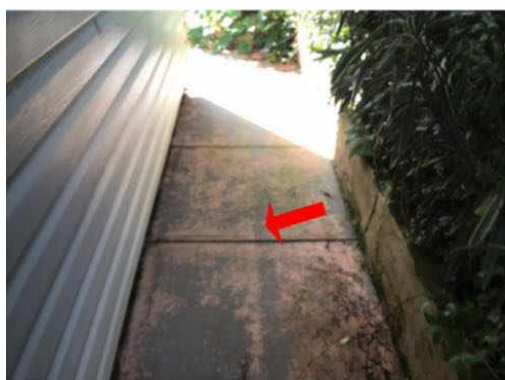
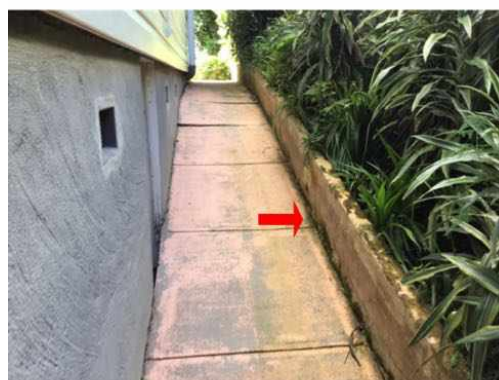
Defects 3.13

Building:	Building 1
Location:	All External Areas
Finding:	Evidence of excessive moisture was present at the time of inspection
Information:	Excessive moisture can attract termites and produce conditions that promote termite attack fungal growth and wood decay.

Excessive moisture is generally caused by deteriorated inadequate or missing roof drainage leaking plumbing pipes or fixtures poorly plumbed HWS overflows or condenser units and poor site drainage.

It is highly recommended that all plumbing and drainage fixtures and fittings be maintained regularly in order to prevent excessive moisture being present in the external / internal property.

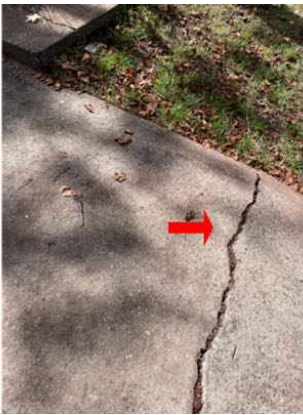
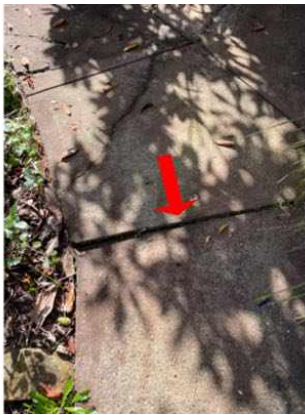
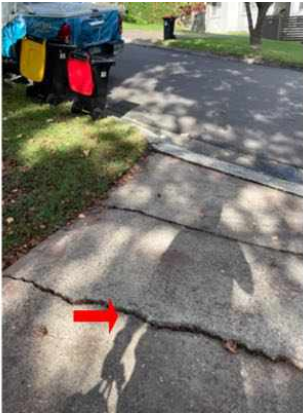
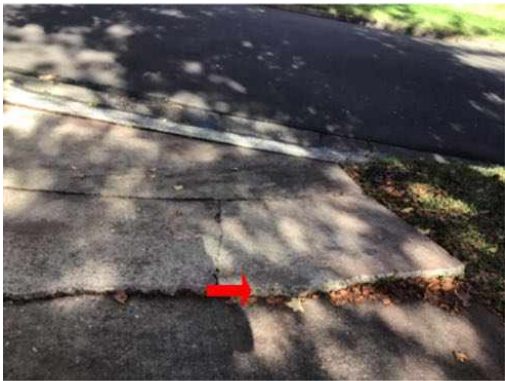
Defects 3.14

Building:	Building 1
Location:	Driveway
Finding:	Subsidence - Local trees and vegetation
Information:	Trees and other vegetation can have a significant local effect on drying of soils. Over a number of years, especially during drought conditions, adjacent trees and vegetation may draw excessive moisture from the soils. The opposite may also occur, where swelling of the soil results when the trees decline or are removed.

As the cumulative moisture deficient is reversed, the surface level around the tree (and adjoining subfloor) will rise and expand laterally. This is often damaging to buildings unless the foundations have been strengthened or designed to cope with the effect.

Subsidence can have complex and varying causes, which will influence the required remedial works. It is advised to begin by consulting a structural engineer to determine the required scope of works. This generally includes some form of underpinning, as well as addressing the underlying cause. Consultation with a geotechnical engineer may also be necessary.

A registered builder specialising in re-stumping would then generally carry out works as advised by an Engineer.

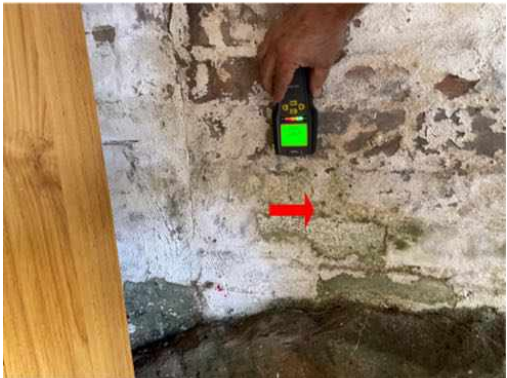
Defects 3.15

Building: Building 1
Location: Garage
Finding: painting deteriorated
Information: Whilst incomplete or missing paint finish is generally an appearance defect, it can also lead to the development of secondary building defects over time. Incomplete areas of paint finish exposes the area to moisture, potentially accelerating the deterioration of underlying building materials.

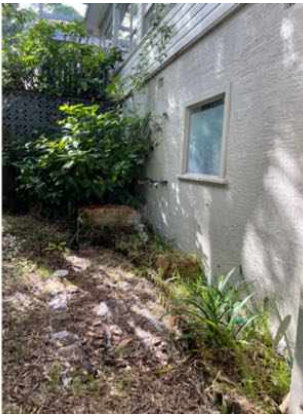
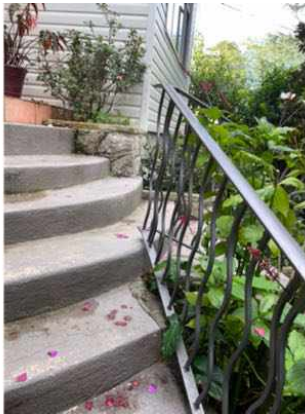
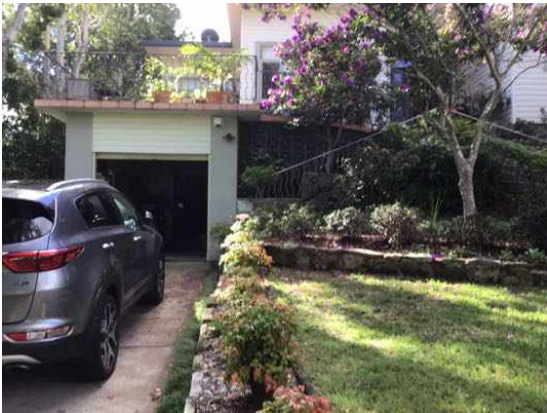
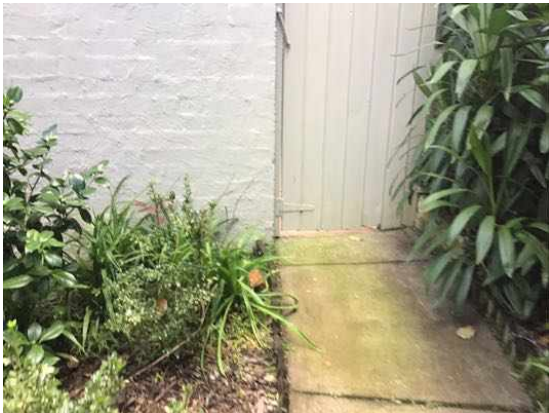
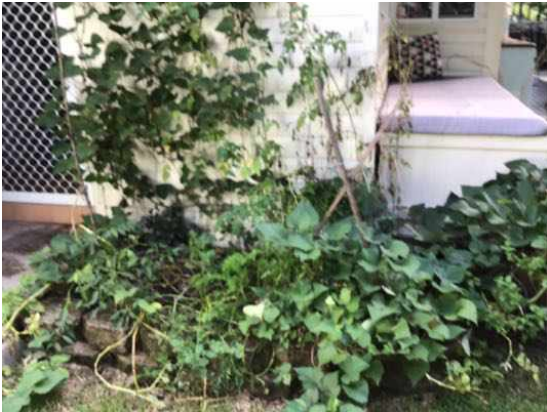
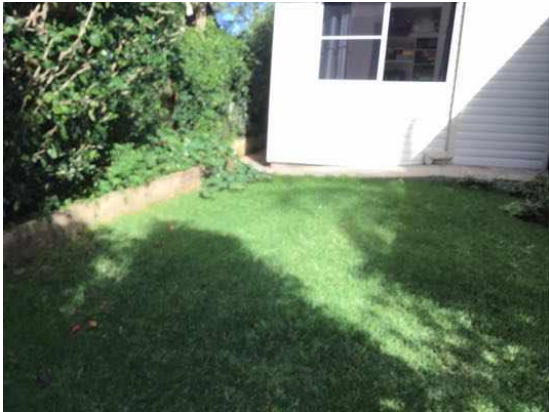
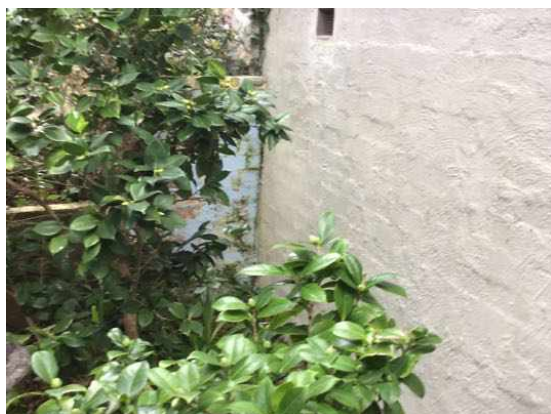
Noted Item

Building: Building 1
Location: All External Areas
Finding: Garden Beds - Conditions Conducive to Termites
Information:

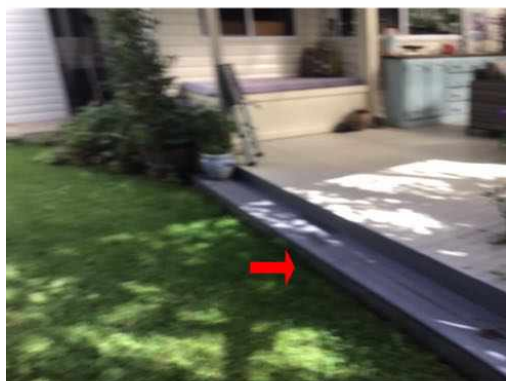
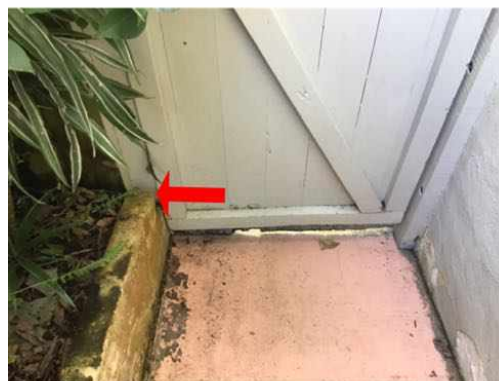
Noted Item

Building:	Building 1
Location:	All External Areas
Finding:	Building materials in direct ground contact - conducive to termites
Information:	Where timber elements are in direct contact with the ground and consequently moisture or dampness they become conducive to termite activity. Whether timber is used as a building element part of a fencing structure or stored as an unused item they can provide an environment that is attractive to termite infestation. When met with excessive moisture timber begins to decay and develop wood rot. Any timbers that are in direct contact with external grounds especially if left untreated or non- durable also provide ingress for subterranean termites into that particular element. The removal of any such materials that may be conducive to termite activity should be removed as soon as possible to minimise the risk of termite attack.

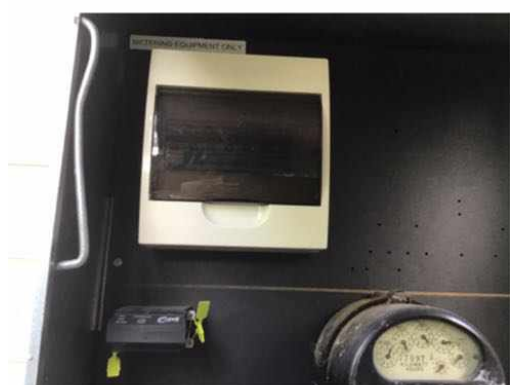
Noted Item

Building:	Building 1
Location:	Yard - Side
Finding:	Termite Management System - no evidence of installation
Information:	The application of a post-construction chemical termite barrier is highly recommended for all properties, particularly if live termite activity has been found on the site previously. Such barriers are highly effective in preventing termite attack on any timber

A durable notice should be placed in the switchboard unit to indicate current termite barriers. At the time of inspection, it appeared as though no termite management system has been installed, with no evidence to suggest preventative works taking place.

The client may consider gaining further advice from a pest controller as to the costs and procedures involved with this application. It is recommended that obtaining such advice be a short-term priority.
