Visual Pre Sale Timber Pest Inspection Report

22 Creer Place Narraweena

Report Number 22 creer pl narraweena 210616

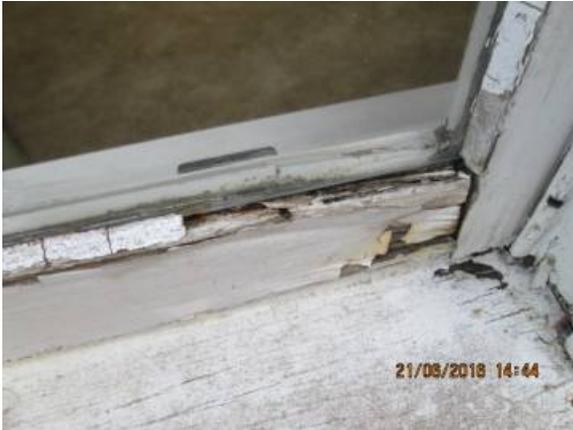
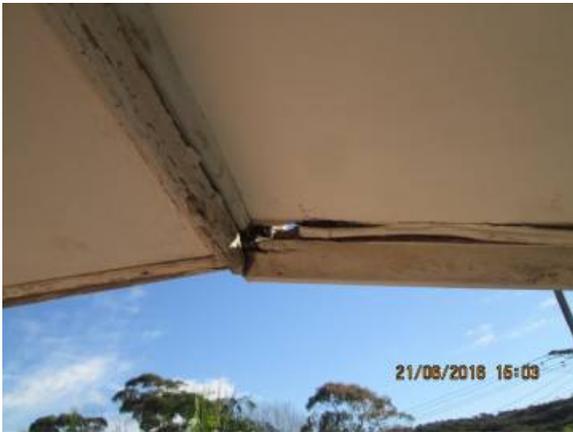
Yes - Wood decay damage was noted to the following timbers/areas.

Window frames: Fascia timbers: Balcony timbers:

Severity:

Southern elevation. Western elevation.

Visible timber damage appears minor to moderate. We recommend damaged timbers be repaired. A builder should be engaged to assess, quote & carry out repair.

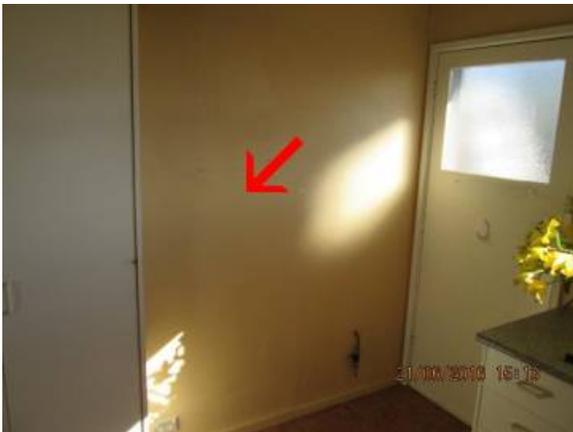
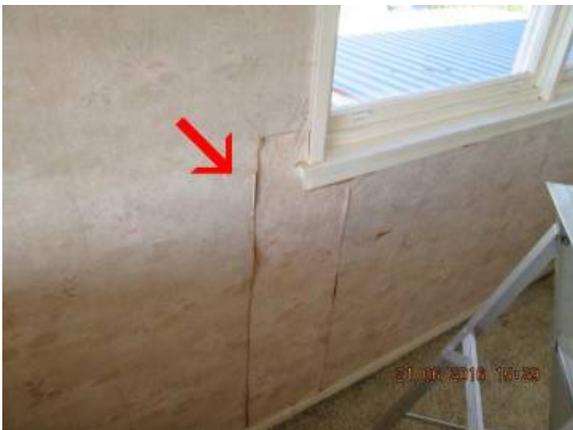
High moisture levels were detected to some internal walls as noted below. The moisture was considered higher than acceptable for the property inspected. This can be an indicator of a free moisture source (water leak) or possible timber pest activity. In all cases where a high moisture level is encountered, we strongly recommend further investigations be carried out to determine the cause of this situation. Moisture was tested in the range of: 80%

Kitchen. Ensuite. Lounge room.

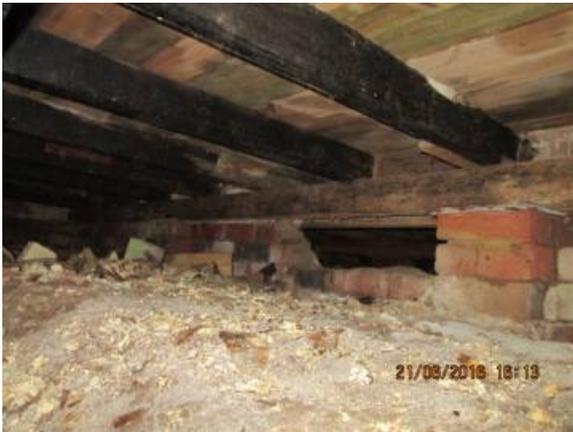
Crawl space was limited due to the method of construction resulting in a limited visual inspection from a distance being carried out. Access gained under ground floor NE bedroom ONLY.

Active termites or other timber damaging pests may be present and not detected in areas where inspection was limited, obstructed or access was not gained. We STRONGLY recommend that access be gained to all inaccessible areas. See Section 2.0 - Reasonable Access

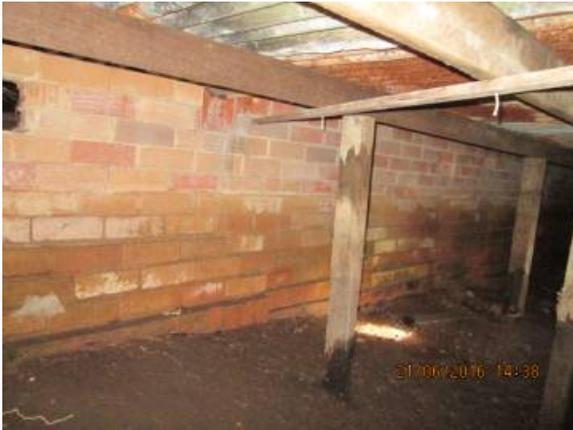
Yes - Wood decay damage was noted to the following timbers/areas.

Formwork timbers.

Visible timber damage appears moderate. We recommend a builder be engaged to quote & repair damaged timbers.

Rear verandah.

We recommend the removal of forming timbers from the under floor area as these predispose the property to termite attack. The under floor soil appears damp. This should be monitored on a regular basis as moist soil conditions are highly conducive to timber pest attack. Water is ponding on the soil within the under floor area. This may be due to a drainage problem or some other factor. This should be rectified as moist soil conditions are highly conducive to timber pest attack.

Rear verandah. Bedroom NE corner.
