# Building Inspection Report

Inspection Date: Fri, 06 Sep 2019

Property Address: 2 Lynette Place, Belrose NSW, Australia

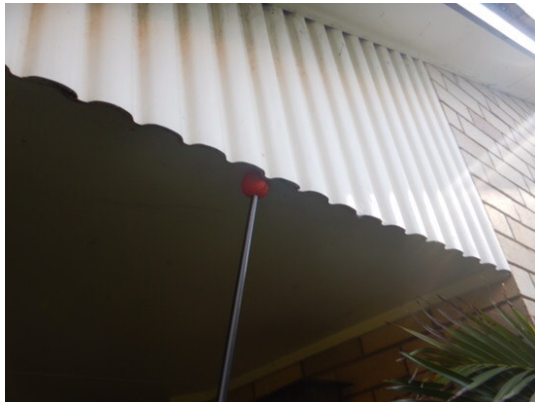
#### Defects 1.01

Building: Main Building  
Location: Yard - Back  
Finding: Asbestos - Suspected ACM Identified on Site  
Information: Reporting on Asbestos is outside the Scope of this Report. This suspected defect is highlighted as a caution only. We suspect, based on our experience in the building industry, that there is a higher risk of the identified building element containing asbestos.

As Asbestos Reporting is outside the scope of this report, we advise that you consider a separate Asbestos Inspection and Condition Audit, which can include the taking of samples for definitive confirmation of the presence of Asbestos.

In the interim, the client is advised to act with caution, especially when considering any damage to building materials general wear and tear renovations extensions demolition and general maintenance activities due to the suspected presence of Asbestos.

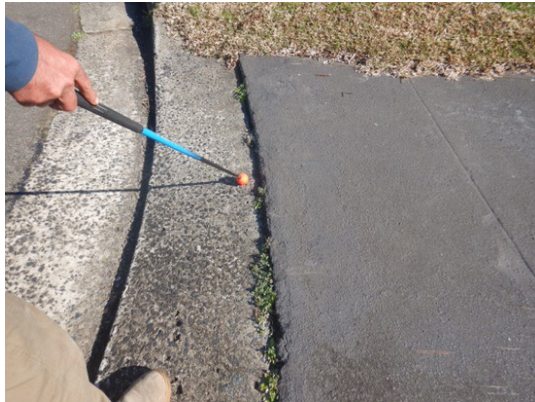
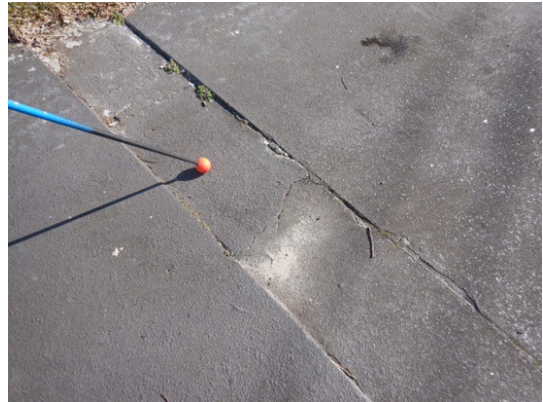
#### Defects 3.01

Building: Main Building  
Location: Yard - Front  
Finding: Cracking - External Concrete Paving Damage Category 1 - Fine (less than 2mm)  
Information: Fine cracks were identified in external concrete paving. Although fine cracks are quite noticeable, they are often only considered to be an appearance defect, and usually do not indicate any structural damage. To be considered a Category 1 or fine crack, the crack is found to be <2mm in width.

Generally the cause of a hairline crack in existing concrete paving such as driveways and pathways is indicative of the expansion and contraction of the concrete. Such causes are generally due to environmental factors, such as moisture levels, weather conditions, root systems of nearby trees or the soil types on which they are laid.

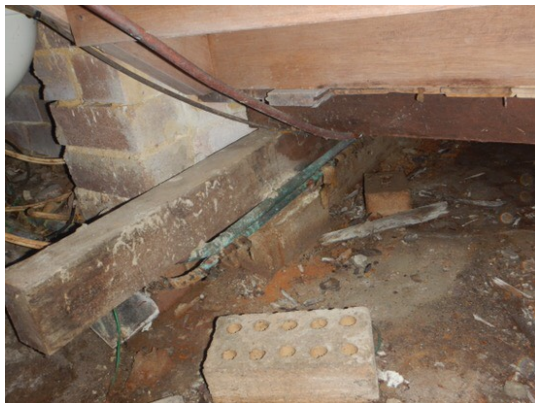
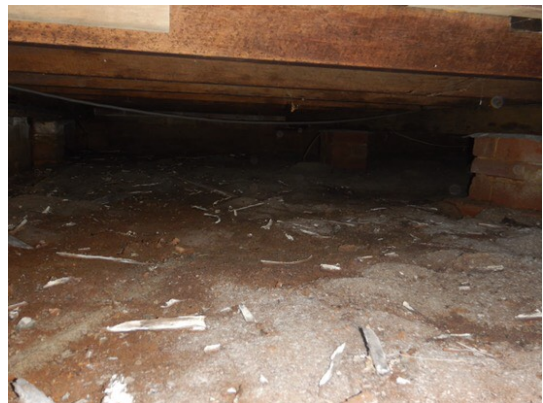
## Defects 3.02

Building:	Main Building
Location:	Subfloor
Finding:	Evidence of excessive moisture was present at the time of inspection
Information:	Excessive moisture can attract termites and produce conditions that promote termite attack fungal growth and wood decay.

Excessive moisture is generally caused by deteriorated inadequate or missing roof drainage leaking plumbing pipes or fixtures poorly plumbed HWS overflows or condenser units and poor site drainage.

It is highly recommended that all plumbing and drainage fixtures and fittings be maintained regularly in order to prevent excessive moisture being present in the external / internal property.

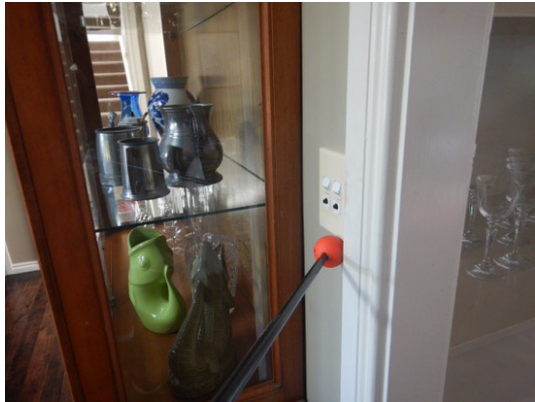
## Defects 3.03

Building: Main Building  
Location: Lounge Room  
Finding: Switches - Damaged/Faulty  
Information: The switches in this area was found to be damaged or faulty at the time of inspection. This occurs generally when the building materials have either aged and decayed or as a result of impact damage (accidental or deliberate). This damage may also have occurred during installation.

Repair and/or replacement of the switches is advised to ensure the fixture and it's associated structures are safe and fully operational. A licensed electrician should be appointed to repair/replace the light switch as soon as possible.

Please note that commenting on electrical works are outside the scope of this inspection. Please engage a licensed electrician to further inspect the property, at client discretion.

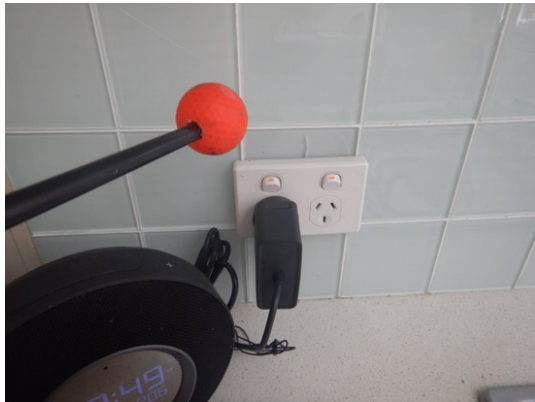
## Defects 3.04

Building:	Main Building
Location:	Kitchen
Finding:	Tiles - Cracked or damaged
Information:	Cracking was evident to the tiling in this area at the time of inspection. While the cracking appears to be minor, this area is frequently exposed to water, allowing potential for water penetration into adjoining sections of walls or flooring.

If left unmanaged, water penetration to these areas may lead to subsequent water damage, which is likely necessitate repair work to affected building elements.

A tiling contractor should be appointed to ensure that no further water damage occurs. The re-application of silicone and grouting throughout remaining tile work is also advised, to further protect the area against water penetration.

Where water penetration has led to water damage, appointment of a relevant tradesperson may be required to repair damaged building elements.

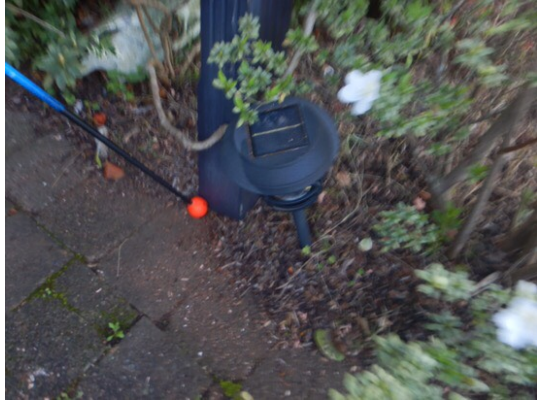
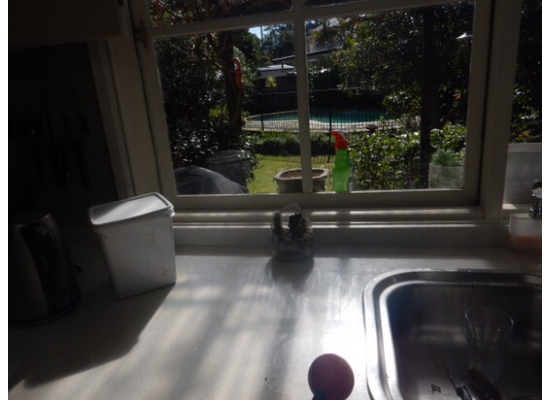
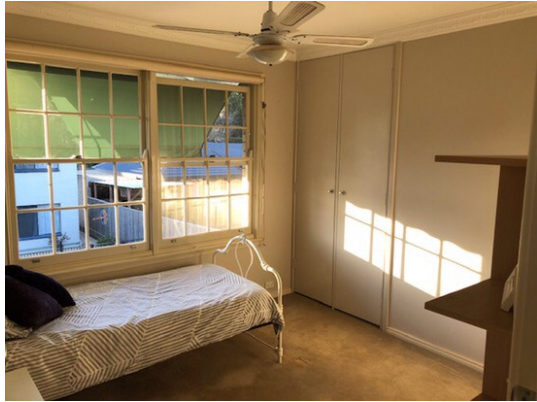
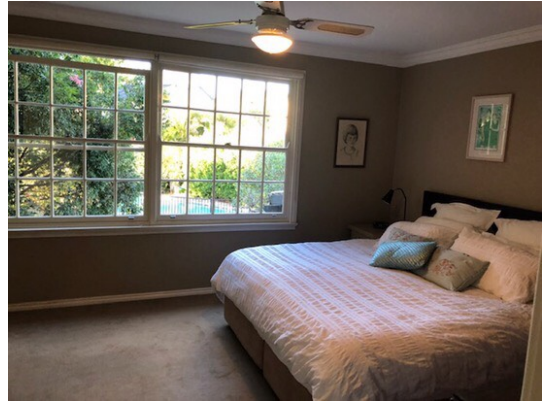
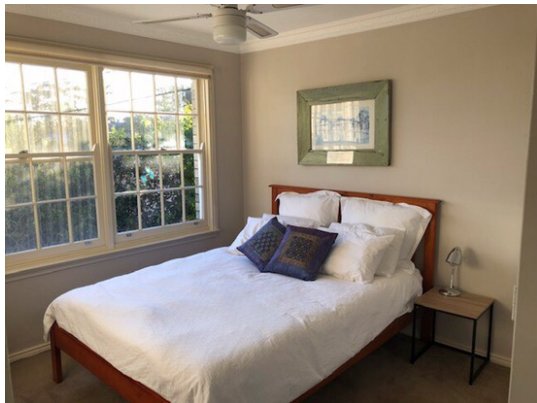
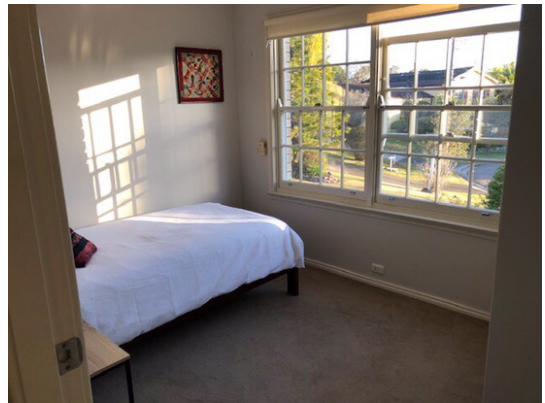
Building:	Main Building
Location:	All Areas
Finding:	Additional Photos - Obstructions and Limitations
Information:	These photographs are an indication of the obstructions and limitations which impeded full inspection of the property at the time of inspection.

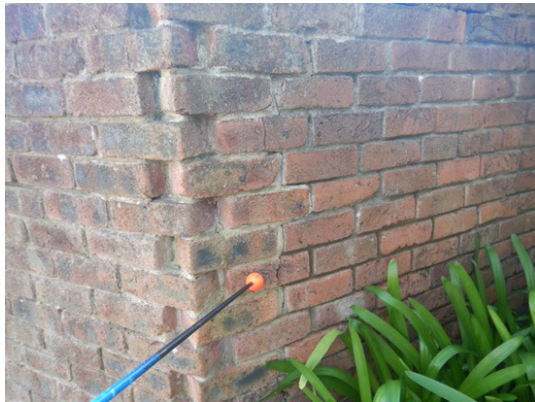
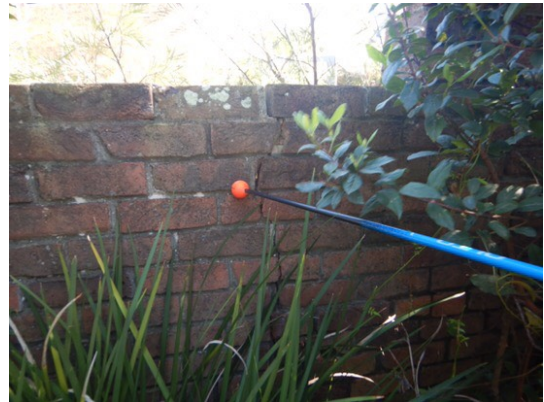
Building: Main Building  
Location: Yard - Front  
Finding: Fence Brickwork - Step cracking  
Information: Step cracking was identified to the brickwork in this area at the time of inspection. Step cracking, which is similar to other forms of cracking, has a variety of possible causes. However, the most common is the subsidence of adjacent footings.

Step cracking is a relatively common defect, and is most likely to occur adjacent to windows, doors and other openings. Mortar failure in the gaps between affected bricks indicates the stresses and tensions affecting the wall.

Where step cracking is extensive or severe, the client is advised to consult a structural engineer. Minor step cracking can be used as a warning sign to address factors causing stress to the wall, which can include the effect of surrounding trees, water leaks, soil erosion, or even the presence of reactive soils in the surrounding area.

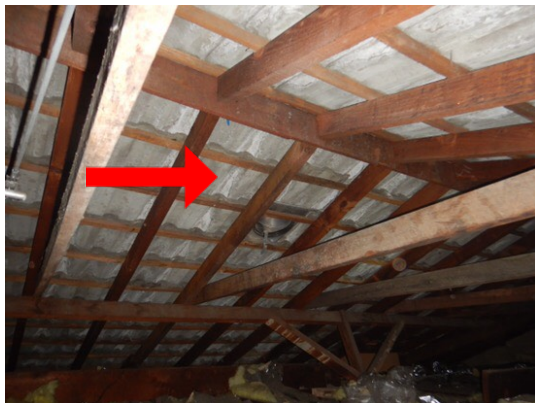
Building: Main Building  
Location: Roof Void  
Finding: Sarking - Missing  
Information: Sarking is missing under the roof sheeting. Sarking acts as an insulator that helps with noise reduction and protects against water penetration. Sarking plays a key role in the operation and function of the overall roofing structure and its performance.

Although not a requirement at the time of construction, replacement of any missing building element is advisable (although this can be quite expensive to do after the time of construction). Where sarking is missing, regular inspections of the roof tiles for cracking and potential moisture penetration is required.

Sarking may be retrospectively fitted by a registered builder at the discretion of the client.
